**ENVIRONMENTAL MITIGATION PLAN**  
**SUTHERLAND 43.5km STREAM CROSSING REPLACEMENT**  
Replacing a 1400mm closed metal pipe with a 4270 x 1840 x 21000 open bottom arch  
on concrete footings

In accordance with the FIA Restoration and Rehabilitation Component,  
Aquatic Activity Area: Fish Passage

September 2009

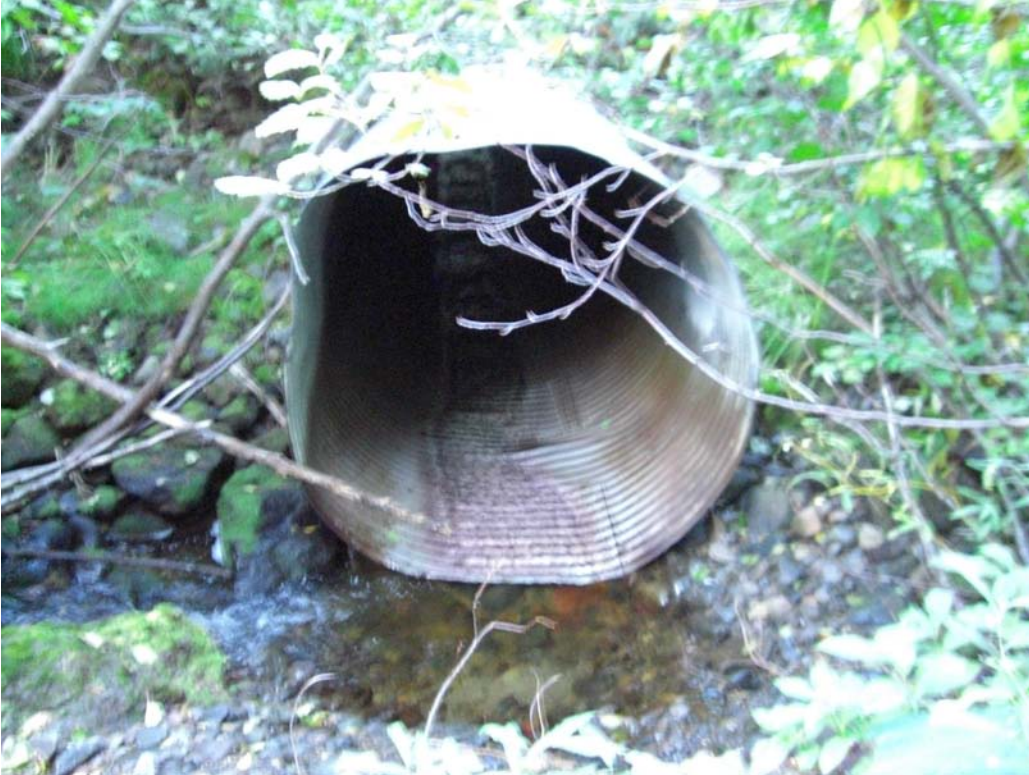
Photo 1. Sutherland 43.5km inlet.

- 1400mm x 19m closed corrugated metal pipe
- 2m fill depth
- 60cm culvert outfall drop with a large outfall pool >1m deep
- 3% culvert slope

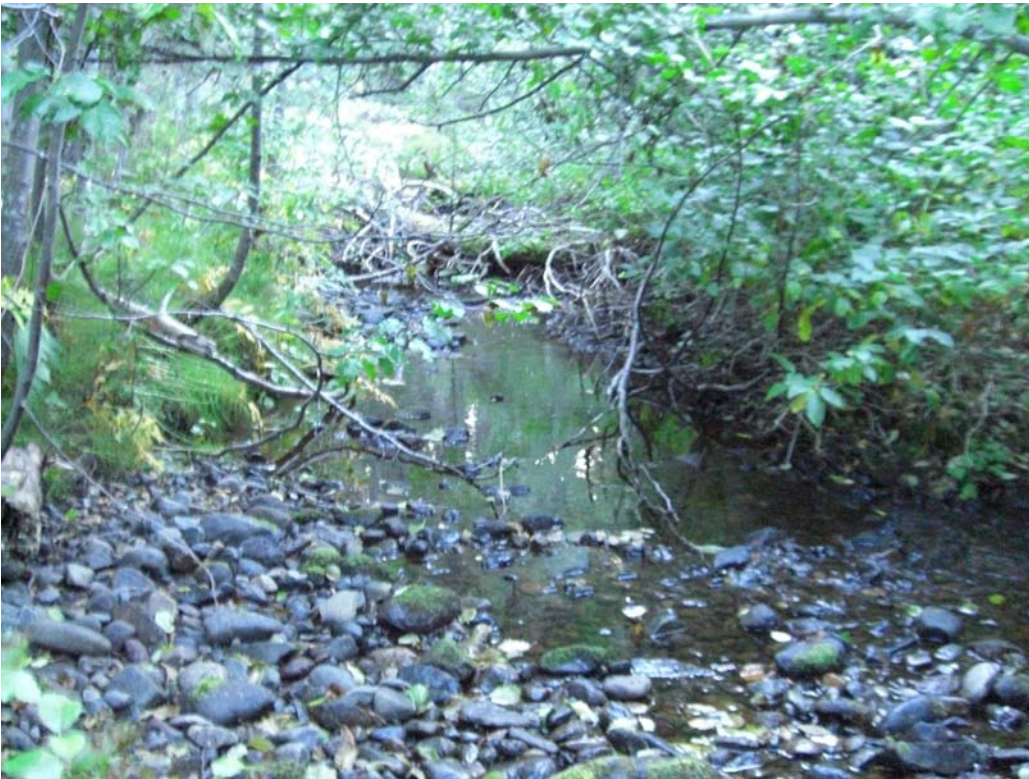
Photo 2. Upstream from culvert.

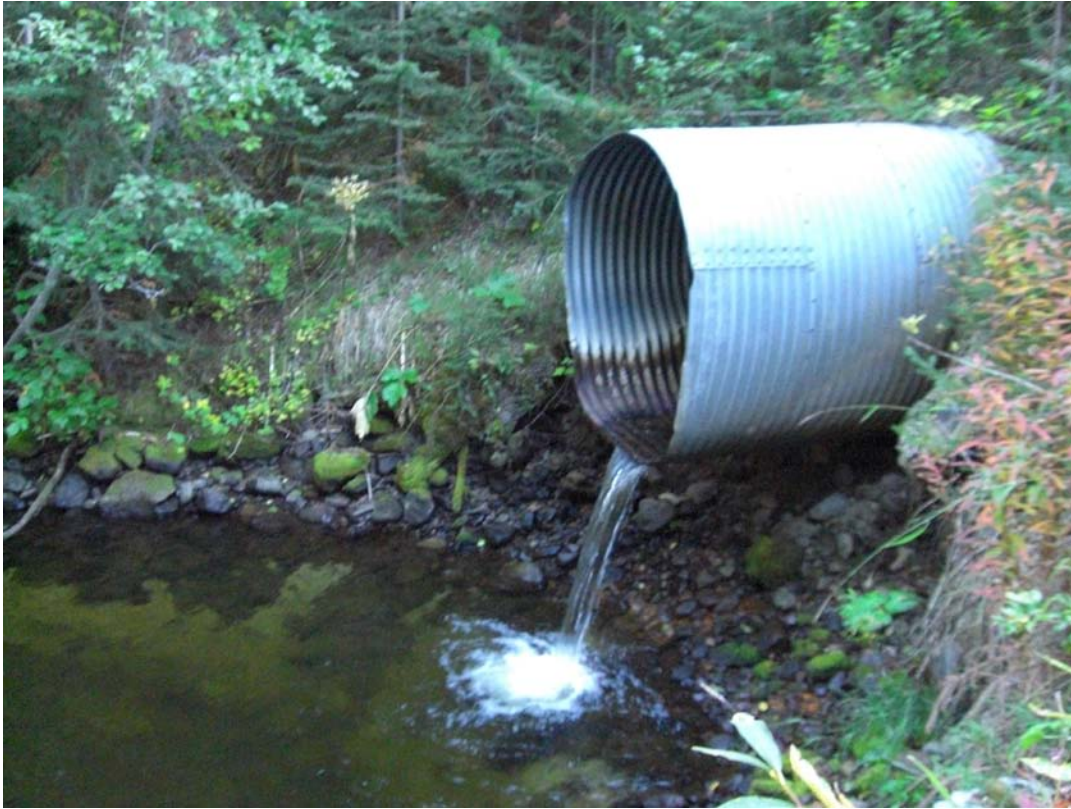
Photo 3. Sutherland 43.5km outlet.

There is a large existing outlet pool that provides excellent habitat and should be maintained.

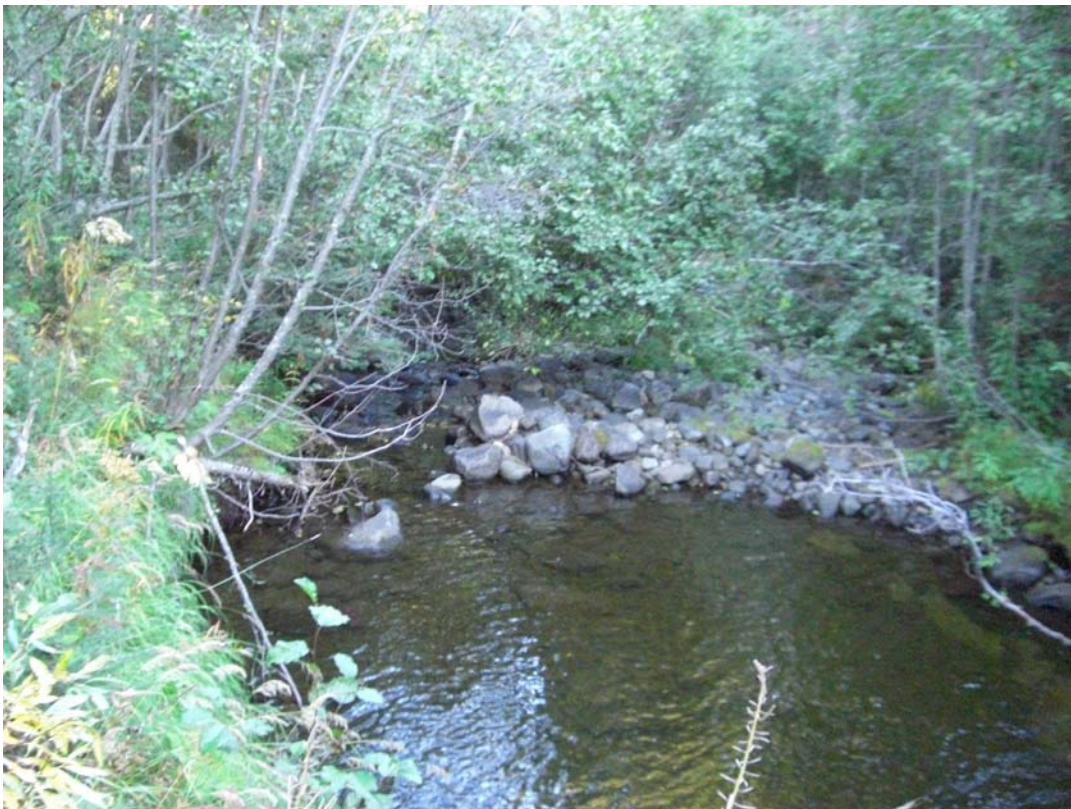
Photo 4. Downstream of existing culvert at Sutherland 43.5km.

- Average stream width is 2.9m
- Streambed composition is 5% sand and silts, 15% gravels, 30% cobbles and 50% boulders
- Gradient varies from 2% to up to 7% due to cascade-pool morphology.
