ENVIRONMENTAL MITIGATION PLAN DIPPER 0.7km STREAM CROSSING REPLACEMENT

Replacing a 900mm closed metal pipe with a 4270 x 1840 x 18000 open bottom arch on concrete footings

September 2009

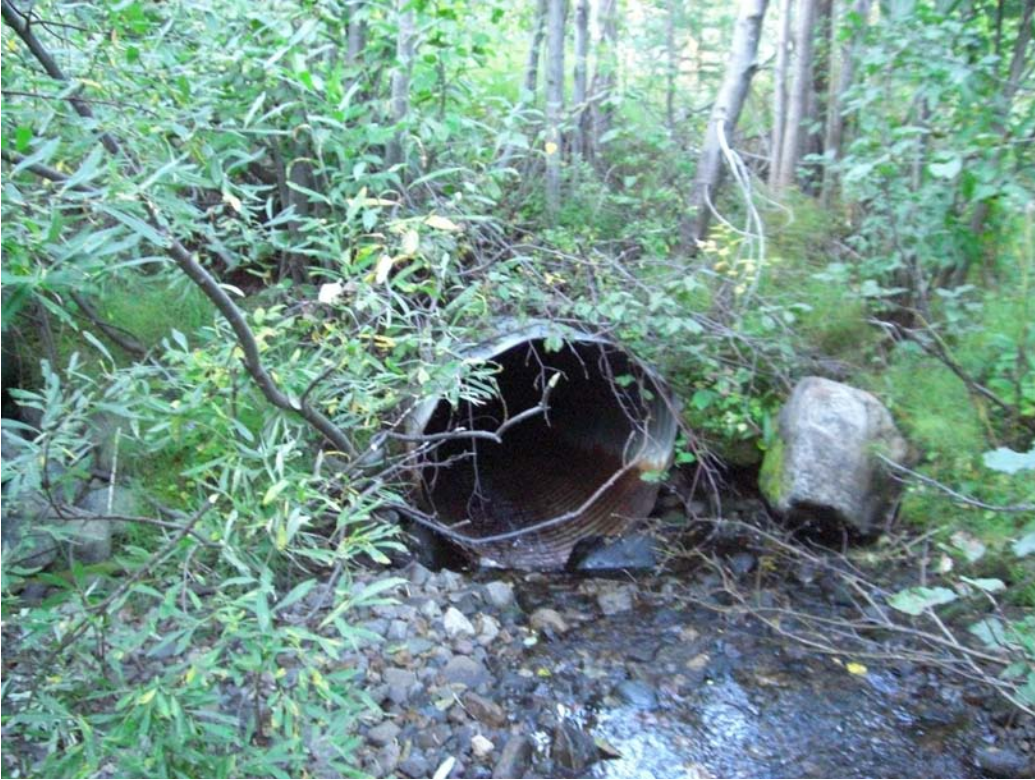
Photo 1. Dipper 0.7km inlet.

- 900mm x 13m closed corrugated metal pipe
- 1.2m fill depth
- 33cm culvert outfall drop with a no outlet pool
- 8% culvert slope

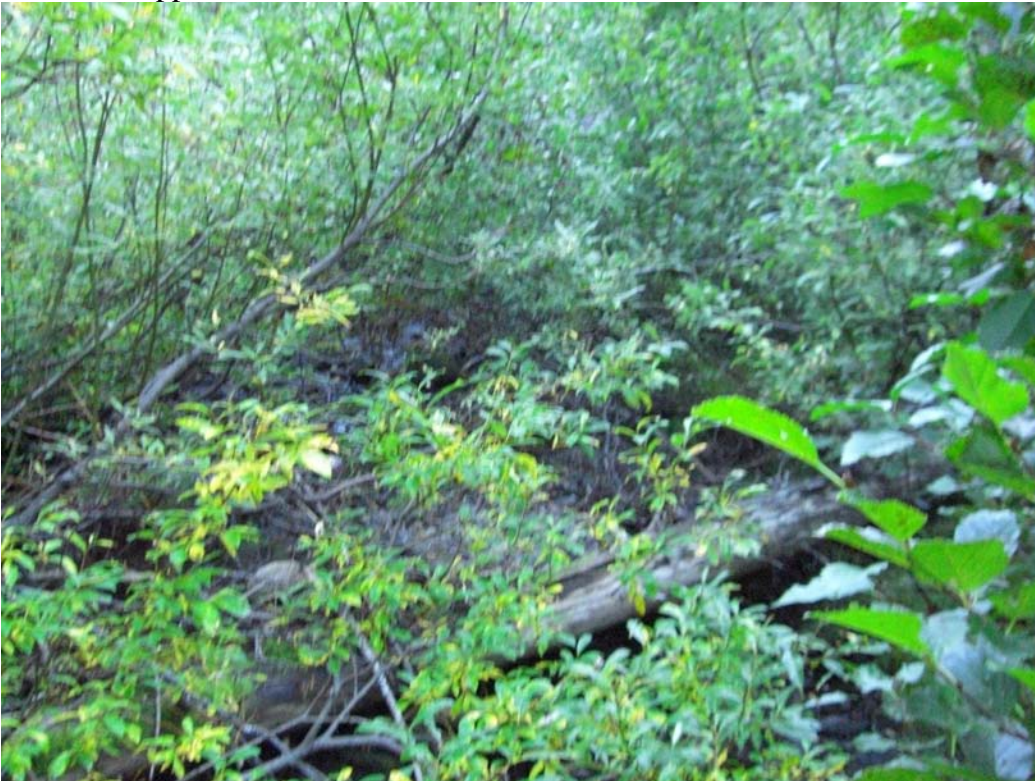
Photo 2. Upstream from culvert at Dipper 0.7km.

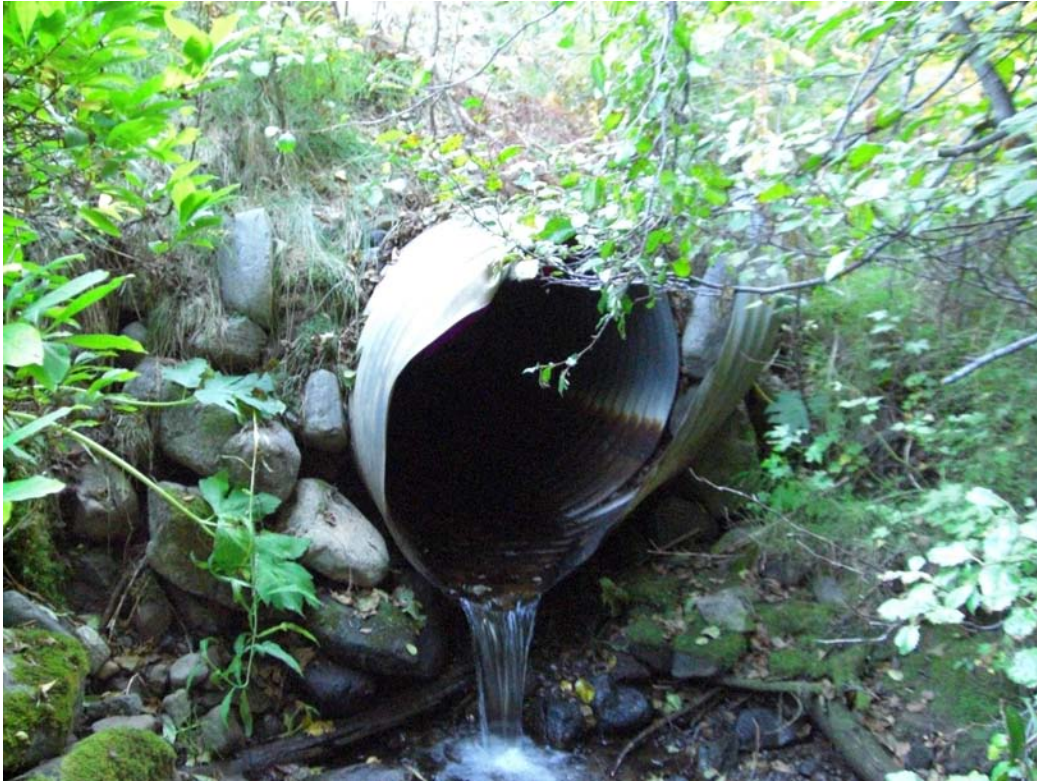
Photo 3. Dipper 0.7km outlet.

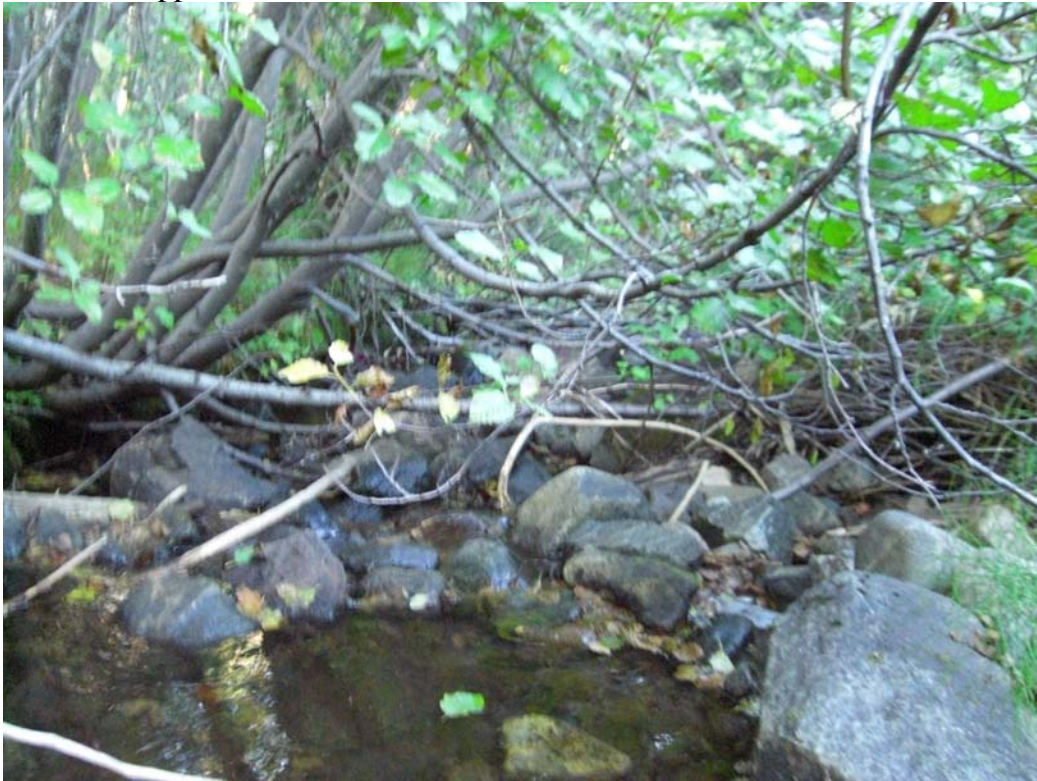
Photo 4. Downstream of existing culvert at Dipper 0.7km.

- Average stream width is 2.4m
- Streambed composition is 10% sand and silts, 30% gravels, 40% cobbles and 20% boulders
- Gradient varies from 6% to up to 10% with cascade-pool morphology.
