Project Completion Abstract
For Environmental Maintenance Projects (Roads Activity Area) & Road Deactivation,
Landslide and Gully Rehabilitation (Terrestrial Activity Area)
Stream Crossing Replacements in the Babine Lake Watershed of the
Sutherland Operating Area, Vanderhoof Forest District, Northern Interior
Forest Region

This project replaces three stream crossings that were barriers to fish passage in the Babine Lake Watershed, Sutherland Operating Area, Vanderhoof Forest District:

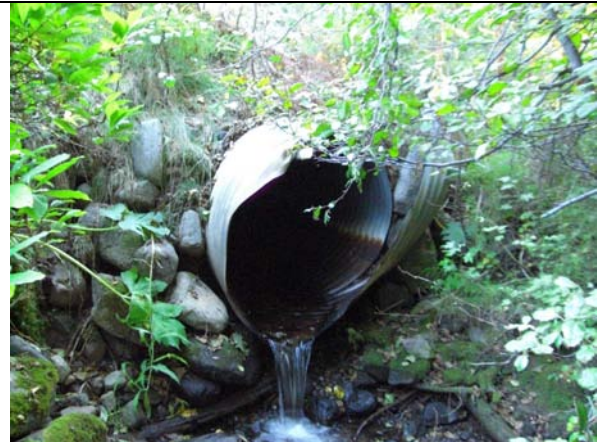
Dipper 0.7km Photo 1. Pre-existing 900mm CMP outlet, September 2009.

1. At 0.7km on the Sutherland-Dipper FSR, replacement of a 900mm closed metal pipe with a 4270x1840x18000 open bottom arch on concrete footings.
2. At 43.5km on the Sutherland FSR, replacement of a 1400mm closed metal pipe with a 4270x1840x18000 open bottom arch on concrete footings.
3. At 26.5km on the Sutherland FSR, replacement of a 800mm closed metal pipe with a 3660x1910x17640 open bottom steel arch on steel footings.

1. The Dipper 0.7km crossing was a 900mm CMP on a 2.4m wide stream with a 33cm drop.
2. The Sutherland 43.5km crossing was a 1400mm CMP on a 2.9m wide stream with a 60cm drop.
3. The Sutherland 26.5km crossing was a 800mm perched CMP on a 2.6m wide

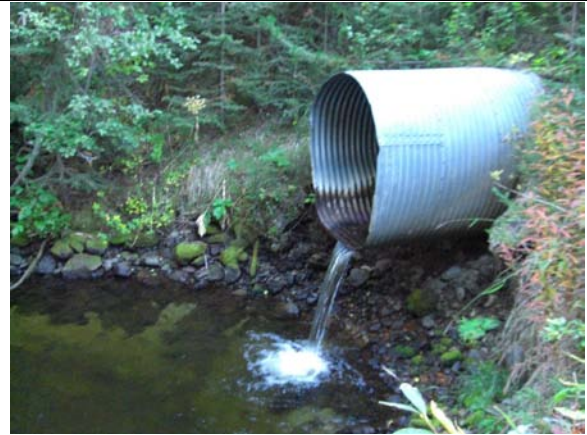
Sutherland 43km Photo 1. Pre-existing 1400mm CMP outlet, September 2009.

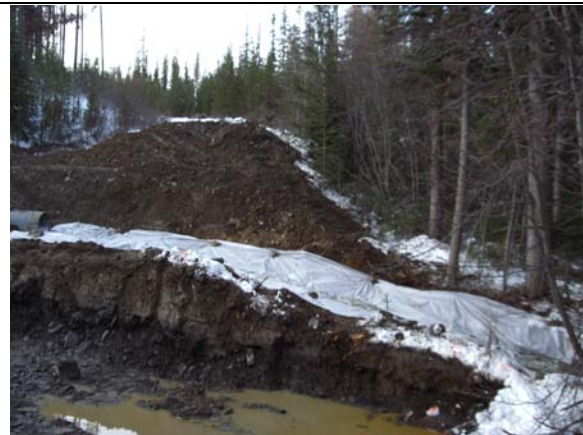
Dipper 0.7km Photo 2. Stream diversion, November 3, 2009.

Stream Diversion: All 3 streams were diverted for construction using diversion culverts and lining temporary channels with plastic.

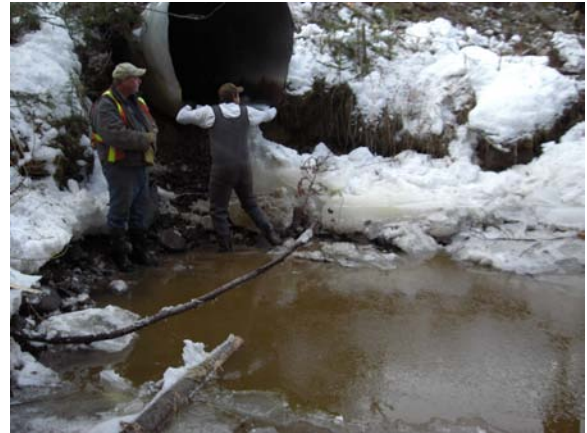
Sutherland 43km Photo 2. Outlet pool to be salvaged, November 11, 2009.

The only crossing with potential overwintering habitat at the site was Sutherland 43.5km, with a large outlet pool approximately 1.5m deep. The pool was created from scouring due to an undersized culvert and needed to be filled in for the new crossing. Overnight minnow traps on November 3, 2009 yielded 3 juvenile Rainbow Trout so the pool was planned to be drained and salvage by dipnetting. The stream was diverted on November 11 and the pool was drained by pumping. One hundred and ten (110) juvenile Rainbow Trout were removed by dipnetting and released downstream in suitable overwintering habitat. The largest was 22cm long while most were approximately 10cm long.

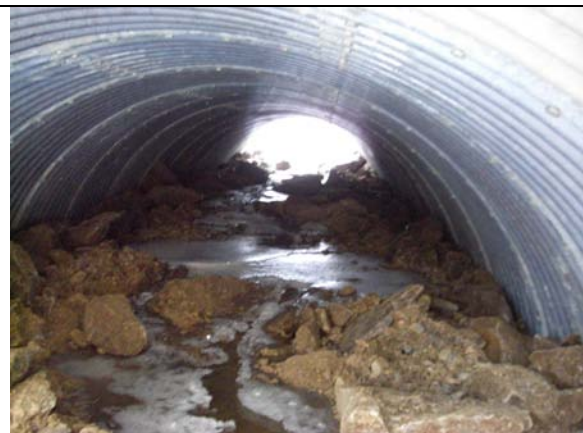
Dipper 0.7km Photo 3. Finished step-pool morphology streambed inside new arch.

The Dipper 0.7km streambed was constructed to 2.4m at 8% which is a step-pool morphology. Large boulders were placed across the arch

every 2-3 metres to create pools with 10-15cm drops.

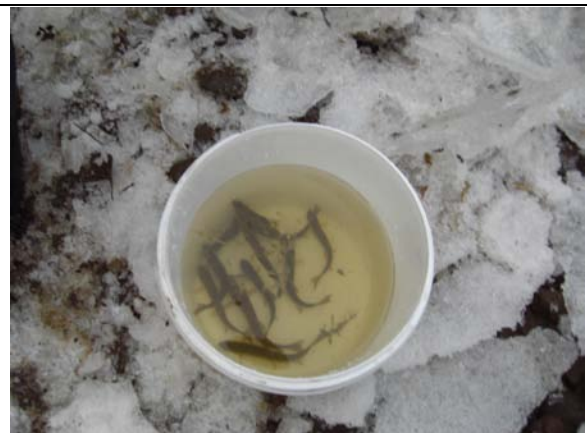
Sutherland 43km Photo 3. Some of the Rainbow Trout salvaged from outlet pool on November 11, 2009.

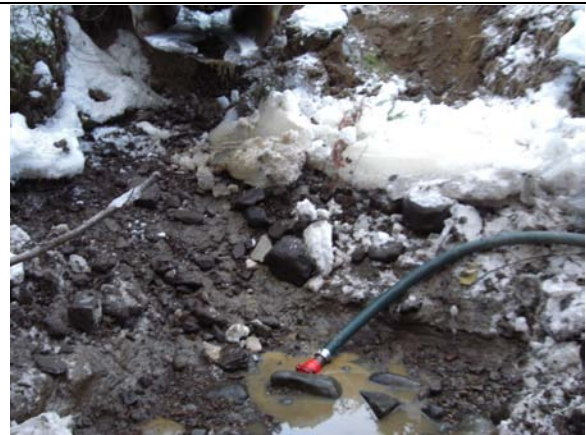
Sutherland 43km Photo 4. Salvaged outlet pool has been completely drained with 110 Rainbow Trout removed by dipnetting, November 11, 2009.

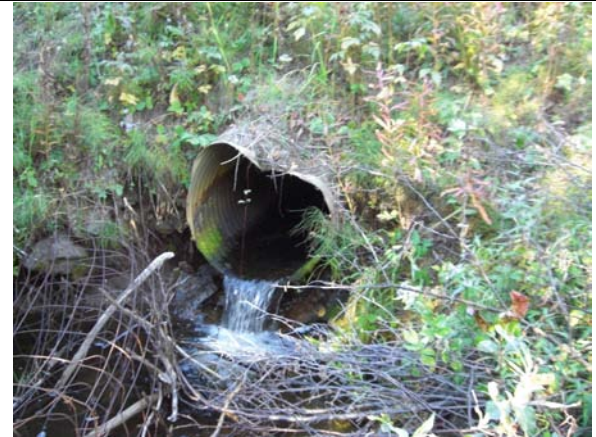
Sutherland 26.5km Photo 1. Pre-existing 800mm CMP outlet, September 2009.

stream with a 20cm drop. The perched inlet had ponded the upstream.

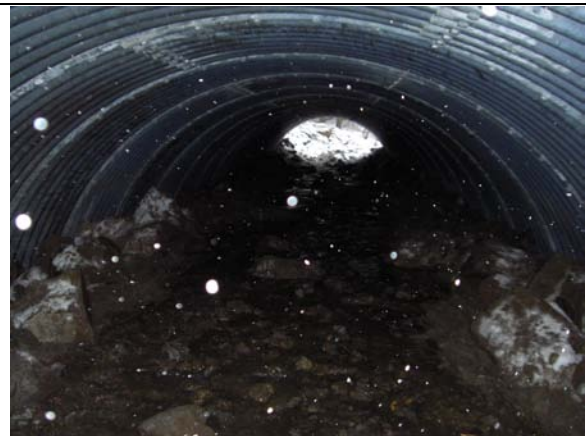
Sutherland 43km Photo 5. Finished cascade-pool morphology streambed, November 17, 2009.

The Sutherland 43.5km streambed was constructed to 2.9m at 4% which is a cascade-pool morphology. Large boulders were interspersed along the stream to interrupt flows and create small pools.

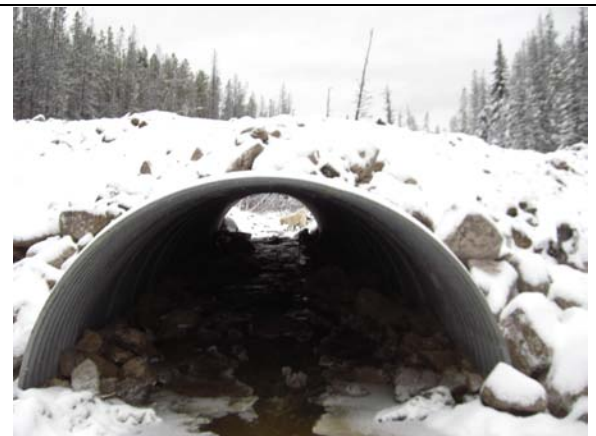
Sutherland 26.5km Photo 2. Finished riffle-pool morphology streambed, November 28, 2009.

The Sutherland 26.5km streambed was constructed to 2.6m and 4% which is on the border of Riffle-Pool and Cascade-Pool morphology. The streambed included some large boulders to slow down flows and create scour pools.
