TRIM Mapsheet: 093K.055

*Stuart Lake  
Lumber Co. Ltd.*

Date: November, 2001

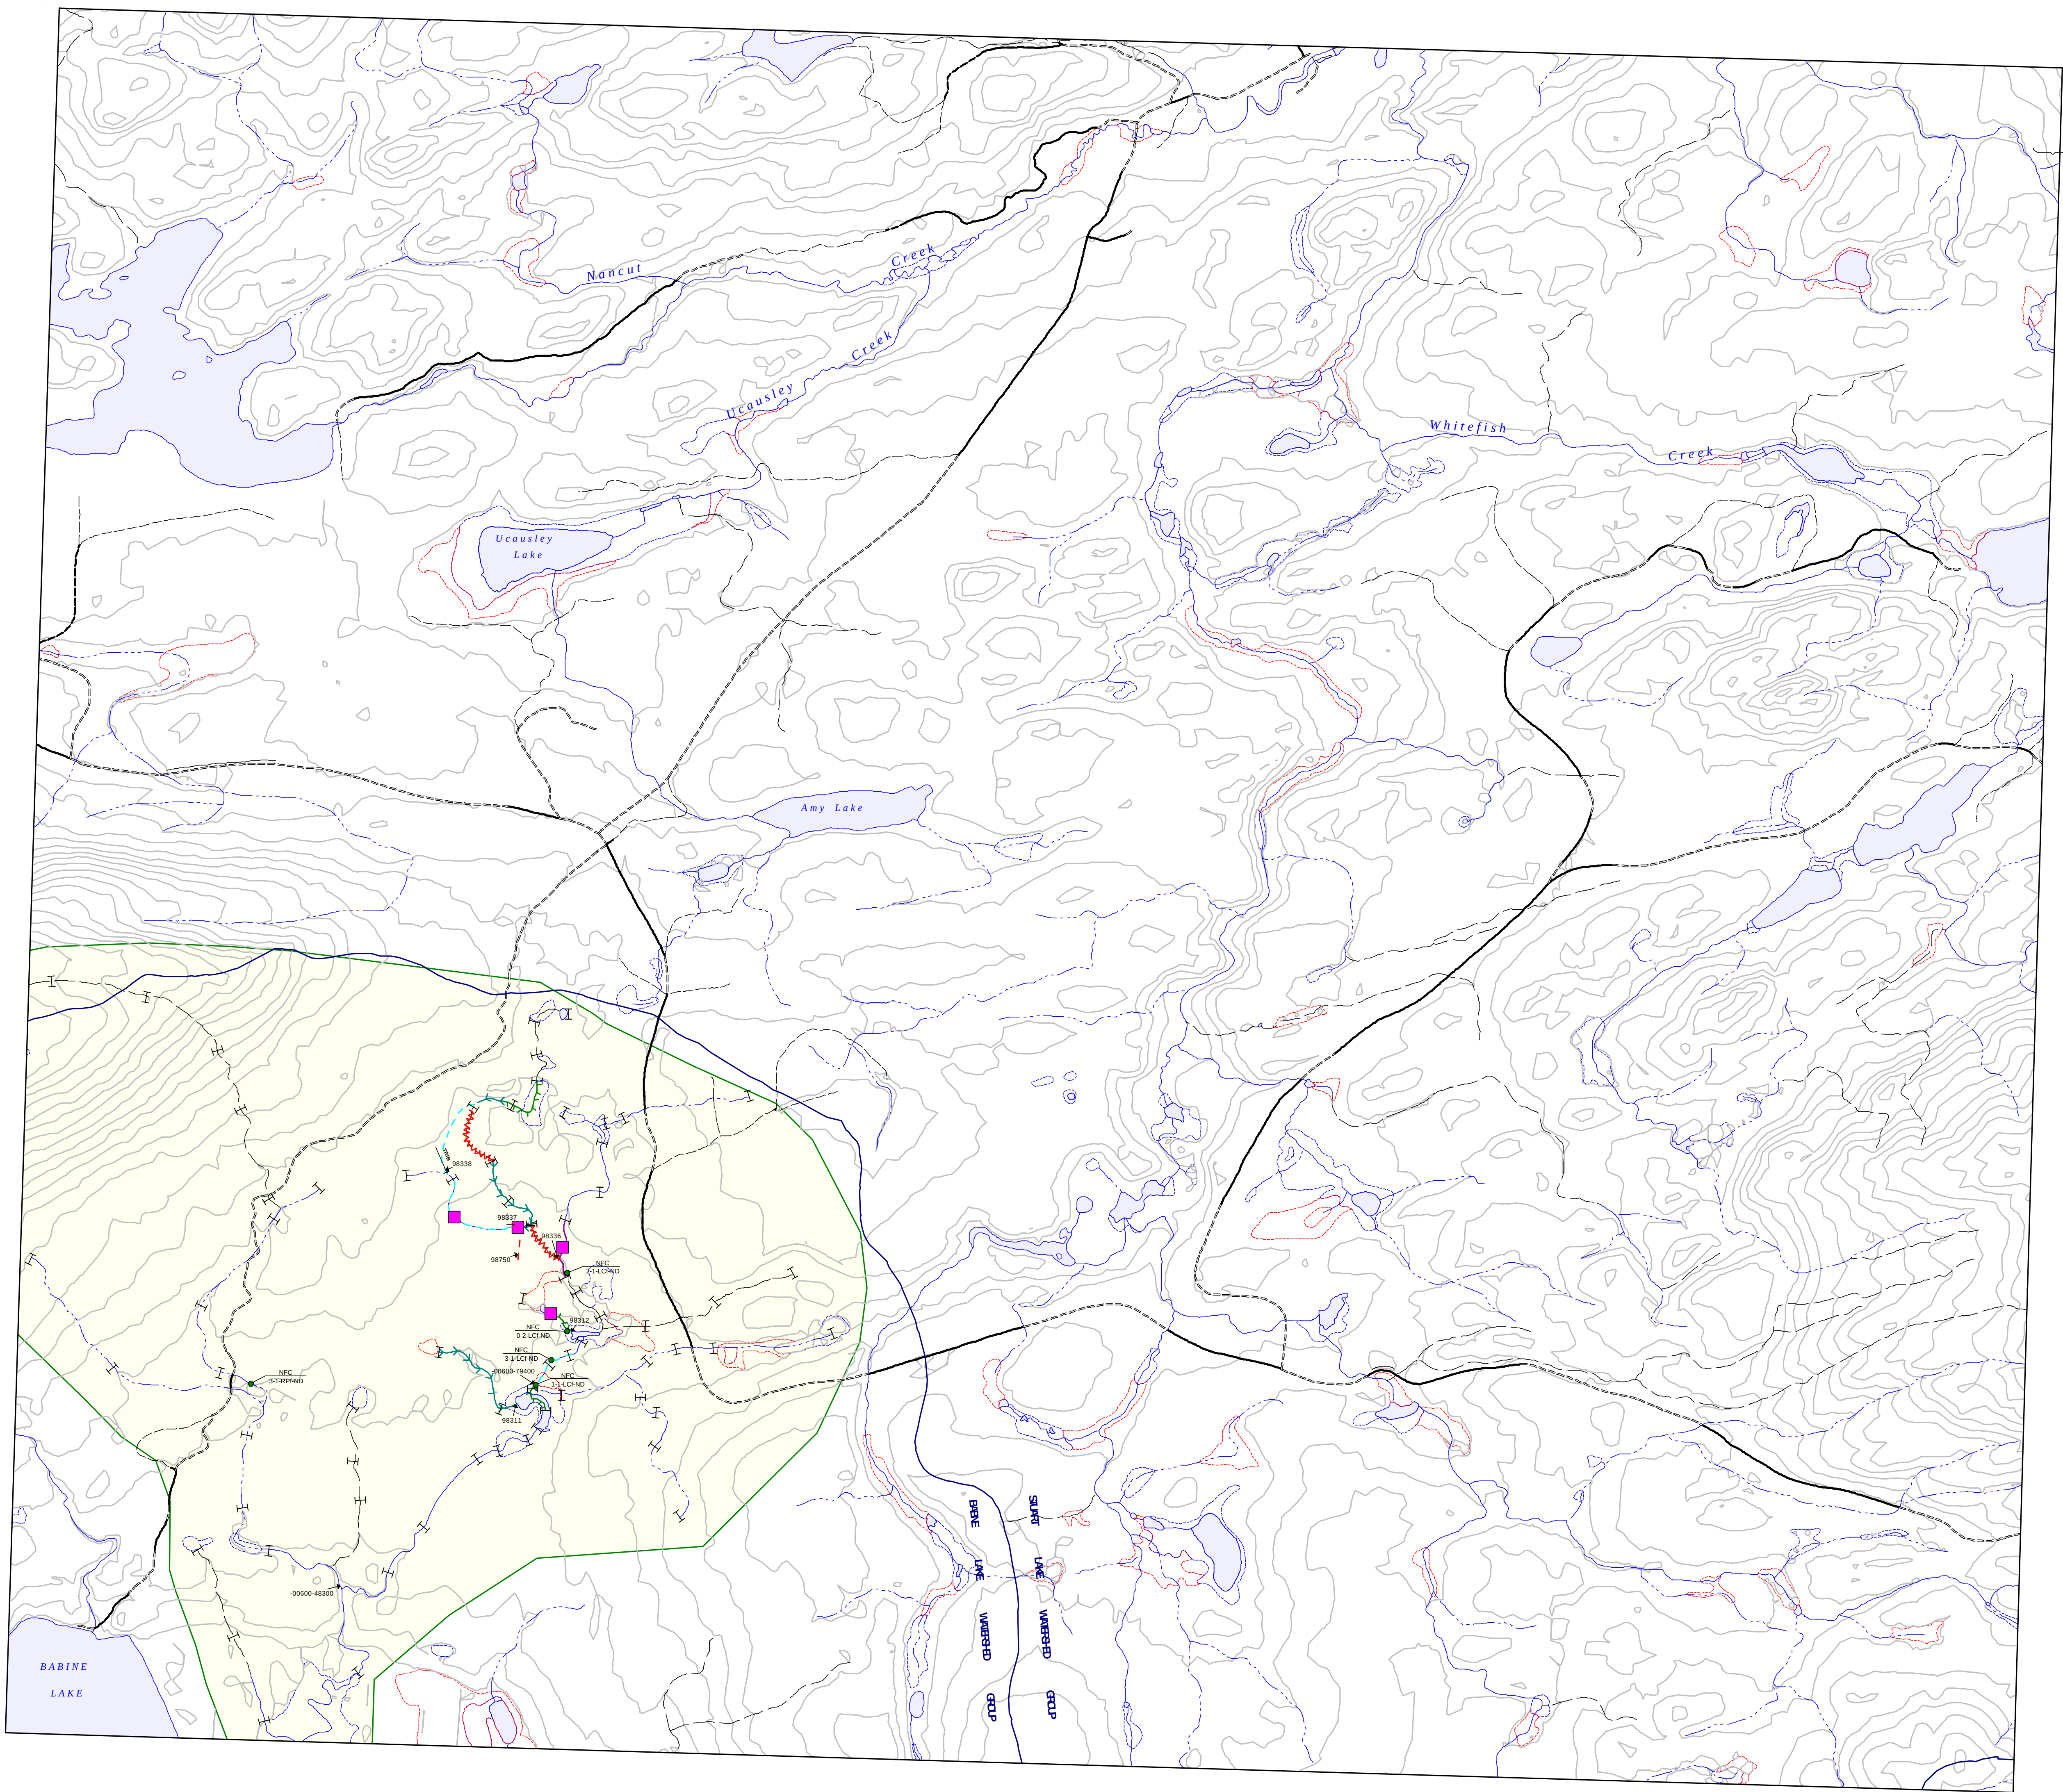
Legend for the Stream Condition Index (SCI):

- S-1 (Solid brown line)
- S-2 (Solid green line)
- S-2\* (Dashed green line)
- S-3 (Solid red line)
- S-3\* (Dashed red line)
- S-4 (Solid cyan line)
- S-4\* (Dashed cyan line)
- S-5 (Solid purple line)
- S-6 (Solid magenta line)
- Seepage (Line with arrowheads pointing right)
- Wetland (Line with vertical tick marks)
- Fisheries Sensitive Zone (Line with vertical tick marks)
- No Stream (Line with wavy zig-zag pattern)
- Dry Depression (Solid dark red line)

\* denotes defaulted classification assigned

The location of sample sites on this project map are not necessarily representative of the true location of the site according to ground-truthing. At the request of the Ministry of Environment, Lands and Parks, site sample locations have been moved onto the TRIM streamline. Corrected GPS information is presented in the 'Field UTM' columns in the project database.
