Hayward Watershed Fish Habitat and Fish Passage Assessment FWCP Project No. COA-F22-F-3524

November 2022

Prepared by: Ciara Sharpe, M.Sc. R.P.Bio.¹ and Angela Addison²

Prepared for: Fish and Wildlife Compensation Program

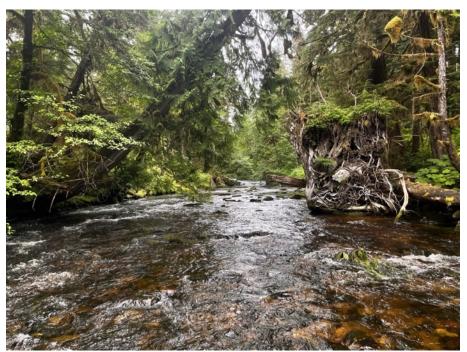
Photo 2. Stream habitat representative of Reach 2, with long riffle sections, boulders, abundant instream cover and habitat complexity.

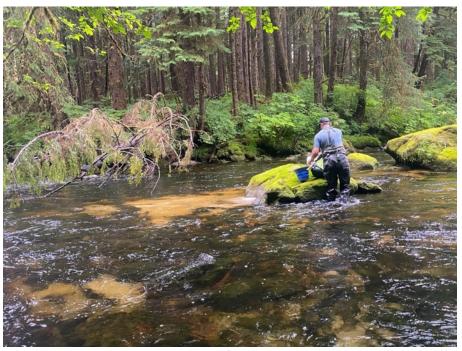
Photo 4. Representative illustration of habitat available in Reach 2 with riffle/run/pool complex and boulders, cobbles, instream vegetation and forest regeneration. Photo taken approximately at 5km, where logging occurred on both sides of the stream bank. Sediment is deposited throughout stream section behind boulders.

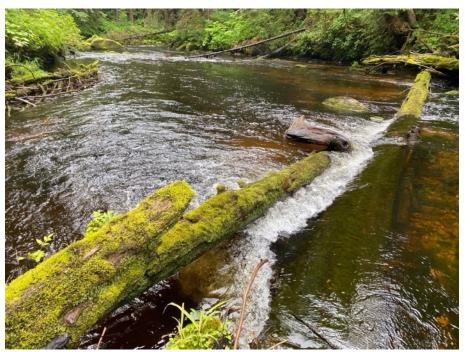
Photo 5. Large woody debris creating large scour pool in Reach 2 of Hayward Creek.

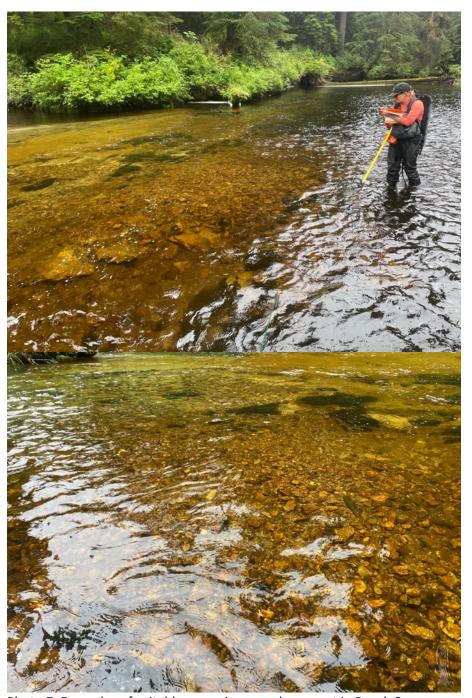
Photo 7. Examples of suitable spawning gravels present in Reach 2.

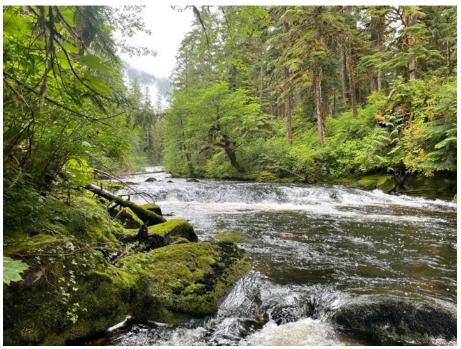
A series of bedrock cascades, the longest of which is 2m long is located at 5.2km and are passable, while a 4m vertical falls located 100m upstream may be passable for certain species (Coho and Chinook Salmon) in higher water on river right due to a narrow lower gradient section (Appendix D: Photo 9 -14). A side-channel starting at 5km on river left also provides fish passage at certain flows around the 4m falls by way of a cascade at the upstream end (16m long, 3m high), with resting pools in several locations along the cascade.

Photo 9. Photo facing upstream at a series of cascades with bedrock substrate downstream of the 4m falls present at 5.4km on Hayward Creek.

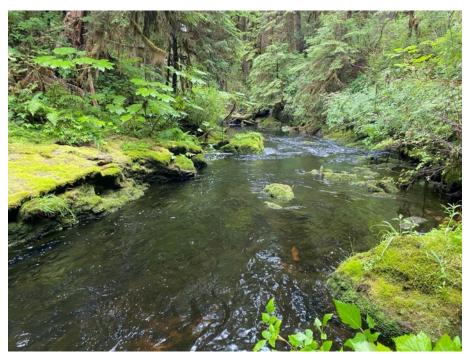
Photo 12. Viewing upstream in side-channel starting at 5km, and providing passage around the falls.

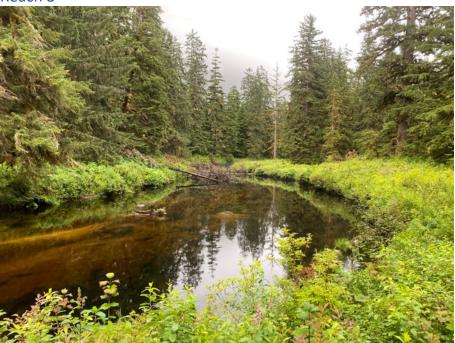
Photo 20. Habitat characteristic of Reach 3 as a deep, low gradient stream section dominated by fine sediment. This section was too deep to wade but contains stable banks, deep pools, cutbanks, overwintering habitat, LWD and a high abundant of rearing salmonids was visually seen.

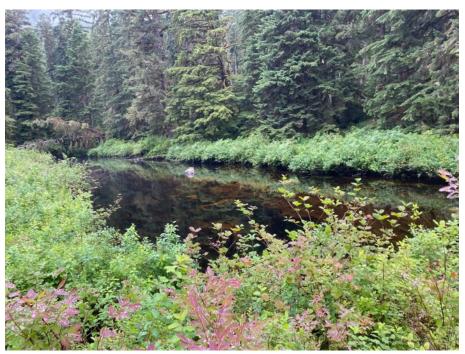
Photo 21. Habitat characteristic of Reach 3. Viewing deep low gradient stream section dominated by fine sediment.

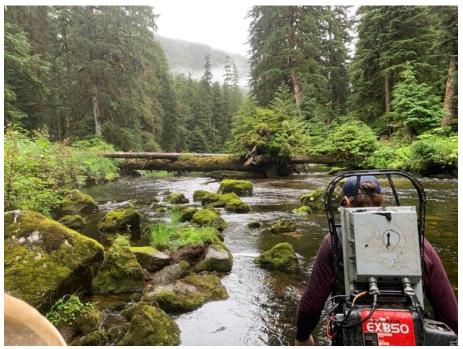
Photo 24. Viewing habitat available in lower sections of Reach 4 with run, riffle pool morphology, boulders and cobble present over 2-3% gradient.

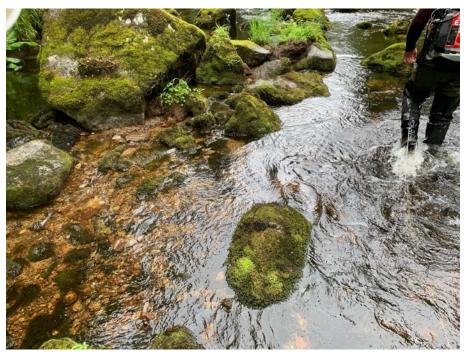
Photo 25. Viewing typical bed material present throughout Reach 4 with boulders, gravels and cobble.

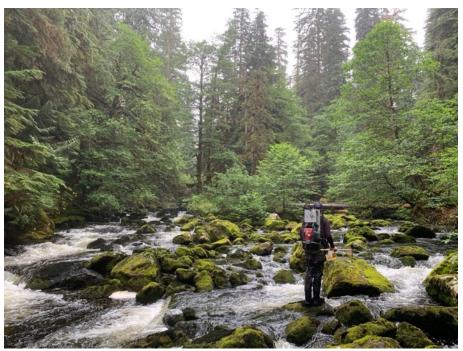
Photo 26. Viewing upstream at higher gradient (6 -8 %) SPb channel morphology present in Reach 4.

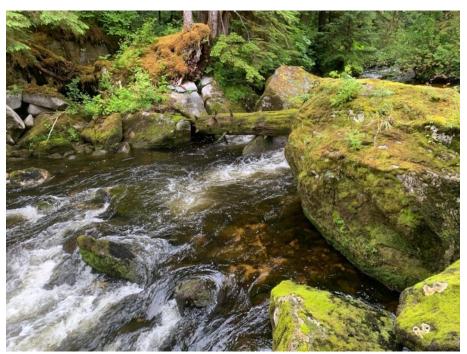
Photo 27. An example of deep pools present (>1m deep) in Reach 4.

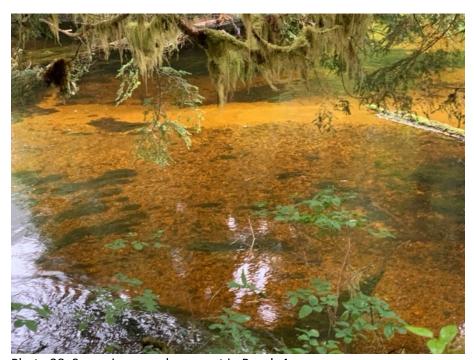
Photo 28. Spawning gravels present in Reach 4.

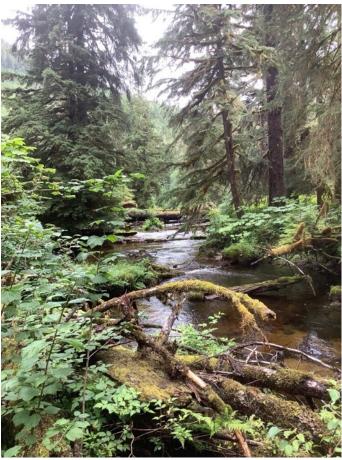
Reach 5

Photo 29. Viewing upstream in Tributary 31 close to the Hayward Creek confluence. Abundant instream cover (LWD, SWD, undercut banks) and bed material is dominated by large gravel and fines (subdominant).

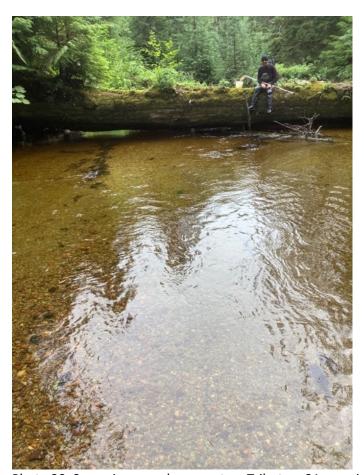
Photo 30. Spawning gravels present on Tributary 31, a main tributary to Reach 5.

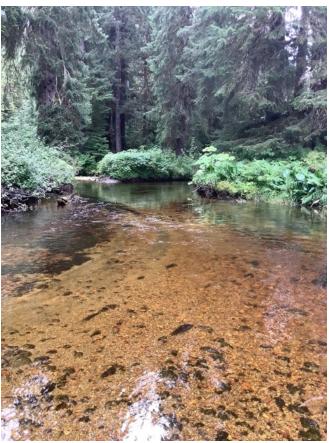
Photo 31. Viewing upstream and habitat present in Tributary 31 with underhanging stream banks, instream vegetation and gravel bed material (dominant). Photo taken approximately 60m upstream of the bridge.

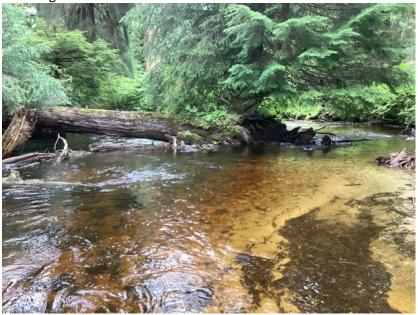
Photo 32. Viewing habitat present in Tributary 31 with LWD and riffle, run, pool complex and underhanging bank.

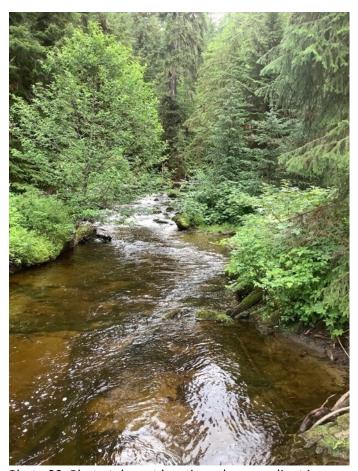
Photo 33. Photo taken at location where gradient increases on Tributary 31.

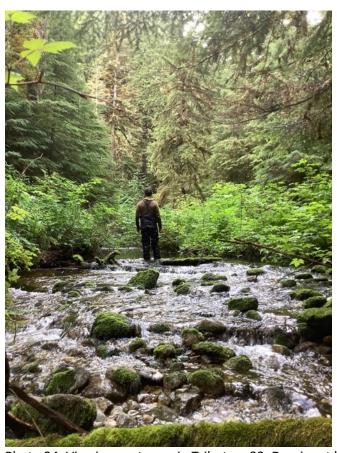
Photo 34. Viewing upstream in Tributary 32. Dominant bed material is cobble with fines (subdominant), overhanging vegetation, SWD and instream vegetation.

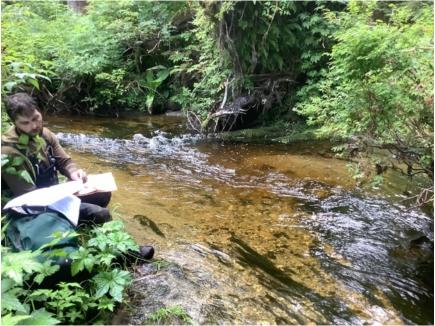
Photo 35. Viewing upstream on Tributary 32 from the confluence of Hayward Creek. Suitable spawning gravels present and abundant instream cover for juvenile fish (instream vegetation, undercut banks, overhanging vegetation).

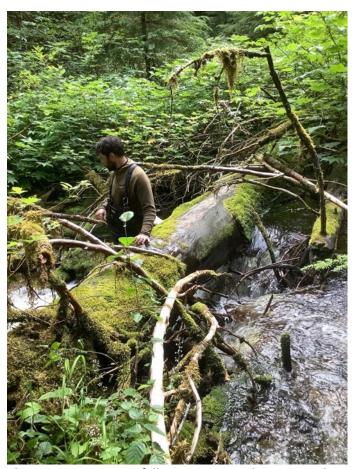
Photo 36. Viewing 1m falls present on Tributary 32 where gradients increase. Juveniles present to 150m upstream.

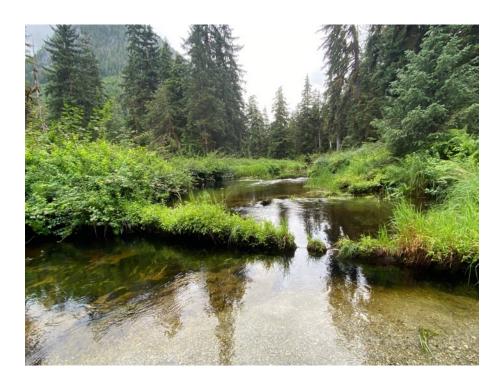
Photo 38. Viewing habitat characteristic of Reach 6, with deep glides and pools, functional LWD and suitable spawning gravels recruited from tributaries.

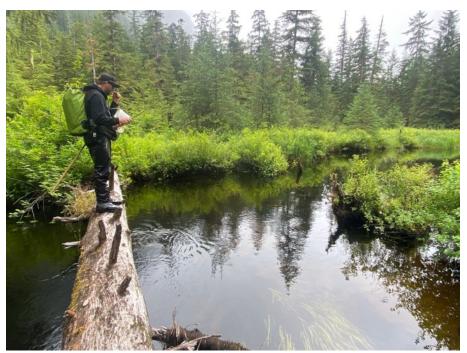
Photo 40. Deep pool and glide complex available in Reach 6. Stable undercut banks, abundant LWD, fine substrate (dominant) and abundant instream vegetation present.

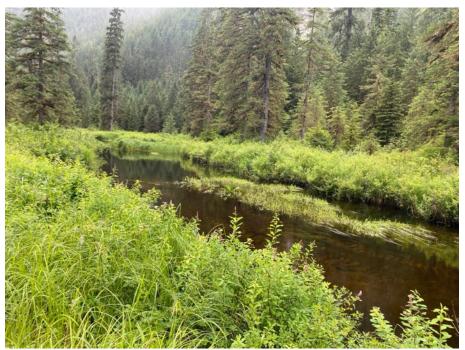
Photo 41. Deep pool and glide complex available in Reach 6. Stable undercut banks, abundant LWD, fine substrate (dominant) and abundant instream vegetation present.

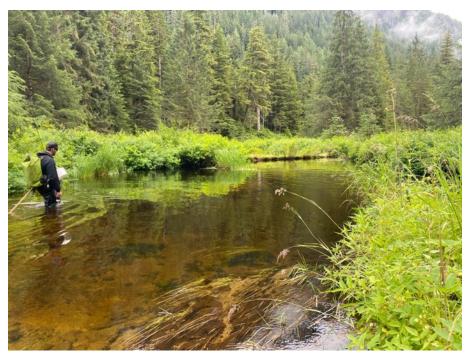
Photo 42. Deep pool and glide complex available in Reach 6. Stable undercut banks, abundant LWD, fine substrate (dominant) and abundant instream vegetation present.

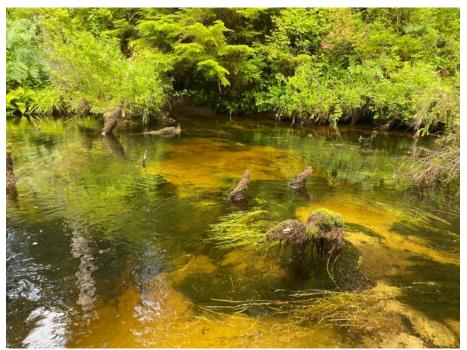
Photo 43. Deep pool and glide complex available in Reach 6. Stable undercut banks, abundant LWD, fine substrate (dominant) and abundant instream vegetation present.

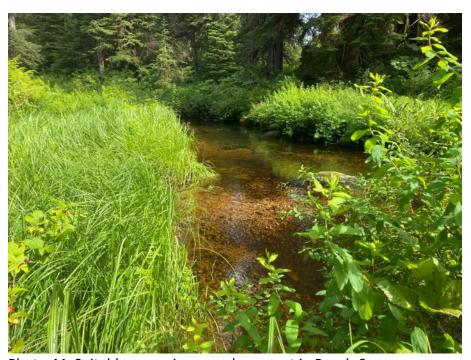
Photo 44. Suitable spawning gravels present in Reach 6.

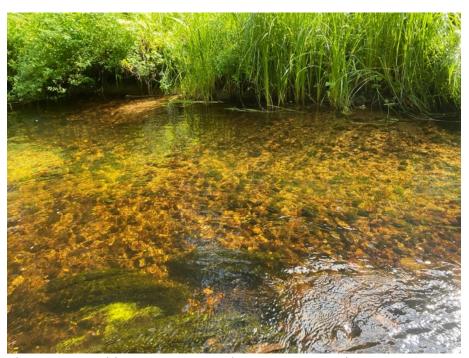
Photo 45. Suitable spawning gravels present in Reach 6.

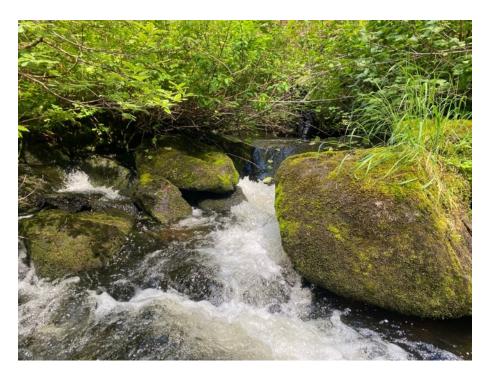
Photo 46. Short 200m section of boulder cascade (9 U 451743 5987401) occurs prior to Lower Hayward Lake.

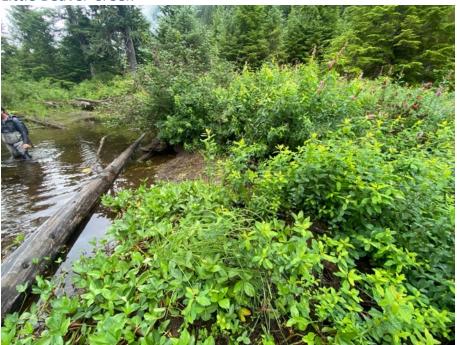
Photo 47. Old beaver dam present at the outlet of Hayward Lake into Little Beaver Creek.

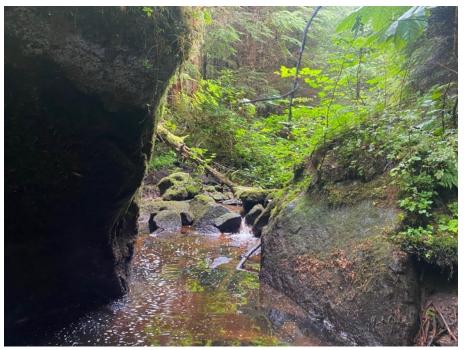
Photo 56. Low water levels present during sampling of Little Beaver Creek. Creek morphology is cascade-pool morphology with evidence of historic scour. Red algae was present during sampling.

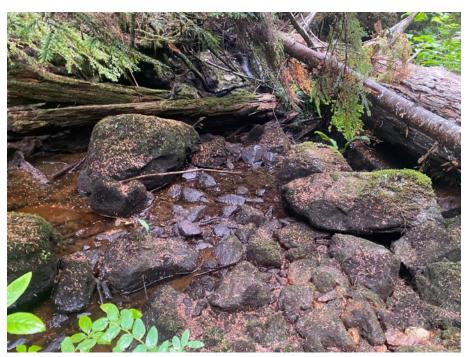
Photo 60. Documented bed material present in Little Beaver Creek downstream of Hayward Lake.

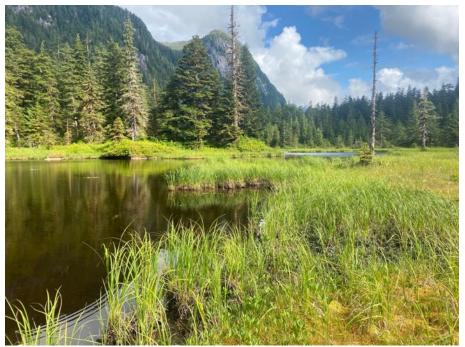
Photo 66. Viewing lower Hayward Lakes below the cascade falls/complex at the outlet of Hayward Lake.

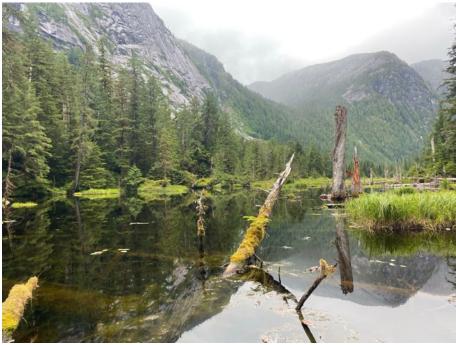
Photo 67. Viewing lower Hayward Lakes below the cascade falls/complex at the outlet of Hayward Lake.

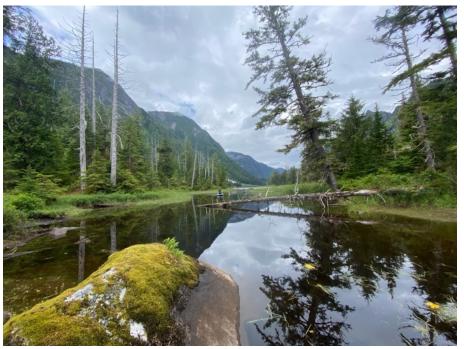
Photo 71. Southeast outlet of Hayward Lake during July 2021 sampling.

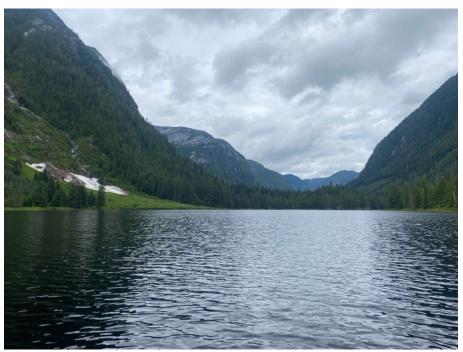
Photo 72. Photo of Hayward Lake facing north towards the outlet to Hayward Lake during July 2021 sampling.
