# Reconnaissance (1:20,000) Fish and Fish Habitat Inventory in the Morice River Watershed

**TRITON**

Environmental Consultants Ltd.

Project Name Morice River Fish Inventory - 1999

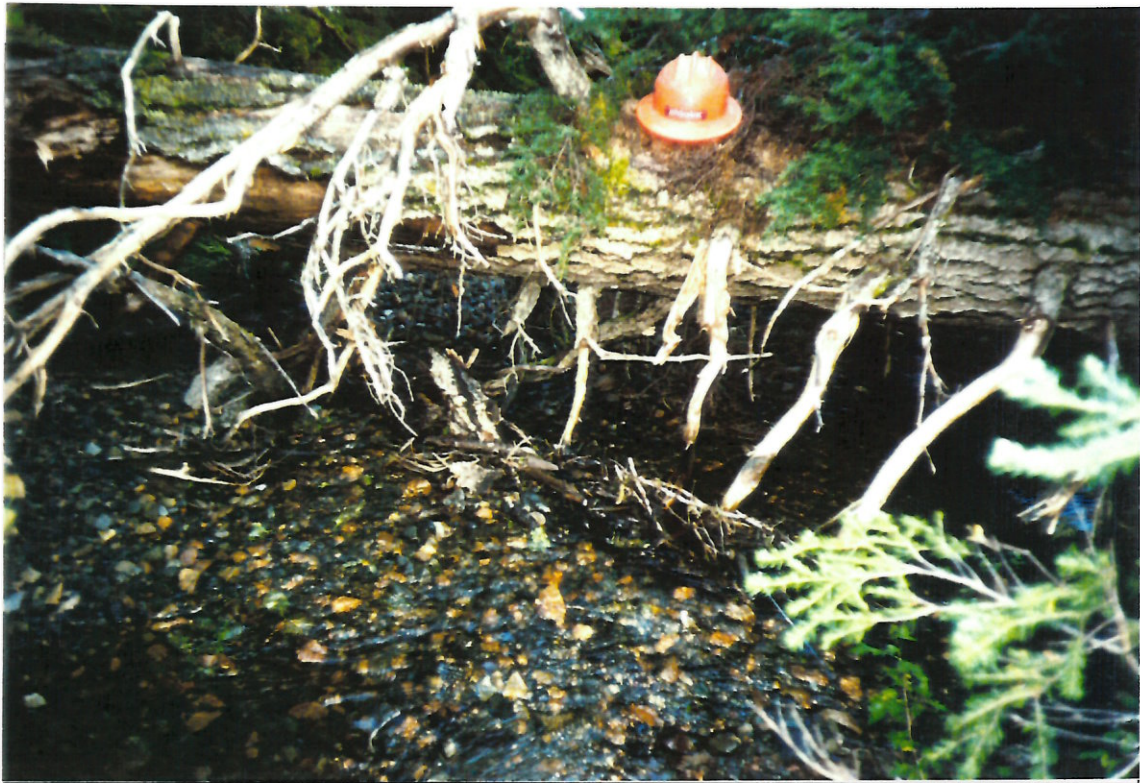
Photo #: 23 - 18  
Site 245, downstream view of high gradient section with high cover.

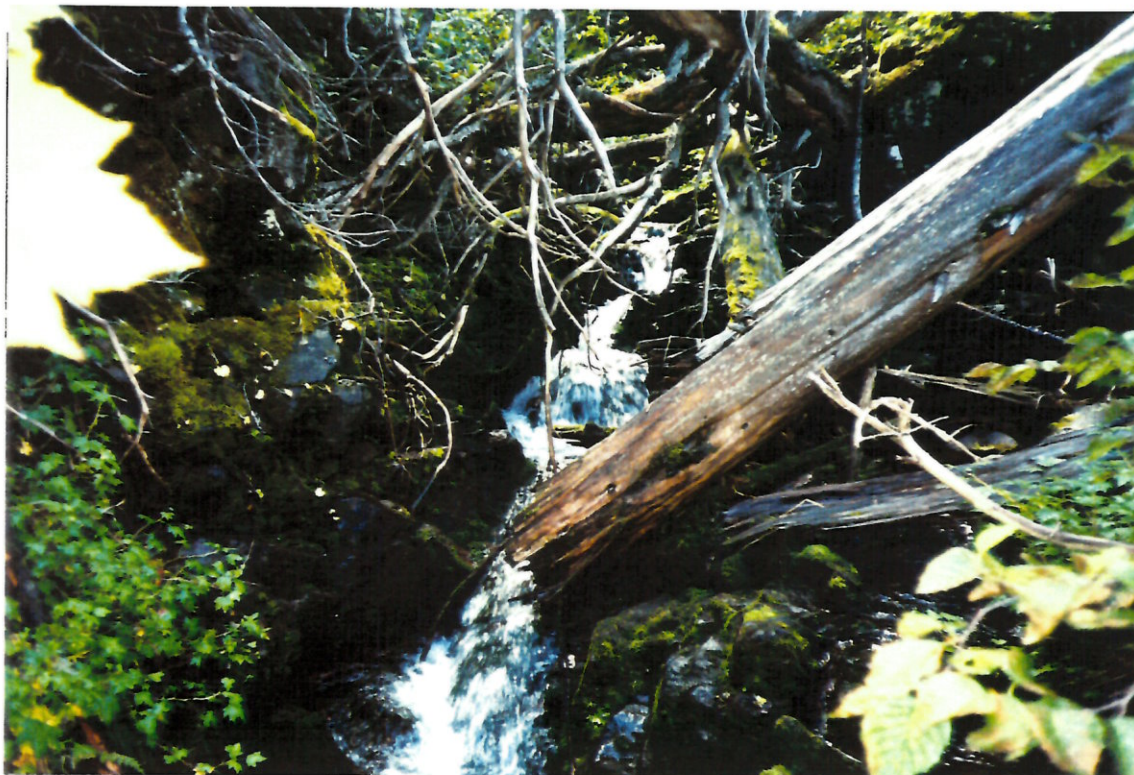
Photo #: 23 - 23  
Site 246, upstream view of 3/3 m cascades (velocity barrier with no plunge pool).

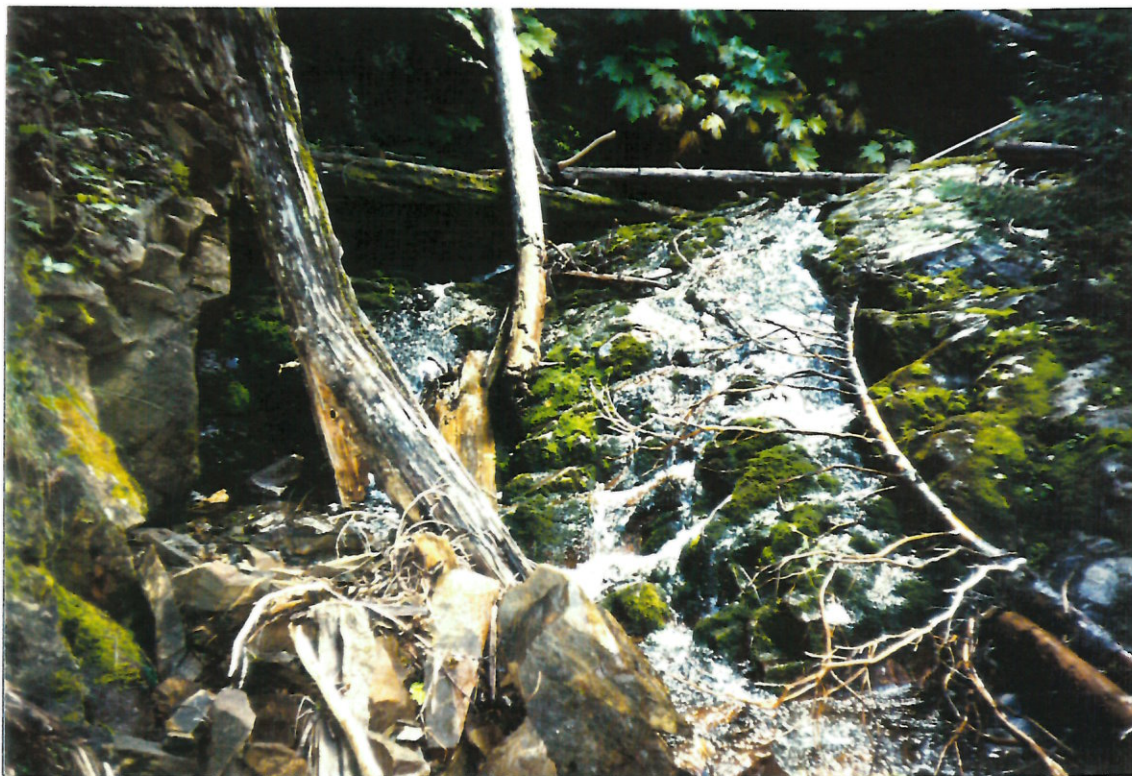
Photo #: 23 - 22

Site 246, upstream view of 3/5 m chute upstream of lower cascades.

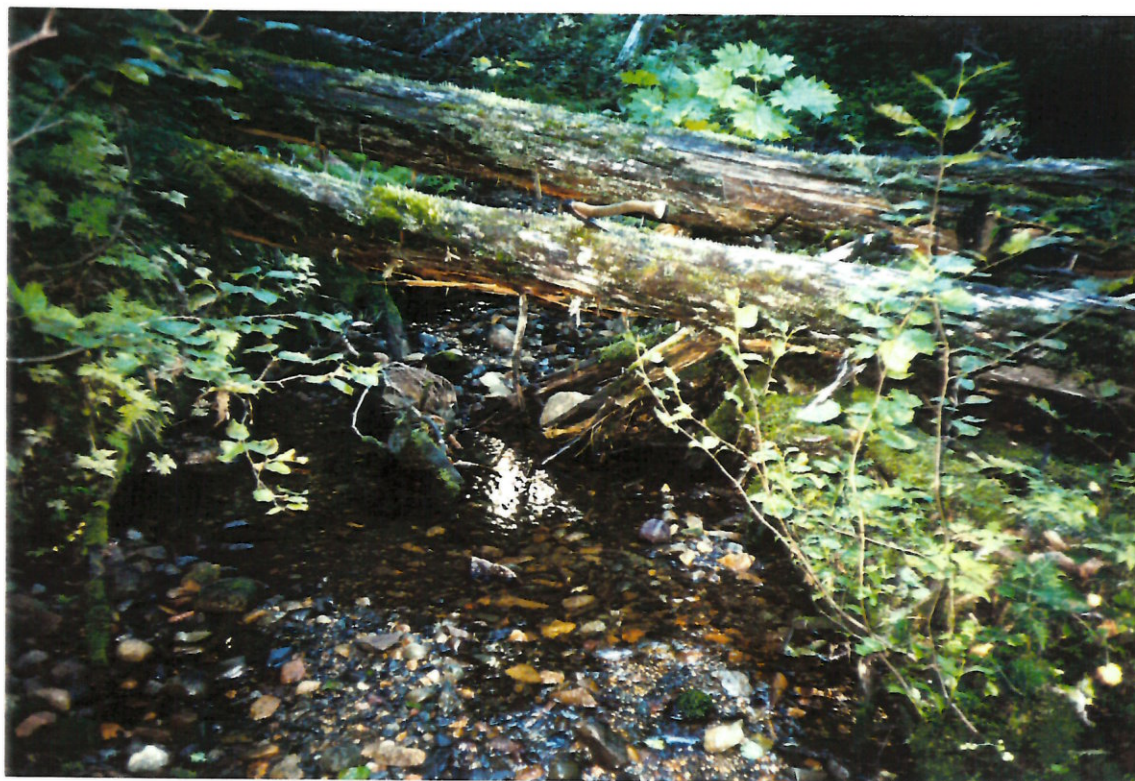
Photo #: 23 - 19

Site 246, upstream view of suitable rearing and spawning habitats.

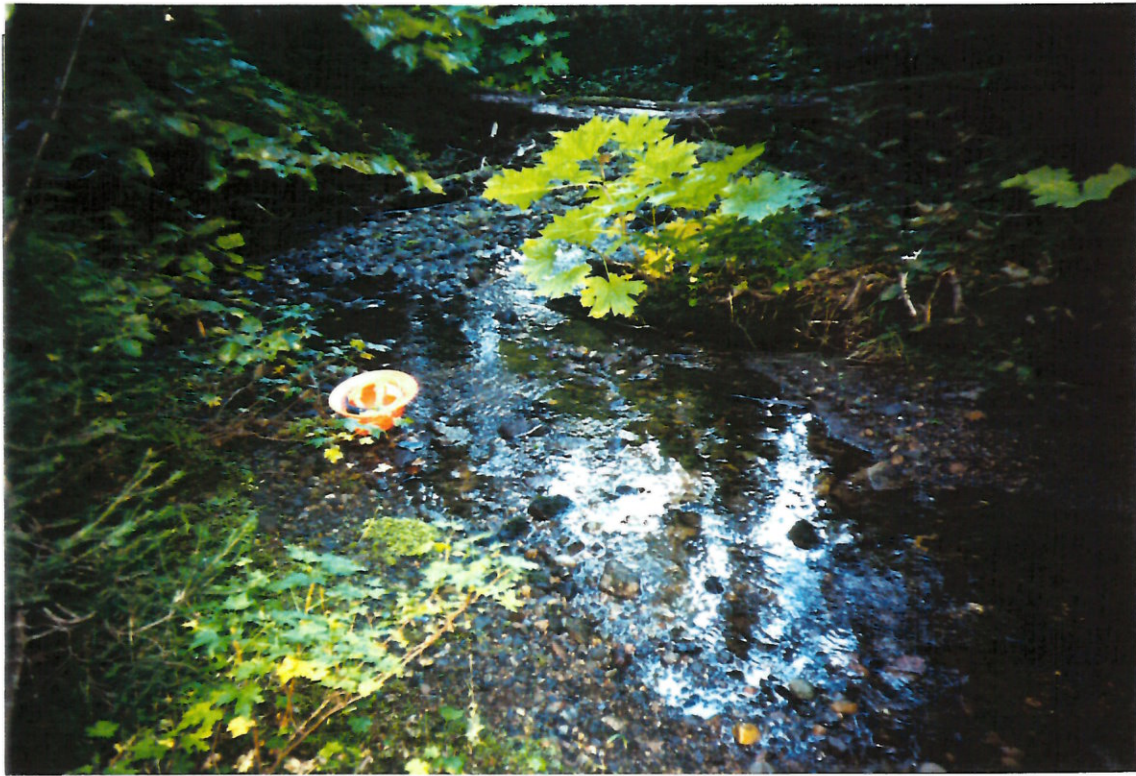
Photo #: 23 - 20

Site 246, downstream view of spawning habitat and functioning LWD.

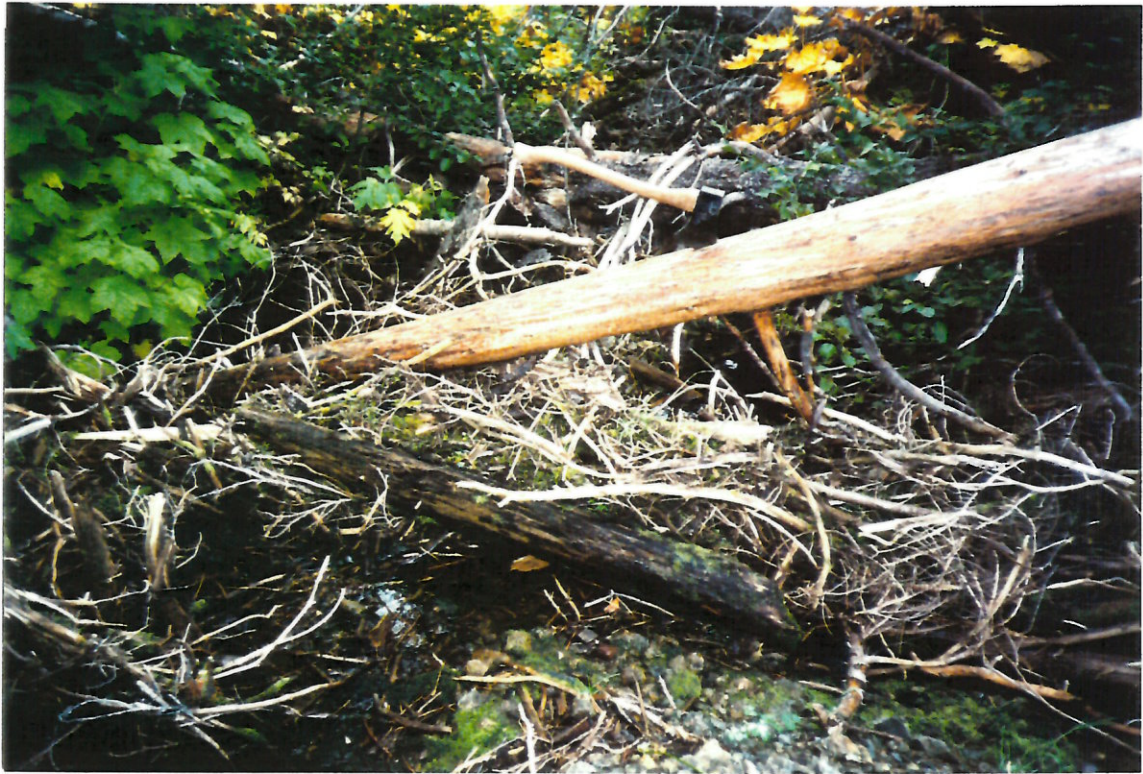
Photo #: 24 - 3

Site 249, downstream view of one of many SWD/LWD jam which create habitat complexity.

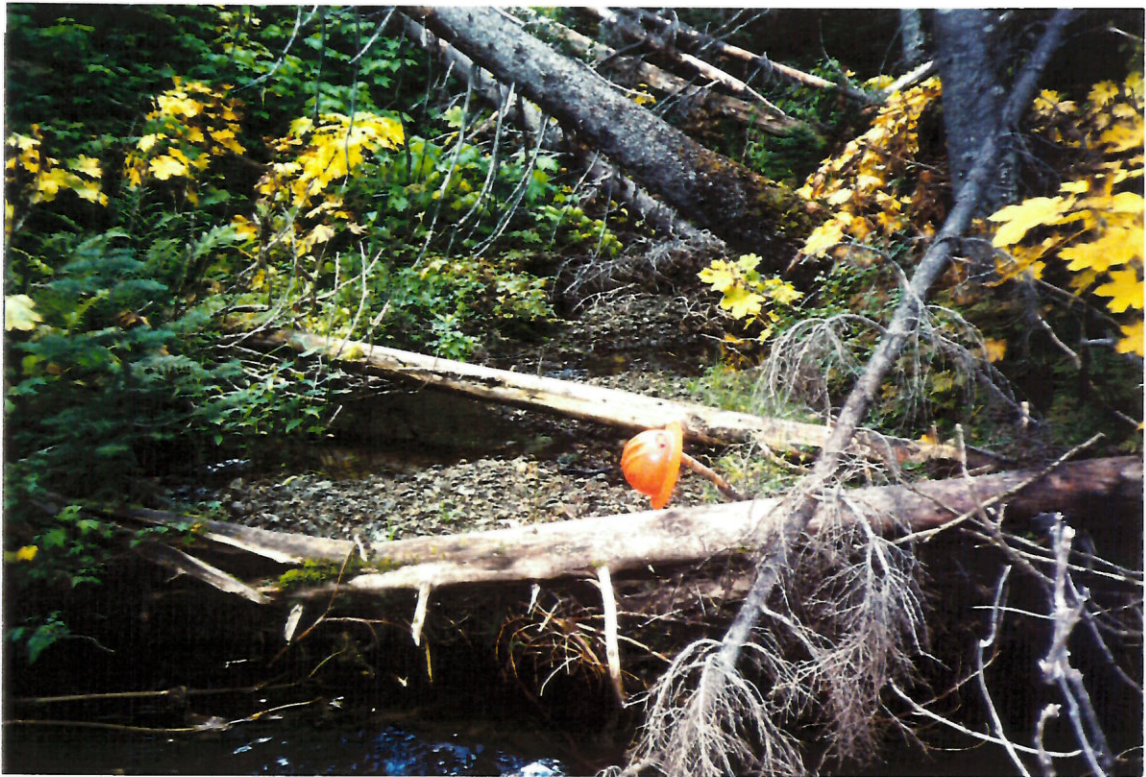
Photo #: 24 - 2

Site 249, upstream view of heavy gravel/cobble section with functioning LWD.

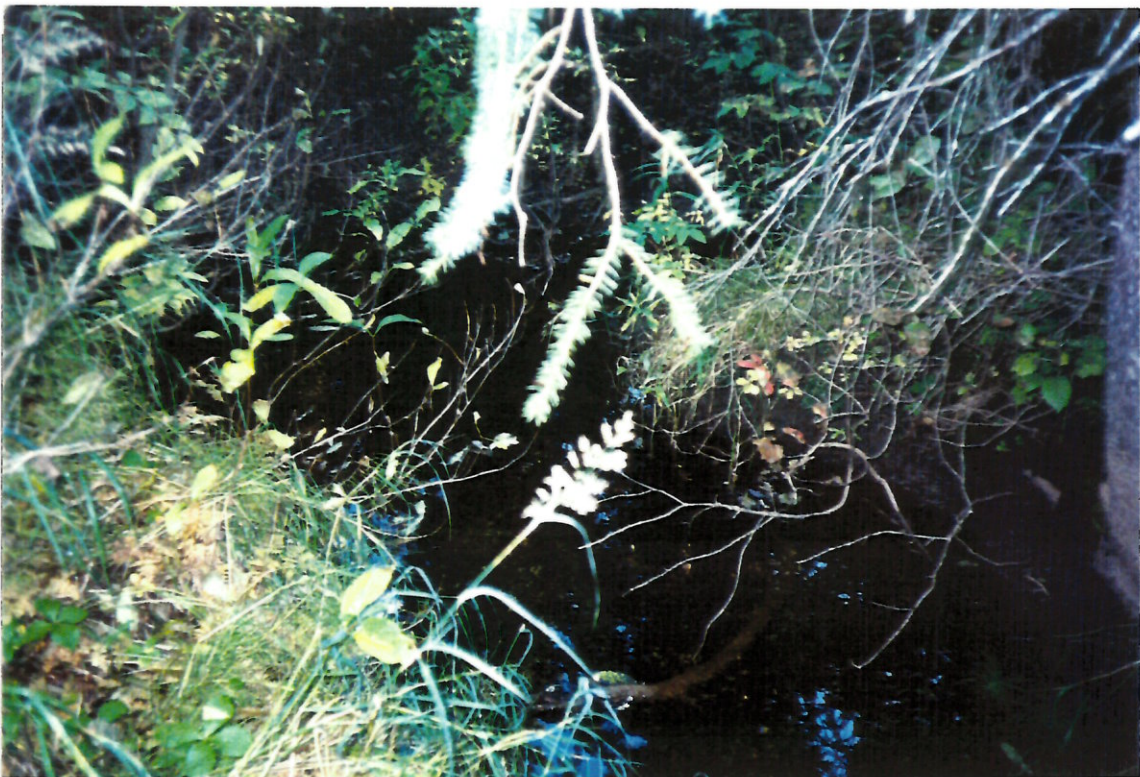
Photo #: 24 - 4  
Site 250, Upstream view of stagnant pool.

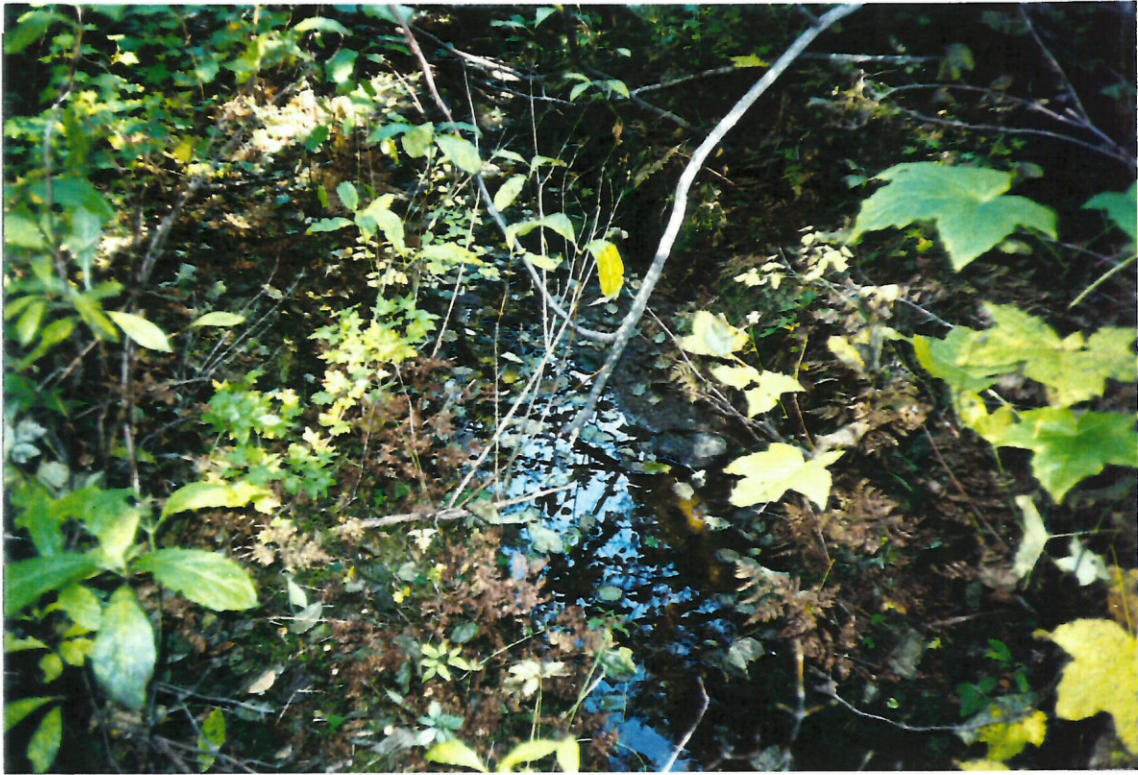
Photo #: 24 - 7  
Site 251, downstream view of stagnant, leaf covered pool.

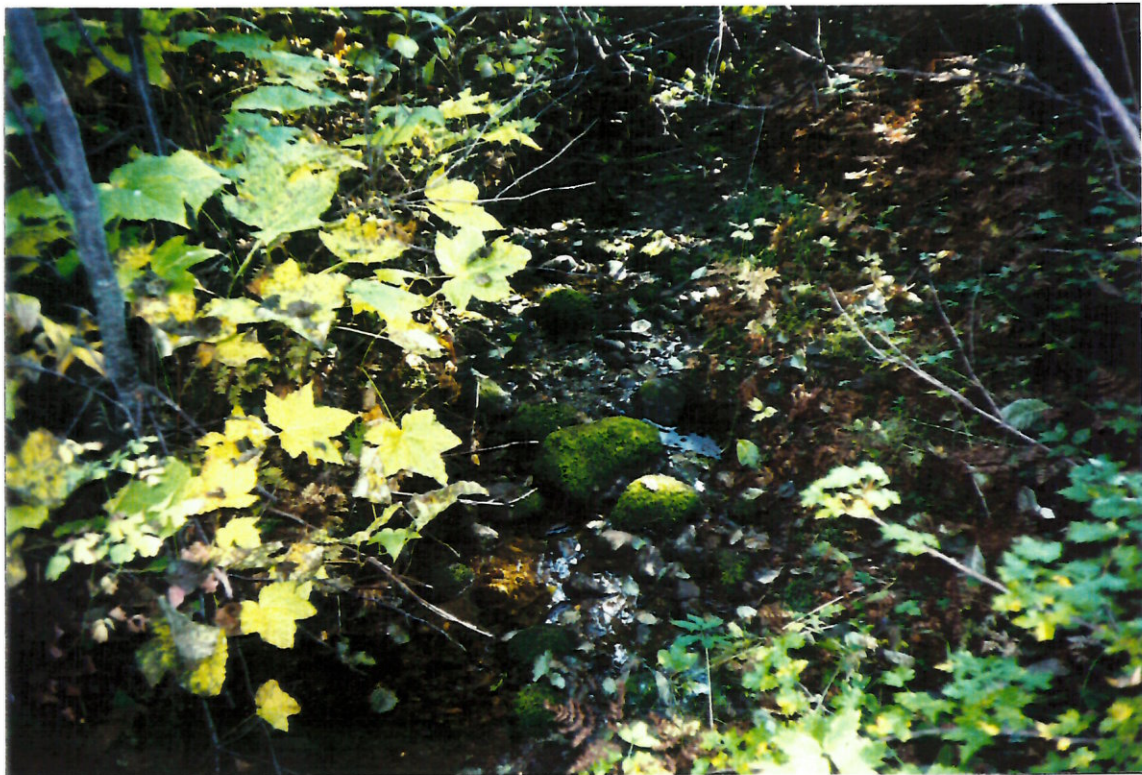
Photo #: 24 - 6  
Site 251, upstream view of riffle/pool complex with large moss covered rocks.

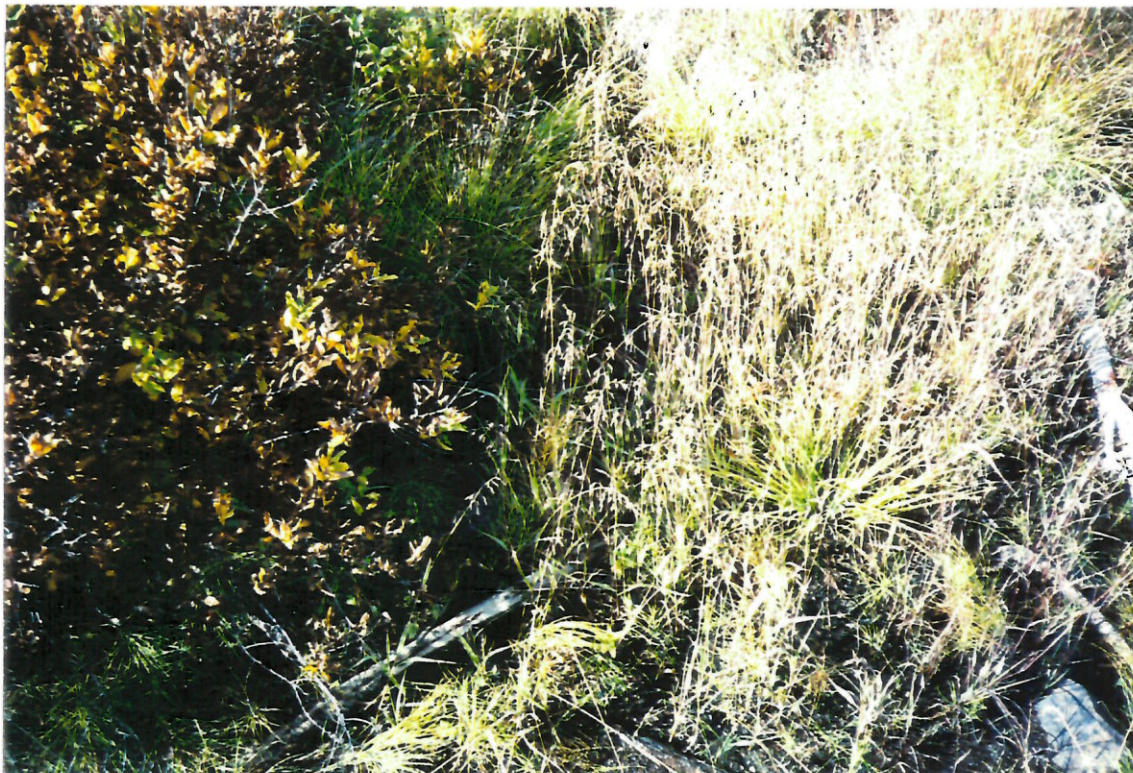
Photo #: 24 - 9

| Form | Section | Comments |
|---|---|---|
| SITE | CHANNEL | Stream runs through cutblock and becomes braided and heavily vascularized, lacks connectivity with isolated pools, and the natural drainage has been altered by cutblock and road crossing. |

Site 252, downstream view of heavily vegetated section of channel.

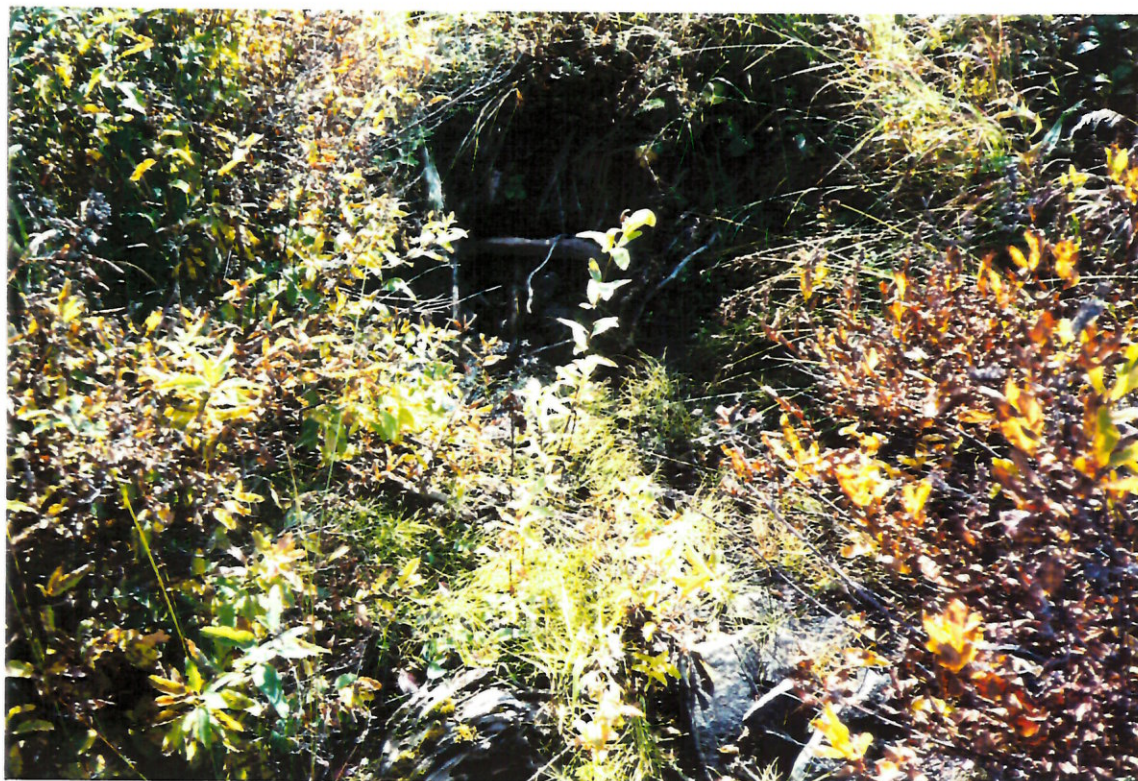
Photo #: 24 - 8

Site 252, upstream view of scoured section of stream with SWD and cobble.

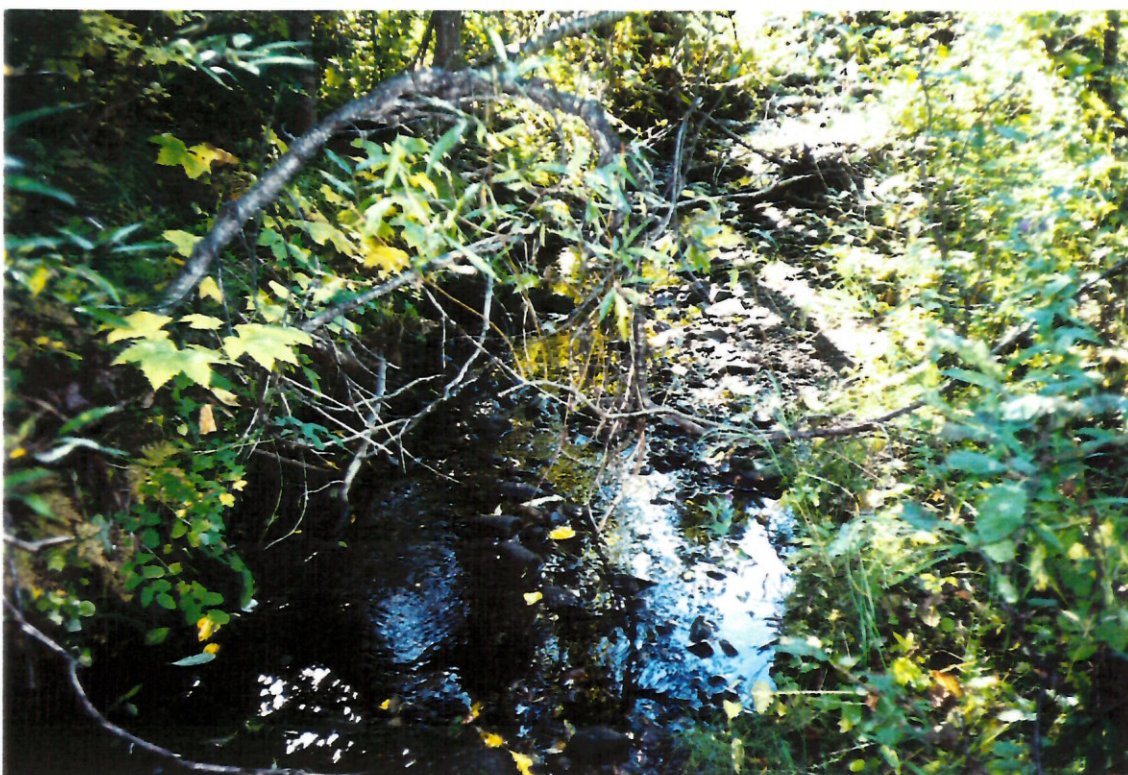
Photo #: 24 - 11  
Site 253, upstream view of riffle/ run section with cobble / gravel substrate.

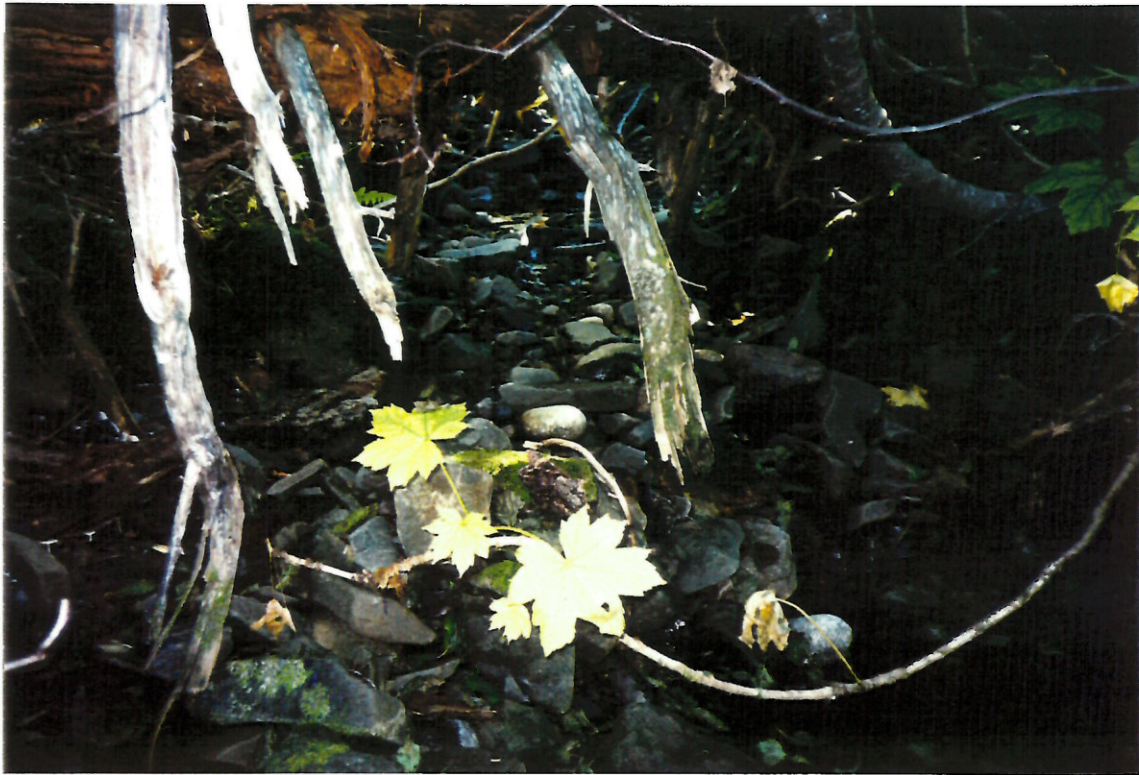
Photo #: 24 - 13  
Site 254, upstream view of high gradient section with small cascades (boulders).

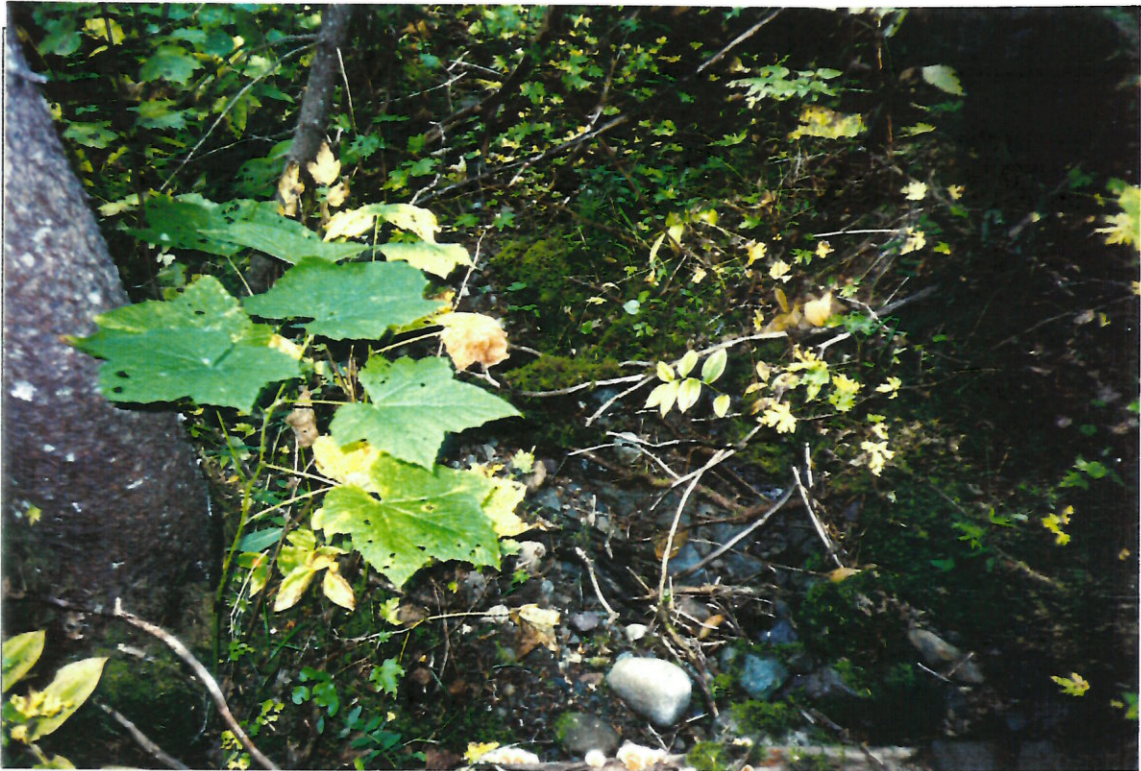
Photo #: 24 - 16  
Site 255, downstream view of high gradient section.

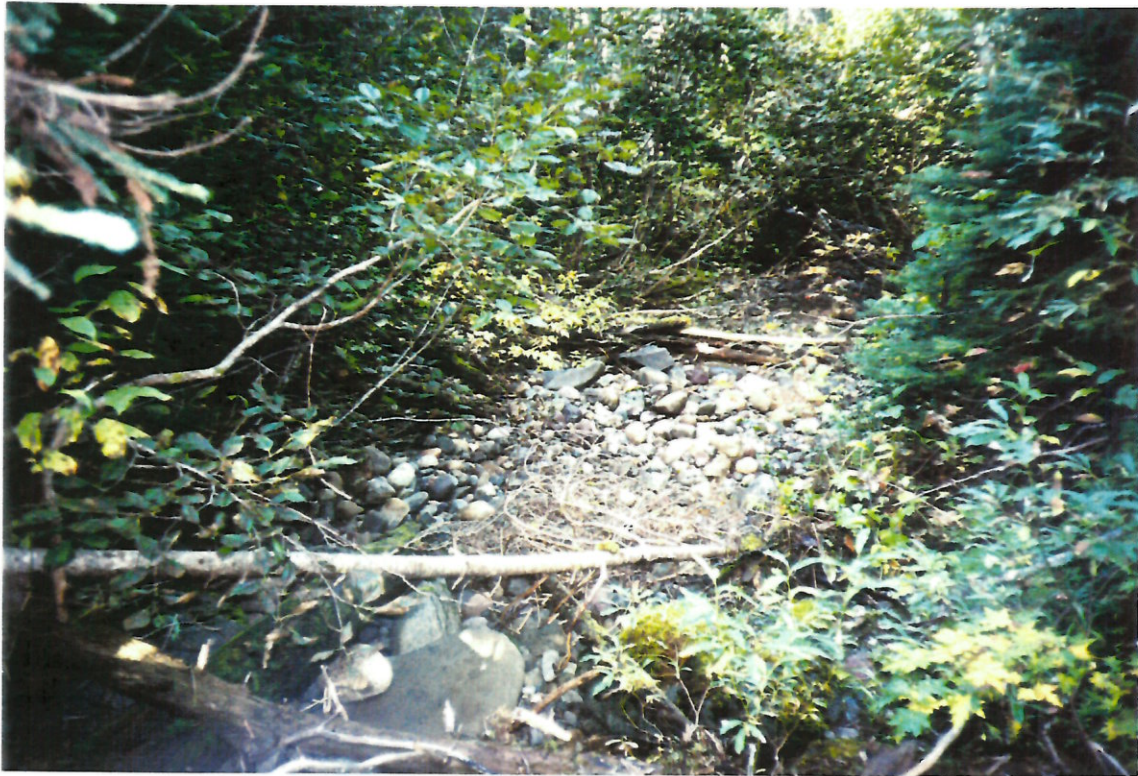
Photo #: 24 - 18

Site 256, downstream view of boulder/cobble section with large D95.

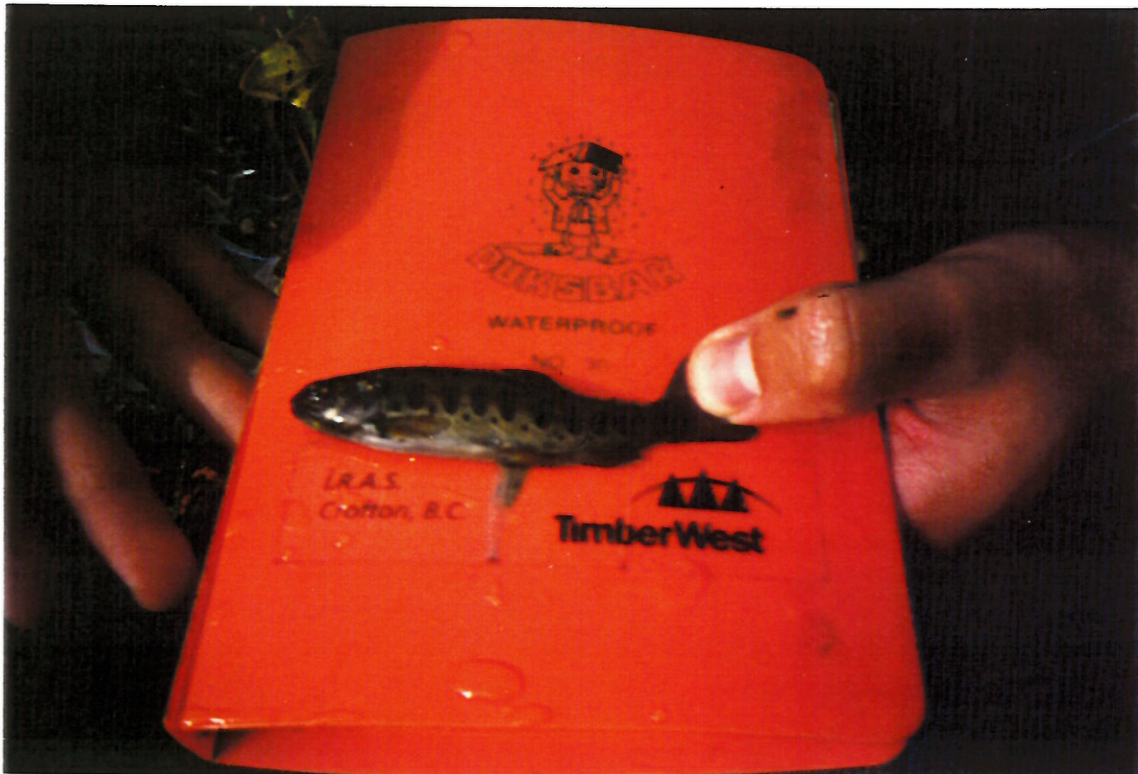
Photo #: 24 - 20

Site 256, photo of a 115 mm cutthroat trout.

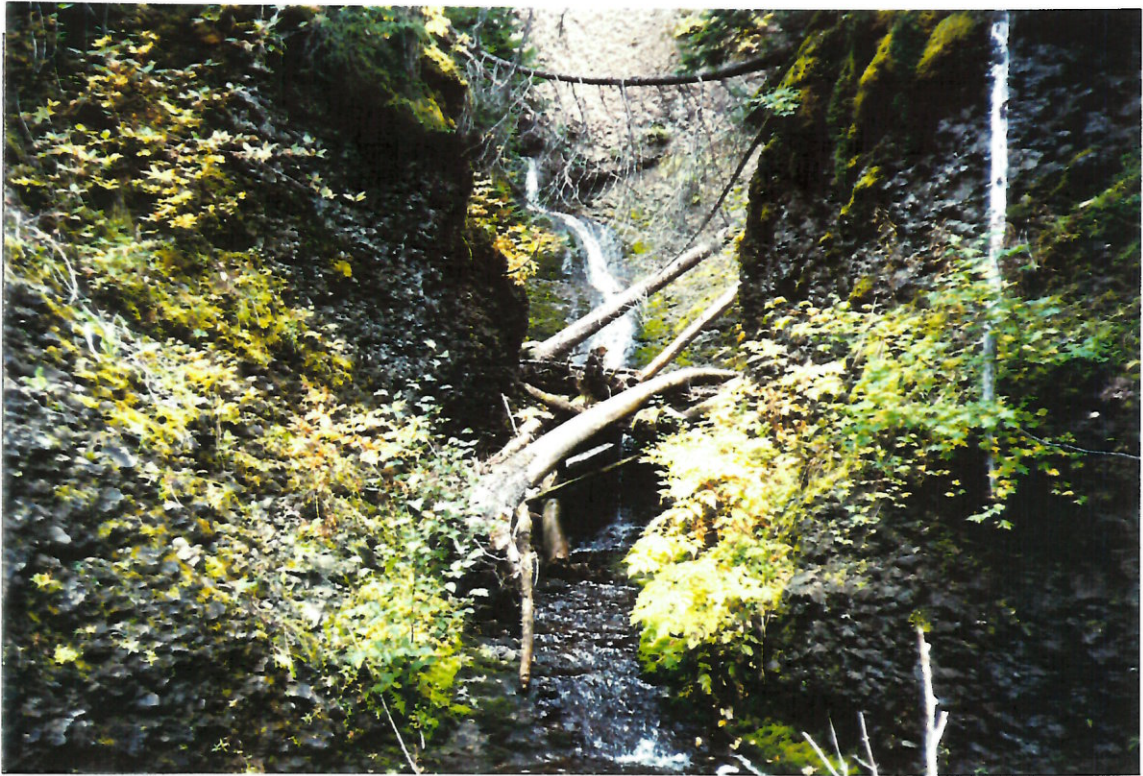
Photo #: 24 - 19  
Site 256, upper limit of fish distribution.

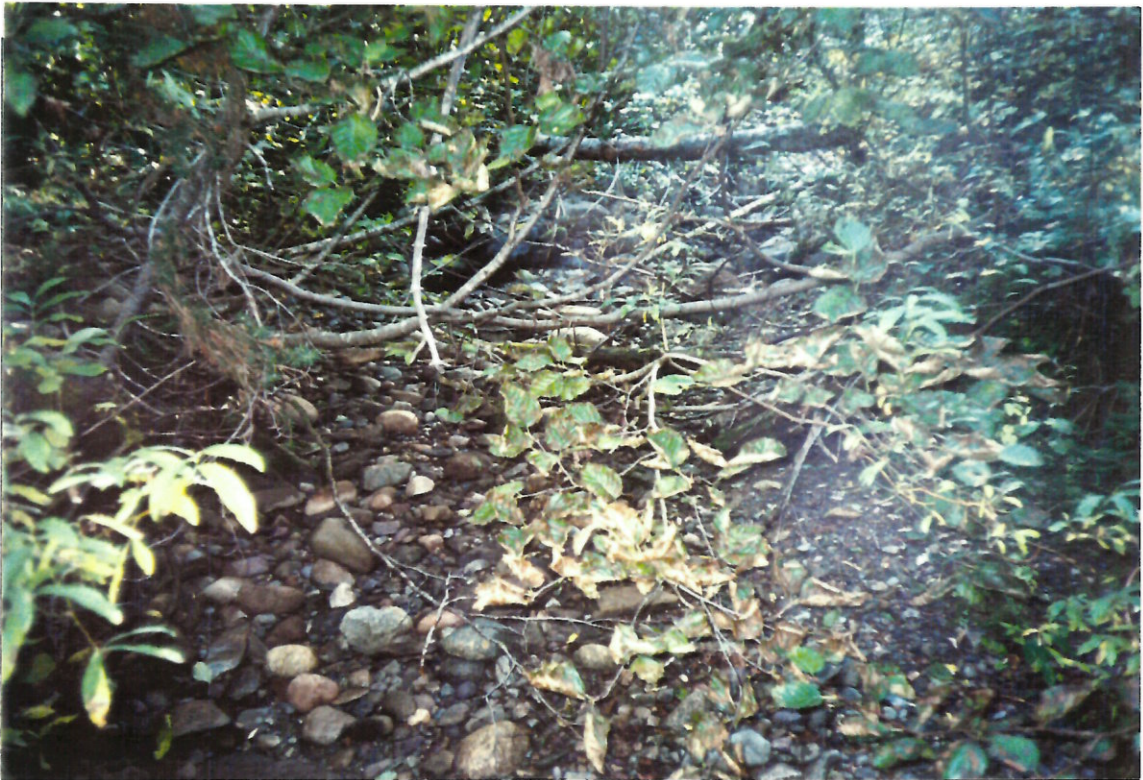
Photo #: 24 - 17  
Site 256, upstream view of typical gravel section with overhanging vegetation.

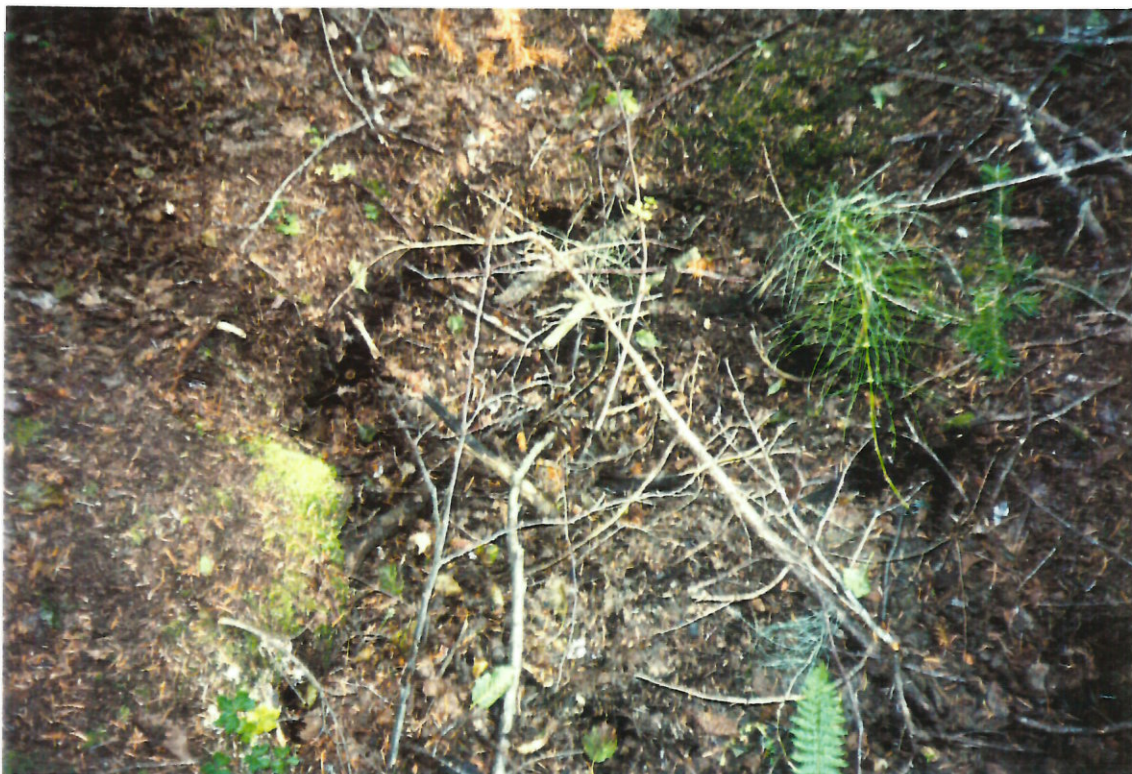
Photo #: 24 - 21

Site 257, upslope view of small depression within vegetated gulley.

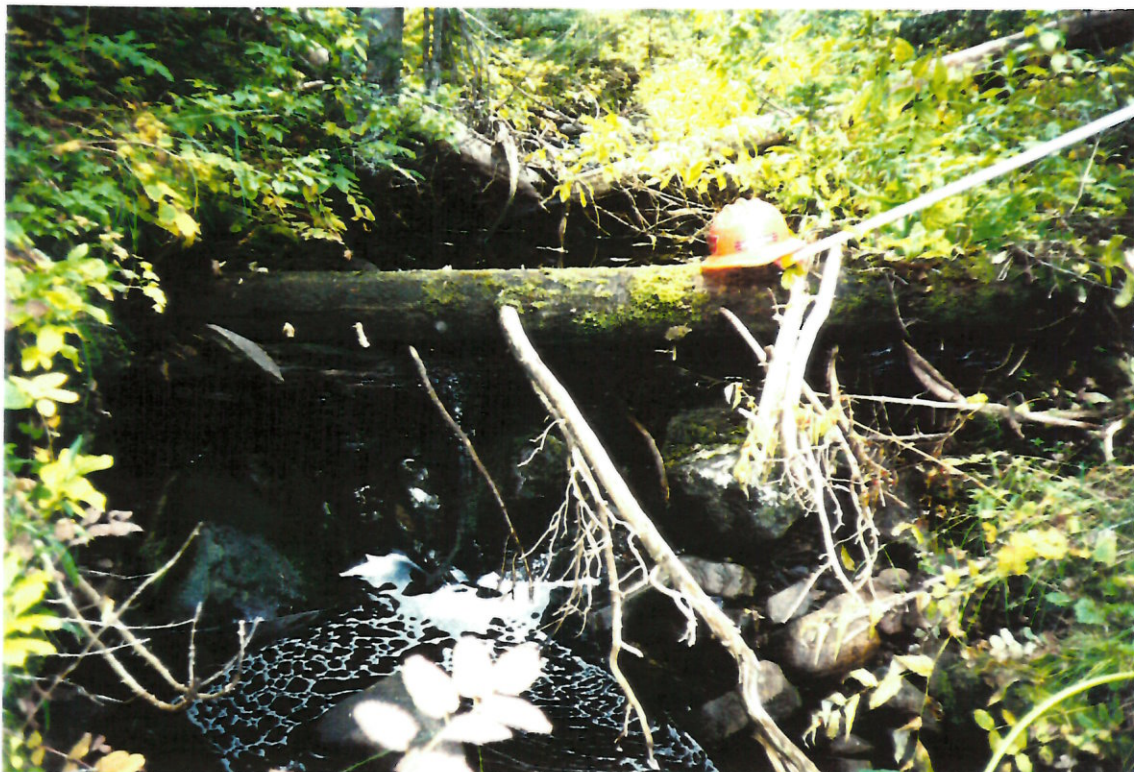
Photo #: 24 - 22

Site 258; upstream view of one of many small <1m cascades (debris jam).

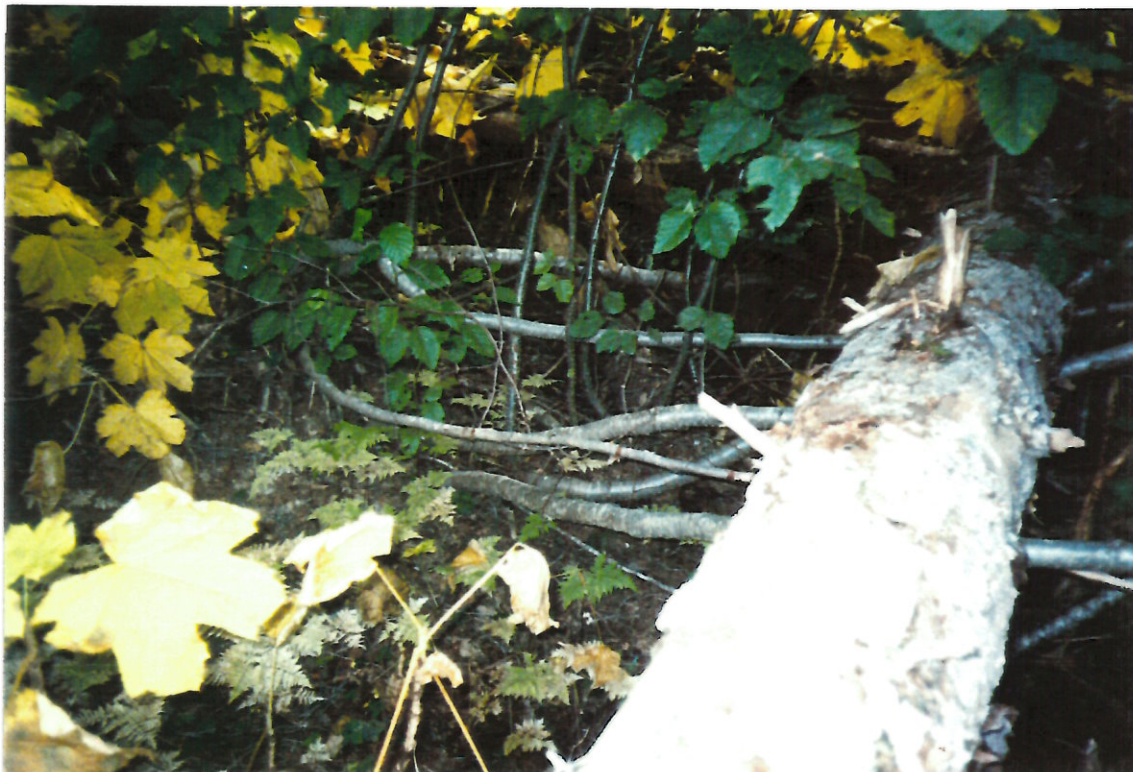
| COMMENT | | | | | | | | | |
|---|---|---|--|--|--|--|--|--|--|
| SITE | SITE CARD | Seepage area with no evidence of scour/water/substrate deposits. Alder swale with Devil's club. | | | | | | | |

Photo #: 25 - 1  
Site 259, upslope view of alder swale.

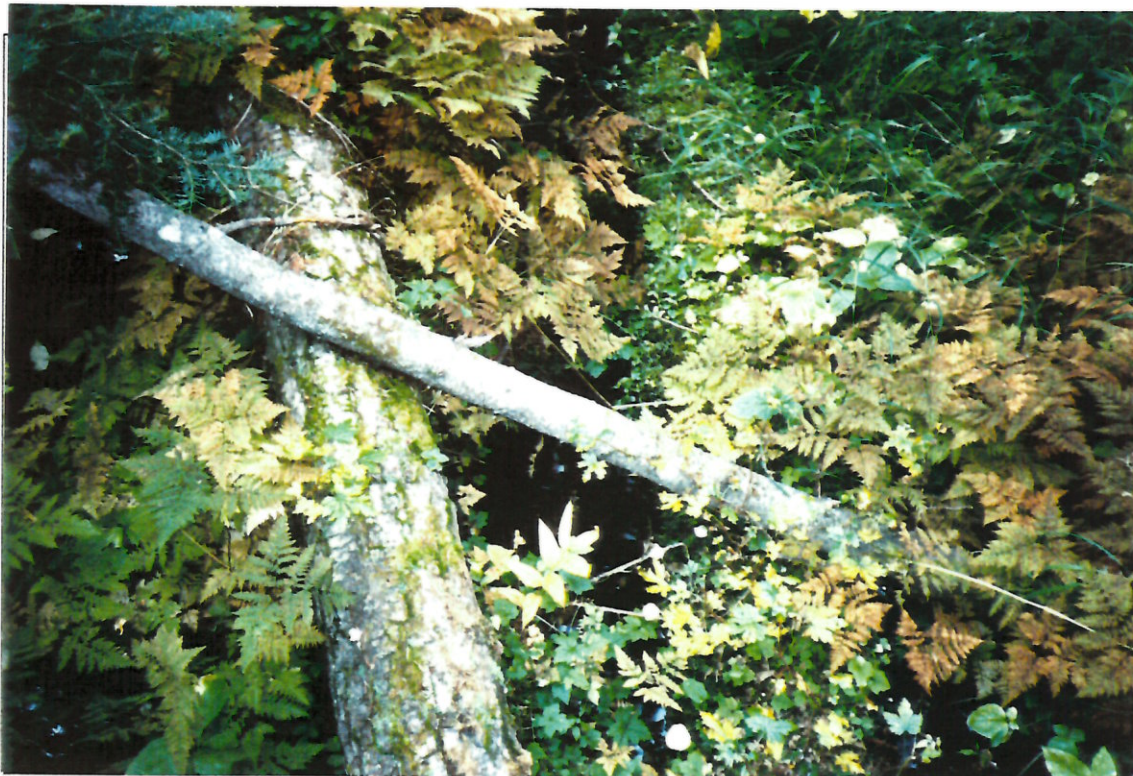
Photo #: 25 - 3

Site 260, downstream view of isolated pool, with functioning LWD

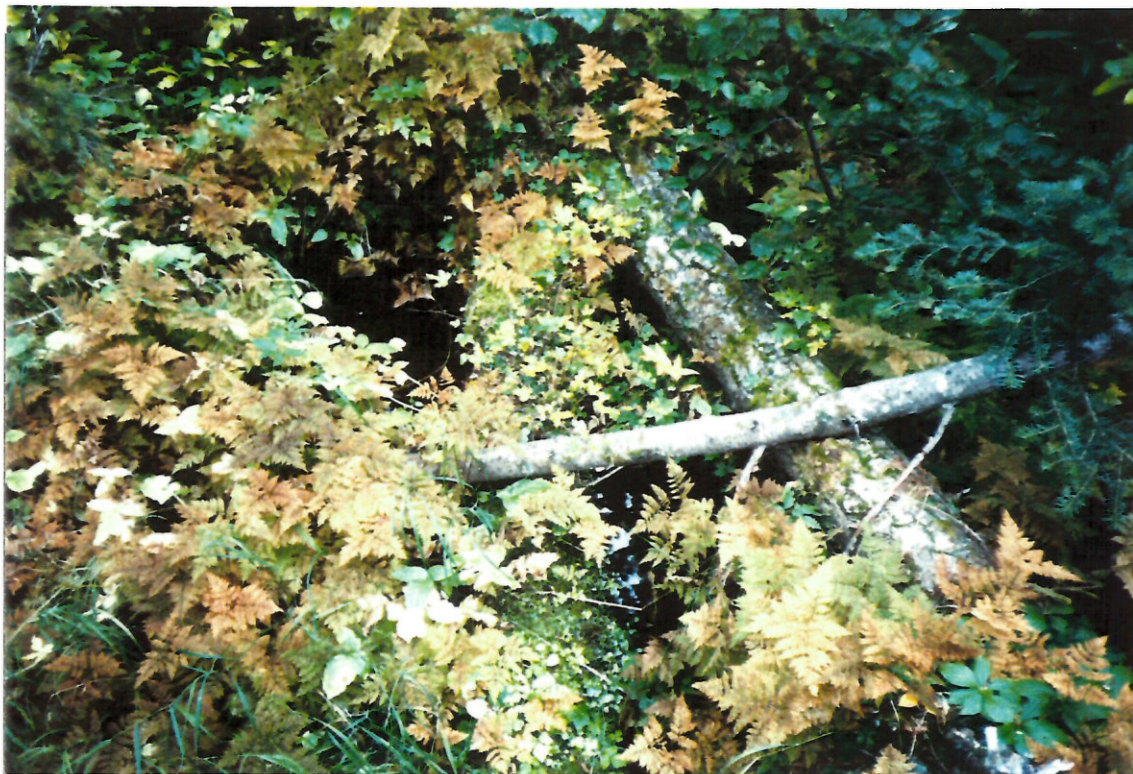
Photo #: 25 - 2

Site 260, upstream view of isolated pool with vascular plants and fines.

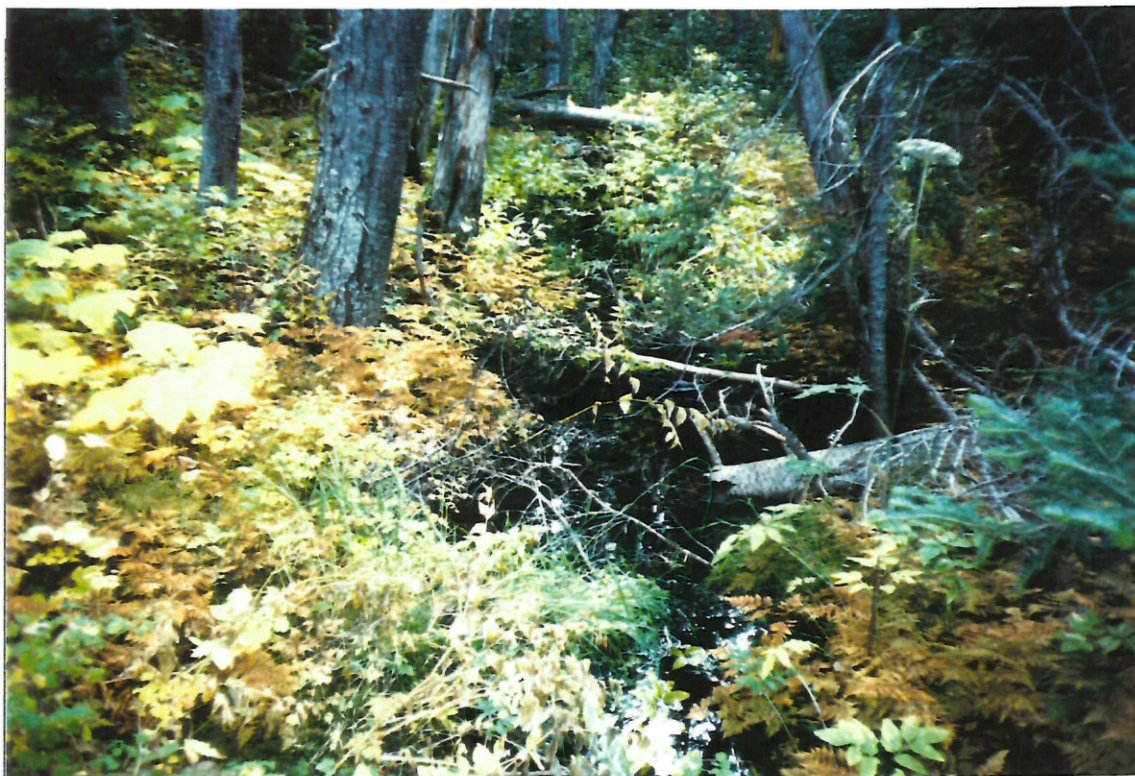
Photo #: 25 - 5

Site 261, downstream view of typical stagnant pool with cobble /fine substrates.
