# Reconnaissance (1:20,000) Fish and Fish Habitat Inventory in the Morice River Watershed

**TRITON**

Environmental Consultants Ltd.

Project Name Morice River Fish Inventory - 1999

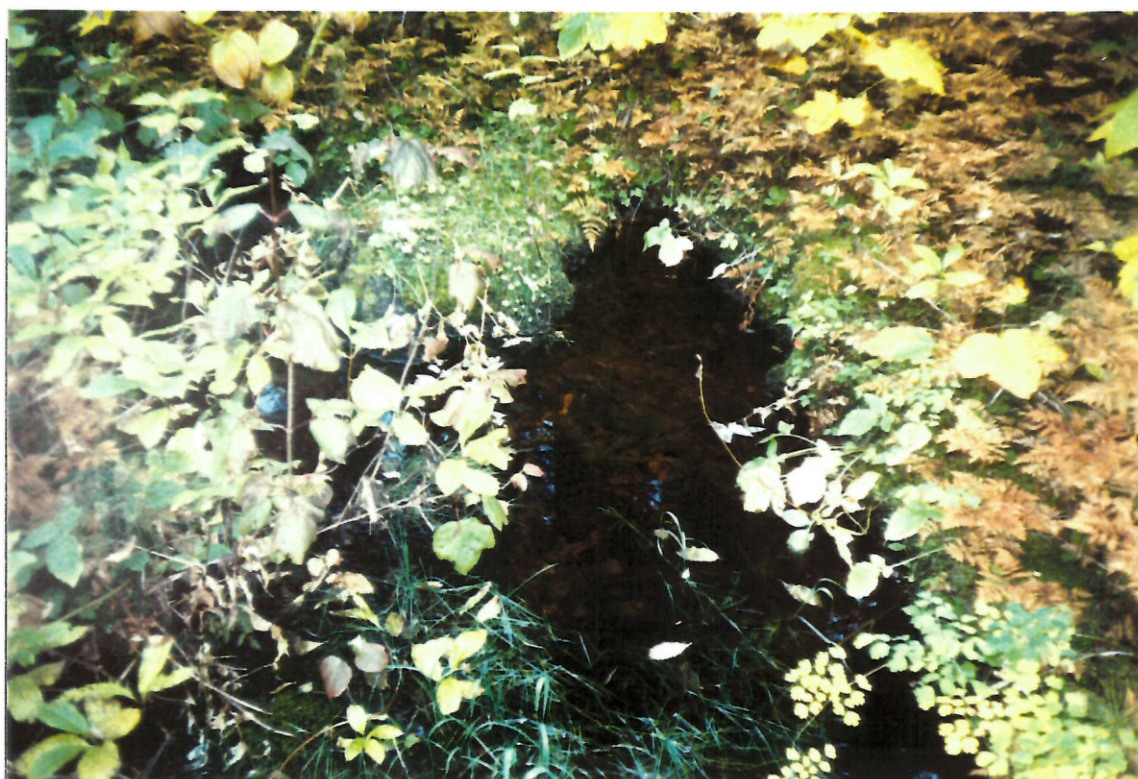
Photo #: 25 - 4

Site 261, upstream view of typical stagnant pool with vascularized vegetation.

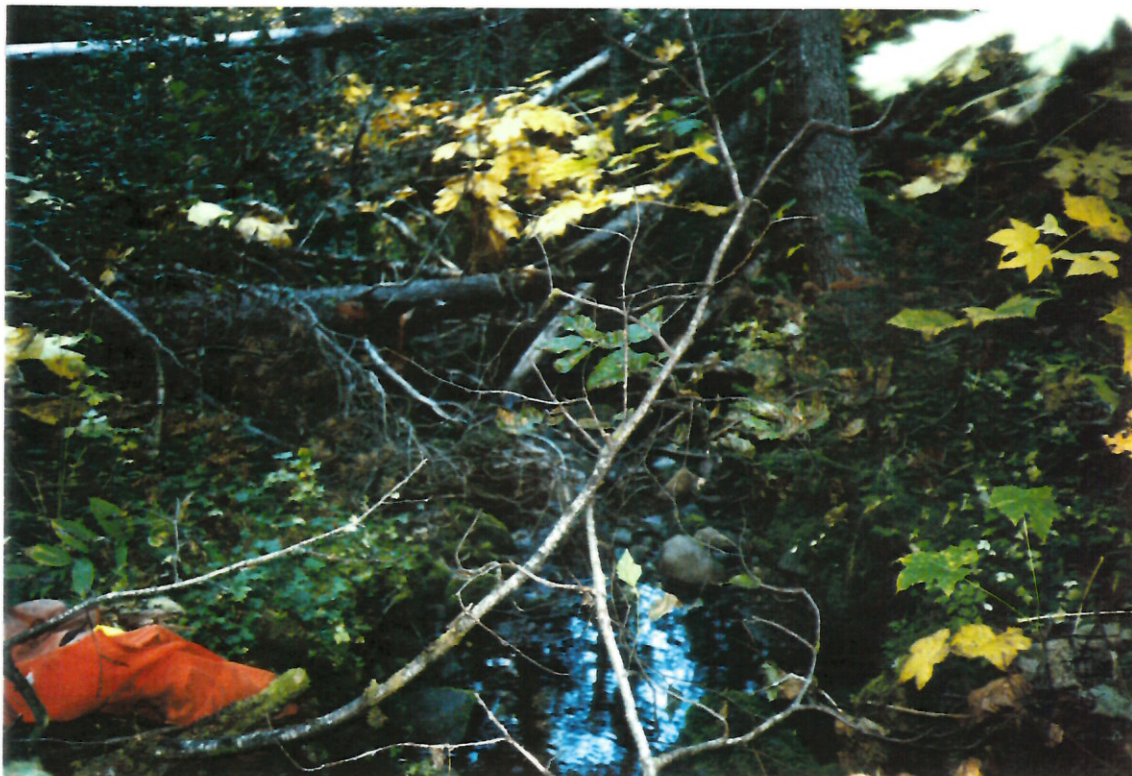
Photo #: 26 - 2  
Site 264, looking downstream at the sampling area.

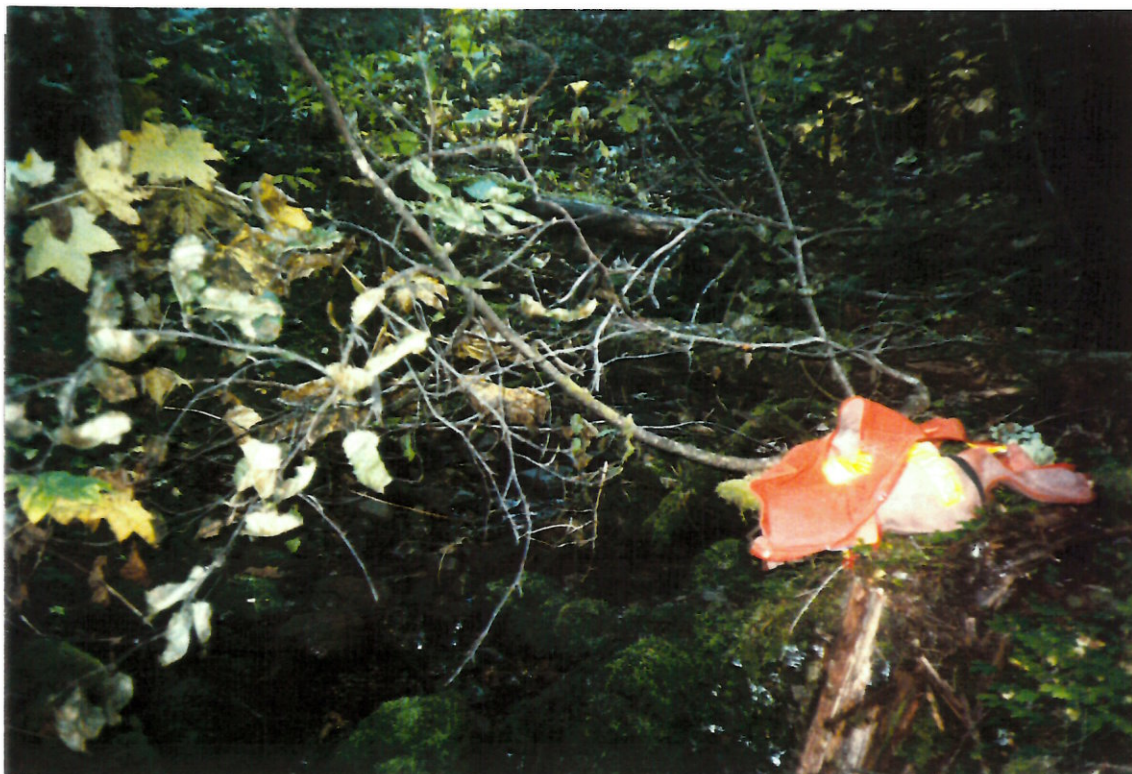
Photo #: 26 - 1  
Site 264, looking upstream at the channel, with vest on the left bank.

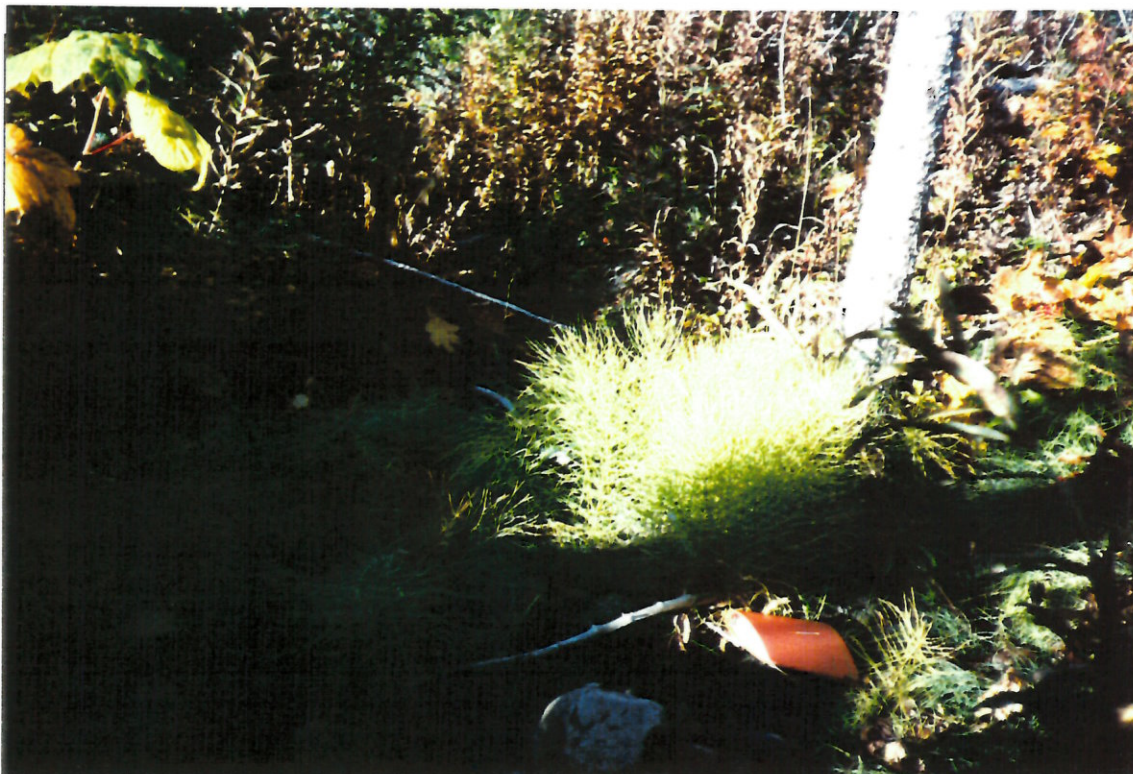
Photo #: 25 - 23  
Site 265, looking downstream at a sediment wedge.

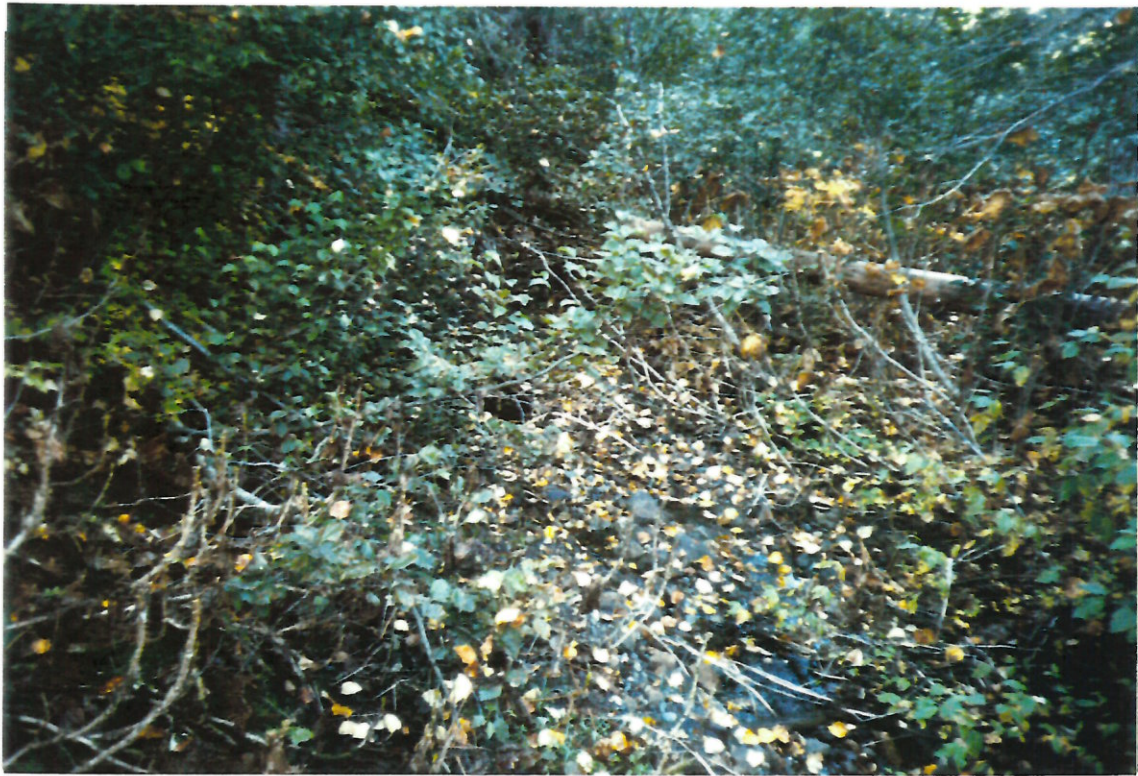
Photo #: 26 - 4  
Site 266, looking downstream at the sampling area.

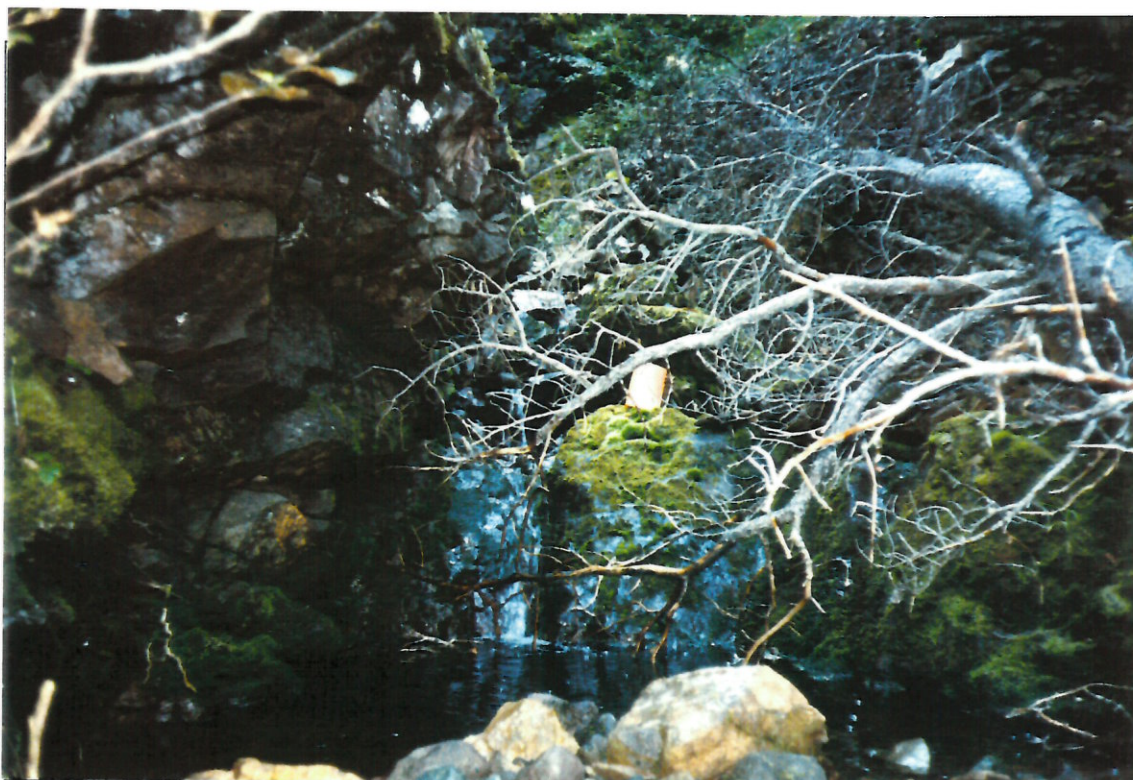
Photo #: 26 - 6  
Site 266, looking upstream at a cascade barrier.

| Form | Section | Comments |
|---|---|---|
| SITE | CHANNEL | C2, d/s of 80cm cascade DV captured, NFC above barrier despite shocking effort. no overwintering noted. |

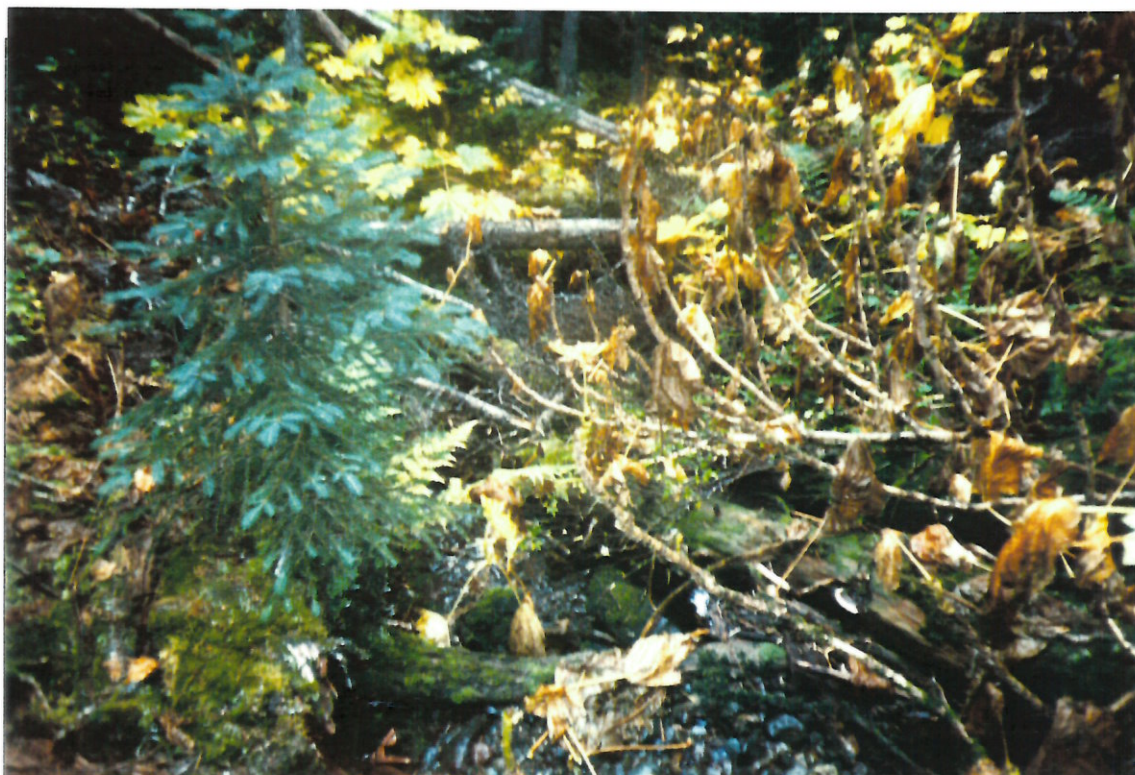
Photo #: 26 - 22

| Form | Section | Comments |
|---|---|---|
| SITE | CHANNEL | C2, 32% slope, intermittent channel, not accessible to fish. |
| SITE | CHANNEL | C5, moss covered boulders noted in the channel. |

Site 269, looking downstream at LWD and devil's club in the channel.

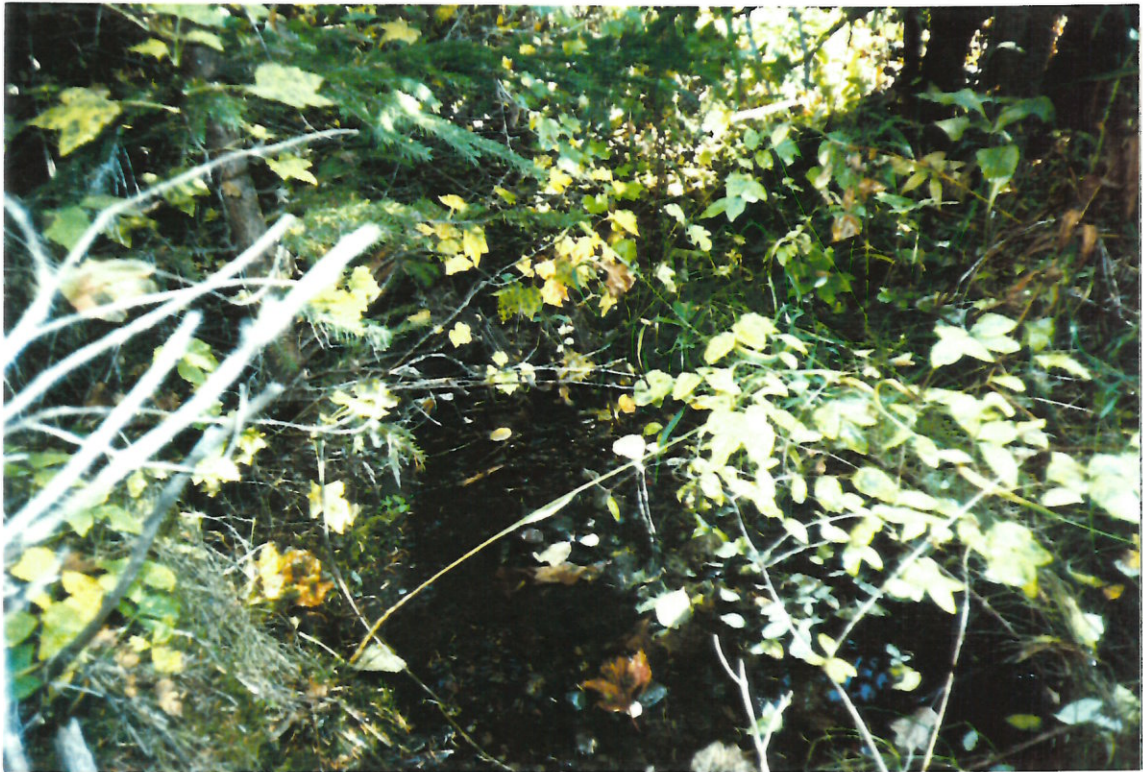
Photo #: 27 - 1  
Site 271, looking downstream at a small channel.

| Name | Comments |
|---|---|
| Rearing Habitat | channel is too small and too steep to accomodate holding fish, no connectivity between pools and 20-40cm cascades noted. |

| Form | Section | Comments |
|---|---|---|
| SITE | CHANNEL | C5, steep, small channel lacking rearing cover and connectivity. |

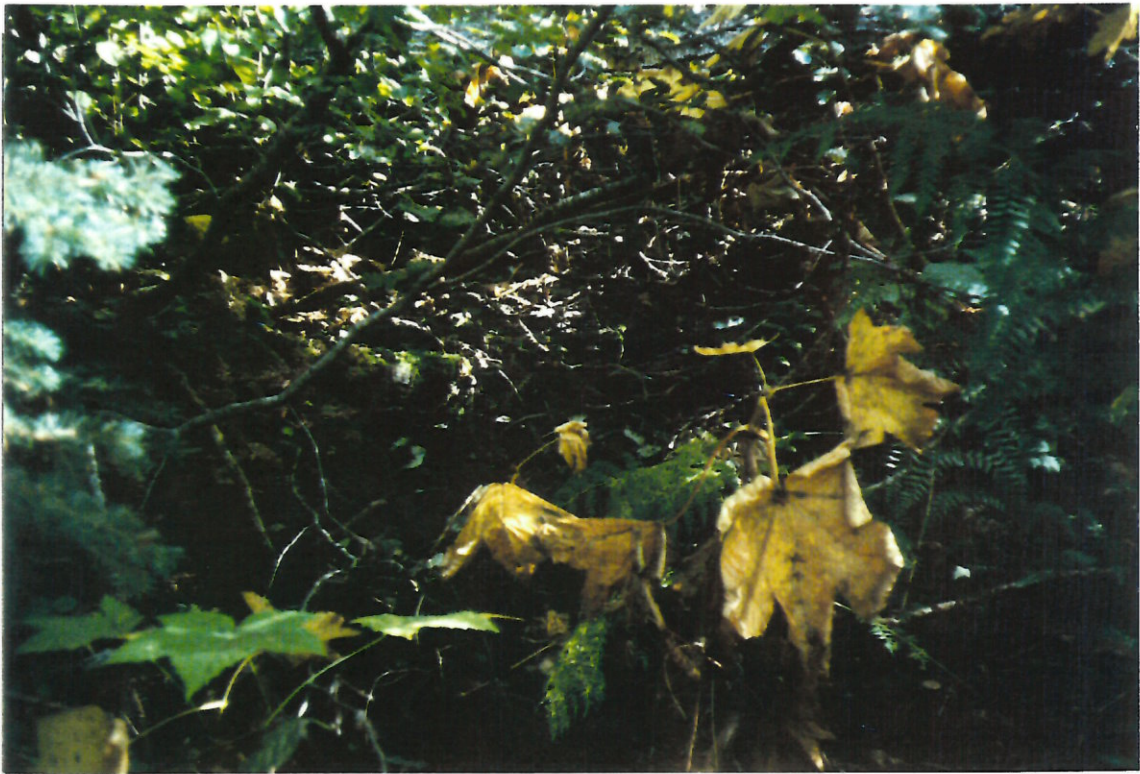
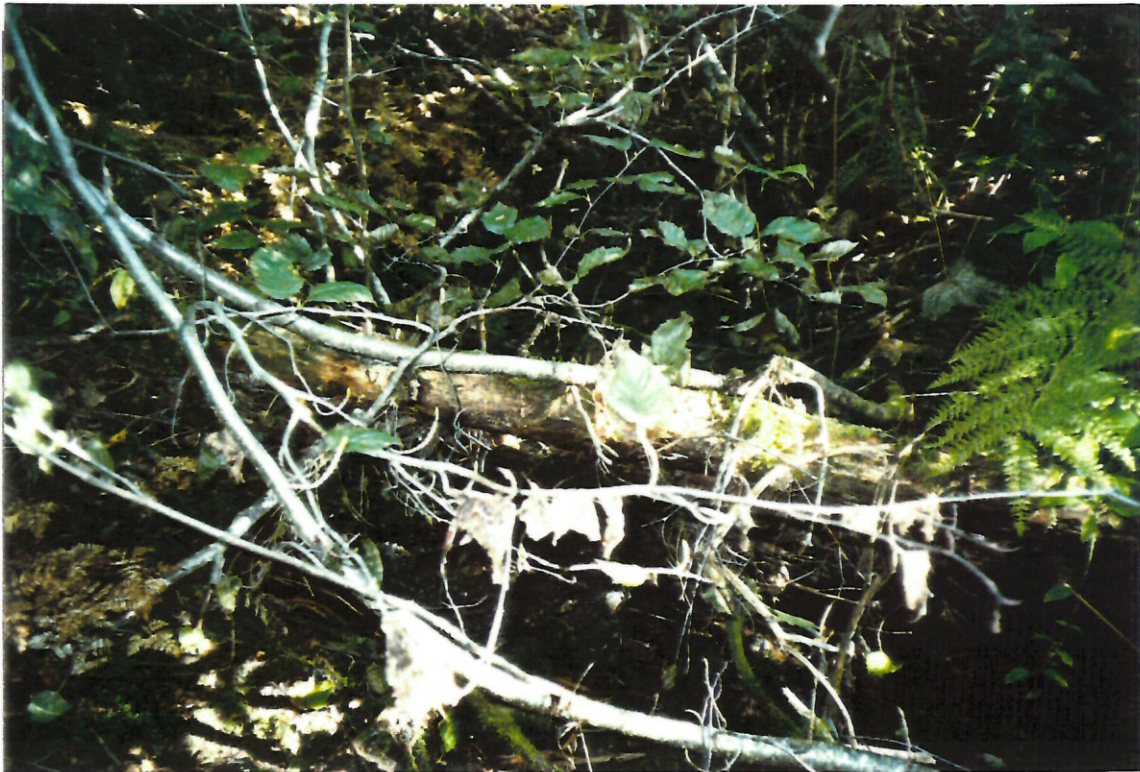
| Form | Section | Comments |
|---|---|---|
| SITE | CHANNEL | C5, poorly defined channel, evidence of low energy/volume, seasonal discharge only. |

Site 272, looking downstream at a stretch of fine substrate and devil's club riparian cover.

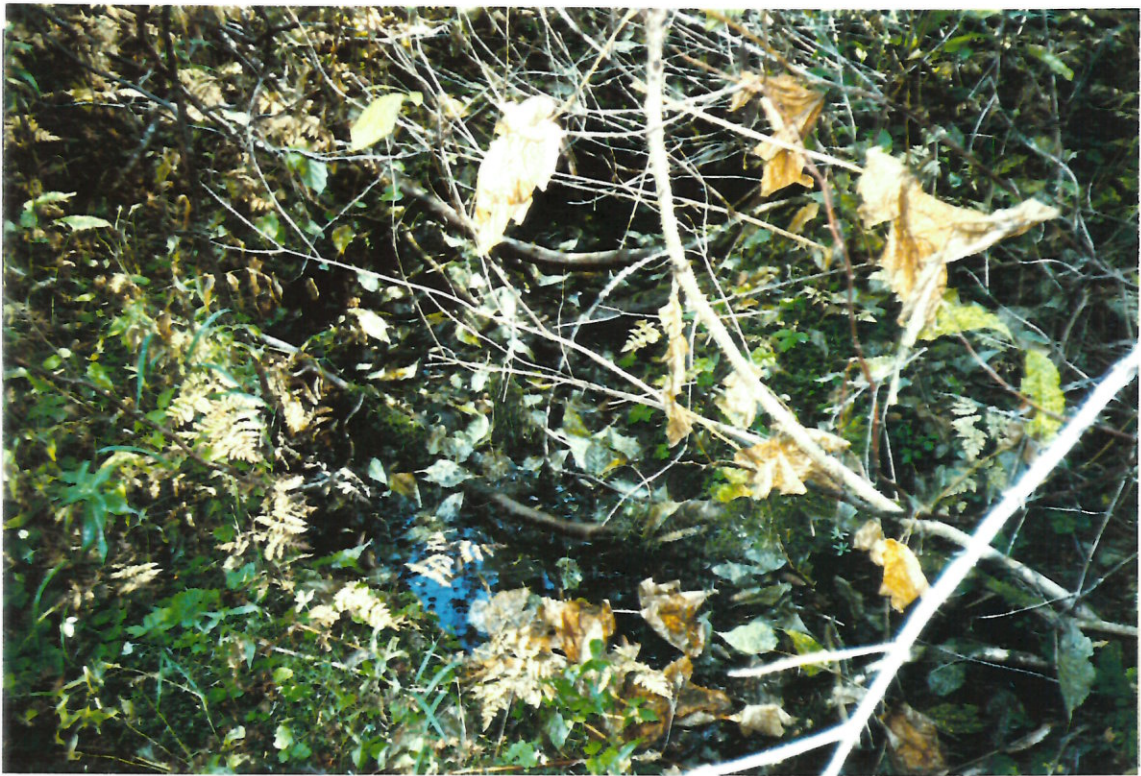
Photo #: 27 - 6  
Site 273, looking downstream at a small pool and willow cover.

| Form | Section | Comments |
|---|---|---|
| SITE | CHANNEL | C5, no suitable waters to shock at the site, just isolated pools separated by mud and willow. |

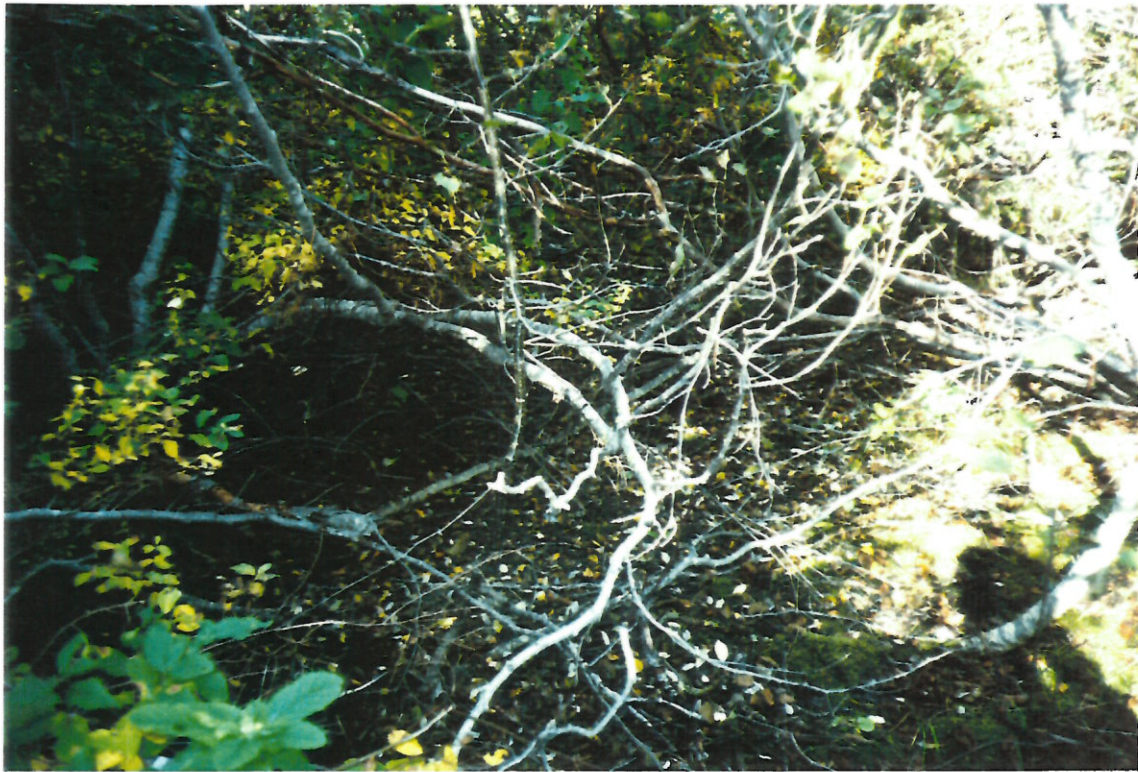
Photo #: 27 - 5

Site 274, photo of drainage classified as "No Visible Channel"

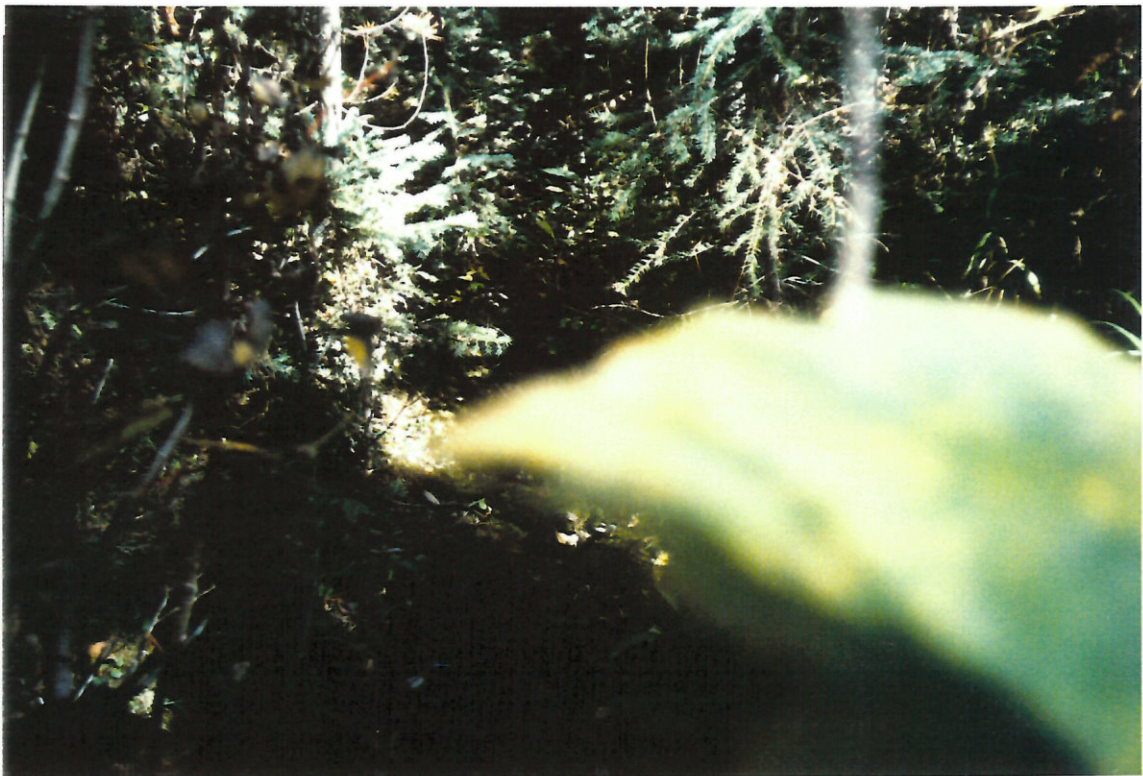
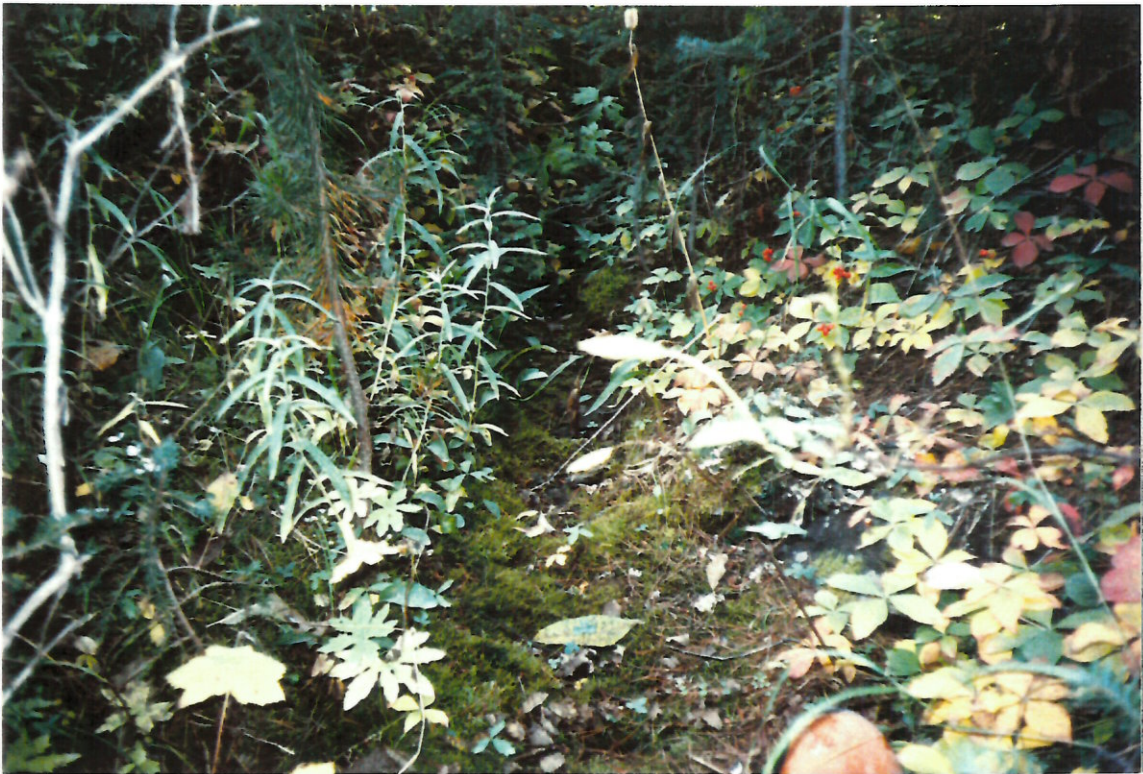
| Form | Section | Comments |
|---|---|---|
| SITE | CHANNEL | C2, vegetated channel, no culvert, no fish access, no water to shock. |
| SITE | CHANNEL | C5, no evidence of recent flow. |

Photo #: 26 - 13  
Site 277, looking downstream at some exposed cobble in the sampling area.

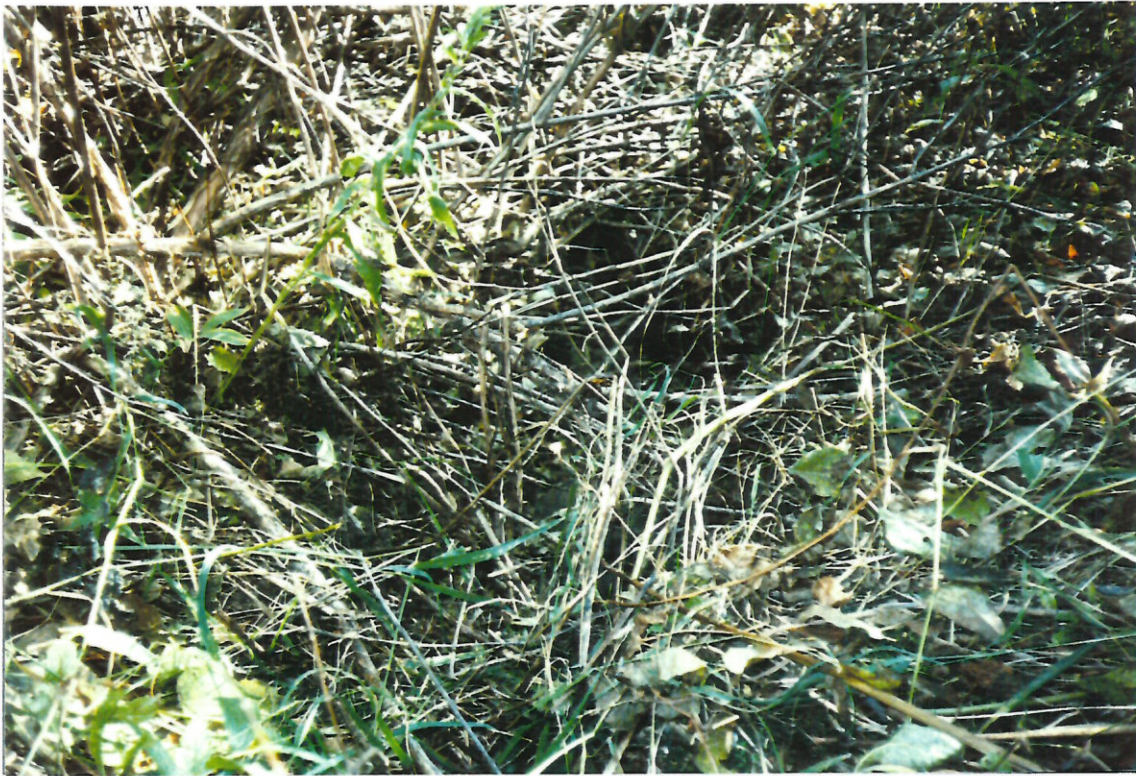
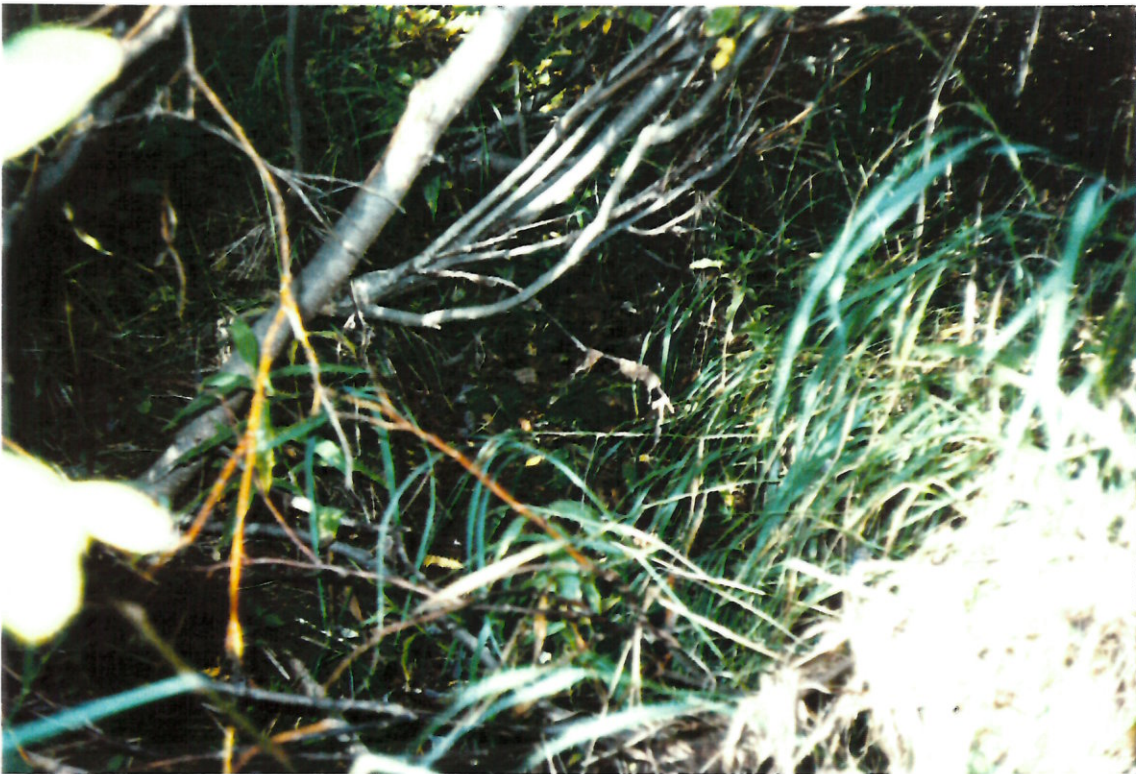
| Form | Section | Comments |
|---|---|---|
| SITE | CHANNEL | C5, the culvert also blocks access upstream. |
| SITE | CHANNEL | C5, small channel, limited and seasonal discharge. No wetted habitat to sample at the time of survey. |

Photo #: 26 - 14  
Site 278, looking downstream at the channel, note the gravels and leaf litter.

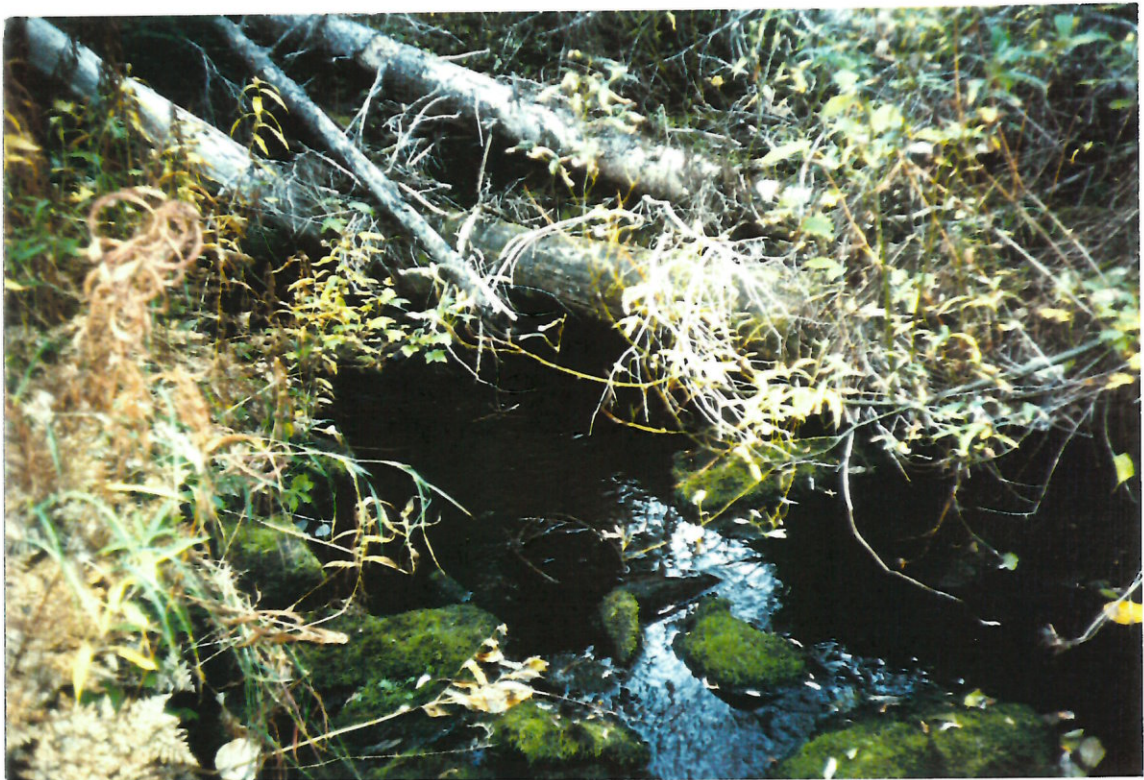
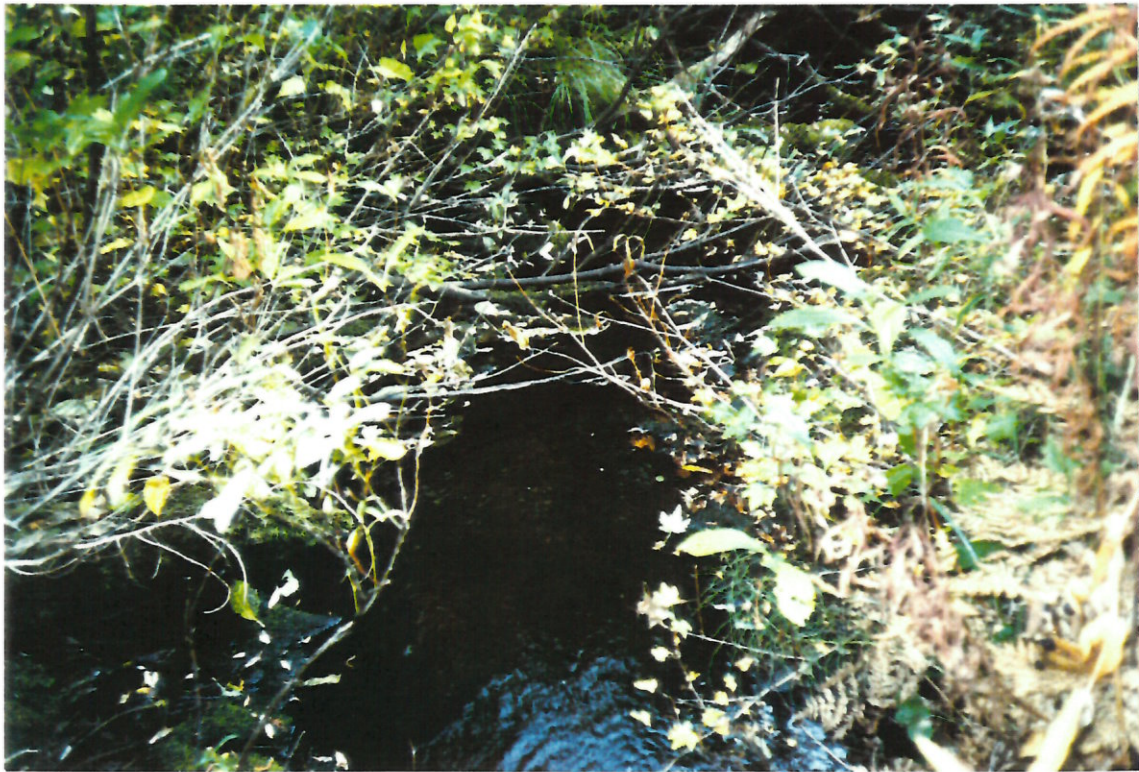
| Form | Section | Comments |
|---|---|---|
| SITE | CHANNEL | C5, large moss covered substrate, water is tannin stained. |

Photo #: 26 - 17  
Site 279, looking upstream at the channel, with boulder/cobble cover.

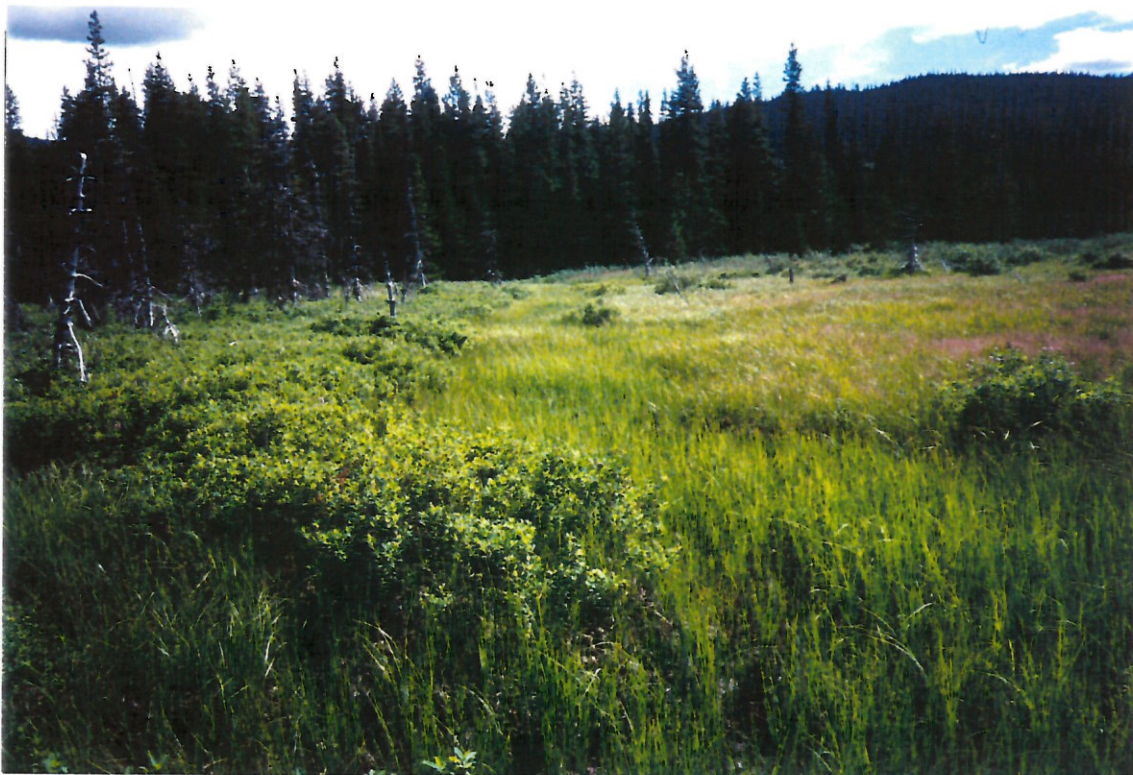
Photo #: 1 - 17

Site 306, photo of reach classified as "NVC", including an abandoned channel.

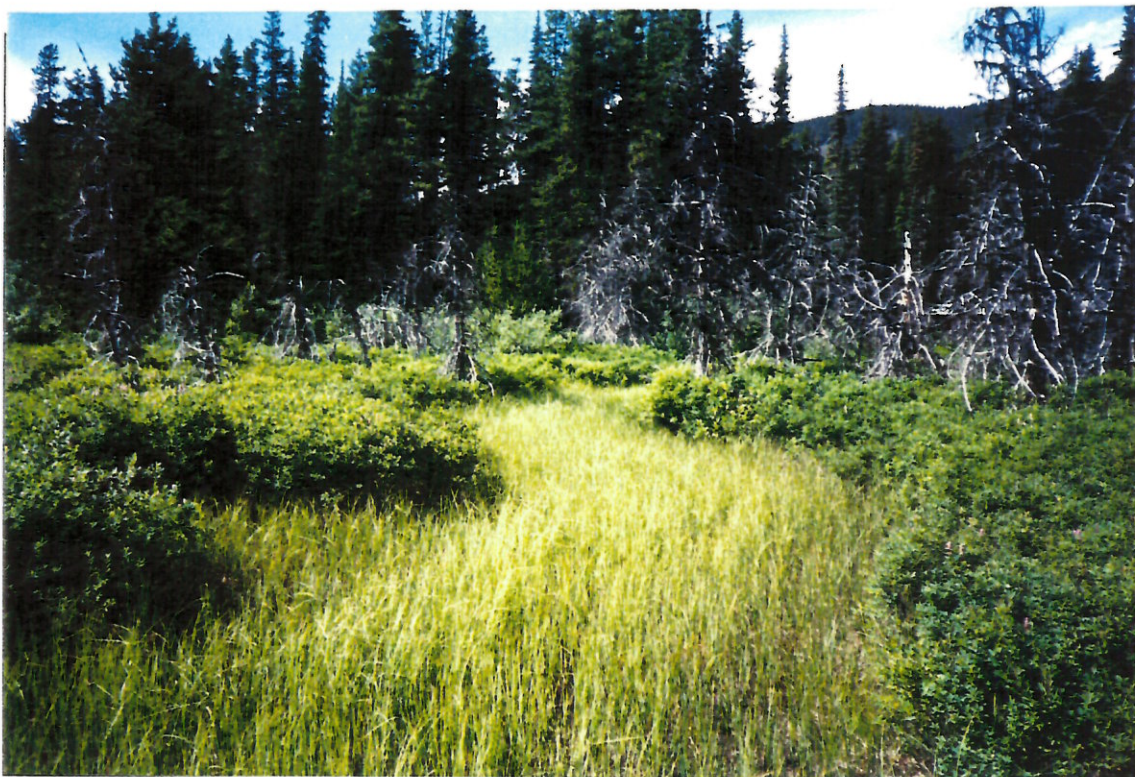
Photo #: 1 - 18

Site 306, photo of sedges in an abandoned channel.

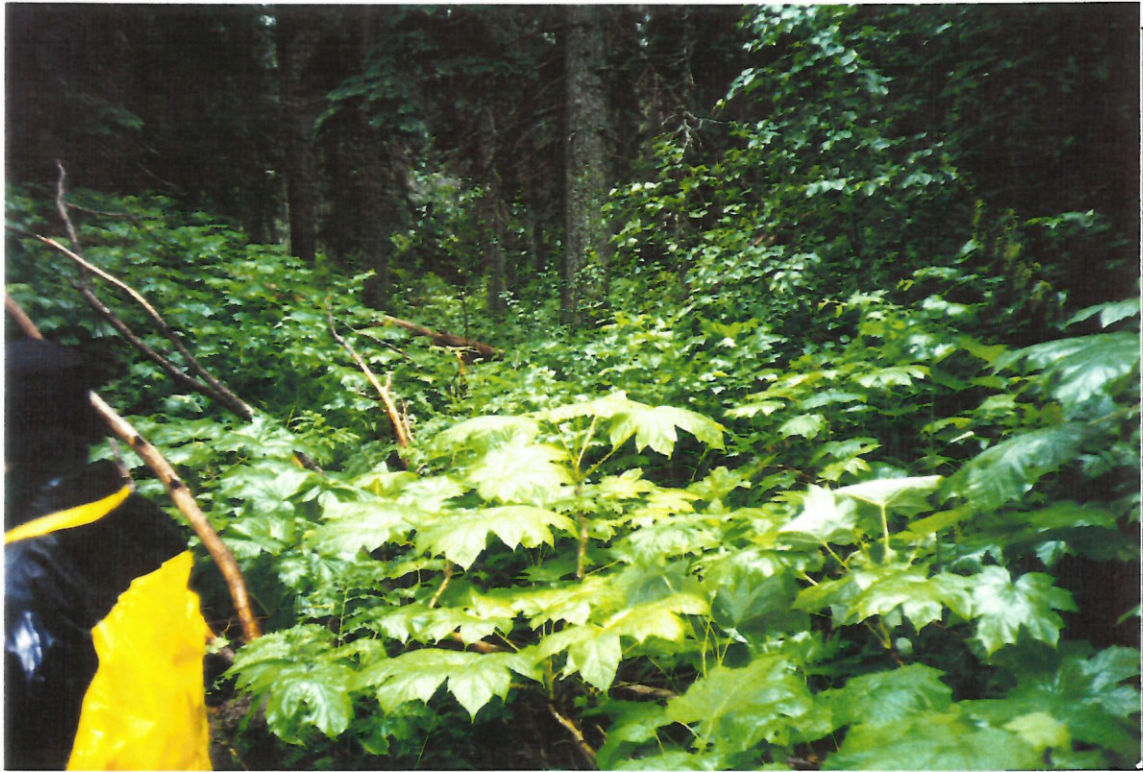
| Form | Section | Comments |
|---|---|---|
| SITE | CHANNEL | C2, Vegetated gully- some small sections of surface scour (2m) no definable channel. |

Photo #: 2 - 3  
Site 310, looking downstream at vegetated gully, 20%.

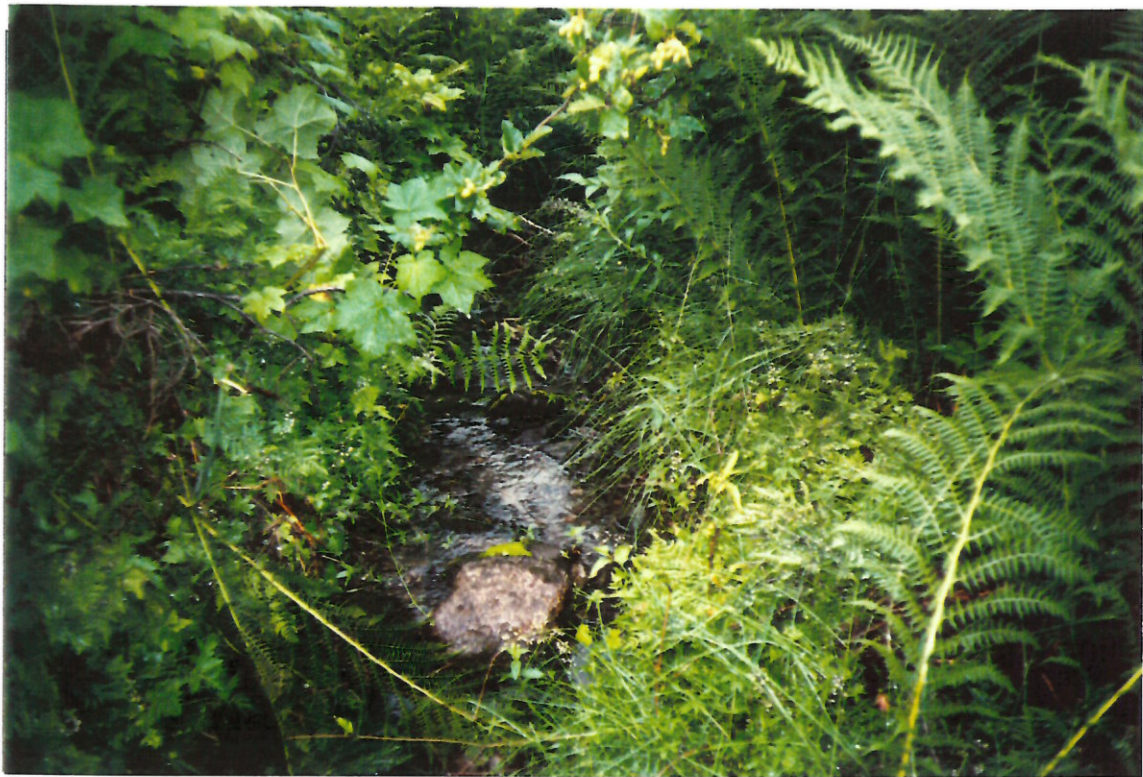
Photo #: 2 - 5  
Site 311, looking upstream at ferns and shrubs covering channel.

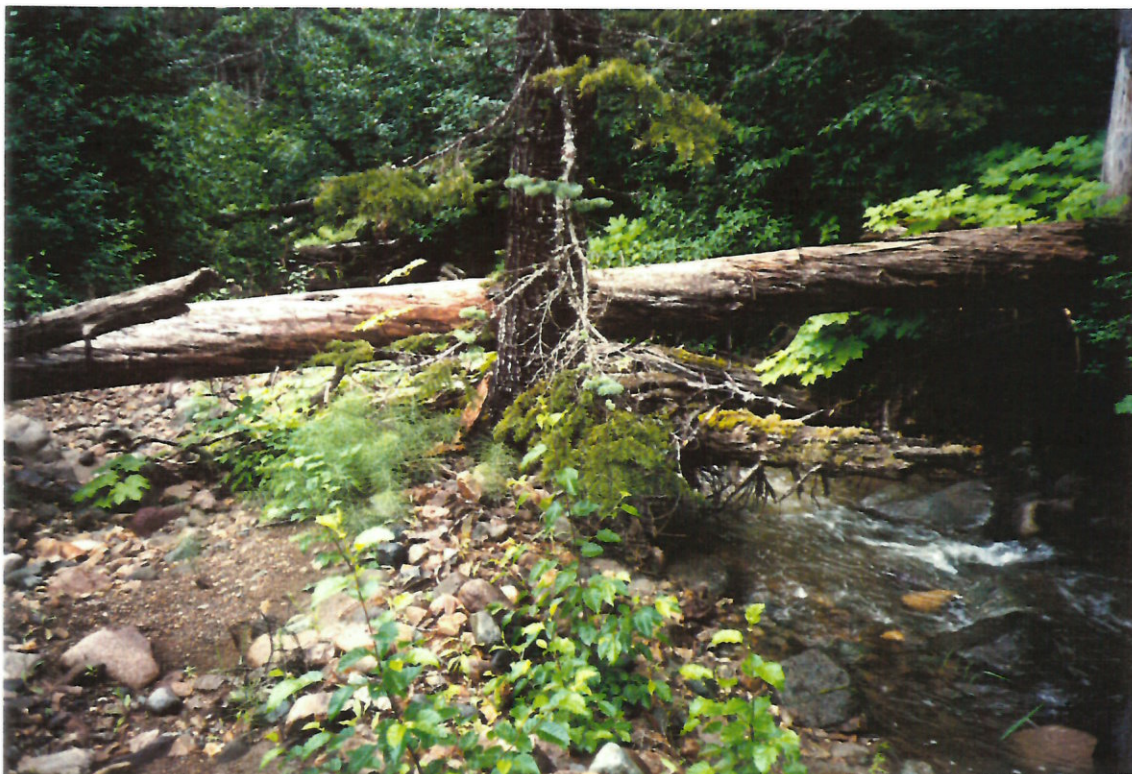
Photo #: 2 - 11  
Site 314, looking downstream at extremely disturbed channel.

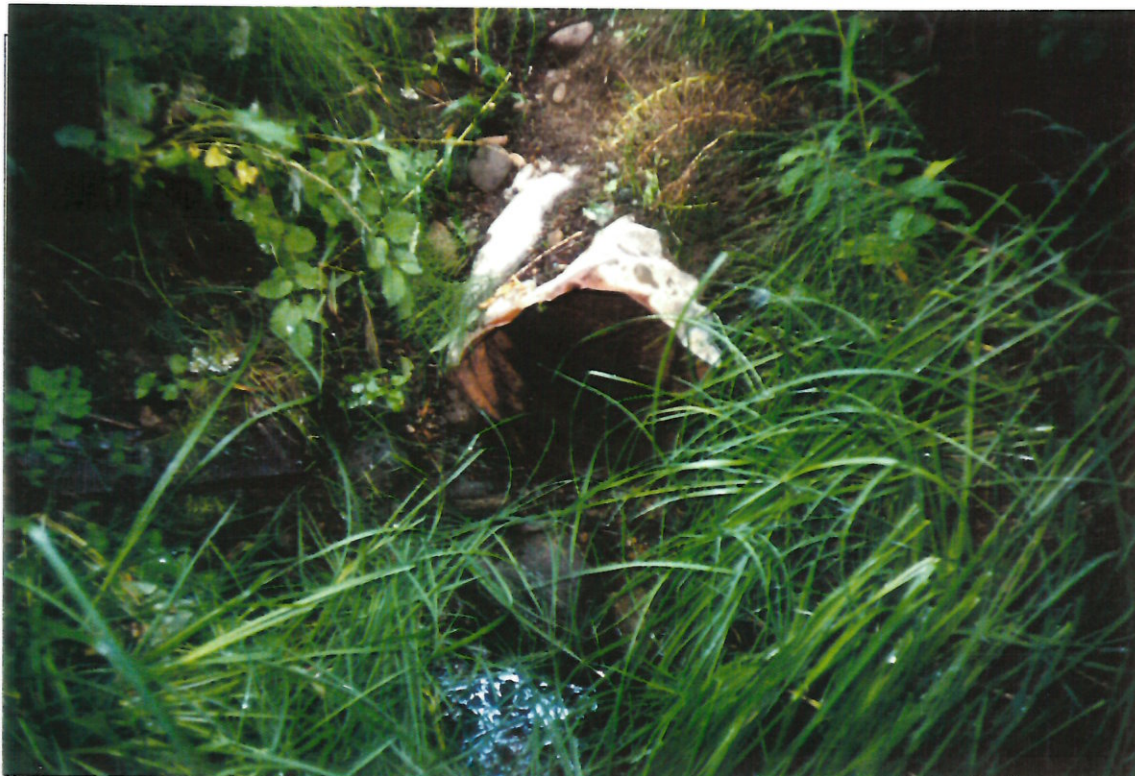
Photo #: 2 - 14

Site 315, looking upstream at culvert 300 mm, pinched at outlet.

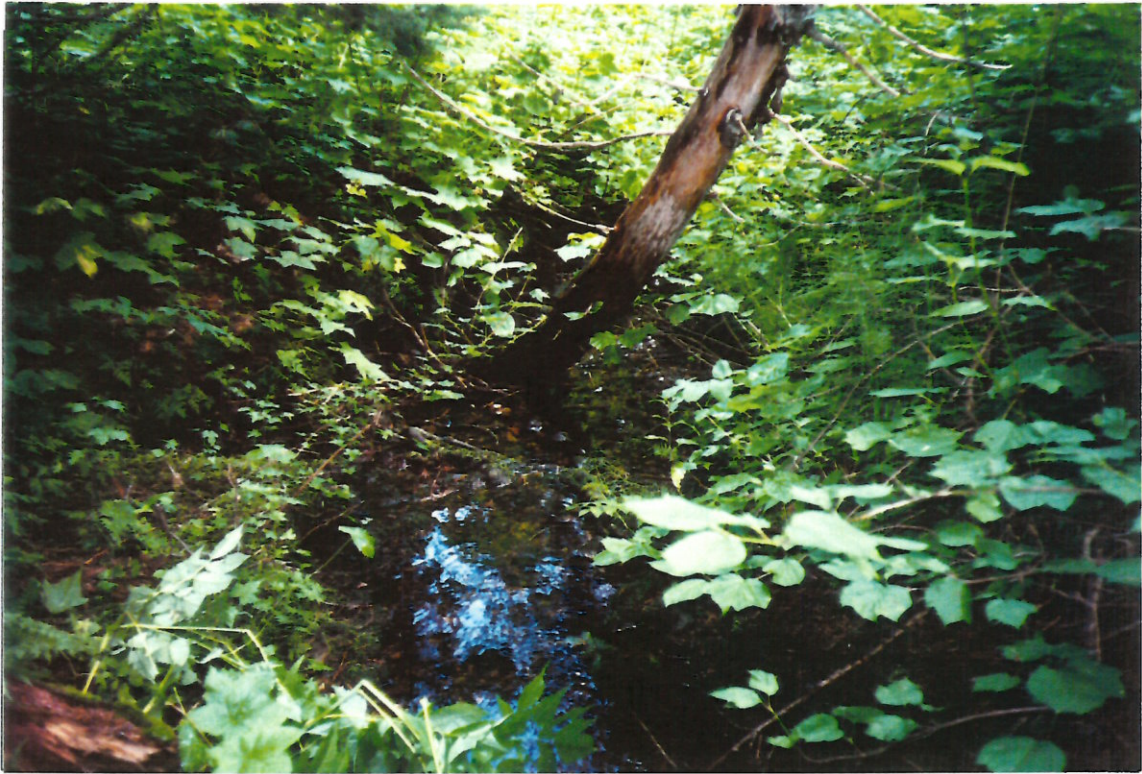
Photo #: 2 - 33  
Site 320, looking downstream at overstream vegetation.
