# Reconnaissance (1:20,000) Fish and Fish Habitat Inventory in the Morice River Watershed

**TRITON**

Environmental Consultants Ltd.

Project Name Morice River Fish Inventory - 1999

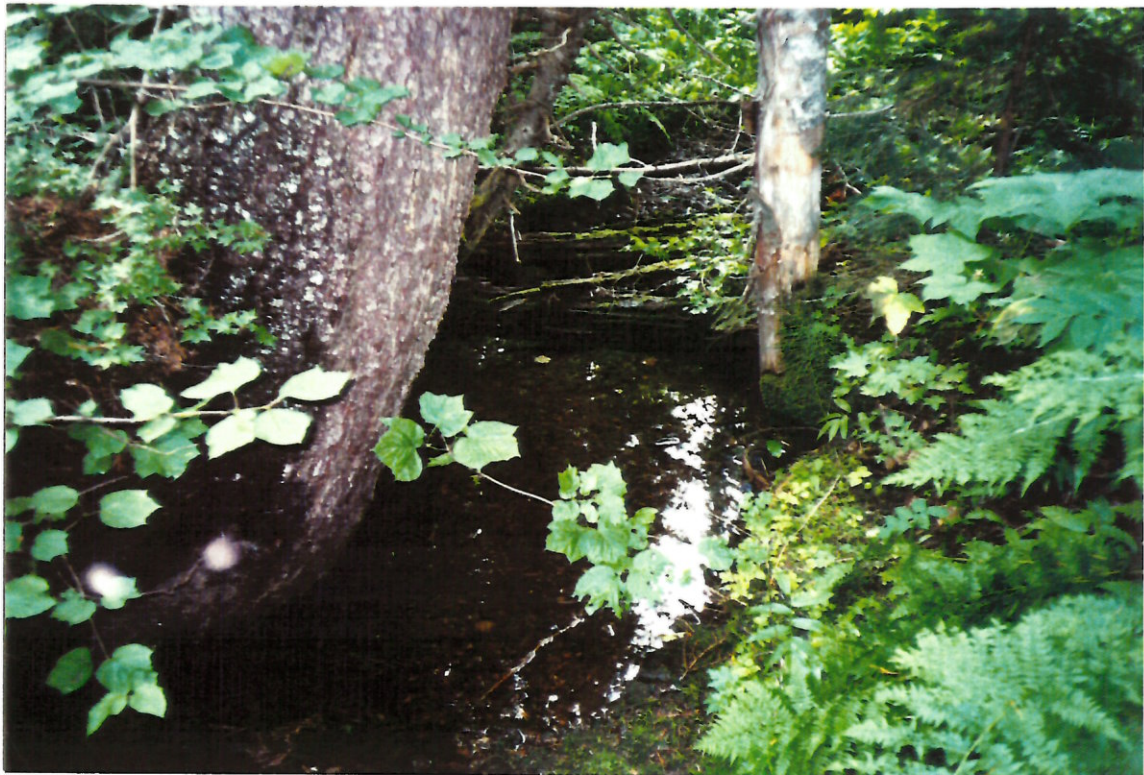
Photo #: 2 - 32  
Site 320, looking upstream at spruce in stream.

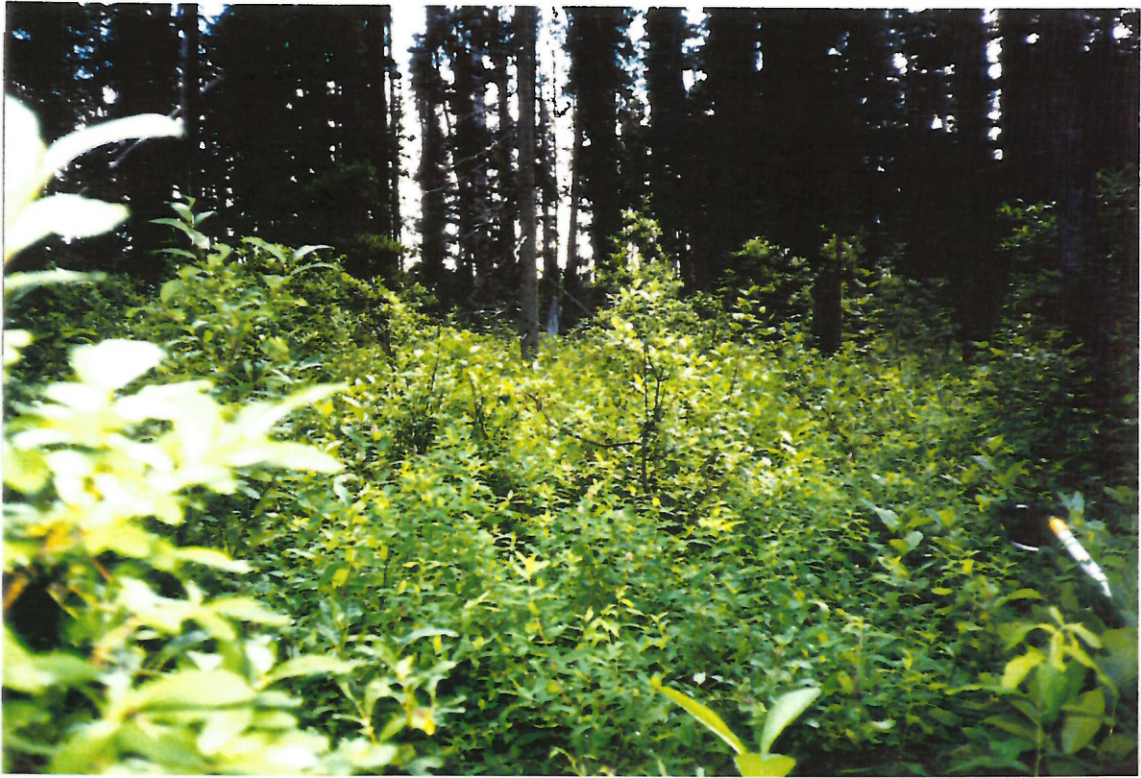
| COMMENT | | |
|---|---|---|
| SITE | CHANNEL | C1, NVC |
| SITE | CHANNEL | No evidence of bed scour, just a vegetated depression. |

Photo #: 2 - 34  
Site 321, looking at reach classified as "No Visible Channel".

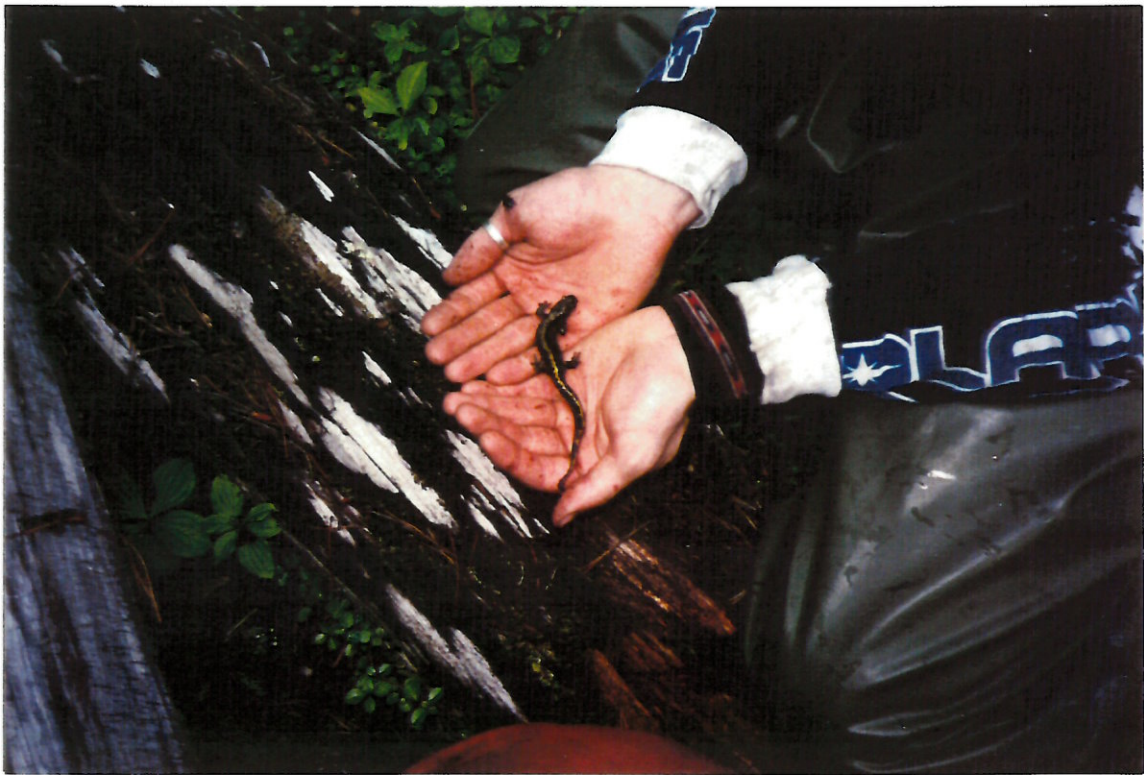
Photo #: 2 - 35  
Site 321, photo of a salamander in the sampling area.

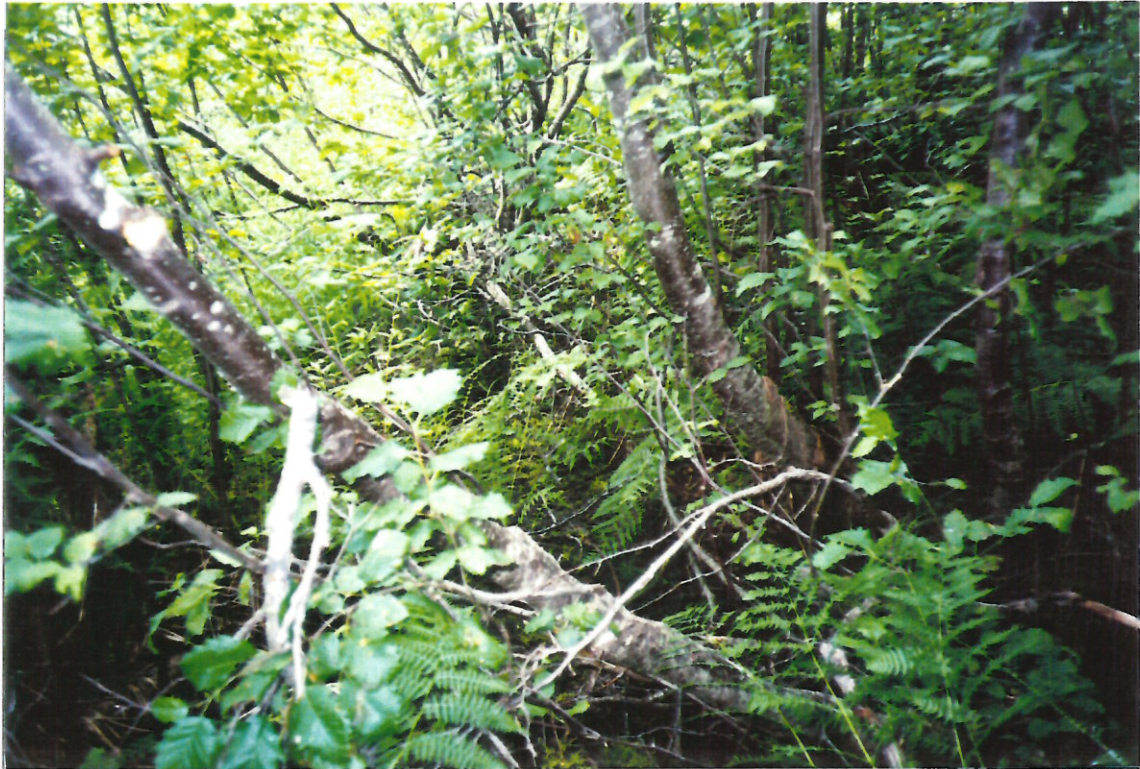
| COMMENT | | | | | | | | | |
|---|---|---|--|--|--|--|--|--|--|
| SITE | CHANNEL | C1, NVC | | | | | | | |
| SITE | CHANNEL | C2, no defined channel, no bed scour. | | | | | | | |

Photo #: 3 - 1  
Site 322, photo of a reach classified as "No Visible Channel"

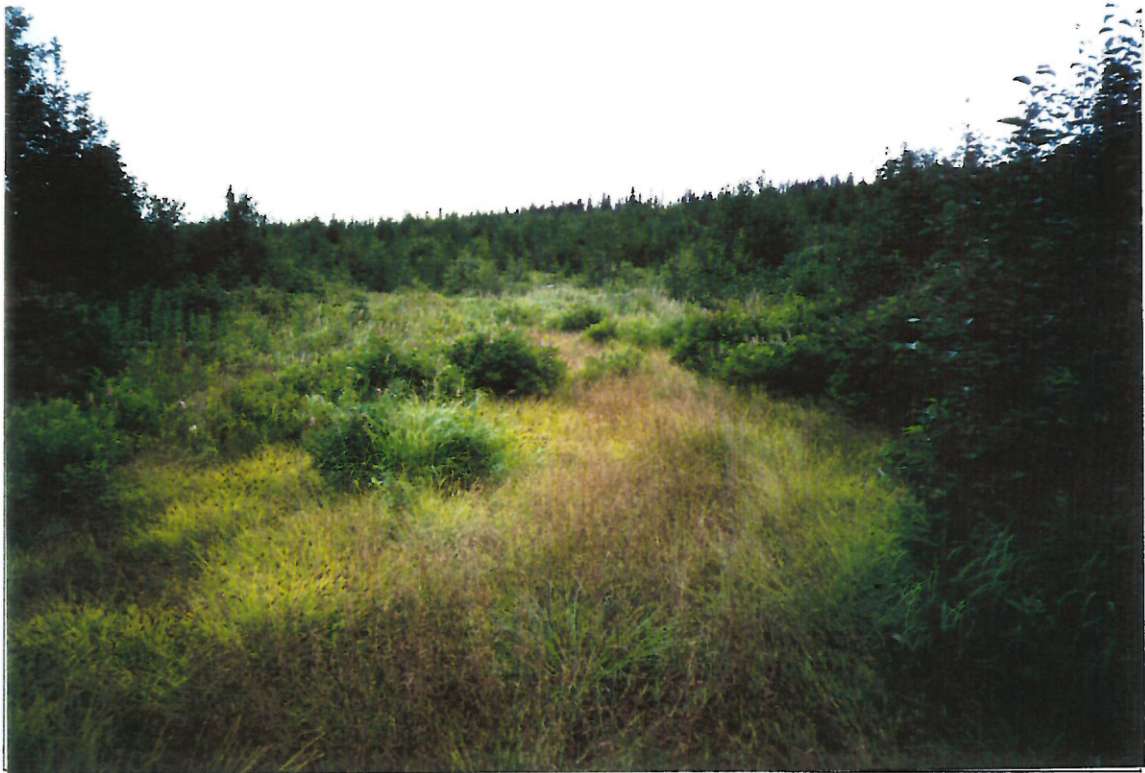
Photo #: 3 - 2

| COMMENT | | |
|---|---|---|
| SITE | CHANNEL | C1, NVC |
| SITE | CHANNEL | C2, no channel, no evidence of bed scour. |

Site 323, photo of a reach classified as "No Visible Channel", this is a vegetated seepage.

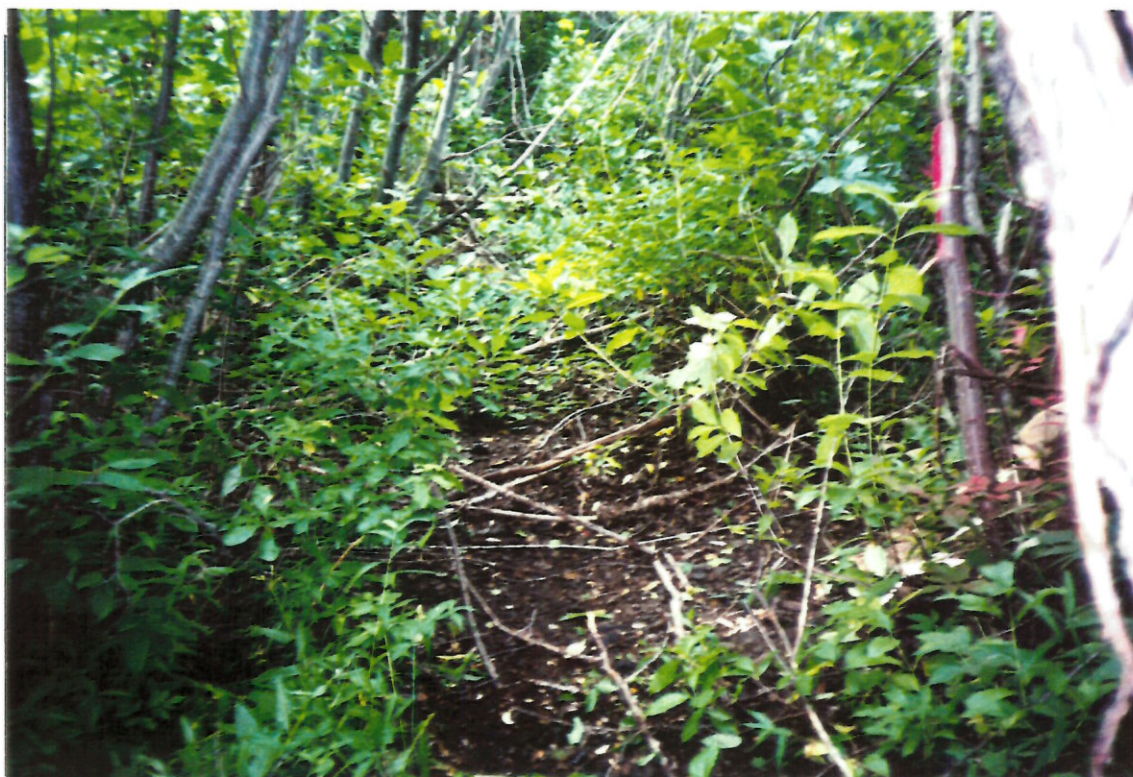
| Form | Section | Comments |
|---|---|---|
| SITE | CHANNEL | C1, S3 |

Photo #: 3 - 5  
Site 325, looking upstream at a dry channel.

| Form | Section | Comments |
|---|---|---|
| SITE | CHANNEL | C2, resample reach in spring, no gradient barriers. |

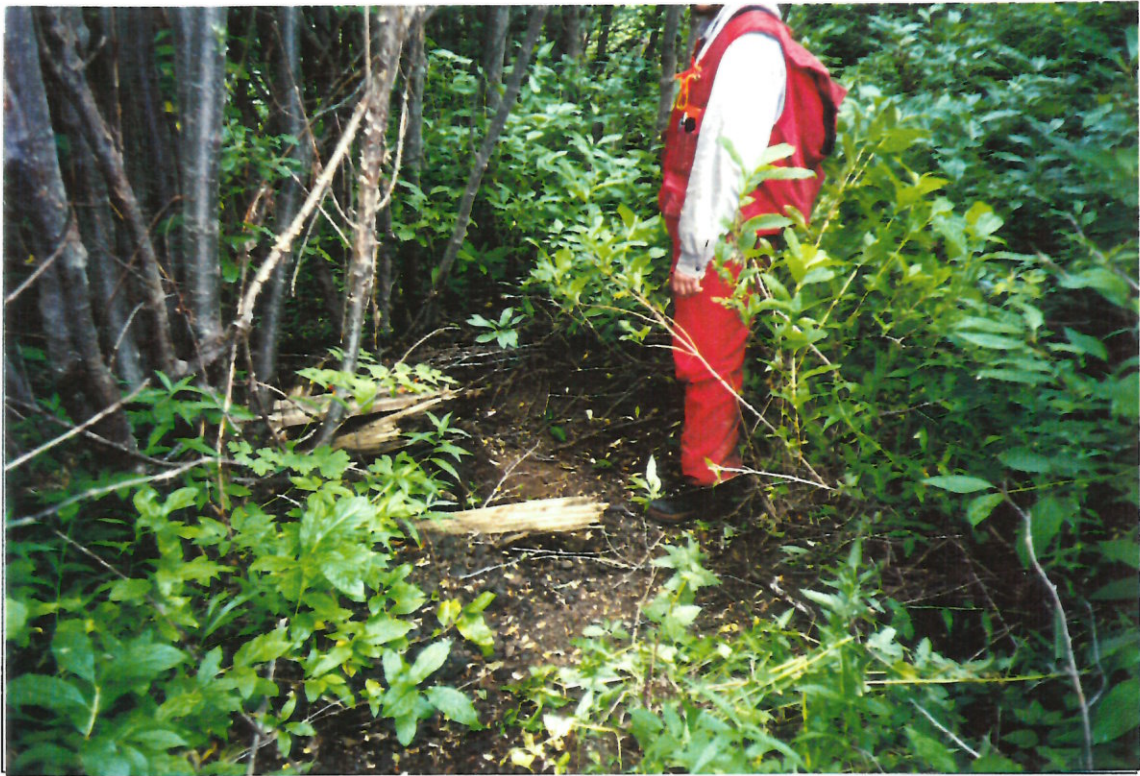
Photo #: 3 - 6  
Site 325, looking downstream at overstream vegetation cover.

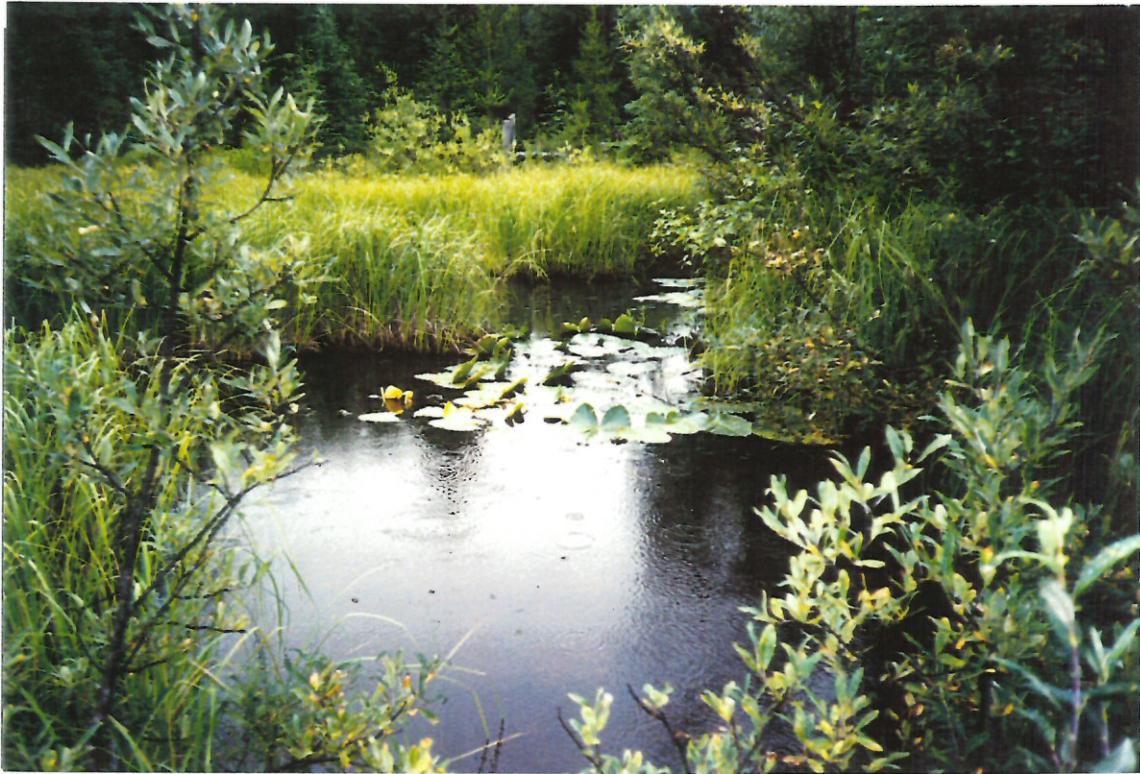
Photo #: 3 - 7  
Site 326, looking downstream at alder and sedges along the stream.

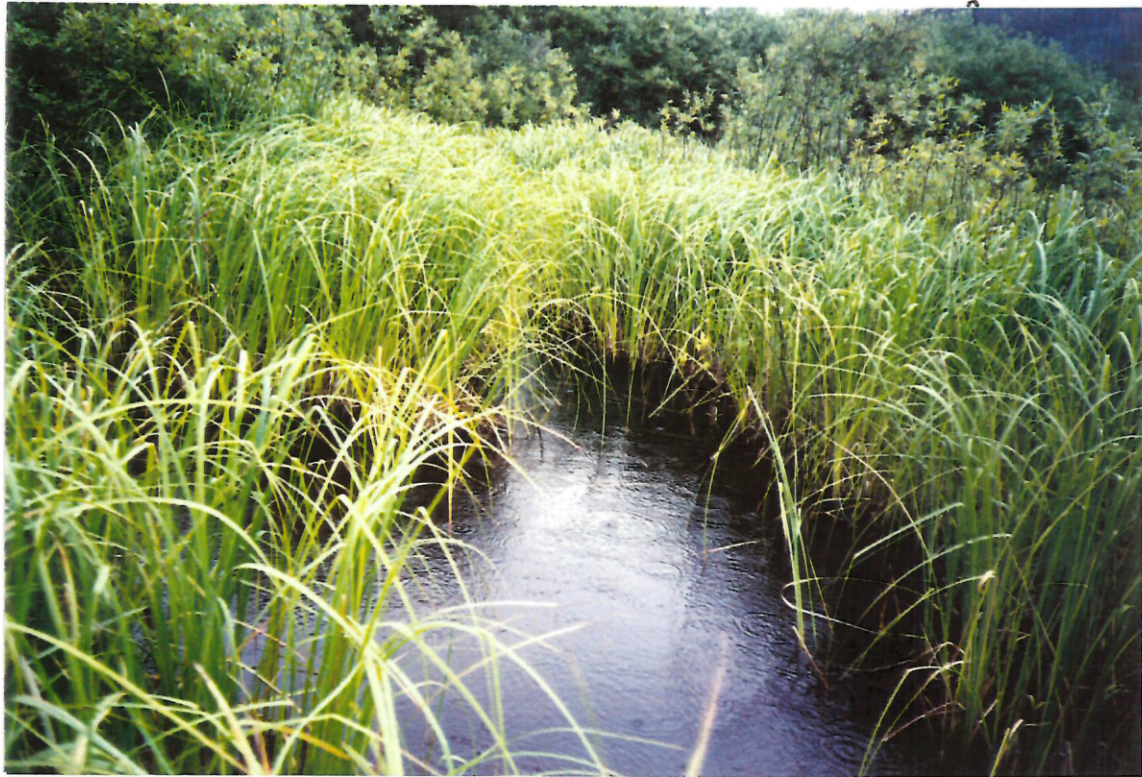
Photo #: 3 - 8  
Site 326, looking upstream at pond habitat.

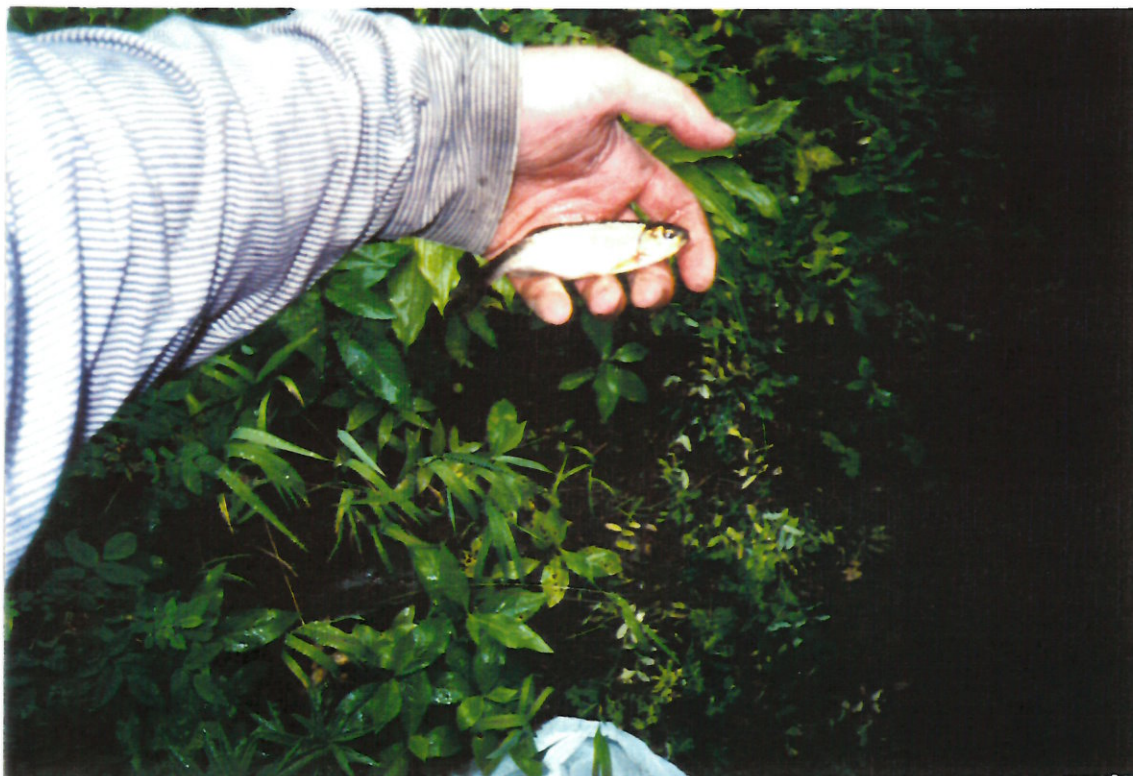
Photo #: 3 - 9

Site 326, photo of an adult redeye shiner

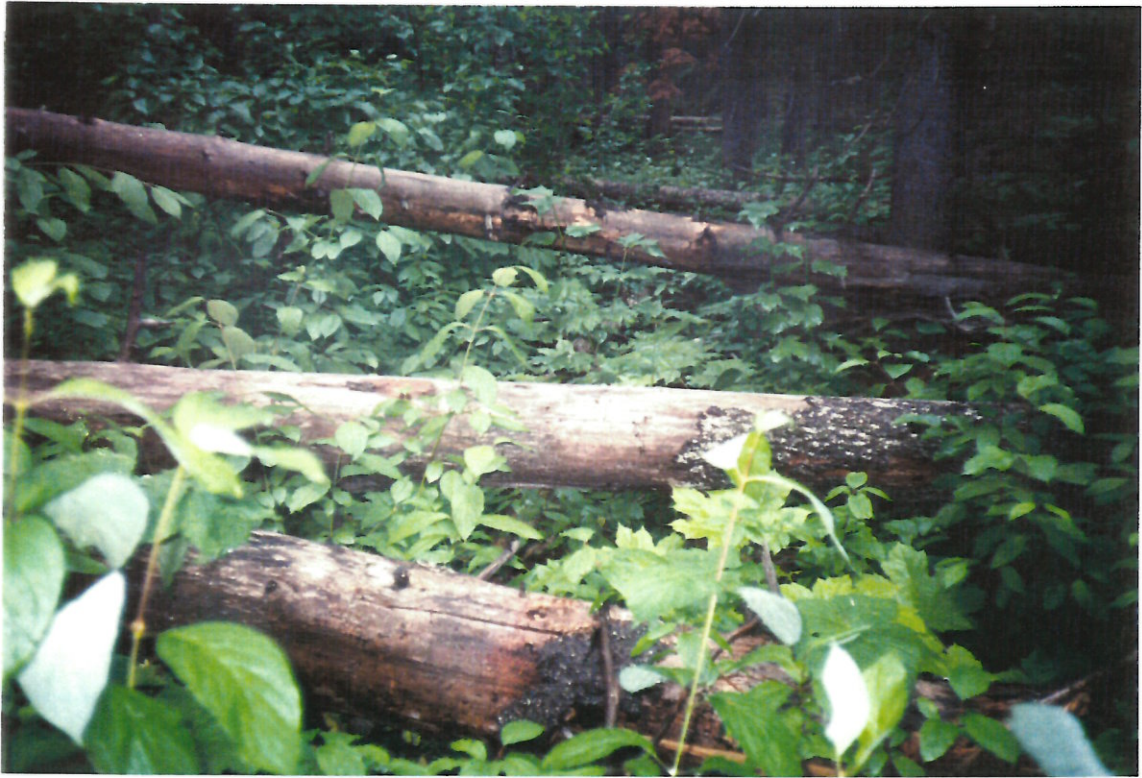
| COMMENT | | |
|---|---|---|
| SITE | SITE CARD | C1, NVC |
| SITE | SITE CARD | C2, Vegetated gully; no evidence of channel or scour. |

Photo #: 3 - 10  
Site 328, looking upslope at vegetated gully.

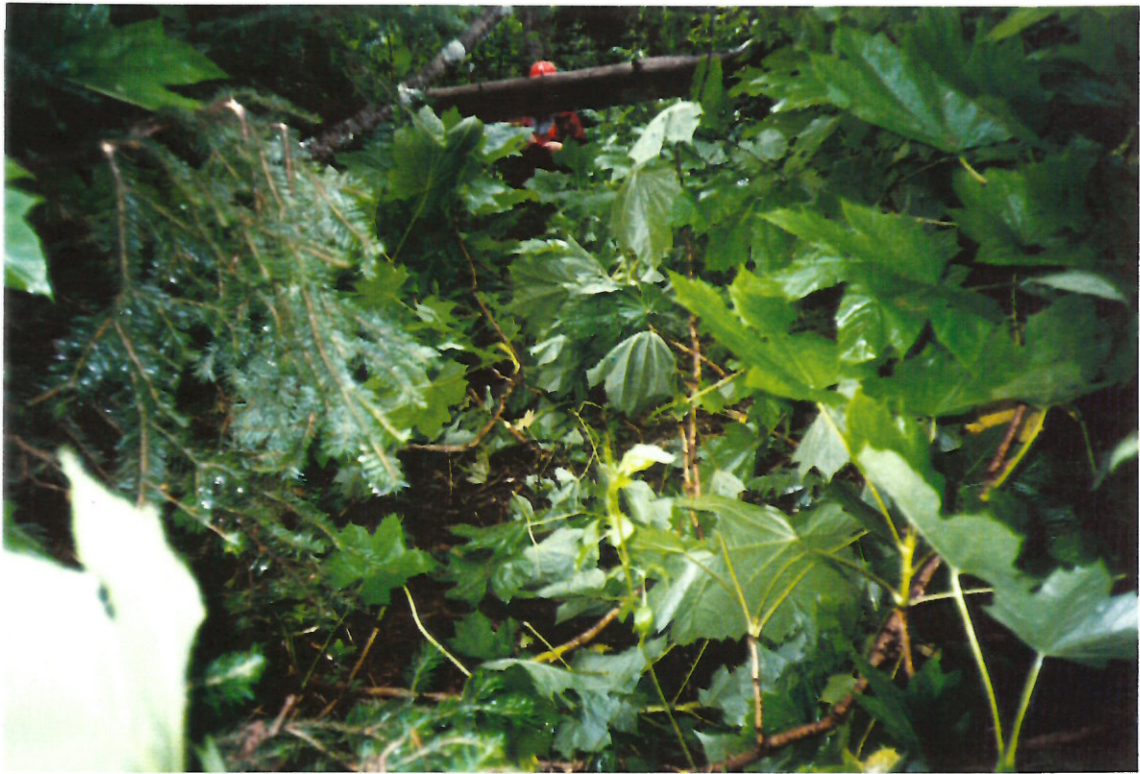
Photo #: 3 - 12  
Site 329, looking downstream at Devil's Club - dry channel

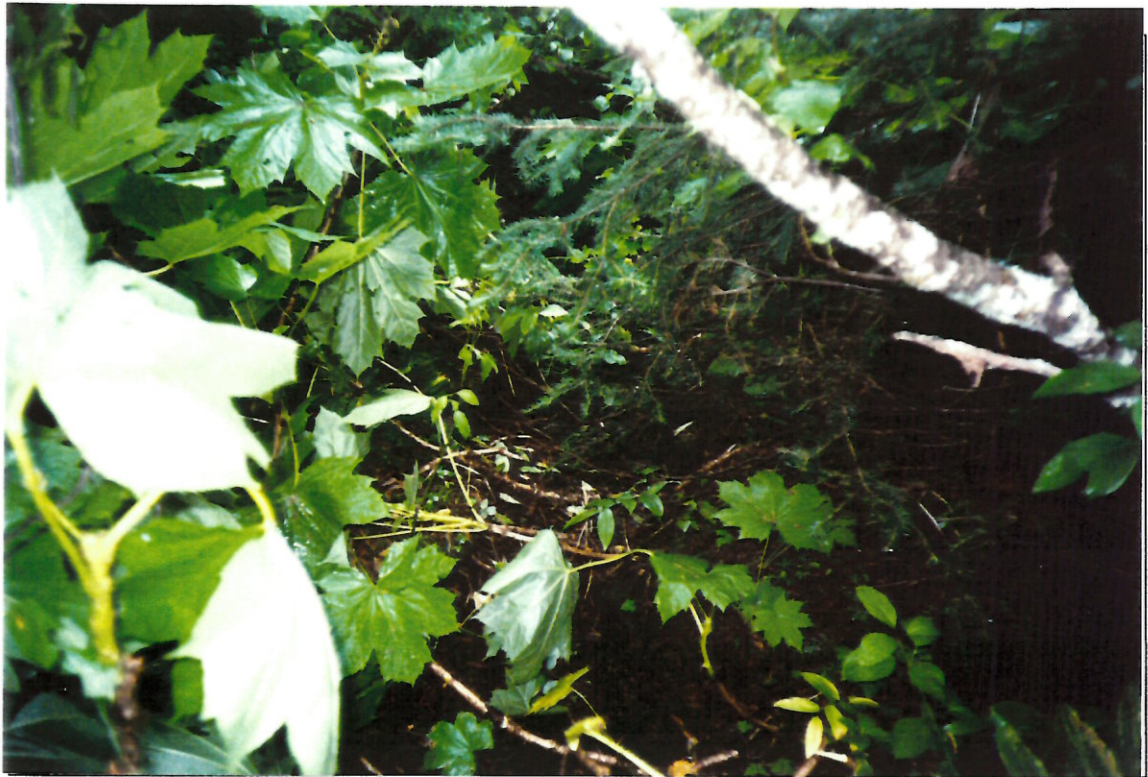
Photo #: 3 - 11  
Site 329, looking upstream at Devil's Club - dry channel

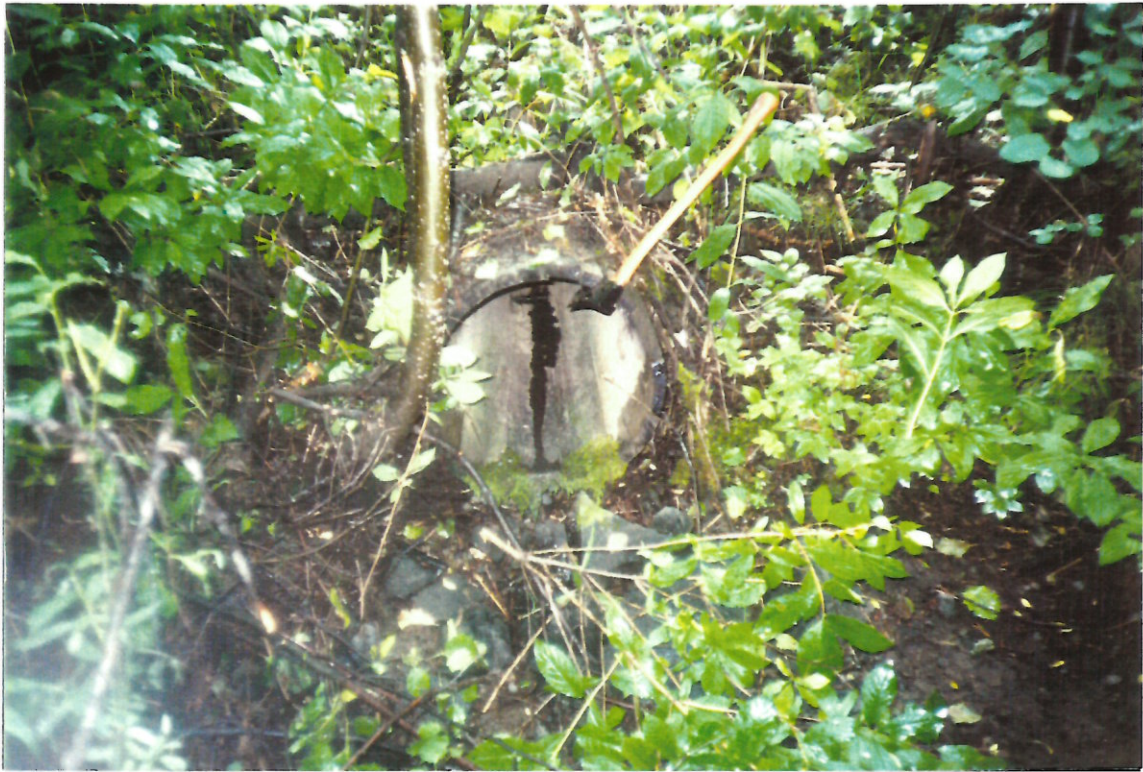
Photo #: 3 - 13

Site 329, looking upstream at wooden CV - axe in CV barrier to fish
