## REGIONAL EXAMPLES OF FISH HABITAT PROJECTS OF THE WATERSHED RESTORATION PROGRAM 1994 - 1996

November 1996

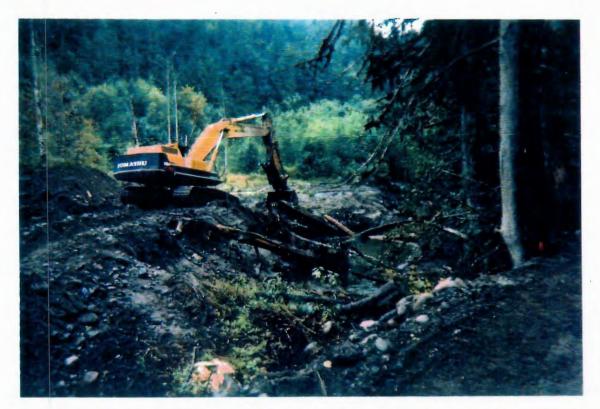
Photo 1. Excavation of deep channel along the side of the dyke in order to prevent beaver dam construction. Large woody debris was left in this channel for cover.

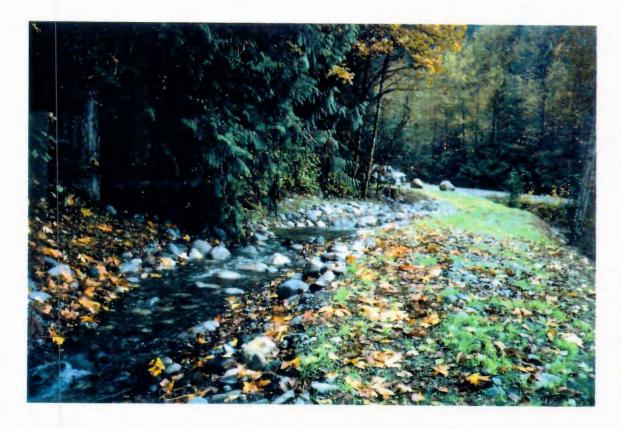
Photo 6. Upper spawning channel delivering water from Anderson Creek to rearing pond.

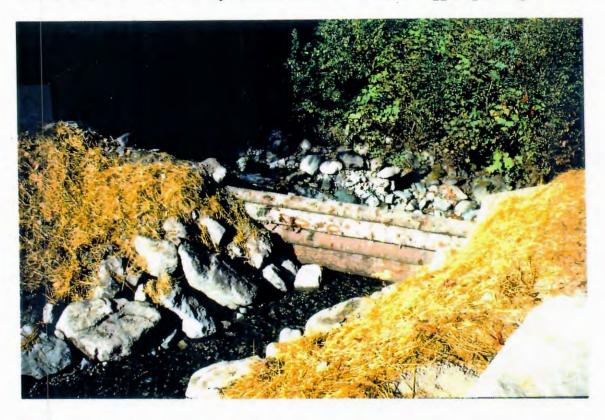
Photo 8. Sheer boom at Anderson Creek.

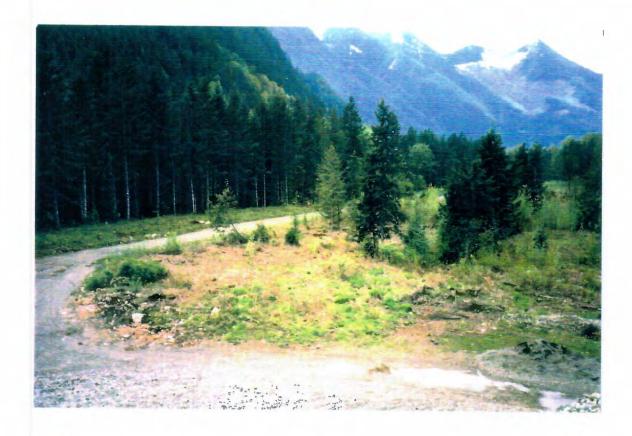
Photo 1. Centennial Trail spawning/rearing channel prior to construction.

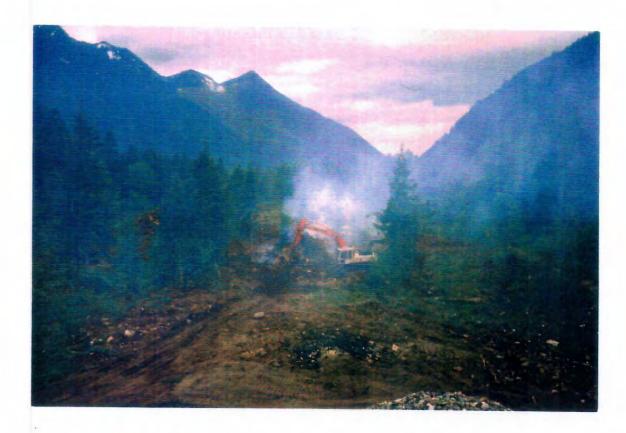
Photo 2: Land clearing and slash burning.

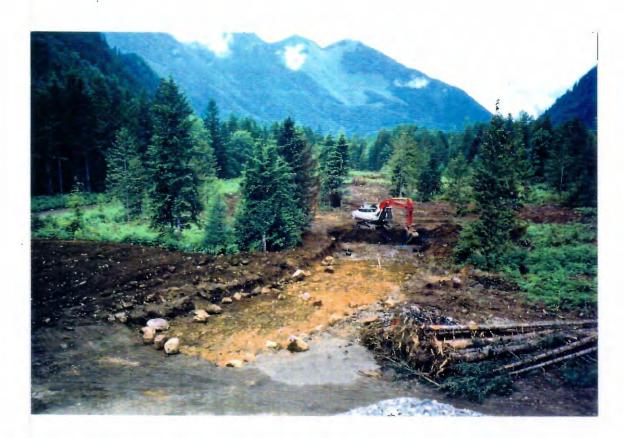
Photo 3. Excavation of channel.

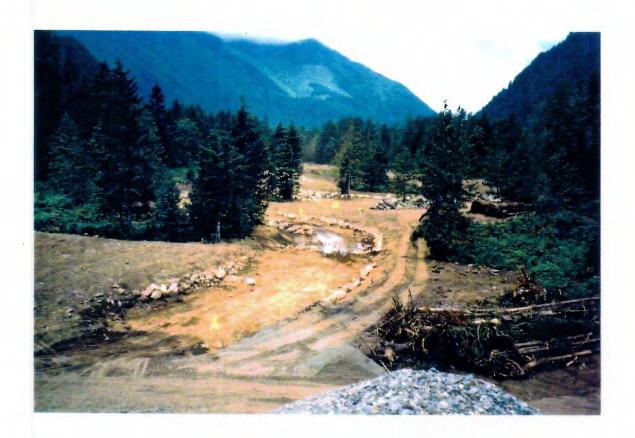
Photo 5. Armouring the channel with boulders.

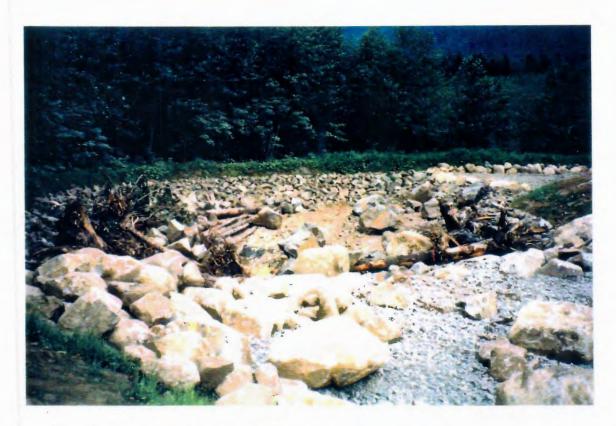
Photo 7. Gravel placement and channel complexing.

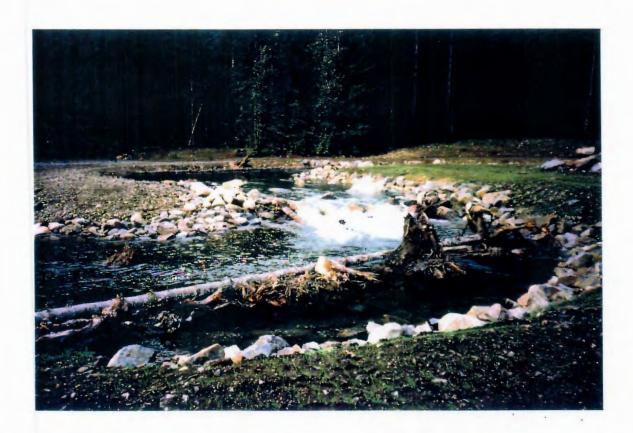
Photo 8. Centennial Trail spawning/rearing channel after construction and hand seeding.

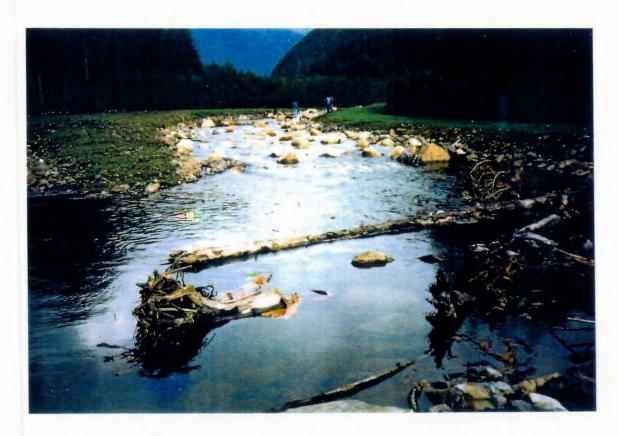
Photo 9. Centennial Trail spawning/rearing channel after construction and hand seeding (prior to hand planting of shrubs and trees by First Nations planters).

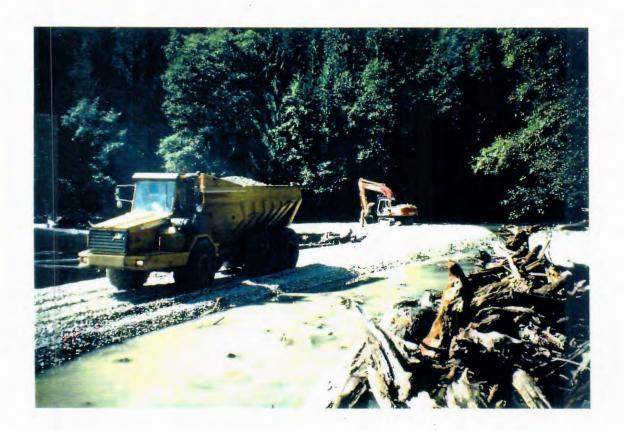
Photo 1. Volvo trucks transporting spawning gravel to lake outlet.

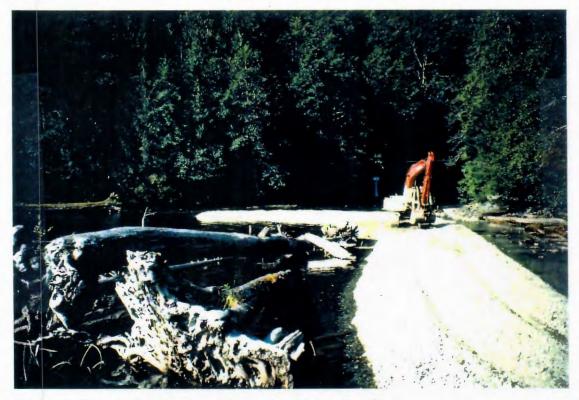
Photo 2. Gravel placed across lake outlet prior to levelling.

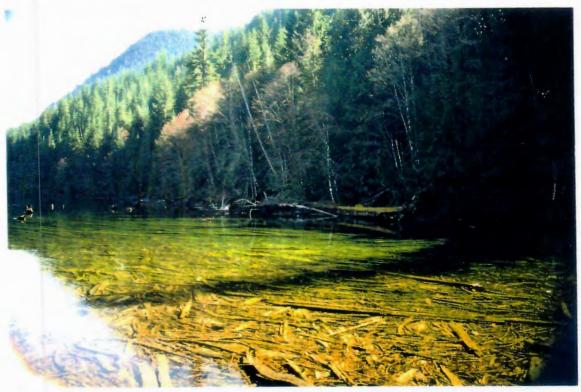
Photo 4. Lake outlet prior to gravel placement.

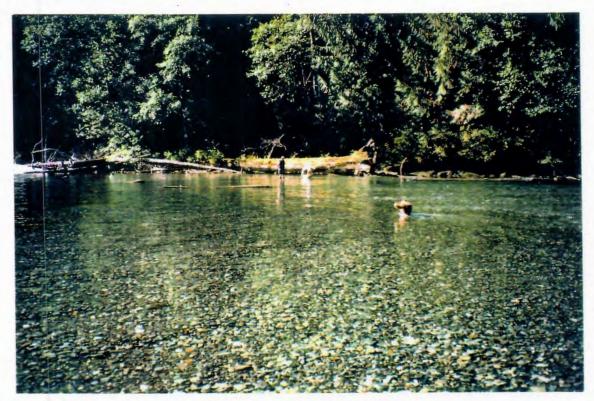
Photo 6. Spawning gravel at lake outlet during September low flows.

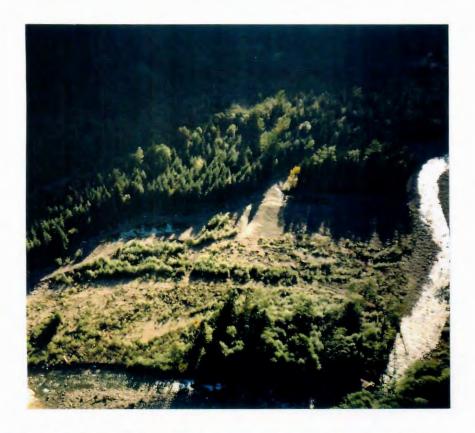
Photo 1. Aerial view of Slesse Creek prior to creation of off-channel habitat.

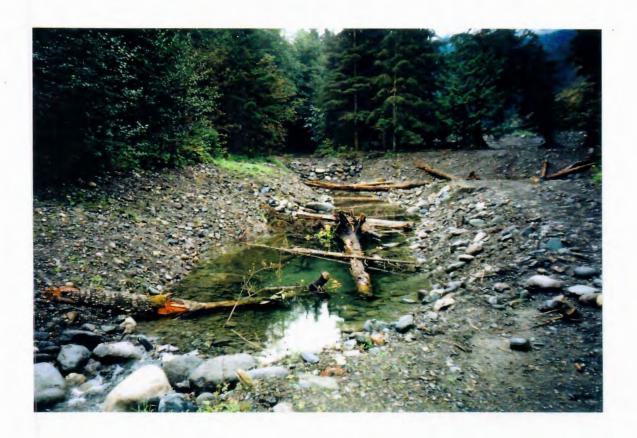
Photo 3. Constructed groundwater channel with large woody debris and boulder placements.

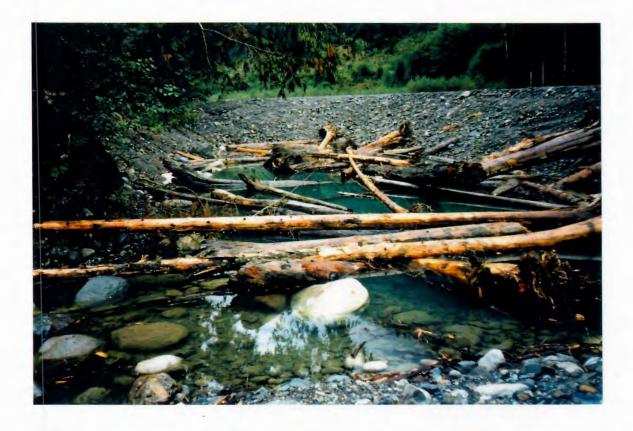
Photo 4. Constructed overwintering pond with large woody debris and rootwad placements.

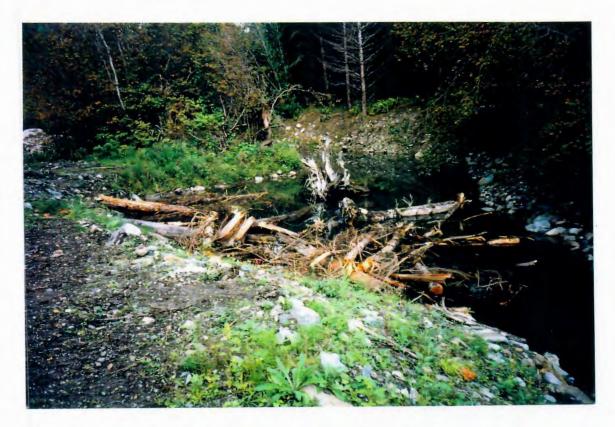
Photo 5. Constructed pond with large woody debris and rootwad placements for a juvenile overwintering refuge for coho.

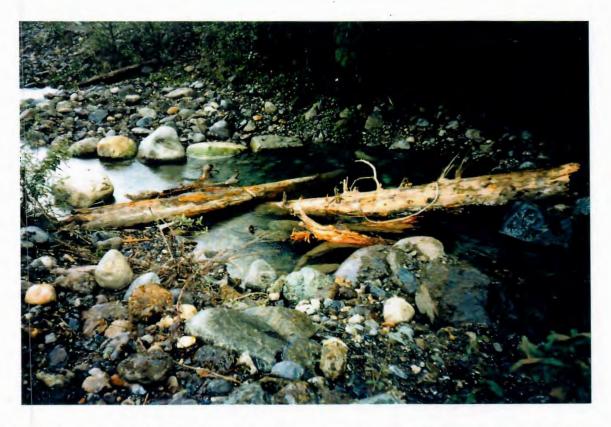
Photo 6. Constructed pool with large woody debris placements for juvenile coho and steelhead summer and overwinter rearing.

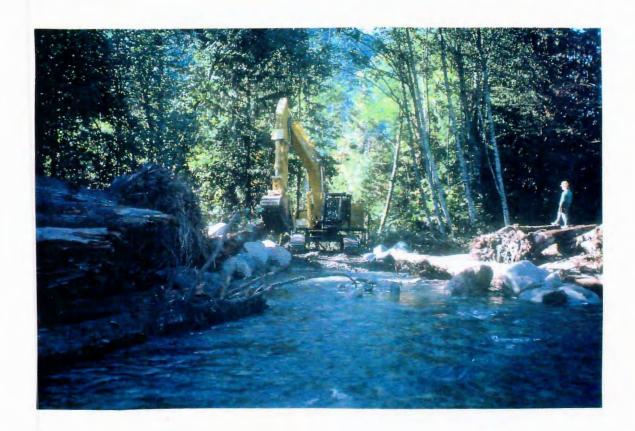
Photo 1. Coquihalla River jam construction.

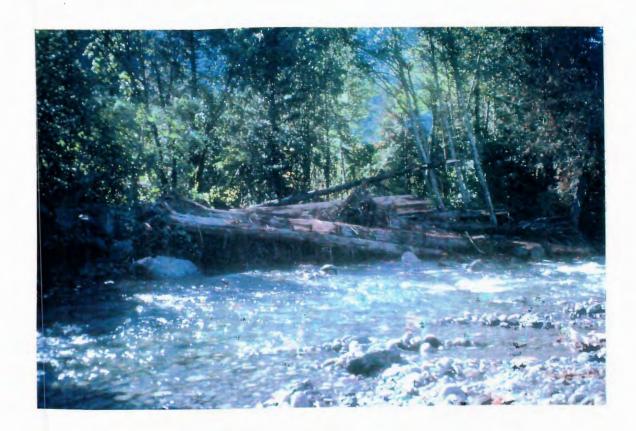
Photo 2. Coquihalla River log jam from gravel bar.

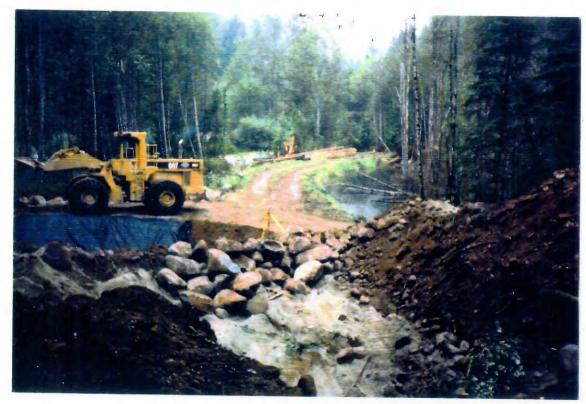
Photo 1 Loader taking material from borrow pit which will become part of pond complex and form entrance pond for channel leading water to new complex. Original pond is contained above dyke in centre right of photo.

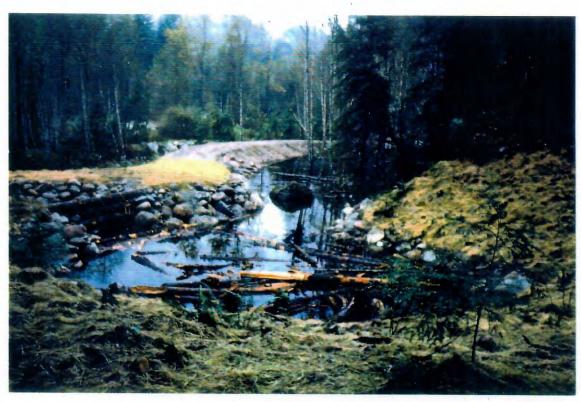
Photo 2 Photo taken immediately after flooding borrow area (lower centre of photo) and from same angle as above photo. Dam was topped and re-faced with well graded back fill to add freeboard and to seal small leaks. Log debris deflector in centre left of photo forms entrance to new channel.

a) Improvements to the previously constructed complex included the addition of spawning gravel to the lower reach of the channel, previously back-watered by the Or Creek pond. The original dam was built up and re-faced with well graded gravel to seal leakage and to increase the freeboard.

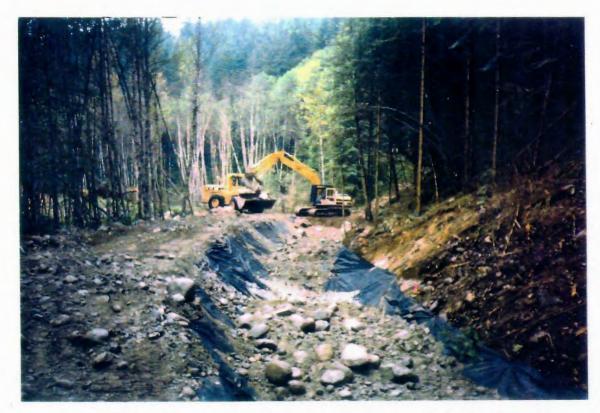
Photo 3 Excavator loading rock sorted from borrow area at start of new complex, into loader, for placement along slope of the new channel. The channel was lined with filter cloth to minimize seepage. The filter cloth was covered with 0.5 metres of clean gravel borrowed from an inactive gravel bar and hauled to channel with the loader.

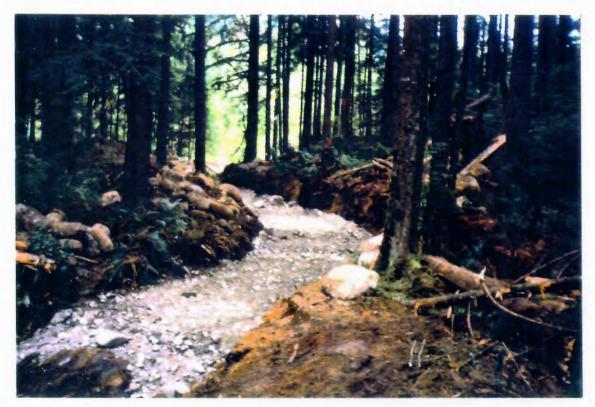
Photo 5 Channel was cut through unsuitable glacial till which had to be over excavated and filled with 0.5 meters of clean gravel hauled from upstream borrow area with front end loader. As this portion of the channel and pond complex meanders through coniferous forest, trees that had to be removed were utilized as complex material throughout project.

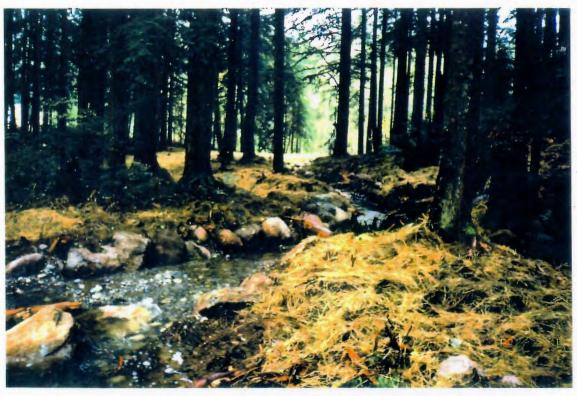
Photo 6 Completed channel as viewed from nearly same angle as above. Note all disturbed areas were seeded with a costal re-vegetation mix and stabilized with a straw covering.

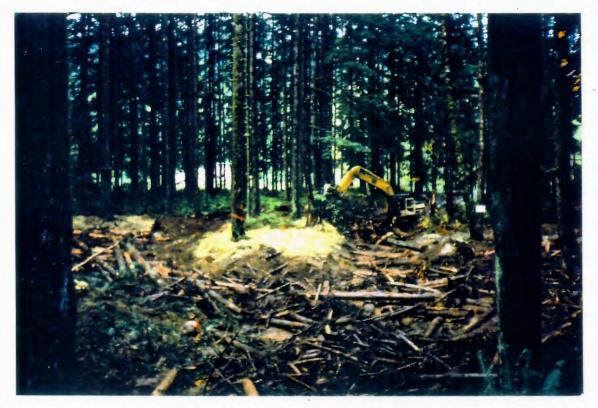
Photo 7 Excavator piling cleared debris (logs, stumps, etc.) into impoundment which will become pond.

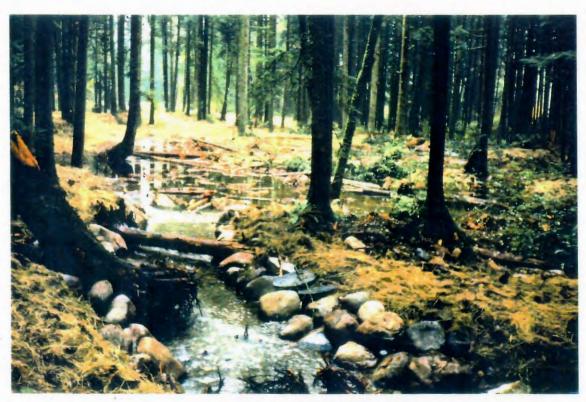
Photo 8 Same pond as above photo taken from a different angle, immediately after back flooding.

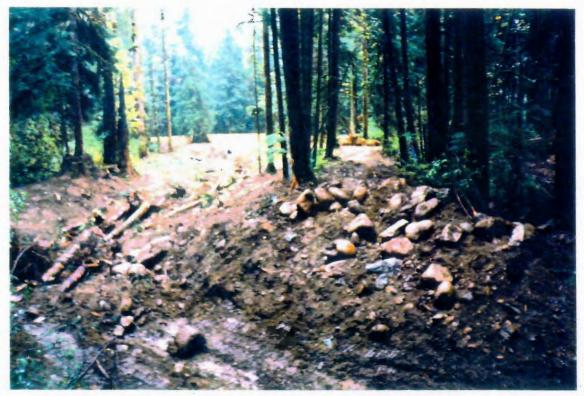
Photo 9 Main pond prior to flooding is just left of centre. Old railway grade was used as dam, is between trees just right of centre.

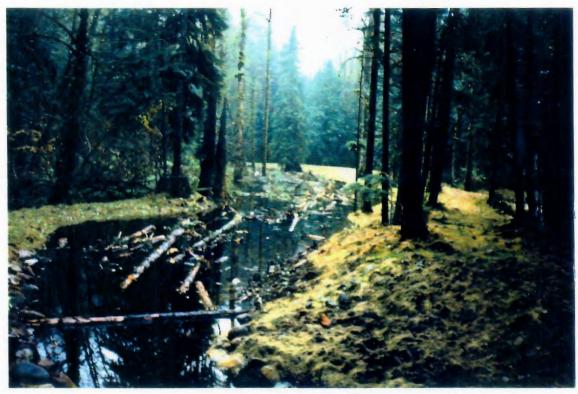
Photo 10 This photo taken from same angle as above immediately after back flooding of the pond.

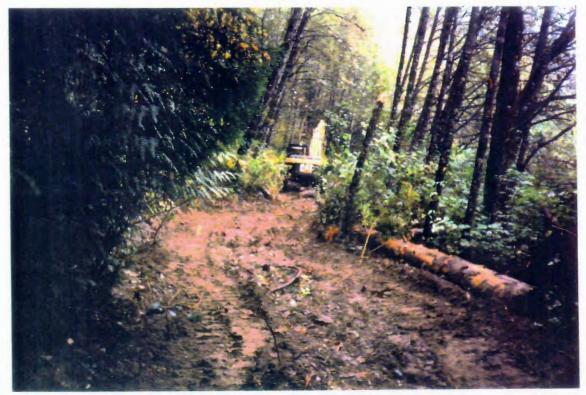
Photo 11 Excavator digging channel at lowermost end of habitat complex.

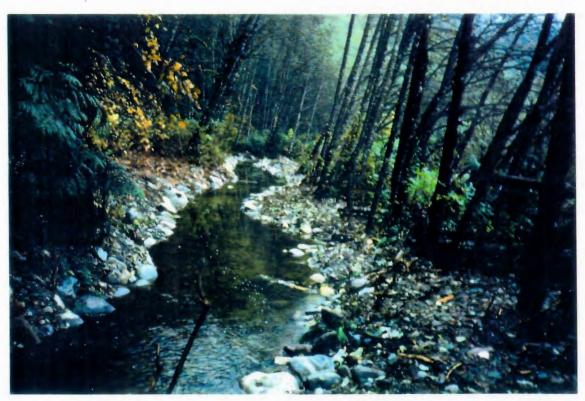
Photo 12 Completed channel taken from same angle as above photo, with outflow.

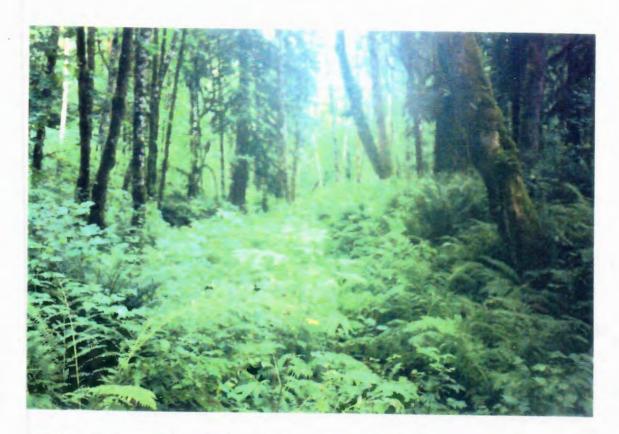
Photo 1. Overgrown channel prior to improvements.

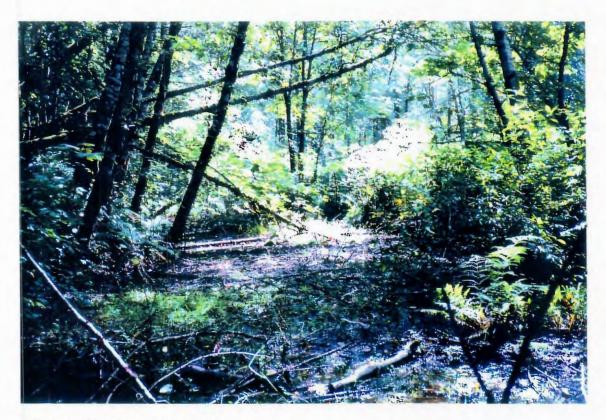
Photo 2. Dry channel prior to improvements.

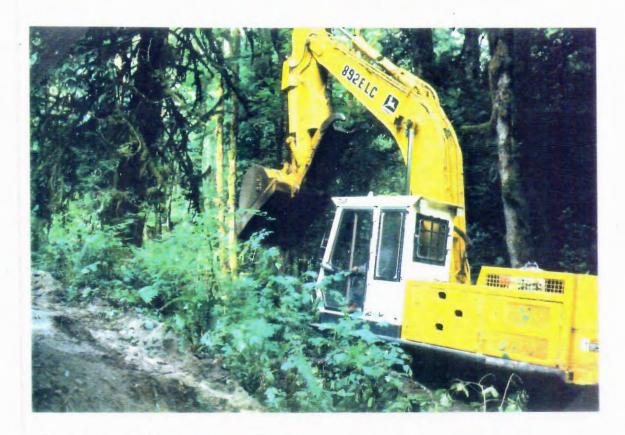
Photo 3. Excavation of overgrown channel.

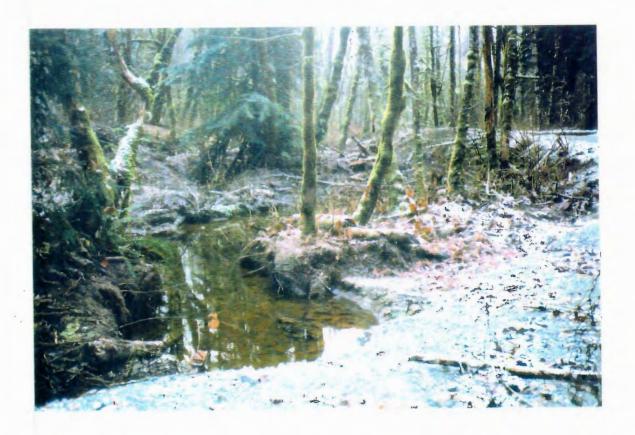
Photo 4. Excavated channel.

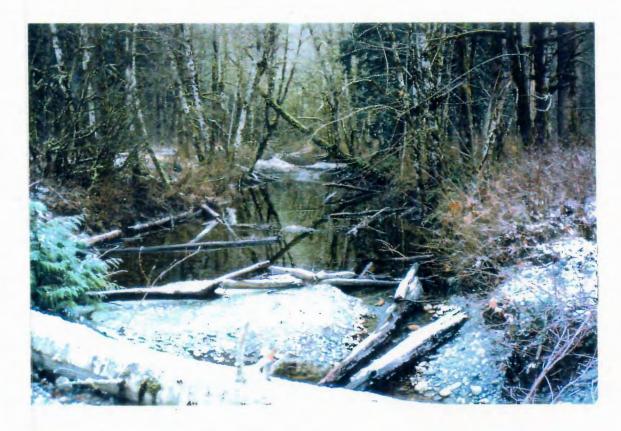
Photo 6. View upstream of forest service road.

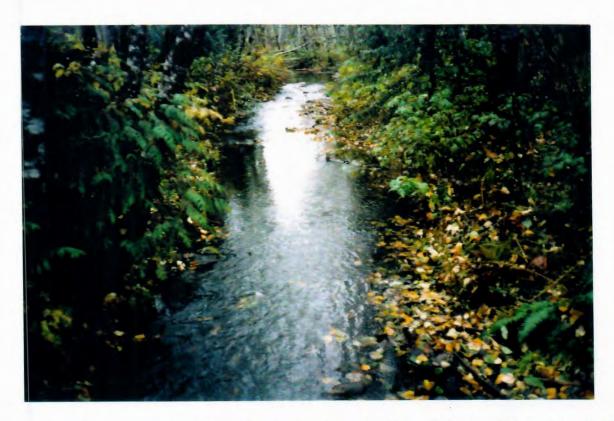
The old-growth forest surrounding Shop Creek was logged to the stream banks about 30 years ago; little structure remained in the channel (less than 50 pieces of large woody debris per km versus 200-300 pieces in an old-growth condition). Rehabilitation of 1.2 km of the mainstem (channel width, 5-6 m) and development of off-channel habitat was undertaken in two phases.

Photo 1. Shop Creek prior to fish habitat rehabilitation. Only poor to marginal salmonid habitat remained in extremely shallow riffles and shallow monotypic pools after logging and clearing since the mid-1960s.

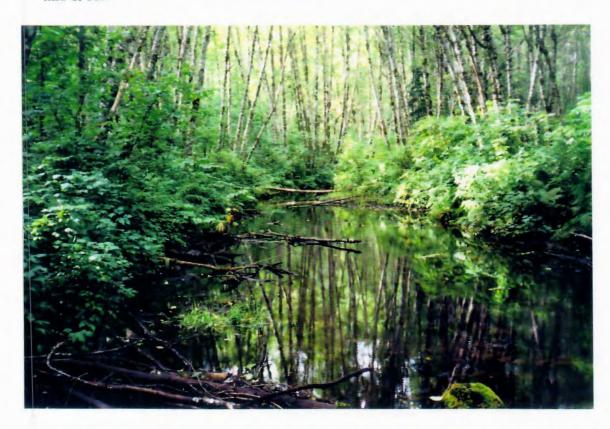
Photo 2. As a result of past logging of the flood plain, 90% of the large logs providing fish habitat in the stream were removed. Although the streambanks are reforested with 30-40 year-old alders, these provide only a very limited supply of natural windfalls.

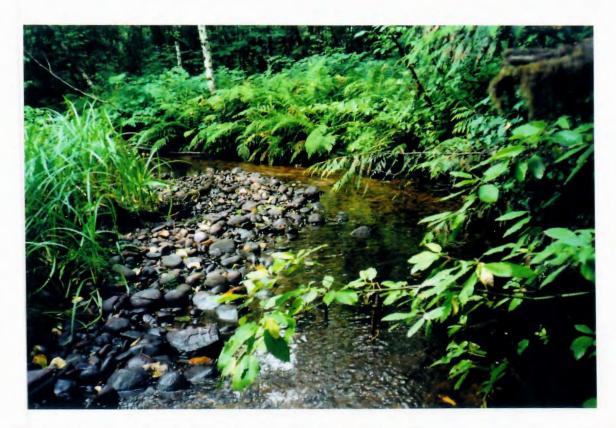
Photo 3. Shop Creek prior to fish habitat rehabilitation. Note lack of natural boulder groups which are prime rearing and overwintering habitat for steelhead fry and parr in stream riffles.

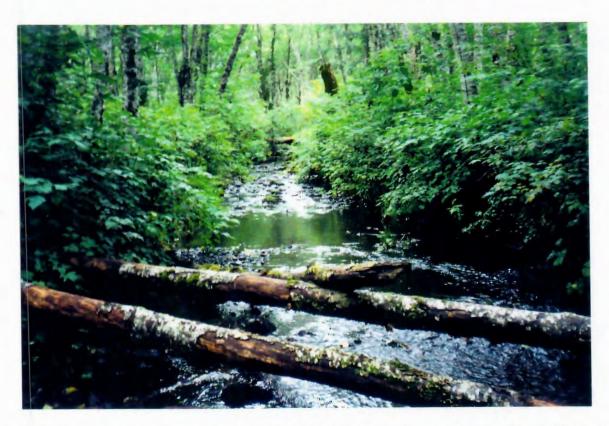
Photo 4. Shop Creek prior to fish habitat rehabilitation. Note lack of large coniferous windfall logs which are required as cover for juvenile fish for both overwintering and summer rearing in stream channels.

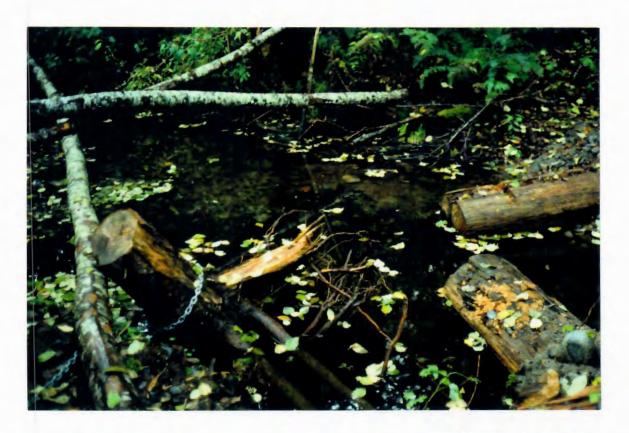
Photo 6. After excavating (deepening) a "run" for fish holding (adult coho and steelhead) and attaching surface (chained) log cover

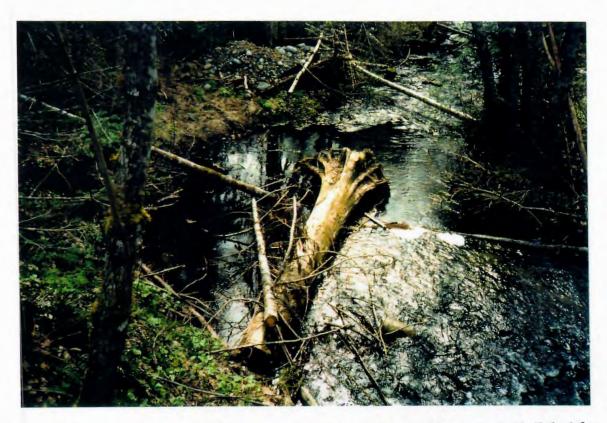
Photo 8. This corner pool was restored by pre-excavating the pool to provide greater depth (0.6 m) for holding of adults and of overwintering juvenile salmonids.

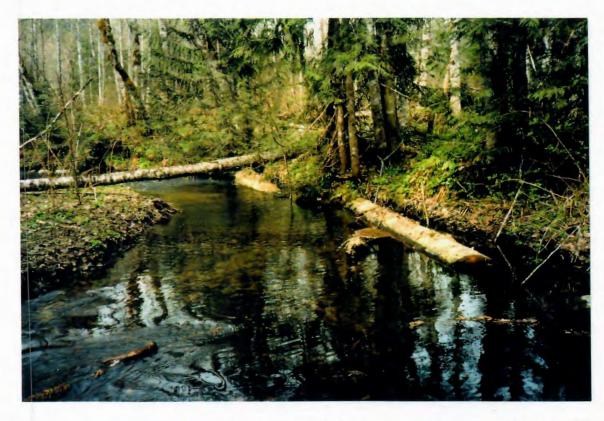
Photo 9. Two-log rafts were chained to large alders on the bank at several sites to provide overhead cover and to induce scour in winter freshets.

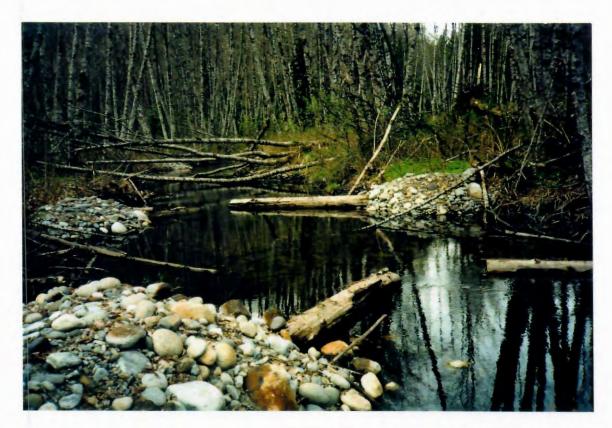
Photo 10. V-log weirs were installed by loading excavated bed materials on logs keyed into banks, and a log cover was attached to increase habitat complexity.

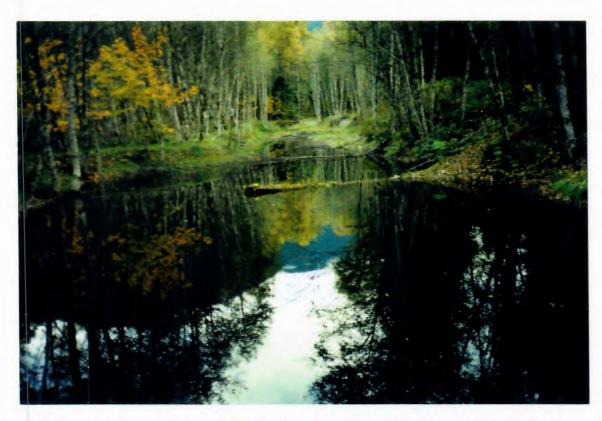
Photo 11. Overwintering pond-channel complex for maximizing over-winter survival of coho. The outlet provides passage for smolts in spring, and the pond-channel complex facilitates multi-species use.

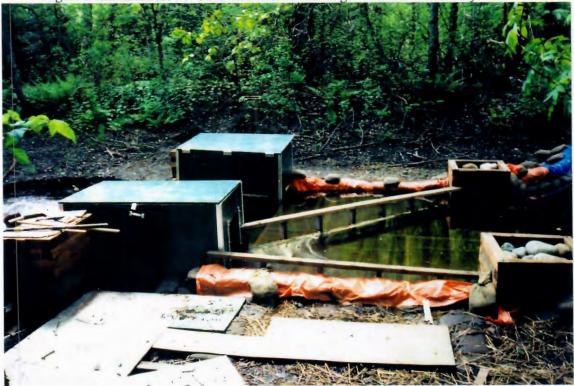
Photo 13. Horizontal screen trap. In 1996, 26% of coho smolts produced from Shop Creek (7150 in total) originated from two constructed groundwater channels and the overwintering pond.

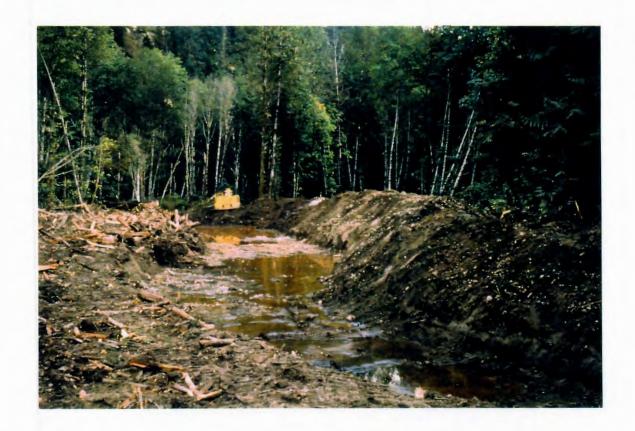
Photo 1. A dam under construction to create a large pond to provide winter refuge habitat.

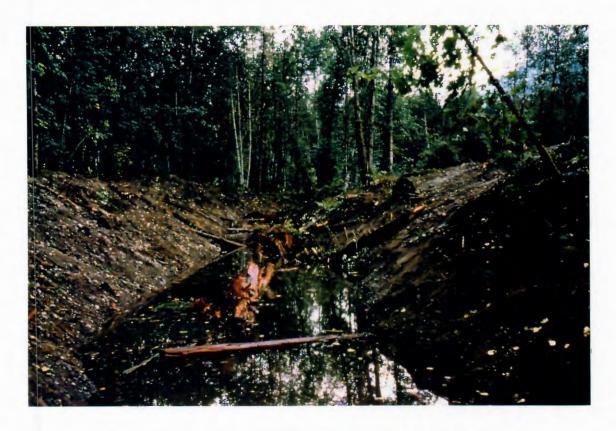
Photo 2. Completed groundwater channel on 28.5 Mile Creek, prior to revegetation.

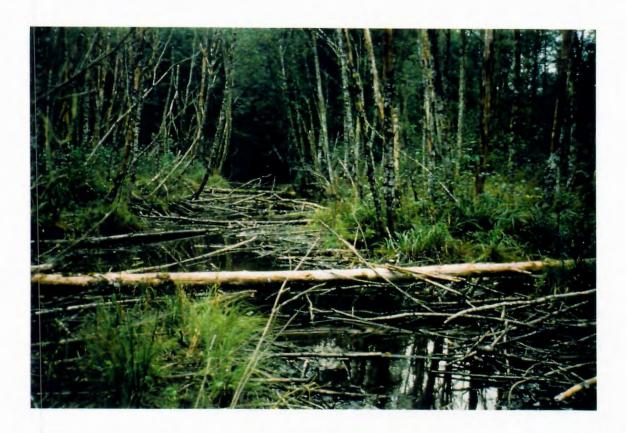
Photo 1. A shallow remnant beaver pond that is too shallow to supply adequate winter refuge habitat on Chuck-Chuck Creek.

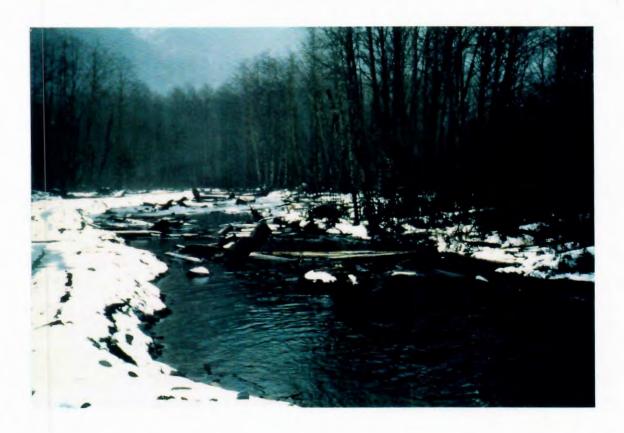
Photo 2. Completed Chuck-Chuck Creek pend with large woody debris added to provide cover.

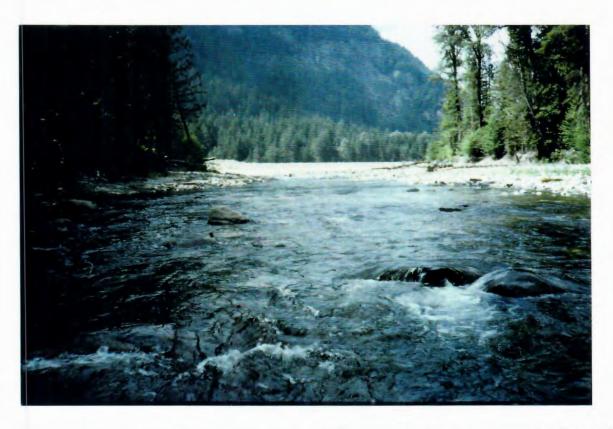
Photo 2. Restored clear waters of Shovelnose Creek with berm in background, after construction in May 1994.

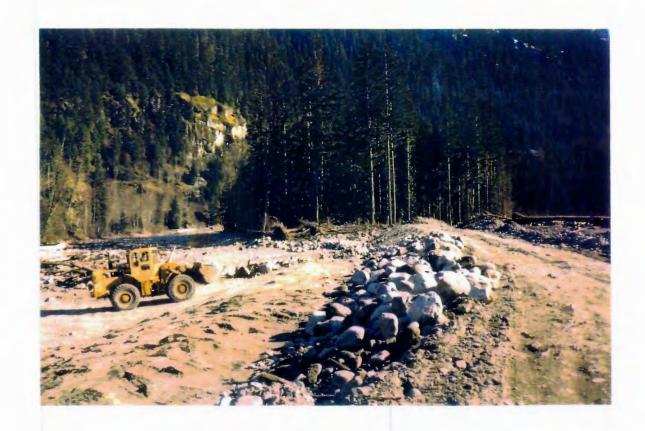
Photo 5. Rock armour placement Shovelnose Creek side.

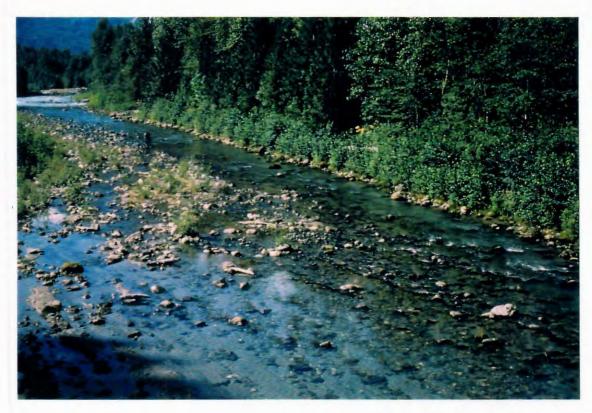
Photo 7. Shallow monotypic section of Shovelnose Creek. During summer low flows this 500 m section was a barrier to adult chinook salmon.

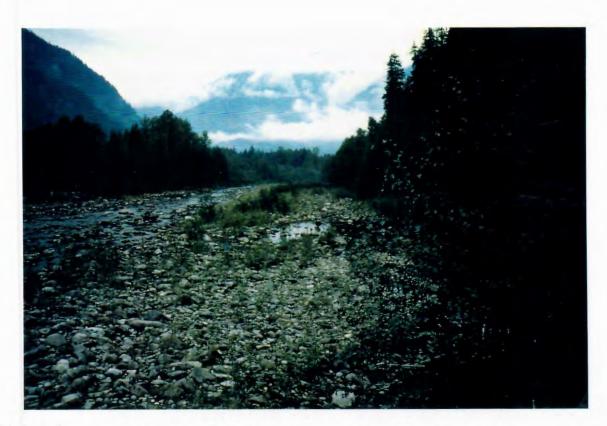
Photo 9. A large gravel bar at the edge of the lowermost section of Shovelnose Creek. A groundwater channel is to be constructed on the right hand side.

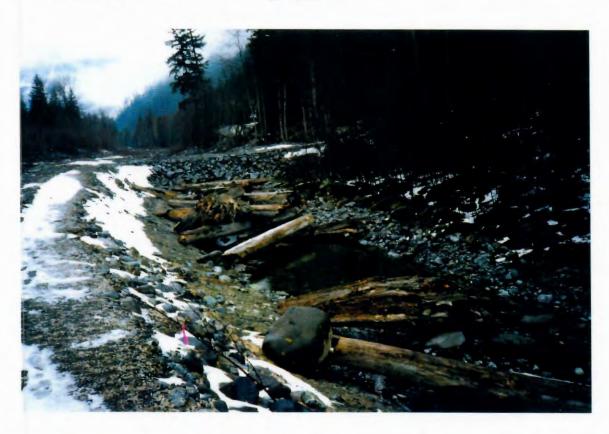
Photo 10. After construction large woody debris was added to the groundwater channel to provide cover.

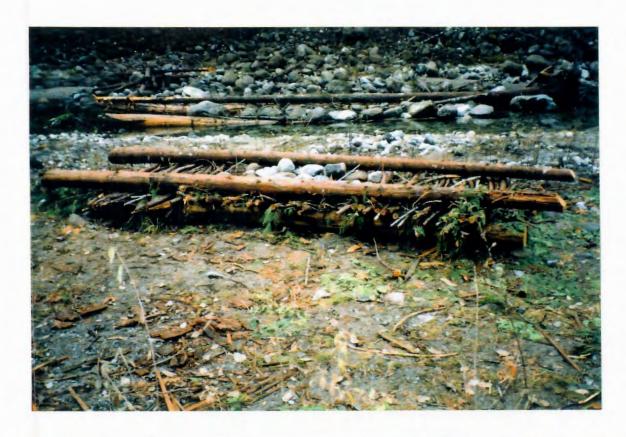
Photos 11 & 12. Artificial log reef is under construction and one is installed below. Reefs comprised of boulders and logs are well inhabited by juvenile salmon, steelhead and char and restore critical fish habitat as they are similar to (mimic) large old growth trees.

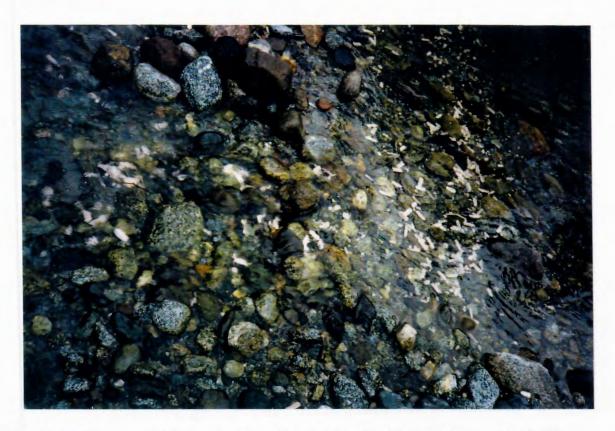
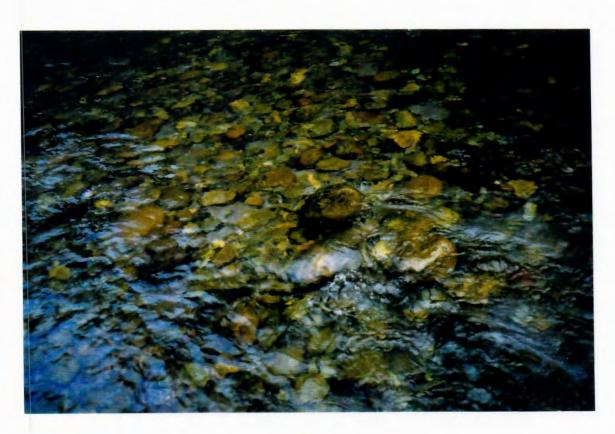
Photos 13 & 14. Depressed fish abundance resulting from logging impacts (often combined with overfishing) depresses the availability of nutrients (phosphorus and nitrogen) crucial to the salmonid food chain. Nutrients can be restored by the use of pellets that release at extremely low target levels (<5 ppb).

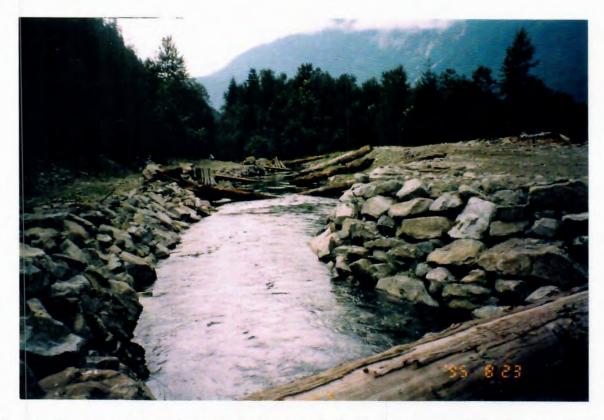
Photo 16. Extension of Shovelnose Creek side channel. Photo taken August 1995, a few days after rewatering the channel. Large chinook salmon moved rapidly into the reach and spawned.

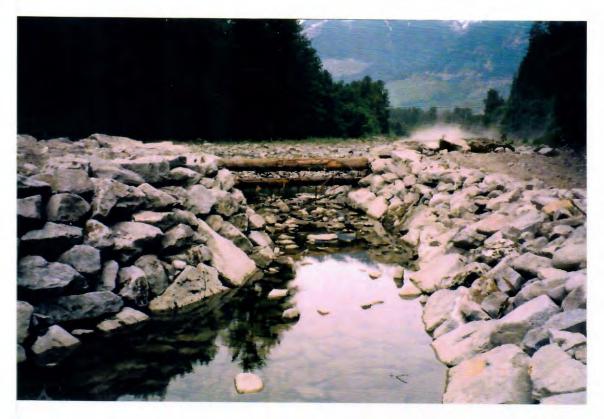
Photo 17. A controlled-flow intake and the placement of large logs across the head of Shovelnose Creek side channel to deflect floating debris.

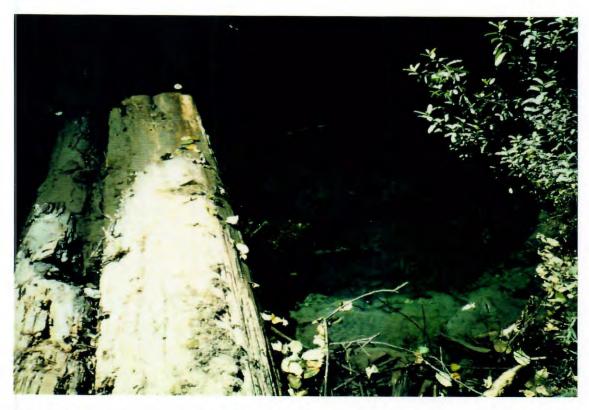
Photo 18. Chinook salmon holding in a deep pool constructed in the previously isolated channel.

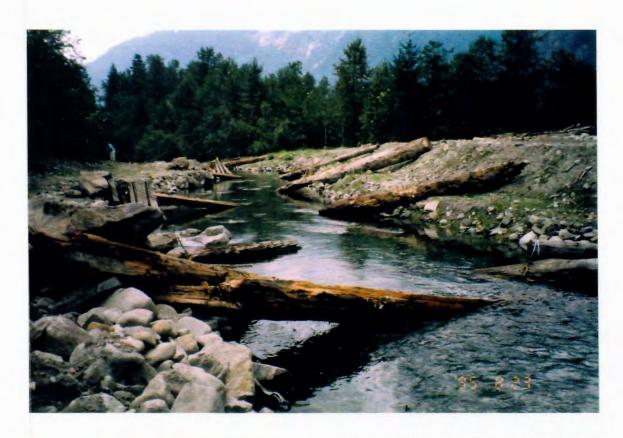
Photos 19 & 20. Selective placements of boulder clusters and holding pools in the side channel also offset habitat losses in the upper unstable reach of Shovelnose Creek.

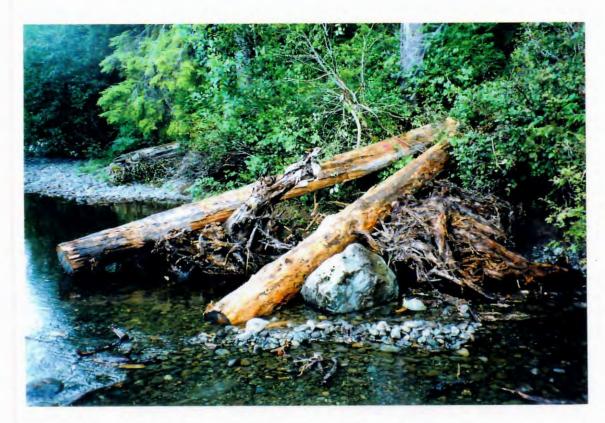
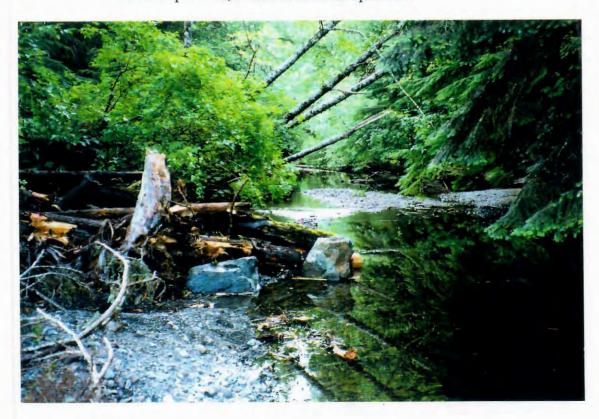
Photos 1 & 2. Streambank log jams were created at W80 sites which also capture large woody debris along the stream margin during high flows: key logs were secured by attaching large boulders. Prime juvenile salmonid rearing and overwintering habitat is provided, as well as cover for spawners.

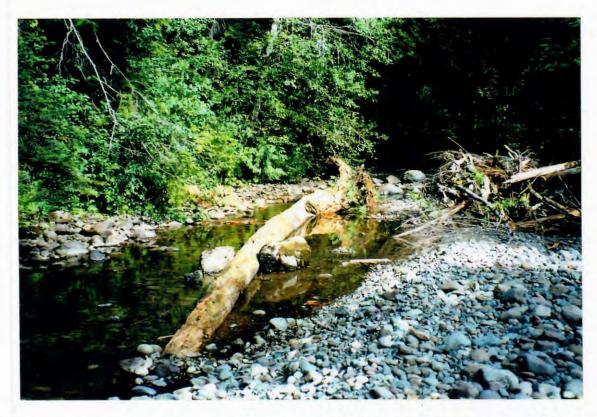
Photo 4. W80 site after placements of boulder clusters combined with large woody debris (LWD) at the head of shallow pools or runs to create prime habitat for rearing salmonids, as well as overwinter refugia (at minimum flow).

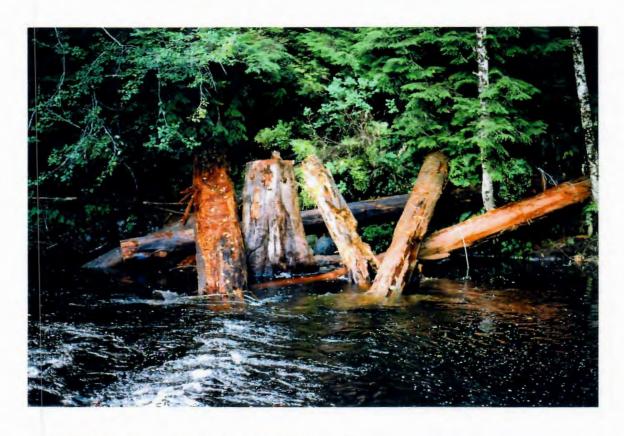
Photo 6. 80 bridge, site 18 after fish habitat rehabilitation.

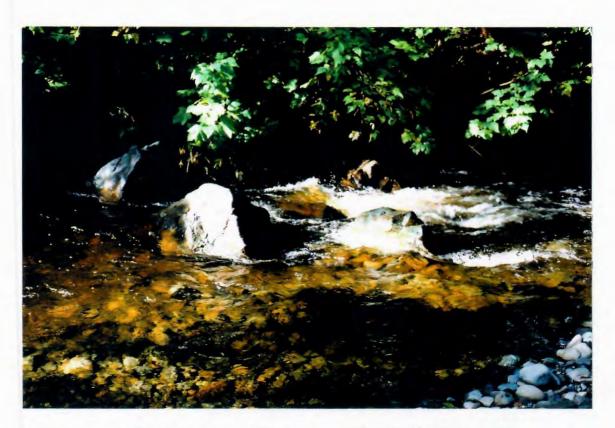
Photo 7. Placements of boulder clusters at W80 site to provide prime habitat for rearing and overwintering of steelhead fry and parr. When scour pockets form small pools, these boulder sites will also be utilized by coho salmon fry.

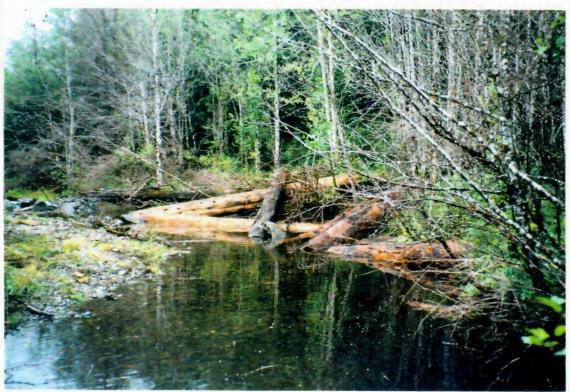
Photo 8. Streambank log jams were created at W103 to W104 sites to capture large woody debris along the stream margin during high flows: key logs were secured by attaching large boulders.

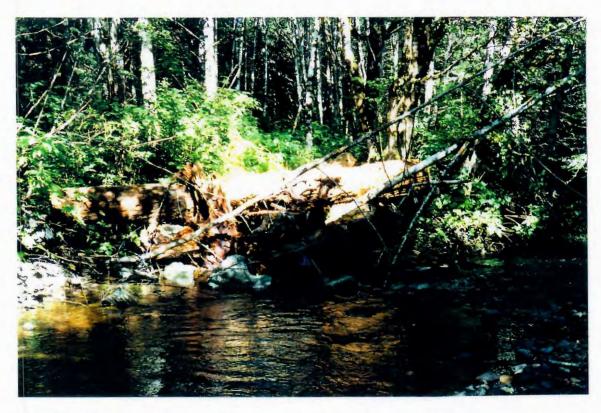
Photo 10. Streambank stabilization and provision of overhead cover with large woody debris secured to boulders at West Main site.

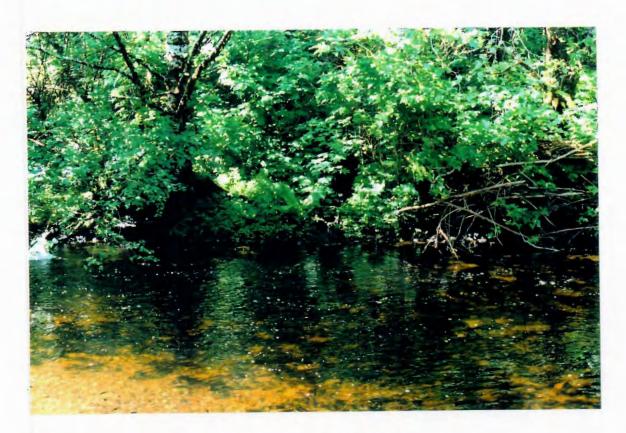
Photo 11. West Main, site 1 before fish habitat rehabilitation.

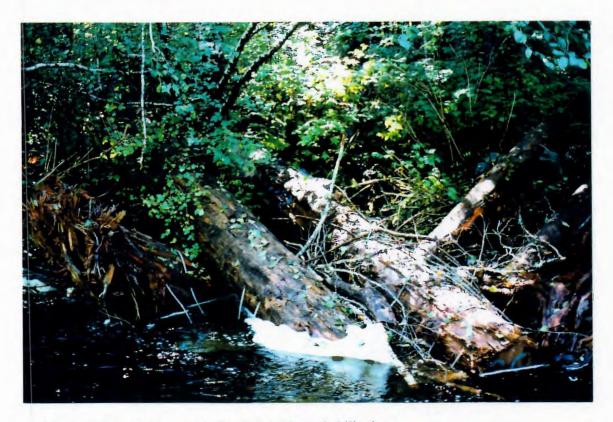
Photo 12. West Main, site 1 after fish habitat rehabilitation.

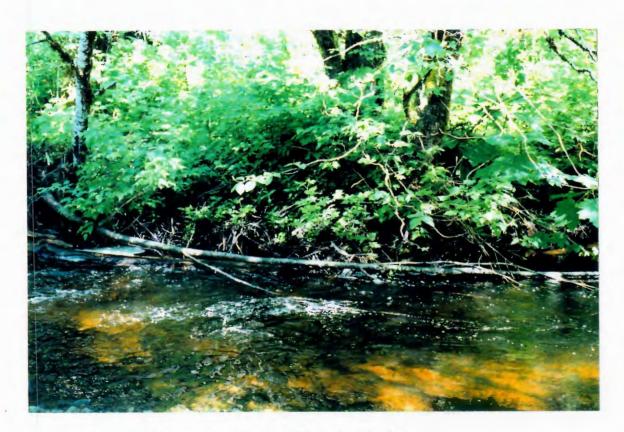
Photo 13. West Main, site 2 before fish habitat rehabilitation.

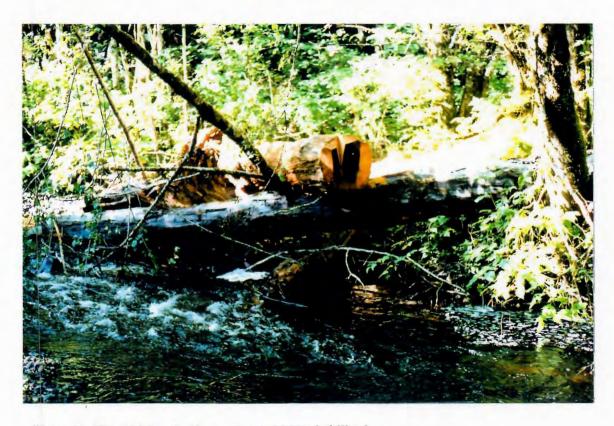
Photo 14. West Main, site 2 after fish habitat rehabilitation.

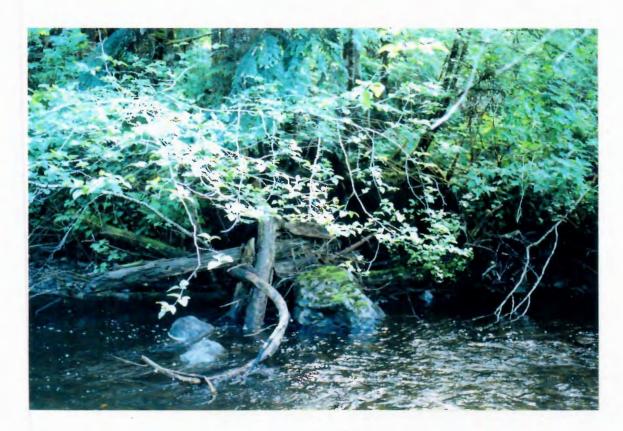
Photo 15. West Main, site 3 before fish habitat rehabilitation.

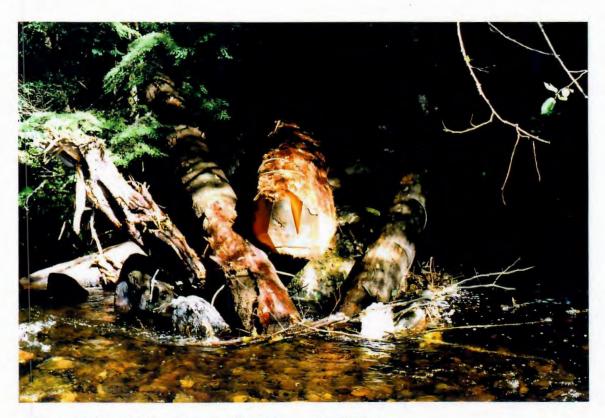
Photo 16. West Main, site 3 after fish habitat rehabilitation.

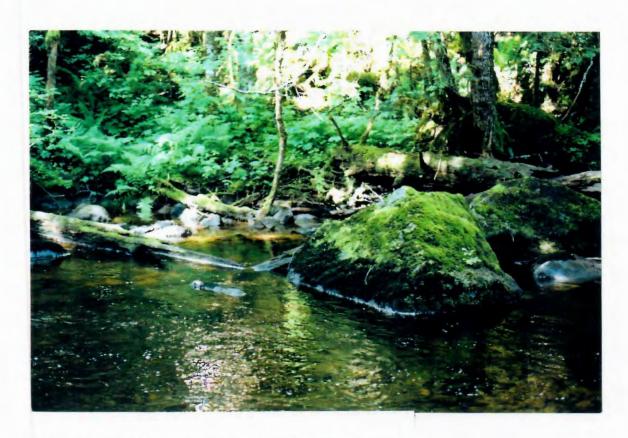
Photo 17. West Main, site 5 before fish habitat rehabilitation.

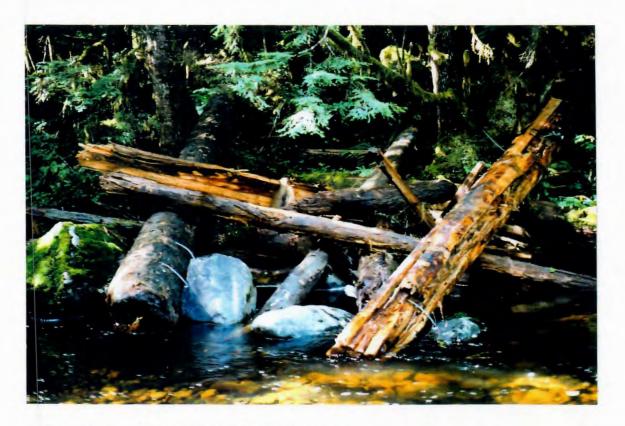
Photo 18. West Main, site 5 after fish habitat rehabilitation.
