## REGIONAL EXAMPLES OF FISH HABITAT PROJECTS OF THE WATERSHED RESTORATION PROGRAM 1994 - 1996

November 1996

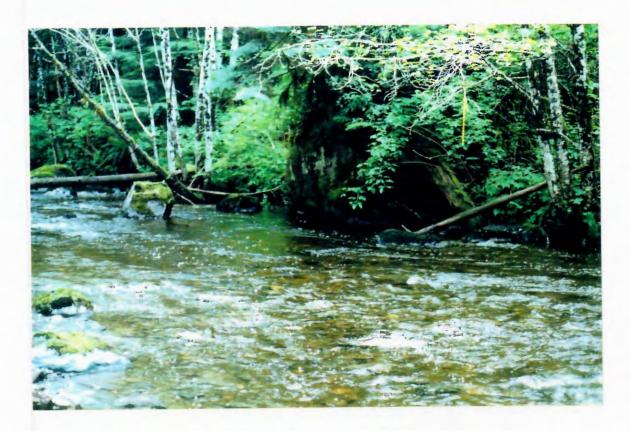
Photo 19. West Main, site 11 before fish habitat rehabilitation.

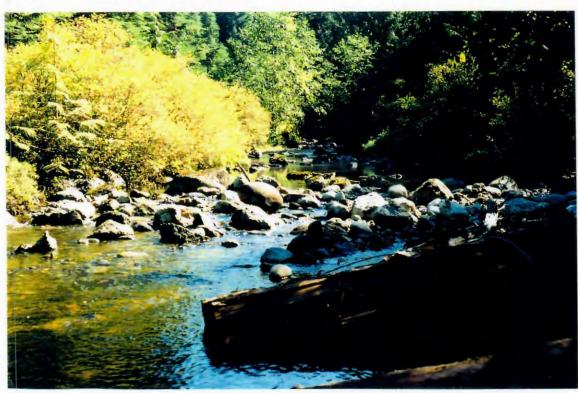
Photo 22. At this site a pool was deepened and a riffle constructed from the largest boulders available on the streambed. Future floods will help maintain this natural pool and riffle profile.

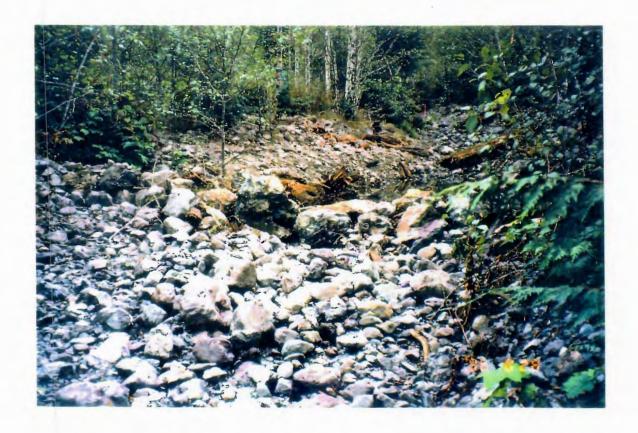
Photo 2. Historic channel (Trib. 1.37) after reconnection and reconstruction.

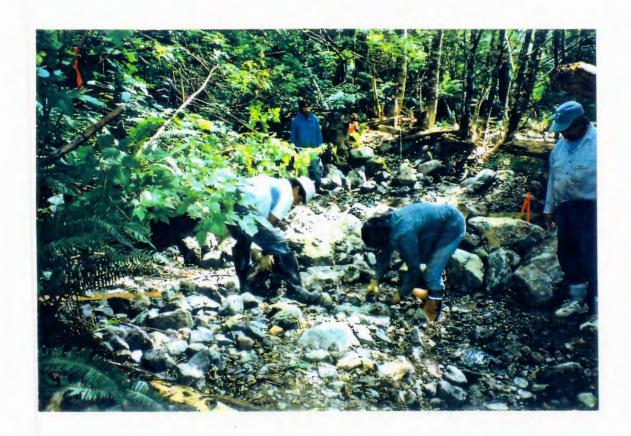
Photo 3. Channel restoration using hand labour and chainsaw winch.

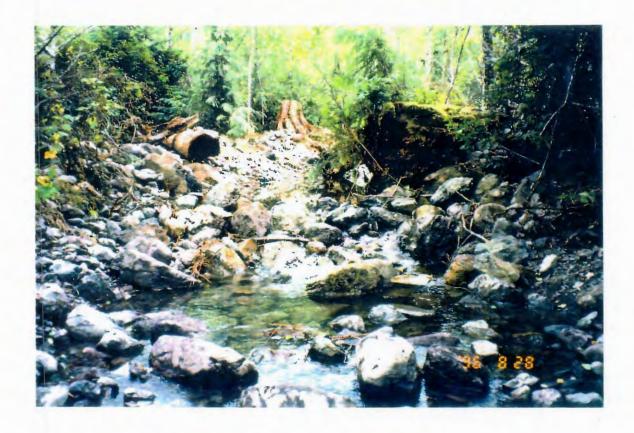
Photo 4. Trib. 1.37 after reconstruction.

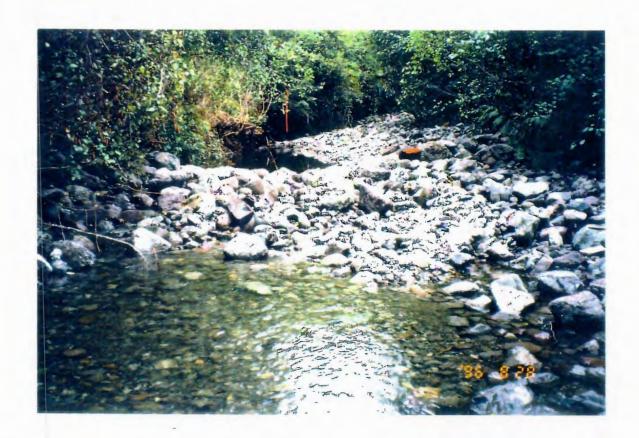
Photo 5. Malksope River pool-riffle construction.

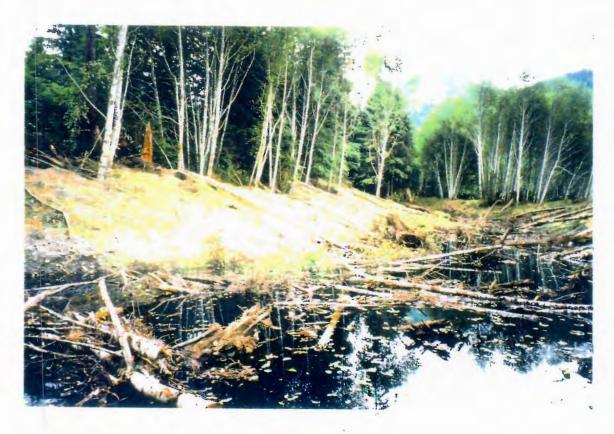
Photo 6. Malksope River backwater pond.

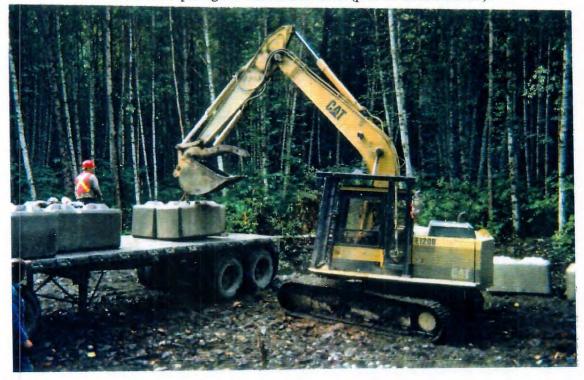
Photo 2. Anchor blocks for rootwad armouring.

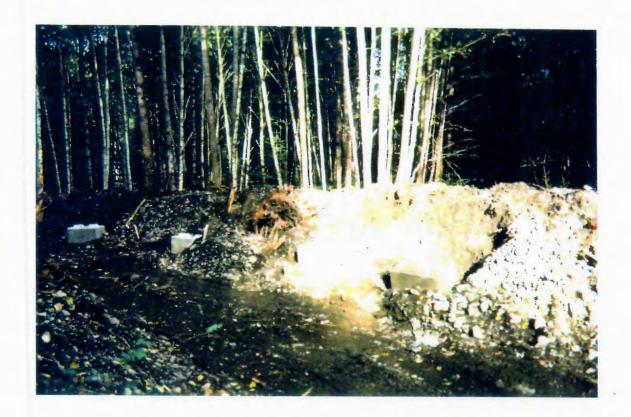
Photo 3. Anchor blocks placed in pits.

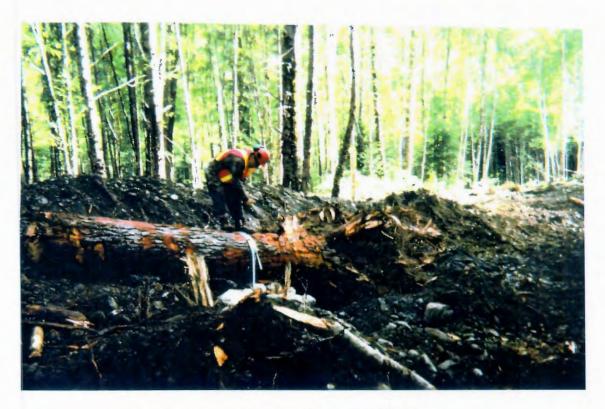
Photo 4. Cabling down large woody debris and rootwad to blocks.

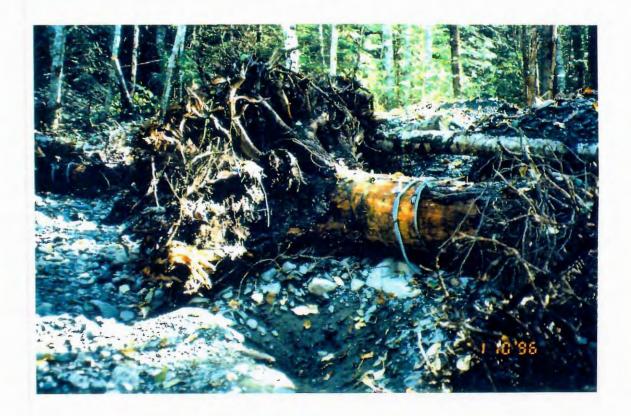
Photo 5. Backfill over tree stem and anchor block.

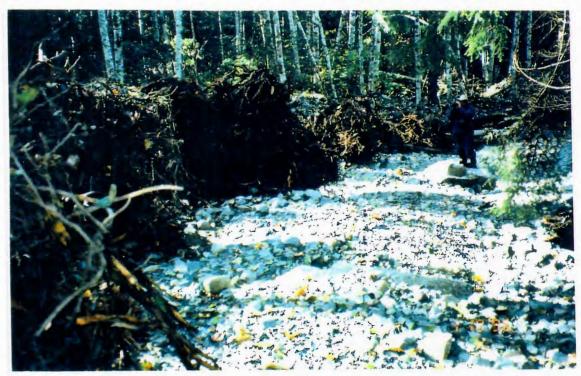
Photo 6. Final armoured bank constructed during low flows.

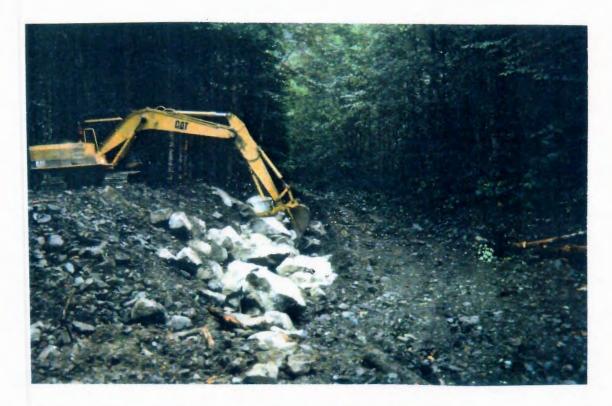
Works began in mid-August in the reaches of concern on the upper Ginulak (work site) when most of the flows were sub-surface and almost all works were completed in the **dry** (prior to fall freshettes). In order to protect the valuable existing spawning habitat two berms were constructed (see photos 7, 8, 9, 10). In addition, the stream channel was redefined by removing aggraded gravels and protecting banks with anchored root wads (see photo 11). Some stream complexing was completed with logs, root wads, and boulder clusters. All disturbed soil was seeded with grasses and planted with Sitka spruce (*Picea sitchensis*) and western redcedar (*Thuja plicata*).

Photo 8. Construction of berm to protect avulsion channel which enters an old road creating a new channel impacting fish habitat.

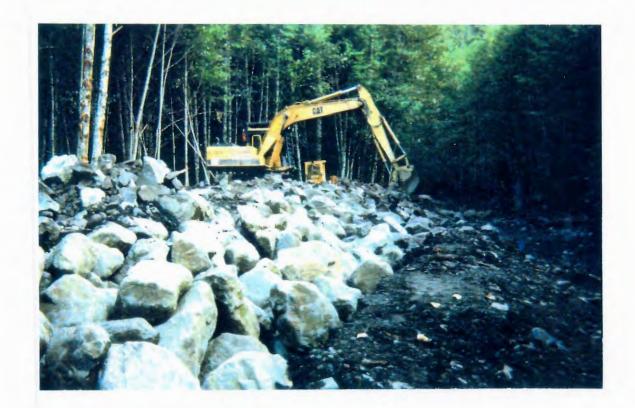
Photo 9. Armouring bank.

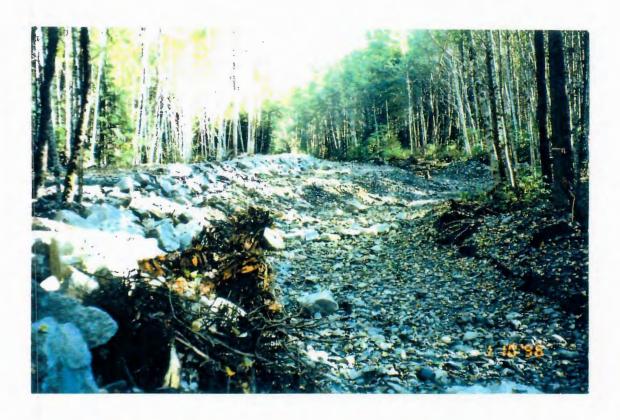
Photo 10. Completed berm - more large woody debris and boulder complexing to be installed.

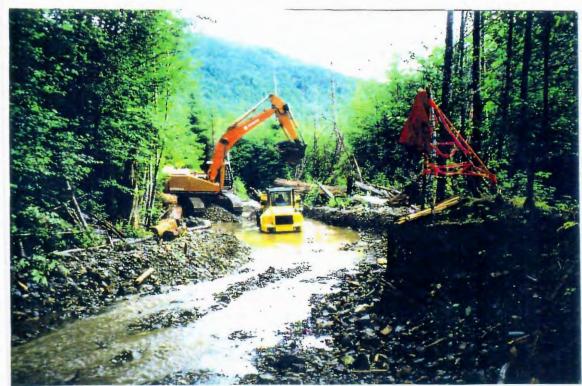
Photo 1. Instream construction of new channel between Cross-section 5 and Cross-section 7 viewed downstream from Cross-section 4. Excavation began at Cross-section 2 and worked downstream towards Cross-section 7.

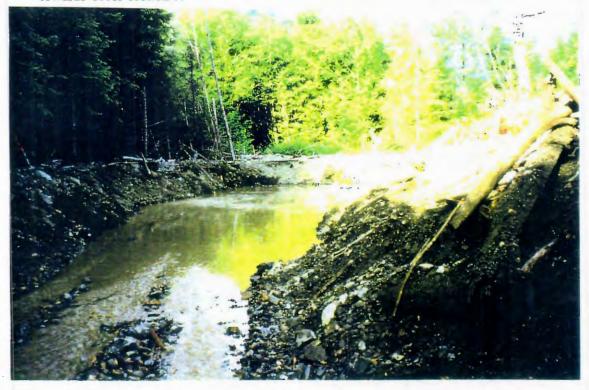
Photo 2. Excavation of the new channel ended at Cross-section 7. Sediment generated from upstream work settled in the pond upstream of Log Jam 3.

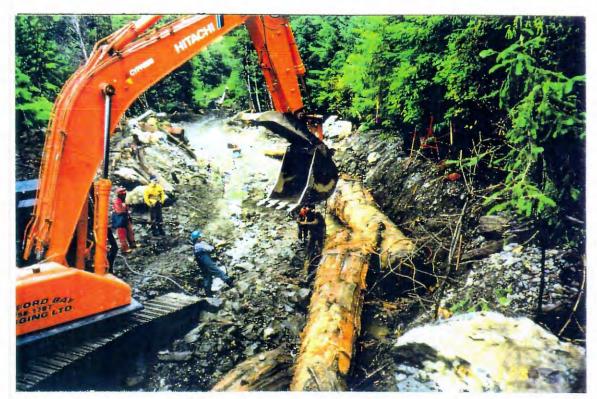
Photo 3. Construction of log bank protection at Bend 4 viewed upstream. Logs are being cabled together and have been anchored to notched stumps above the creek (note cables extending into the bush).

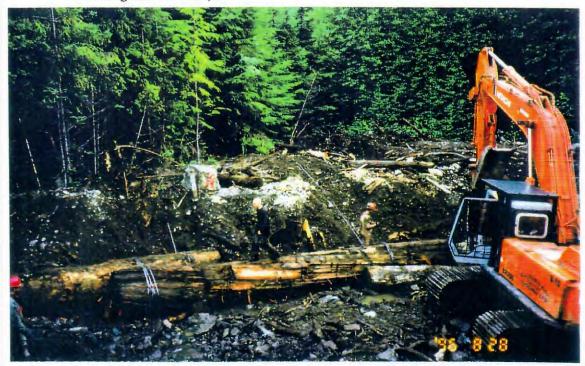
Photo 4. Construction of log bank protection at Bend 4 viewed from right bank. Logs are cabled together and have been anchored to anchor rocks buried at the base of the adjacent slope (note cables extending into the bush).

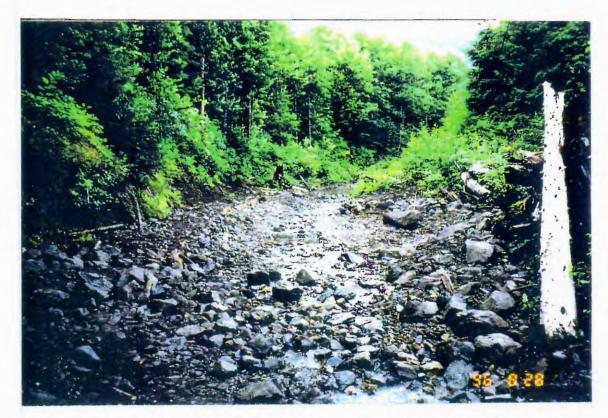
Photo 5. Completed instream work showing upstream view of Riffle 2 in the foreground.

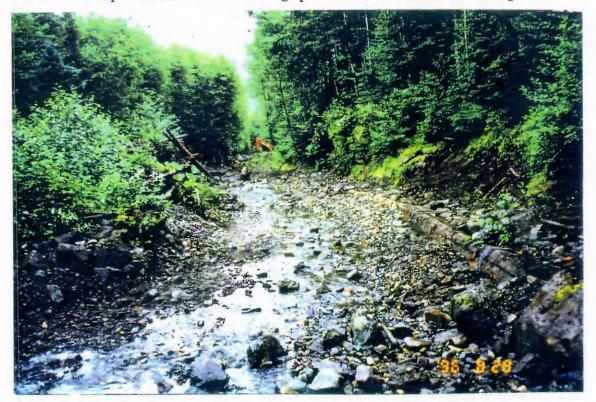
Photo 6. Completed instream work showing downstream view of log bank protection at Bend 1.

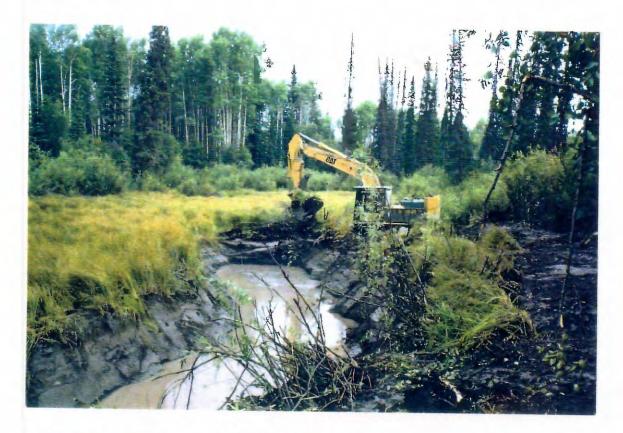
Photo 1. Excavating refuge channel within dried pond area.

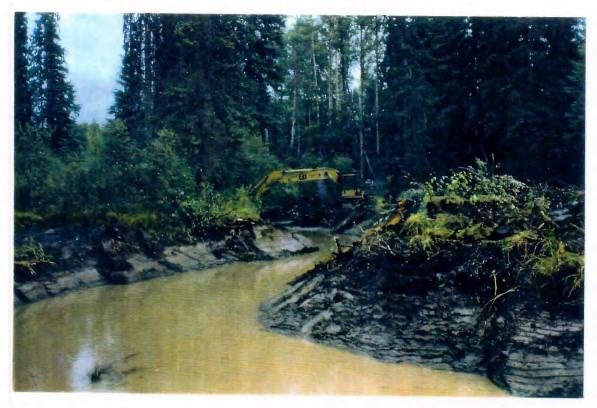
Photo 2. Excavating refuge channel between two ponds.

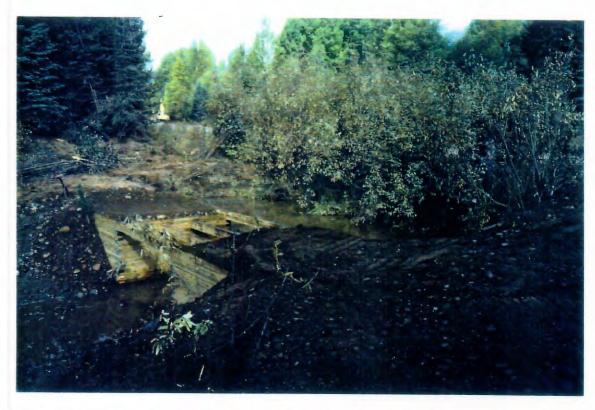
Photo 4. Laminated treated timber enumeration sill at outlet of pond complex. Culvert through road is in center of photo.

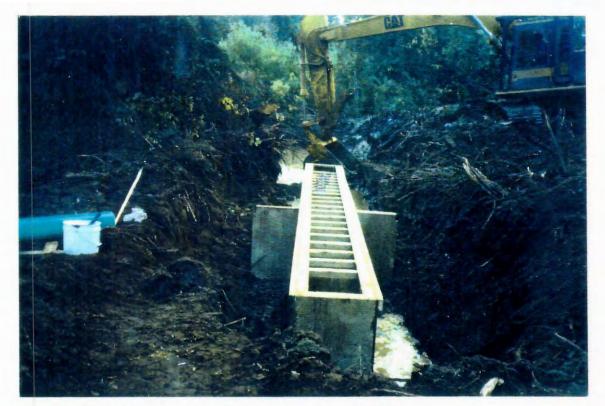
Photo 5 (Above) Treated timber fry fishway prior to backfilling. Beaver pond and dam is just left of excavator bucket.

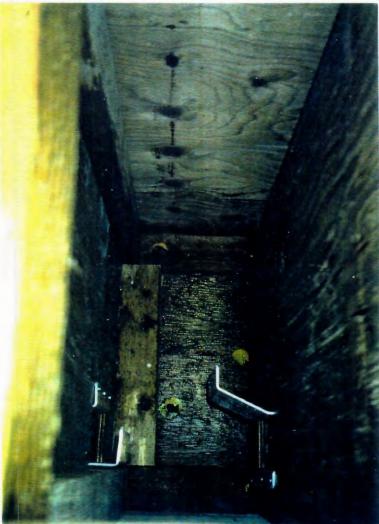
Photo 6. Inside view of baffle/port detail of fry fishway. Aluminum deflectors are screwed into plywood baffle at port. The port is 3.75 in x 8 in. high.
