FISH PASSAGE CULVERT INVESTIGATIONS 2014

Babine TSA

Prepared By: MarLim Ecological Consulting Ltd.

February 2015

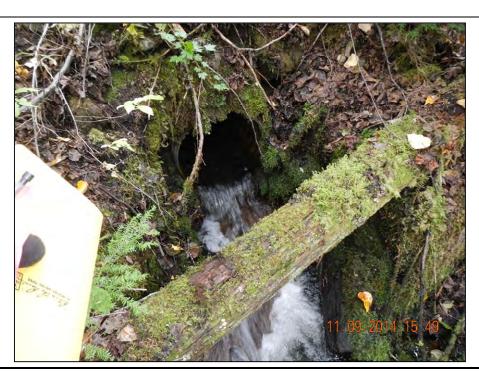
Photo 2: M14-025

Description: Outlet

It is recommended that the current culvert be replaced with an open bottom structure with a minimum 2.70m span.

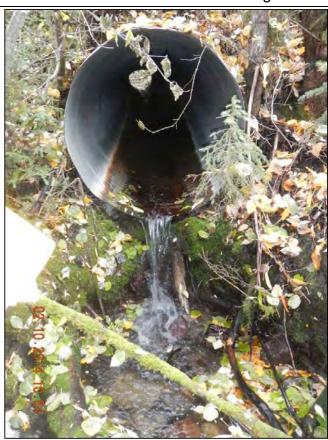
Photo 15: M14-063

The stream had an average channel width of 2.80m and a gradient of 9.0%. The outlet pool depth was 0.31m. There was no presence of beaver activity at this site and no fish were observed. The valley fill at the site was deep and it was determined that this stream had high habitat value.

Description: Outlet

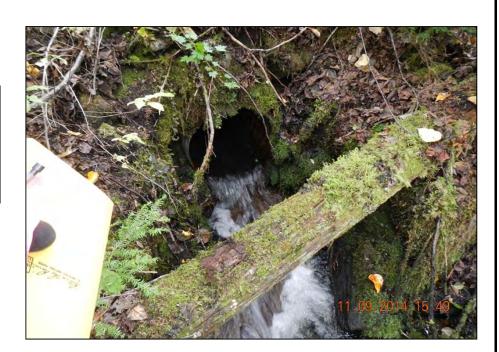
Photo 2: M14-025

Description: Outlet

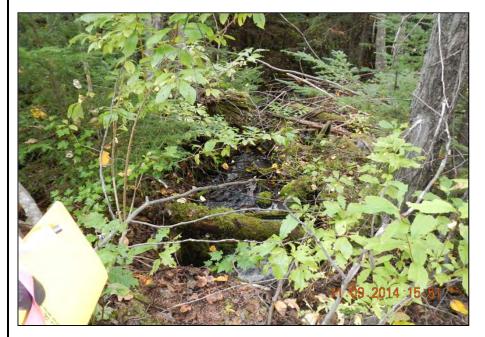
Photo 3: M14-025

Description: Debris at outlet.

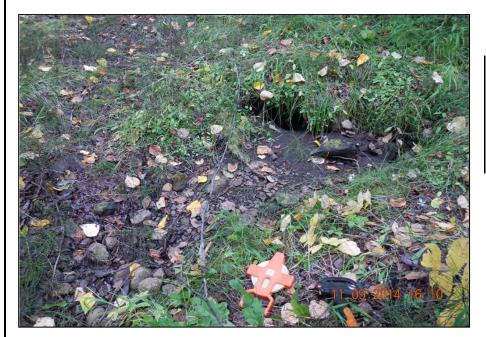
Photo 7: M14-025

Description: Road washing out.

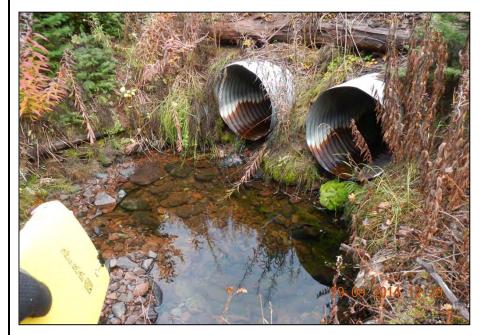
Photo 10: M14-050

The stream had an average channel width of 2.54m and a gradient of 6.0%. The outlet pool depth was 0.46m. There was no presence of beaver activity at this site and no fish were observed. The valley fill at the site was deep and it was determined that this stream had high habitat value.

Description: Outlet

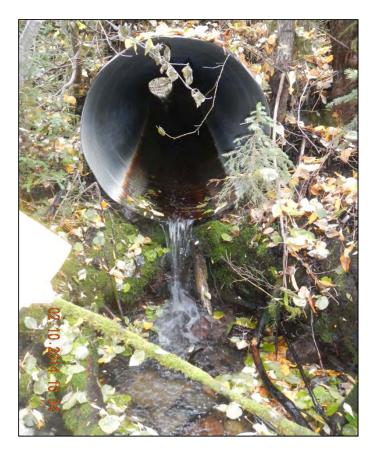
Photo 15: M14-063

Description: Outlet

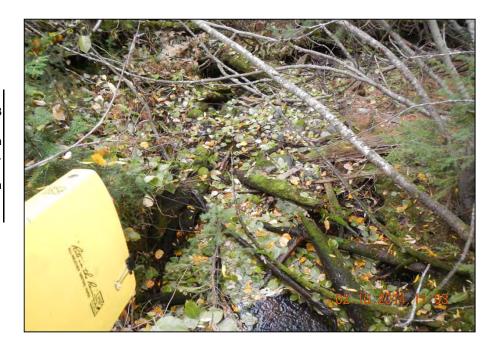
Description: Debris in downstream channel.

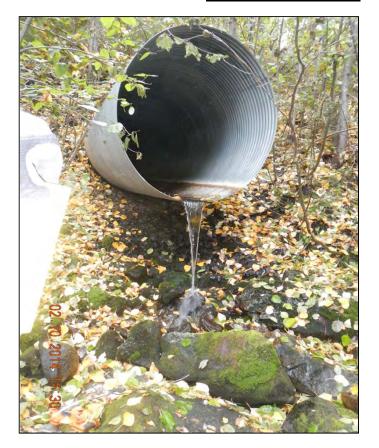
Photo 22: M14-064

The stream had an average channel width of 4.13m and a gradient of 12.0%. The outlet pool depth was 0.29m. There was no presence of beaver activity at this site and no fish were observed. The valley fill at the site was deep and it was determined that this stream had high habitat value.

Description: Outlet

It is recommended that the current culvert be replaced with an open bottom structure with a minimum span of 4.20m, and the channel at the crossing site be restored.

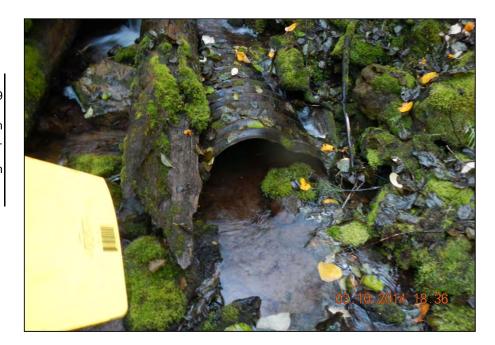
Description: Outlet - bottom culvert, non-functional.

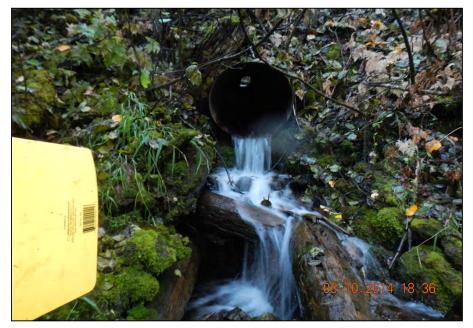
Photo 34: M14-099

Description: Outlet - top culvert.

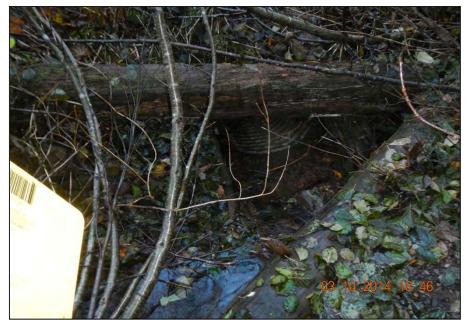
Photo 38: M14-099

Description: Debris built up at inlet, burying bottom inlet.
