The purpose of this report is to present background information and results from effectiveness evaluations conducted on instream structures, riparian, road deactivation, and stream crossing works that were installed between four and eight years ago by watershed restoration programs. In 2006, Gitksan Watershed Authorities was retained by the Pacific Salmon Commission to conduct a effectiveness monitoring in three Mid Skeena sub-basins: the Kispiox, Kitseguecla, and the Suskwa.

This watershed restoration effectiveness monitoring assessment is part of a larger regional effort to ensure treatment designs and their applications are effective, and if not, provide technical feedback to refine designs. As well, the evaluations will rate the extent of watershed recovery achieved and help to ensure funds are spent on the most cost-effective treatments.

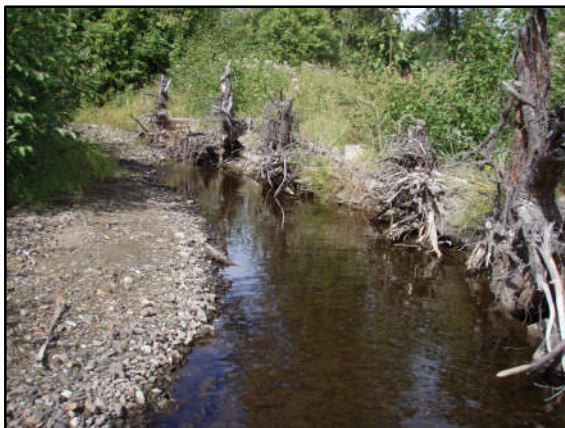
Figure 8. View upstream at P8-1.

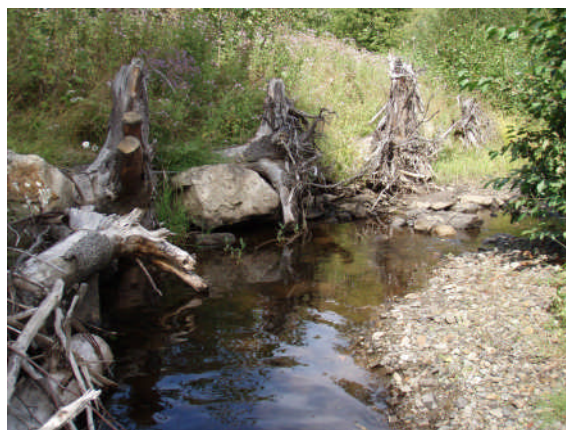
Figure 13. View upstream at P8-2.

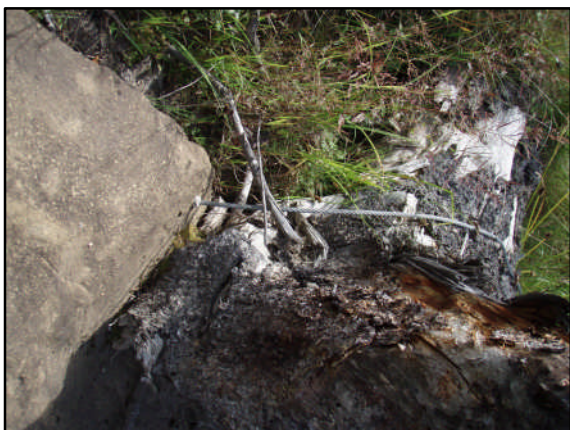
Figure 14. Log-boulder cabling.

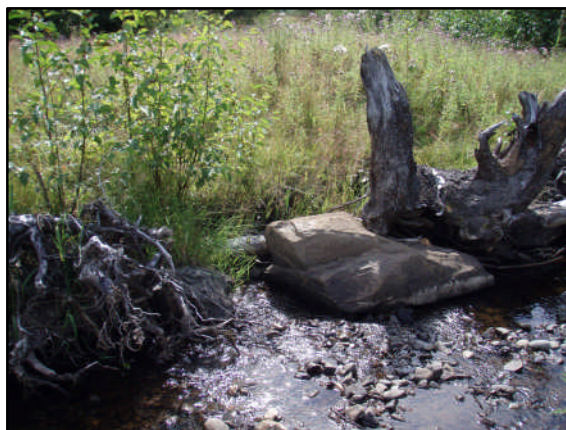
Figure 25. Boulder-rootwad placement.

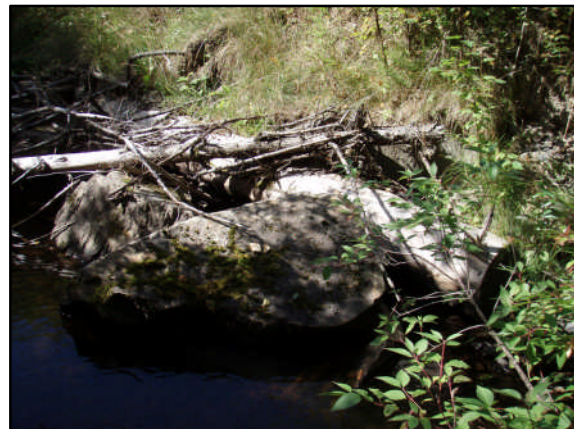
The log cluster has worked out exceptionally well in achieving the objective of stabilizing the stream channel, and as well, providing cover and promoting riparian growth. The structure is integral and in excellent condition. Material recruited to the site is also performing well. When the Kispiox Trail culvert is replaced with a bridge or open bottom structure, this installation will require monitoring.

Figure 17. Downstream end of Site P-6.

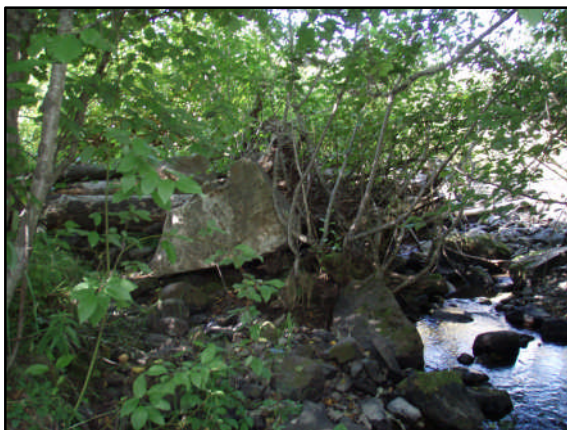
Figure 18. Site P-6 view upstream.

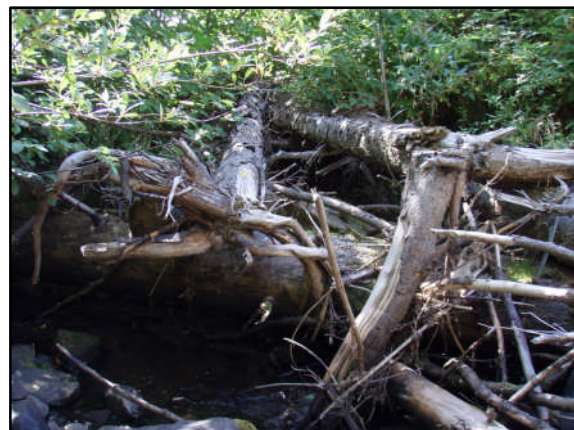
Figure 19. Site P-6 view downstream.

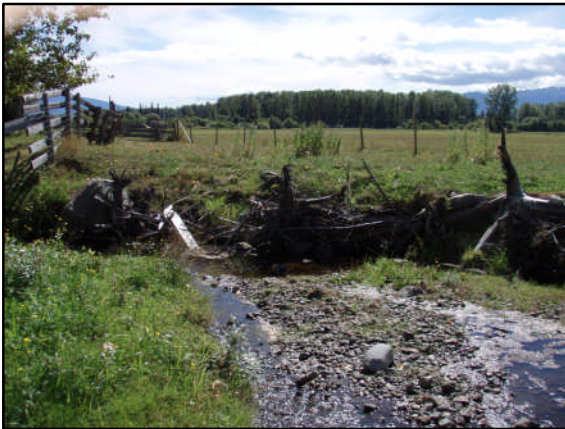
The Site P-2 restoration installation is achieving its objectives of reducing bank erosion, creating instream habitat, and reducing water velocity. All structural components are integral with no sign of instability. There is minor bank erosion upstream of the installation as seen in Figure 31. It is recommended that angular rock could be hand-placed at this point for 4-5 m upstream to reduce any erosion in high flow events.

Figure 21. Downstream segment of P-2.

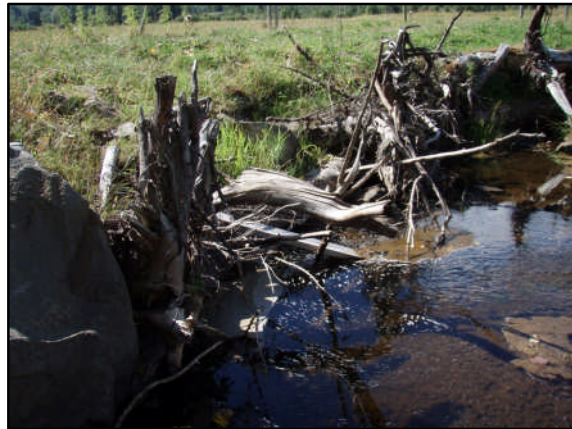
Figure 22. View upstream of P-2.

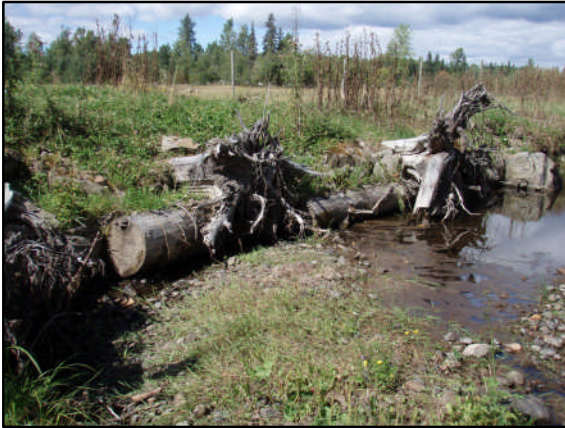
**Figure 23. View upstream of P-2.**

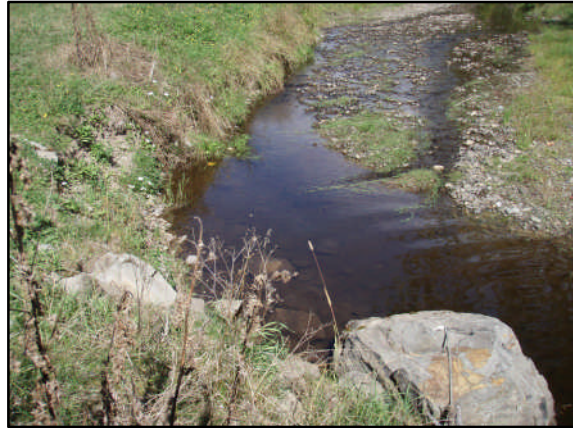
**Figure 24. View upstream of P-2.**

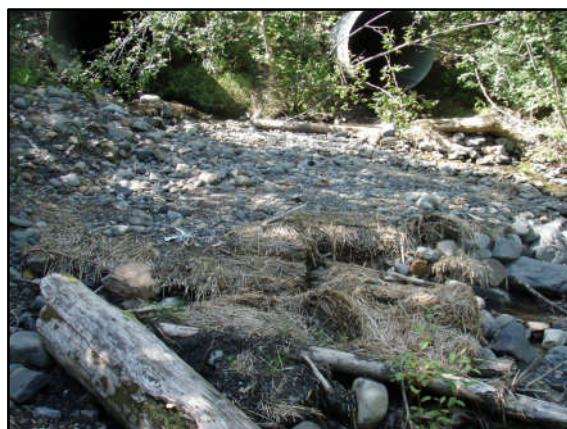
Figure 32. Remnants of hay sediment traps.

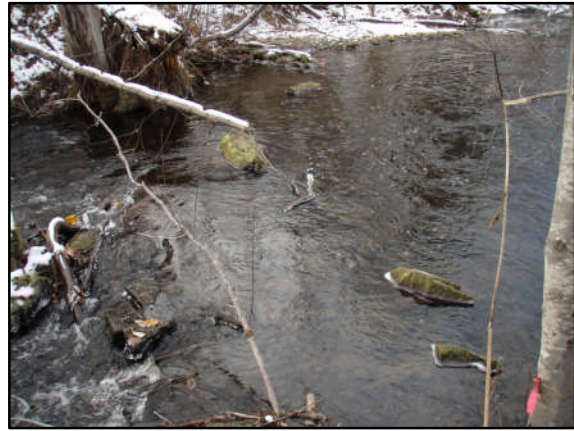
The rock weir downstream of the culvert was easily located and shown in Figure 37. This weir installation was built on the base of the weir installed at an unknown date; likely at least 20 years old. This old weir was installed and the channel relocated to increase the outfall pool depth. The original channel flowed to the right as shown in Figure 38. McElhanney (1999) reported that the rock weir increased the water level in the outlet pool below the culvert, but needed to be increased in height to mitigate the outfall drop which is a partial barrier to fish passage.

Figure 37. Rock weir at downstream end of pool.

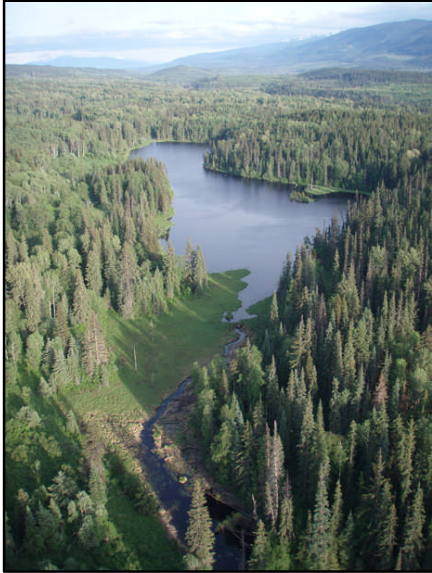
**Figure 52. Skunsnat Lake and outlet from the northwest**

The Kispiox Trail crosses Skunsnat Creek at approximately 70.3 km. Since the early 1960s when the culvert was installed there have been recurring fish passage problems and implementation of short-term solutions. Baffles were first installed in 1965 to assist fish in low and high flows; as well, it was recommended that the culvert be replaced by a bridge (DFO 1966, Hancock *et al.* 1983). The fish ladder below the road crossing washed out in the October 1978 flood; a jump pool was constructed in 1979 by Department of Highways; and baffles needed to be replaced in 1981 (Hancock *et al.* 1983). Metal baffles were installed in 1998, but proved largely ineffective in slowing culvert water velocities.

Skunsnat Creek culvert outlet pool and the channel for a short distance downstream are bedrock controlled. The culvert is undersized, extreme flow velocities create a velocity barrier, and the outfall barrier causes difficult or no fish passage. These factors combine together to work against fish passage.

A modified K log weir was placed upstream of the road crossing, but the structure has failed and there is currently no evidence of it. Logs were positioned downstream of the outlet pool to function as instream and bank deflectors, but these too have failed and are not visible. Individually, and as an aggregate, restoration efforts in Skunsnat Creek are rated poor with no tangible benefits to fish.

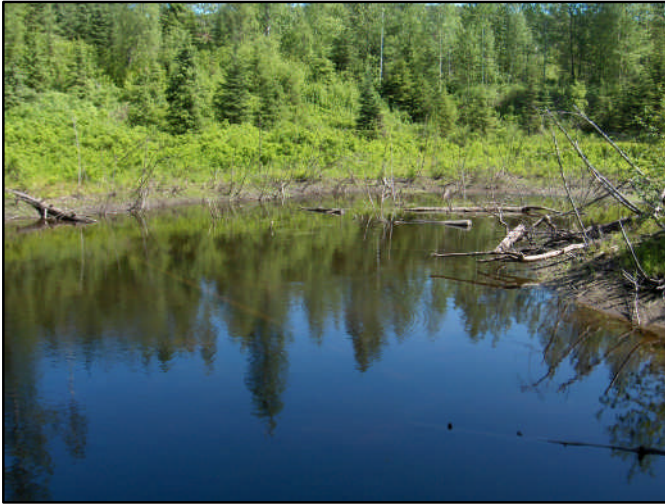
A total of 32 instream structures were placed and include 19 instream deflectors, 3 bank deflectors, 9 log weirs, and 1 rock weir. Evaluations found no structures in place, though pieces were scattered around the stream banks and adjacent floodplain. Our observations indicated that floods or highwater had breached most beaver dams and had randomly relocated the relatively small sized material making up the instream structures. Log pieces from the placed structures are currently providing limited cover and stream complexity. Overall, restoration efforts in Twin Creek are rated poor with no tangible benefits to fish or habitat.

**Figure 54. Typical beaver pond in lower Twin Creek**

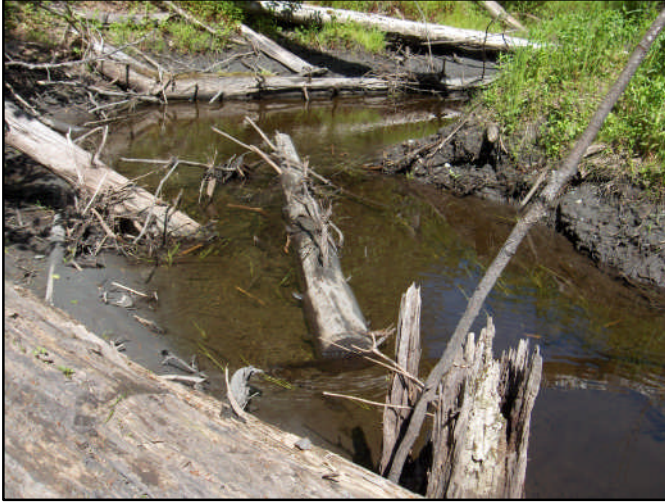
**Figure 55. Twin Creek showing fine organics and naturally contributed woody debris.**

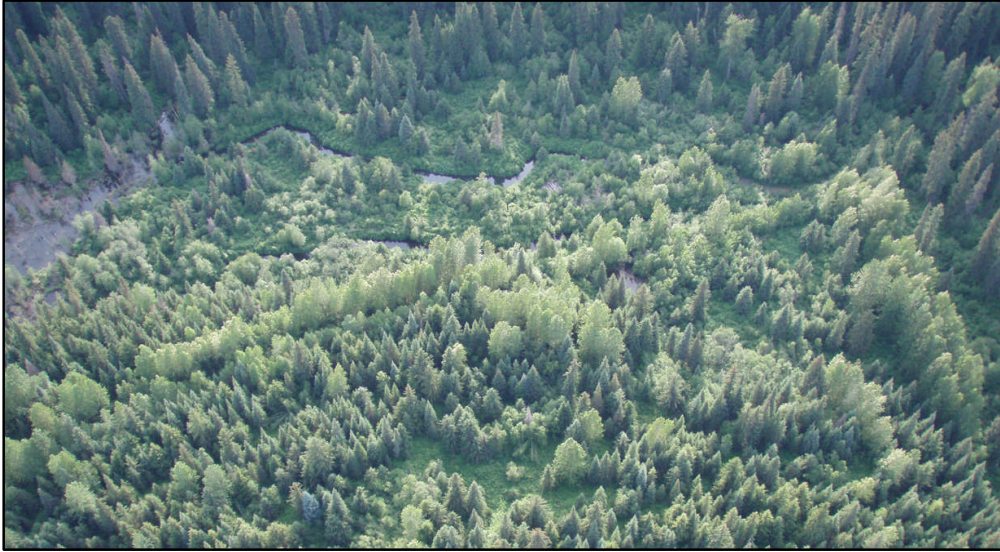
Two groundwater channels were excavated in 1997 on a tributary to lower Nangeese River. The objective was to provide spawning and rearing habitat over and above what was currently available in the tributary. These channels were constructed upstream of and provide access to an active beaver pond complex, which in turn is 1.3 km upstream of Nangeese River. The west channel is approximately 170 m in length, while the east channel is 210 m in length. Channel depth averages 1.10 m with a range between 0.5 and 2.1 m; the deeper areas function as pools. The majority of the mostly fine grained, silty materials excavated for the channels was placed on both side of the channel and subsequent erosion has infilled the channels on average 9 cm in depth. The channel side berms have revegetated; however there is basically no instream cover.

**Figure 57. Photo shows beaver pond on the left, west channel at the top, and east channel in the middle.**

Dissolved oxygen (DO) levels and water temperature were recorded, and juvenile trapping was conducted for a 11 month period starting in mid-May 2006 to April 2007. The results indicated that average DO levels were 3.6 mg/L from a mean of 4.2 at the top to 3.0 at the bottom of the west channel. The west channel temperature averaged 6.9 C<sup>0</sup> with seasonal ranges from 16.2 to 0.7 C<sup>0</sup>. Juvenile trapping did not capture any fish.

This restoration effort suffers from a lack of site suitability, conceptual planning, and adult recruitment. The site should have been initially monitored with test pits that would indicate ground water DO levels, temperature regime, and seasonal water quantities. It is recommended that the site be abandoned.

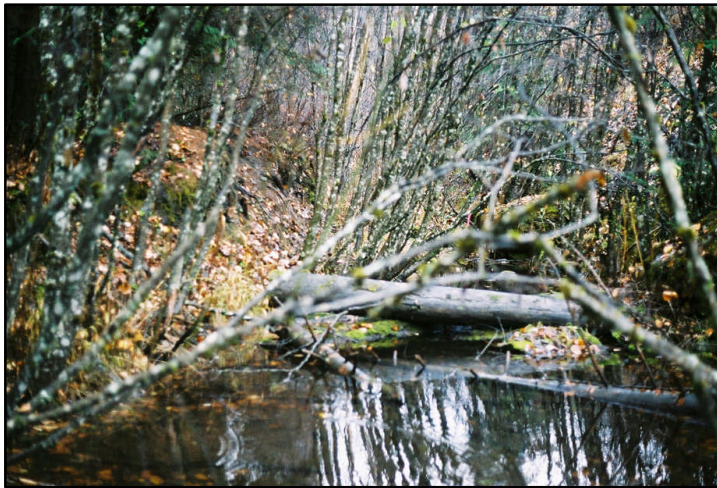
The channel is groundwater fed by Natlan Creek subsurface flows. In this evaluation study, unidentified fry were noted utilizing the lower 147 m of the channel. Pools depths measured 0.45 to 0.5 m in depth and didn't appear to be infilled to any degree. The LWD mostly provided cover and did not substantially add to structural complexity of the stream. Low water levels precluded access into or out of the ground channel and Natlan Creek. The minimum dissolved oxygen concentration measured was 9.2 mg/L and the water temperature was 3.2C°. Overall, this site was suitable for instream works, well-planned, and is providing low cost and high value benefits.

Figure 89. View upstream of pool and LWD, 38 m from mouth.

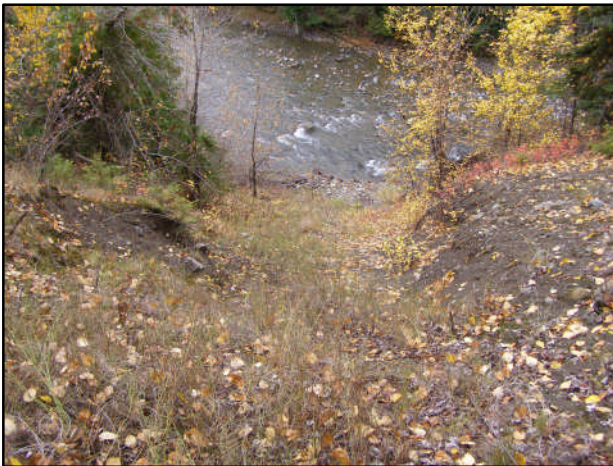
**Figure 101. View down Slide 1 to Kitsequecla River.**

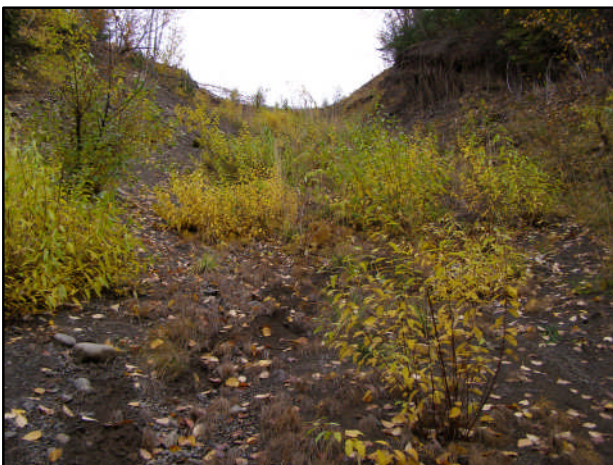
**Figure 102. View up Slide 1.**

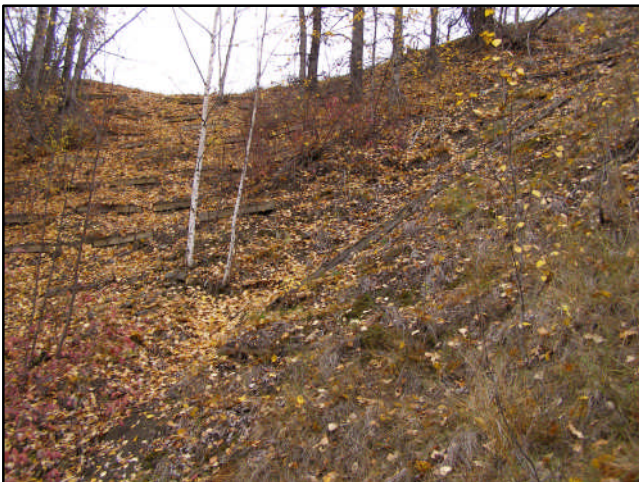
**Figure 106. View of upper Slide 2.**

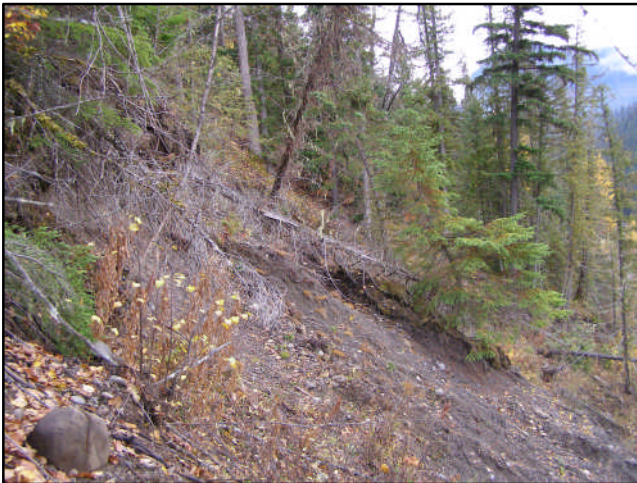
being ravelling. On Slide 3, the upper, northern portion has experienced light slumping. The southern portion of Slide 4 and Slide 5 are experiencing active wasting and the live pole drains are no longer functional. These sections need to be reconstructed and then maintained. We recommend a hydrologist visit the site and make recommendations on potential drainage solutions that may be an opportunity upslope of Slides 4 and 5. If drainage solutions aren't apparent, we recommend installing a rock blanket the lower portion of Slide 5 and the southern lower section of Slide 4. Overall, this effectiveness evaluation rates the site as fair to good.

**Figure 110.** View across the upper portion of Slide 5.

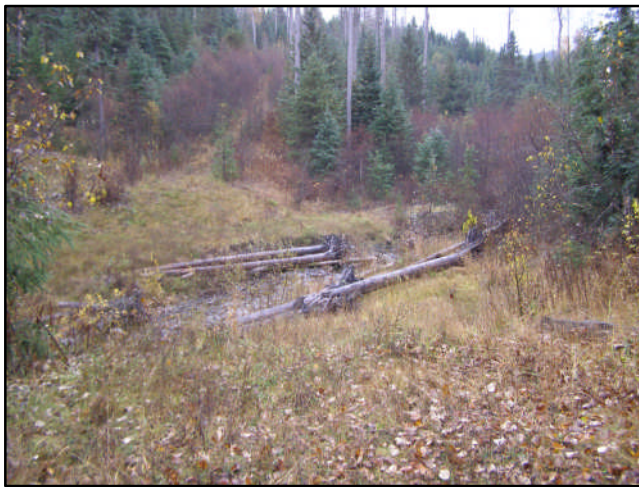
**Figure 116. View southward across Tributary 1 crossing from Photo Point 2.**

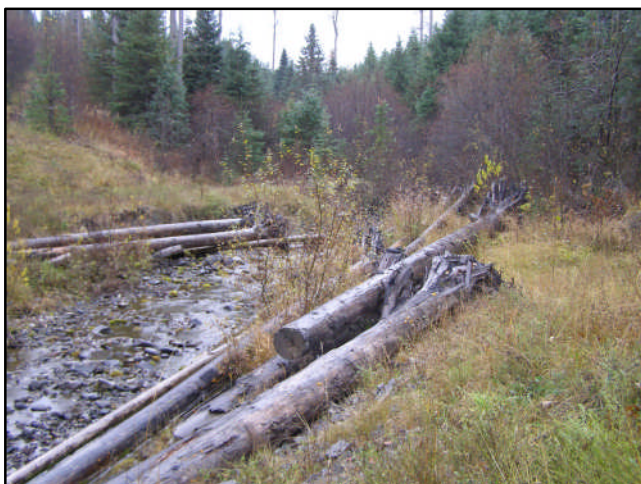
**Figure 117. View upstream from Photo Point 2.**

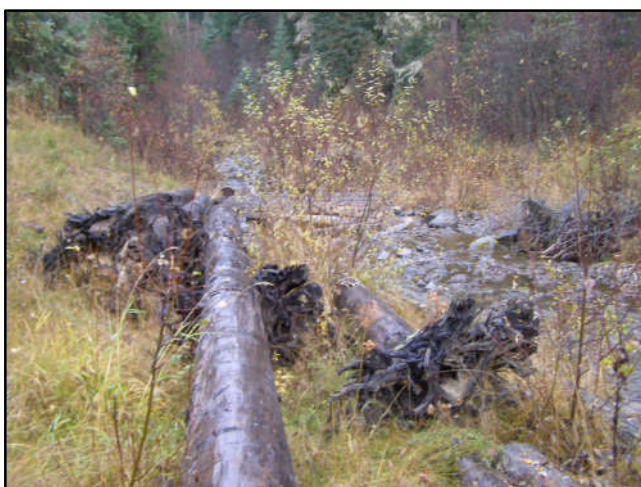
**Figure 118. View downstream from Reference Post 2.**

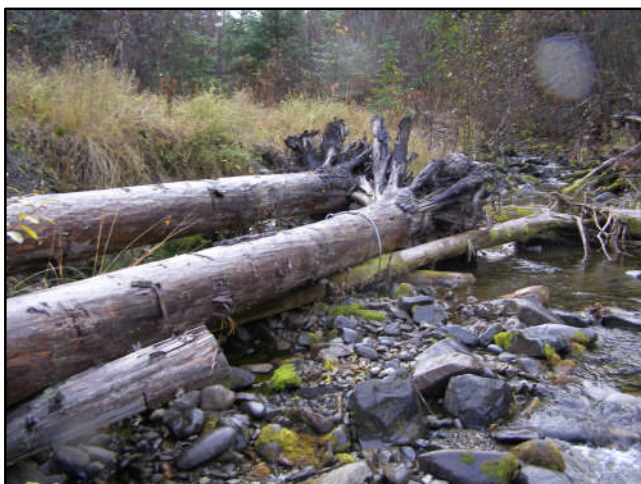
**Figure 120. View upstream from Reference Post 6.**

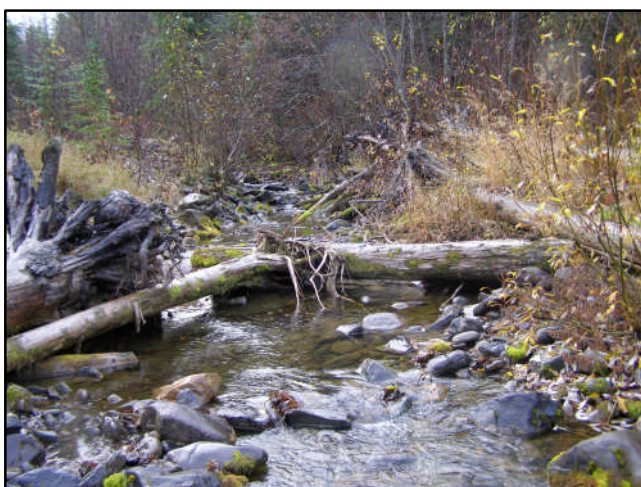
**Figure 121. View upstream from Photo Point 1.**
