**BULKLEY/FULTON WATERSHED
FISH PASSAGE CULVERT ASSESSMENT PROGRAM**

January 12, 2010

Ecofor Consulting Ltd.
PO Box 1270
Fort Saint James, BC
VOJ 1P0
(250) 996-2151

EPN 2009-2029-001

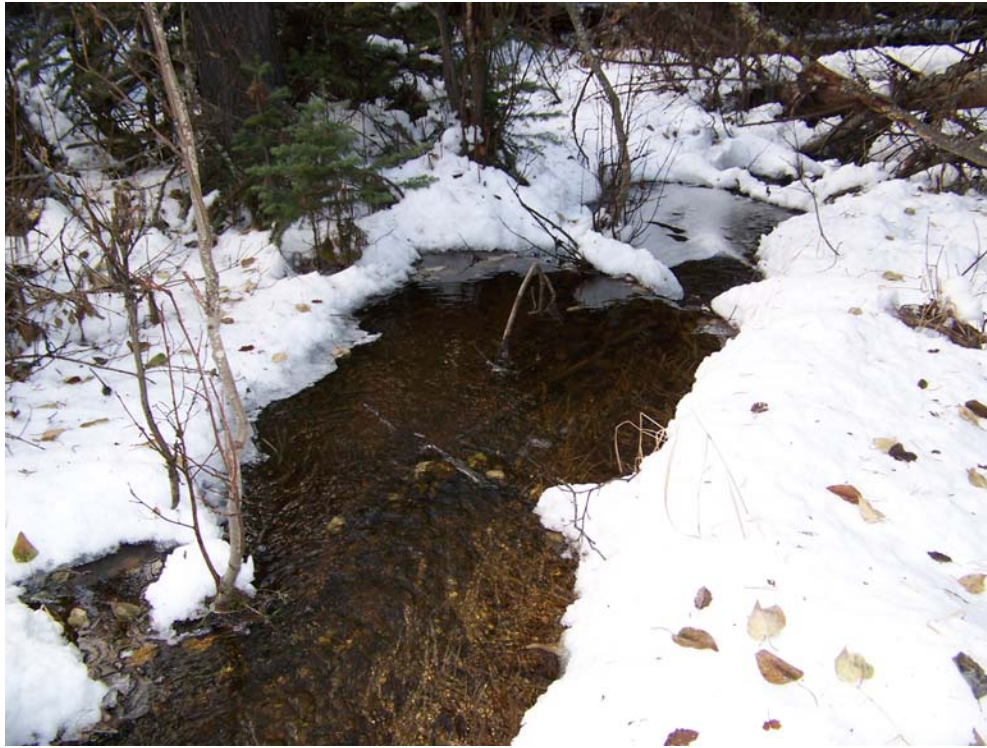
View of habitat downstream
from culvert outlet.

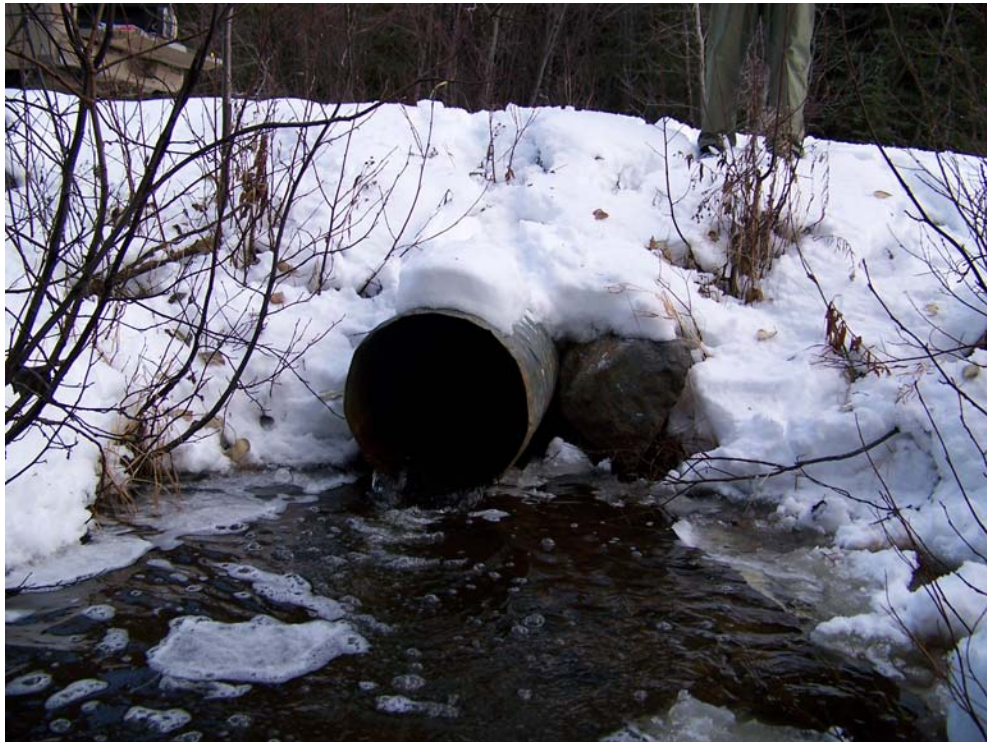
View of the culvert outlet.

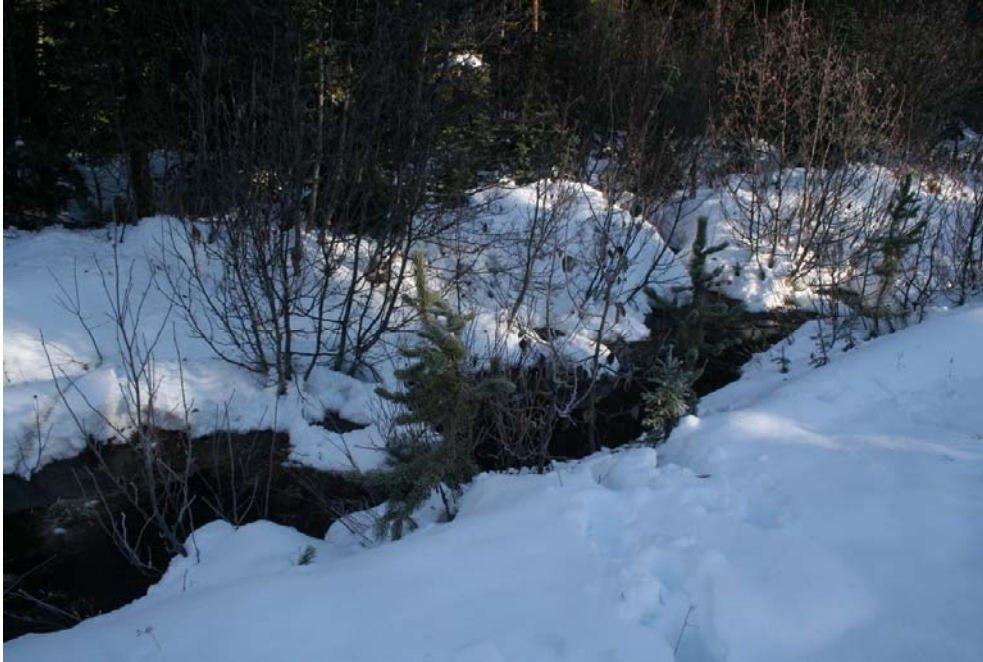
View of the habitat
downstream of the culvert
outlet.

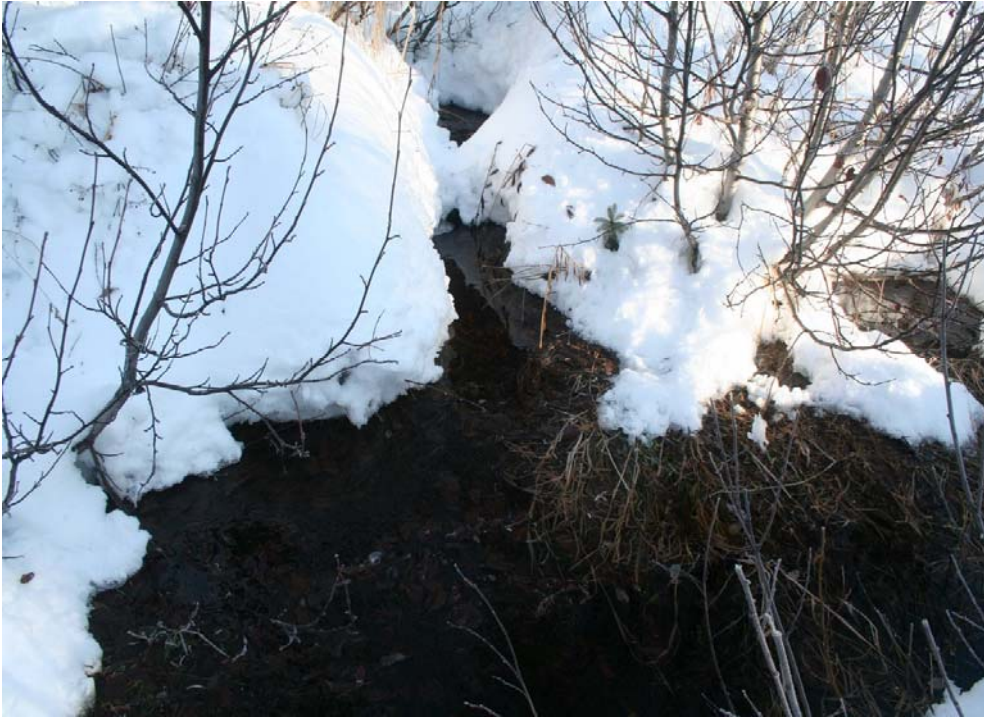
View of the culvert inlet.

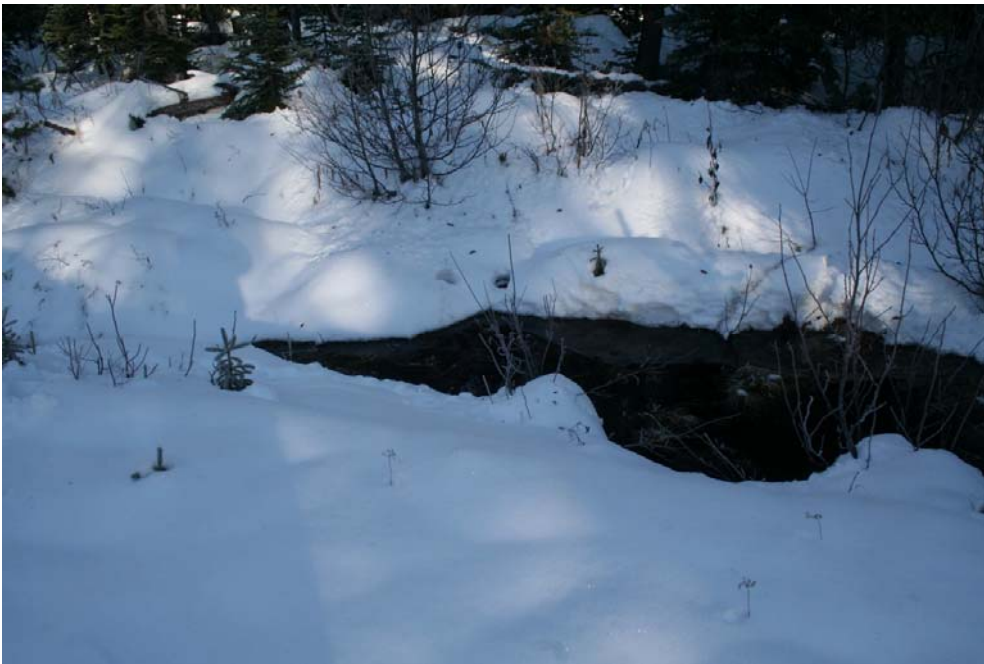
View of the habitat upstream
of the culvert inlet.

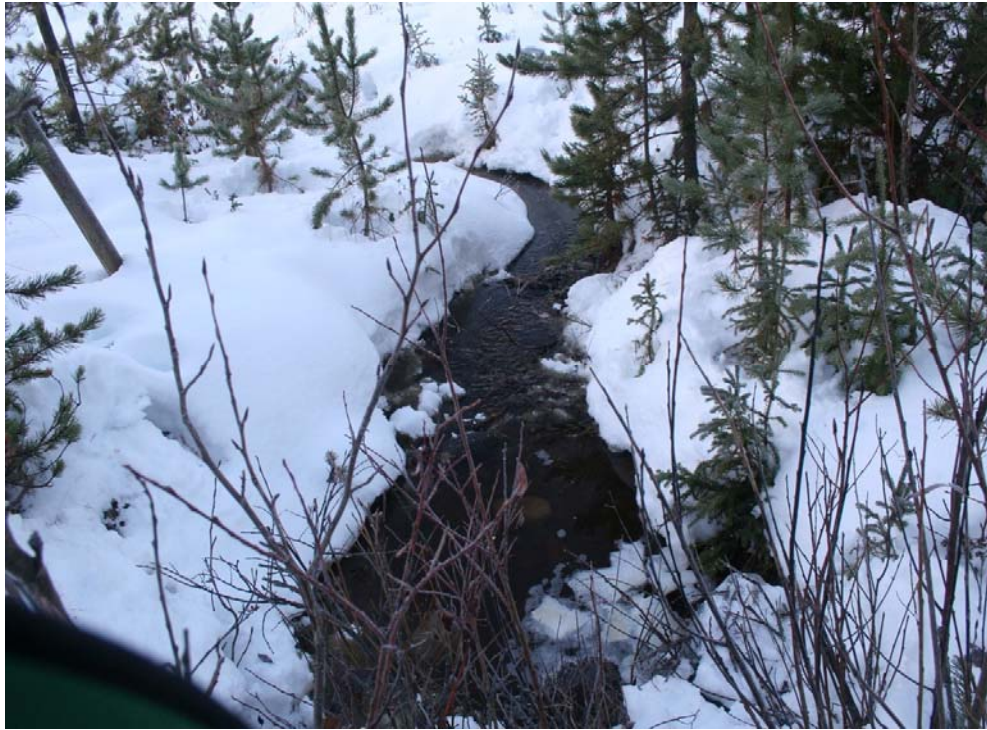
View of the habitat
downstream of the culvert
outlet.

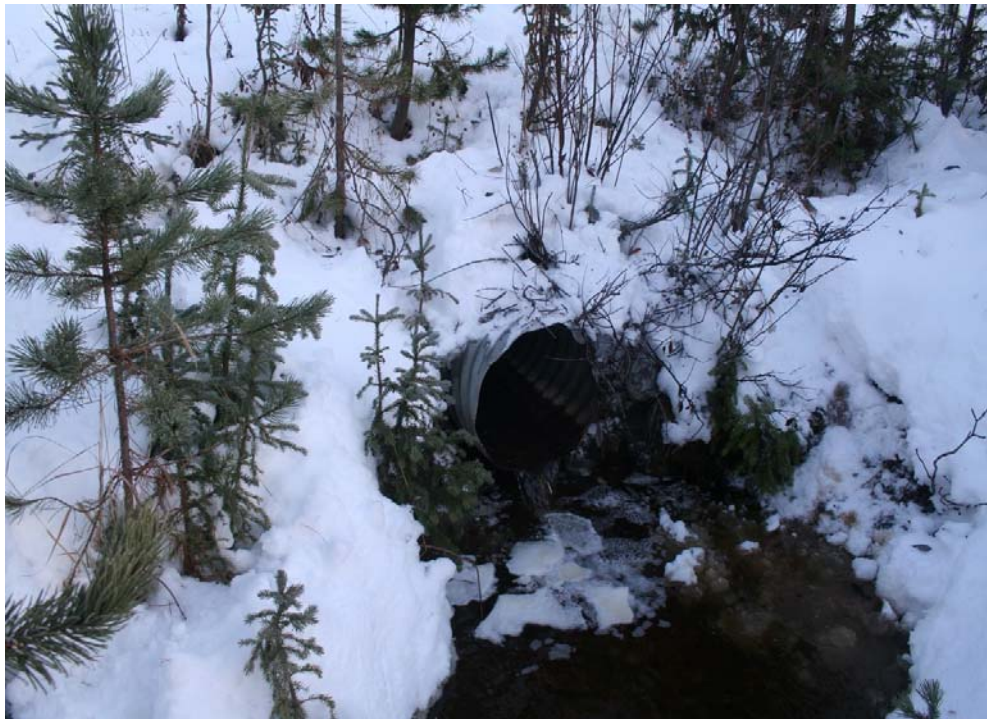
View of the culvert outlet.

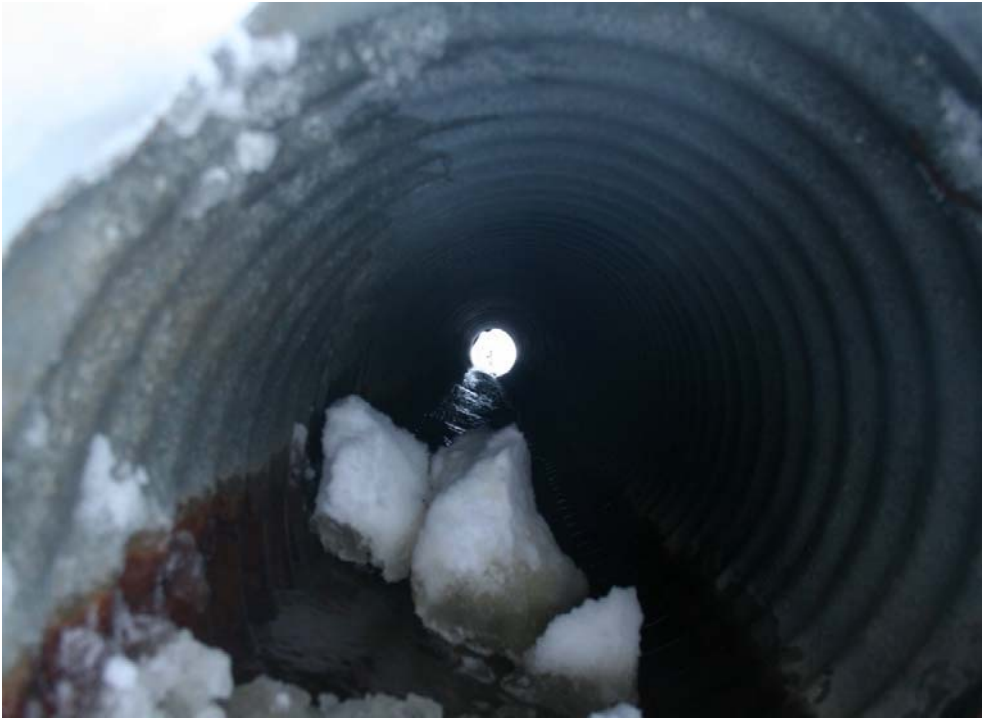
View of barrel.

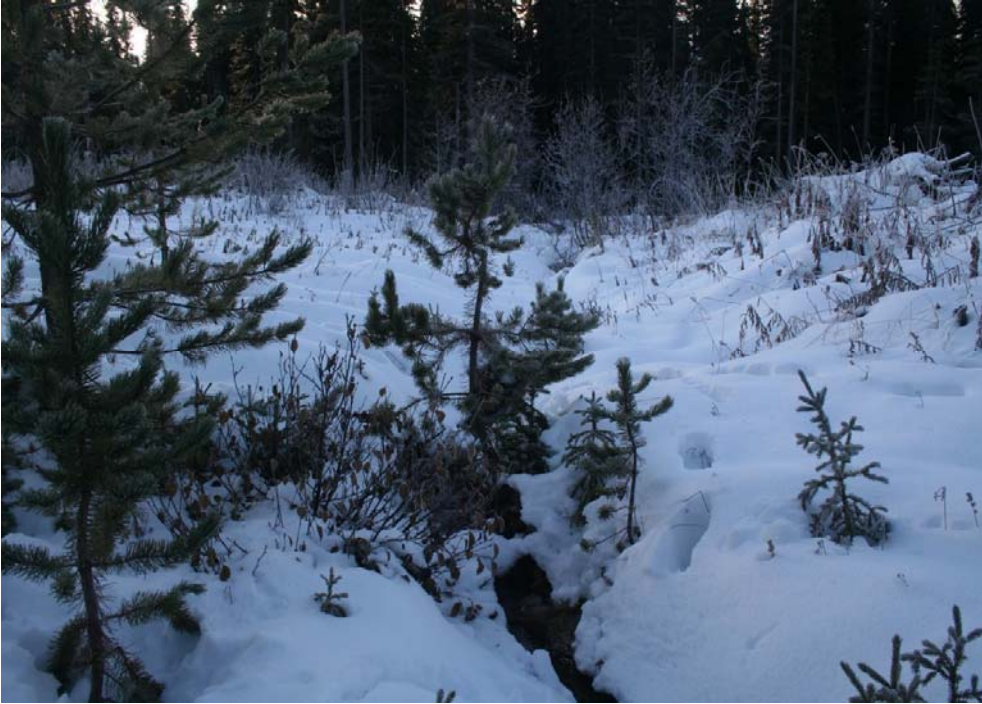
View of the habitat above the
culvert inlet.

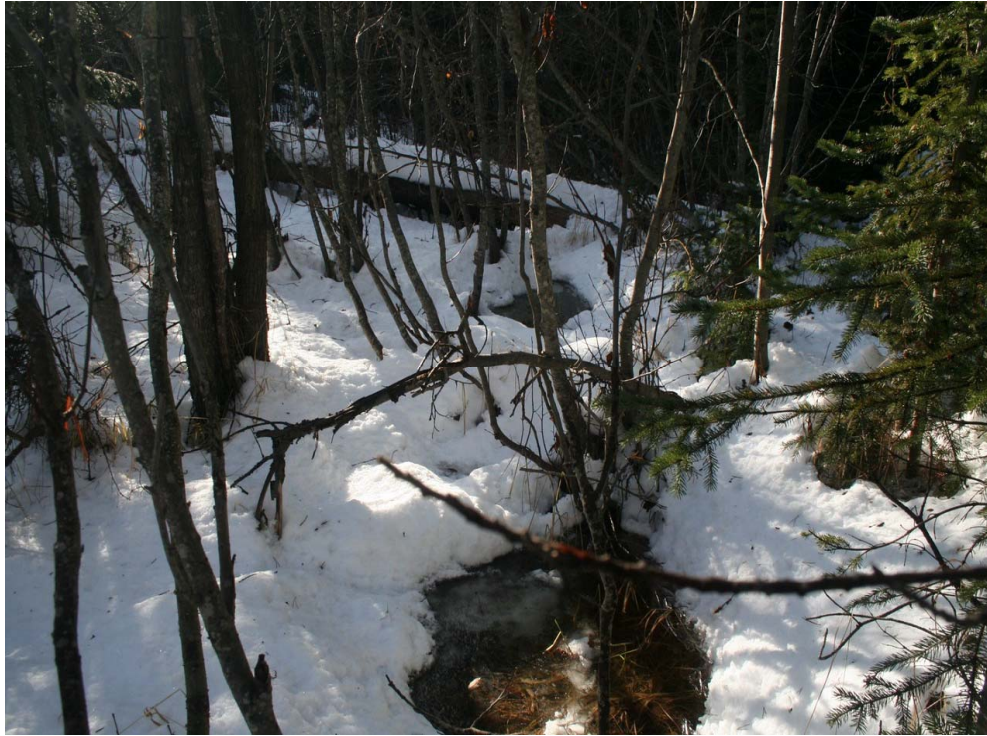
View of the habitat
downstream of the culvert
outlet.

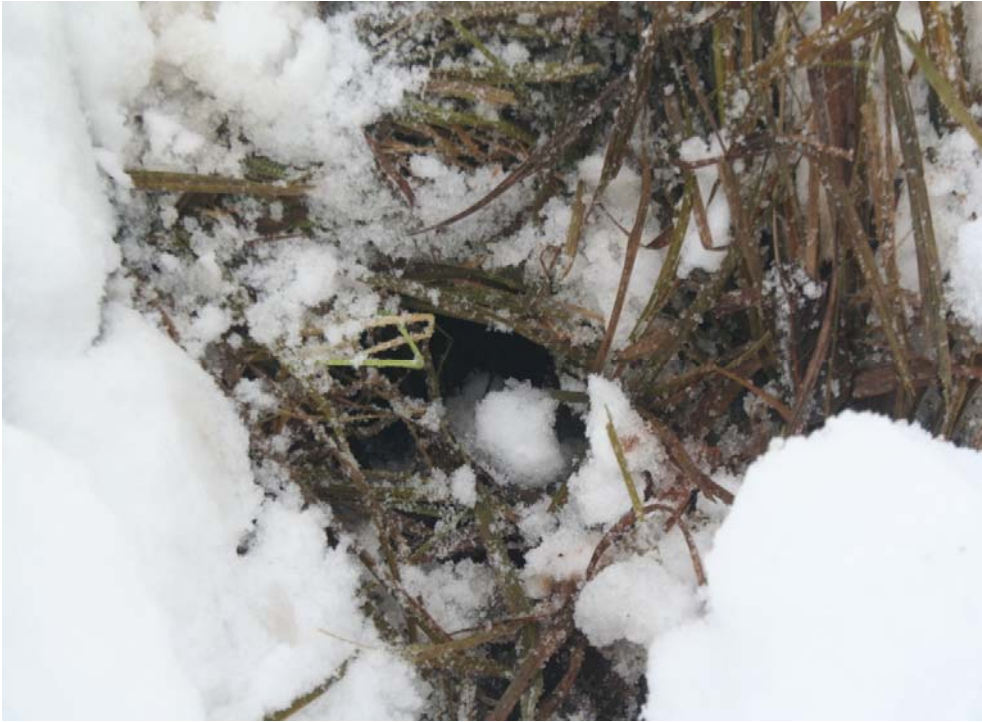
View of the culvert inlet.

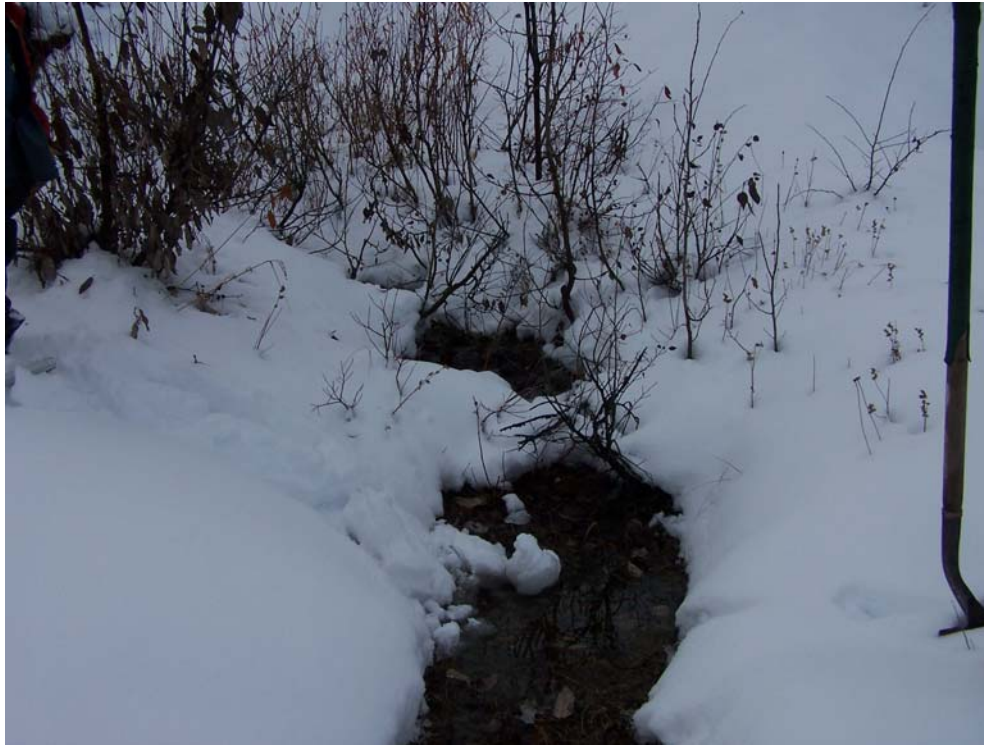
The culvert has been removed from this location; there is some slight scour due to the concentration of ditch flows.

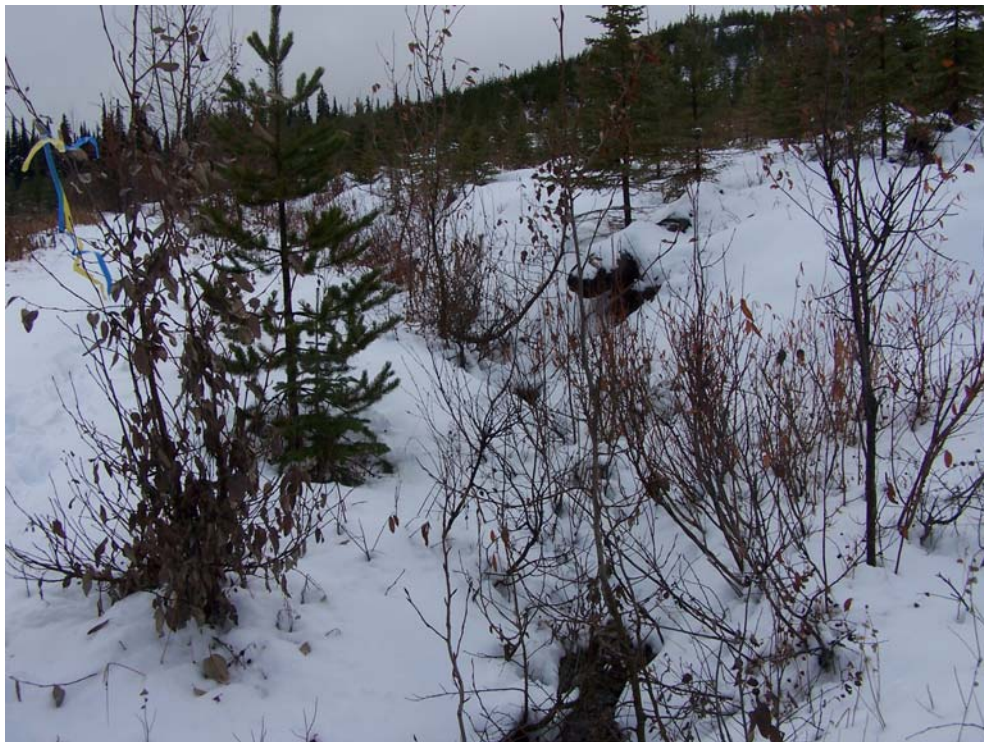
The crossing would have transported some ditch flow and run-off from the surrounding cut-block. Other than the ditch flows there is no other evidence of any scoured stream channel.

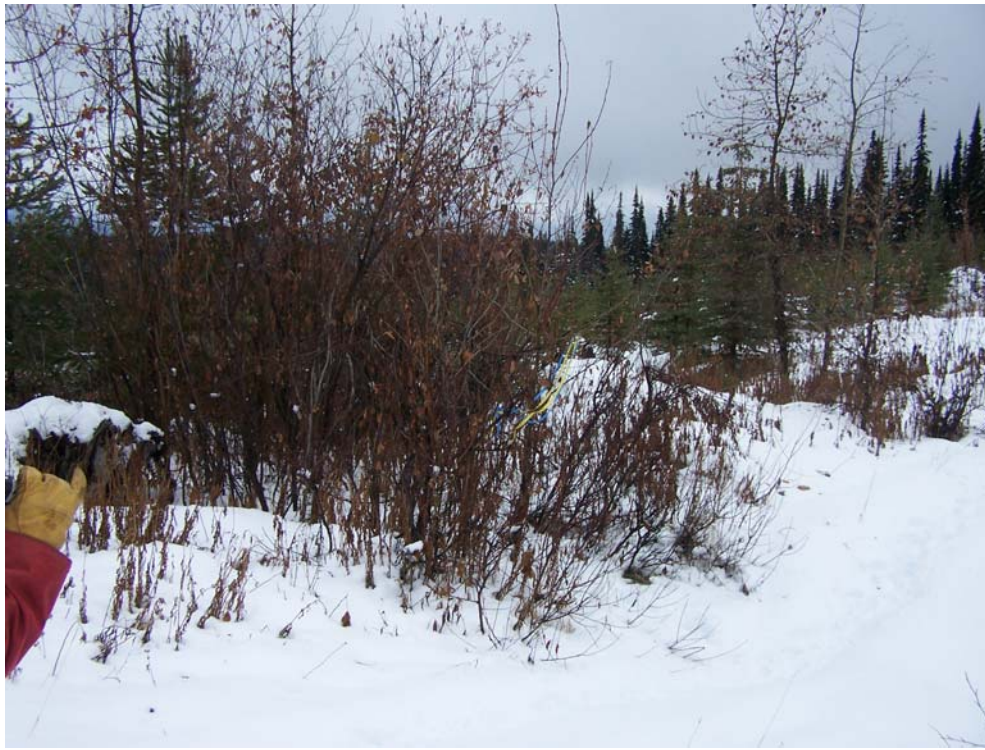
The culvert has been removed from this location; there is no stream or any signs of flowing water or a scoured stream channel downhill of the road crossing.

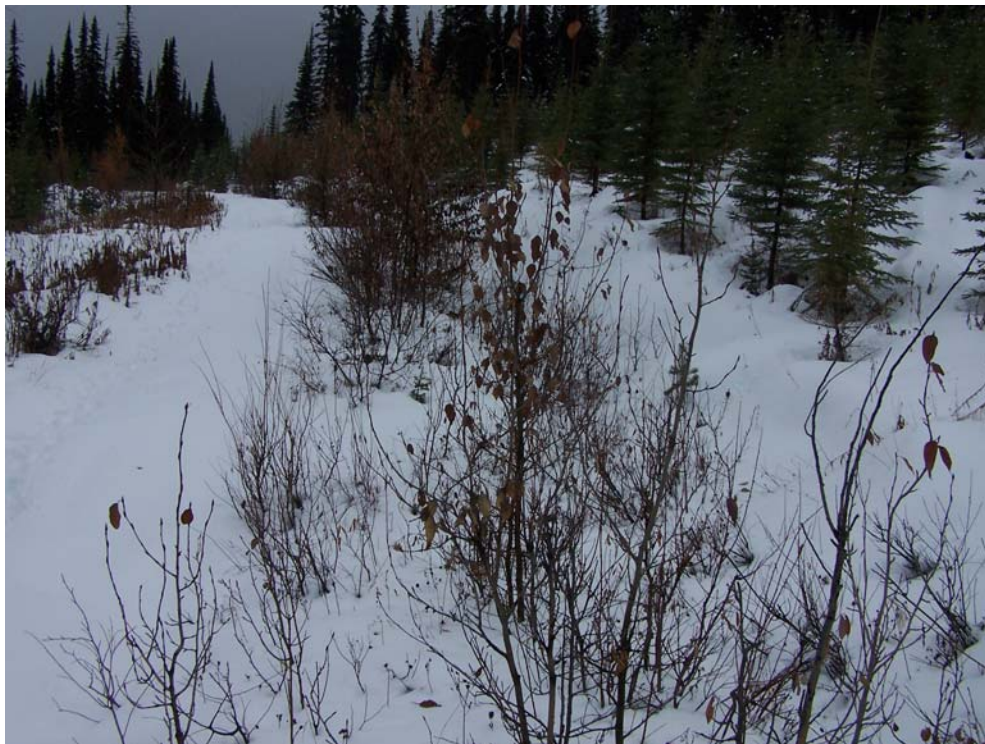
The crossing would have transported some ditch flow and run-off from the surrounding cut-block.

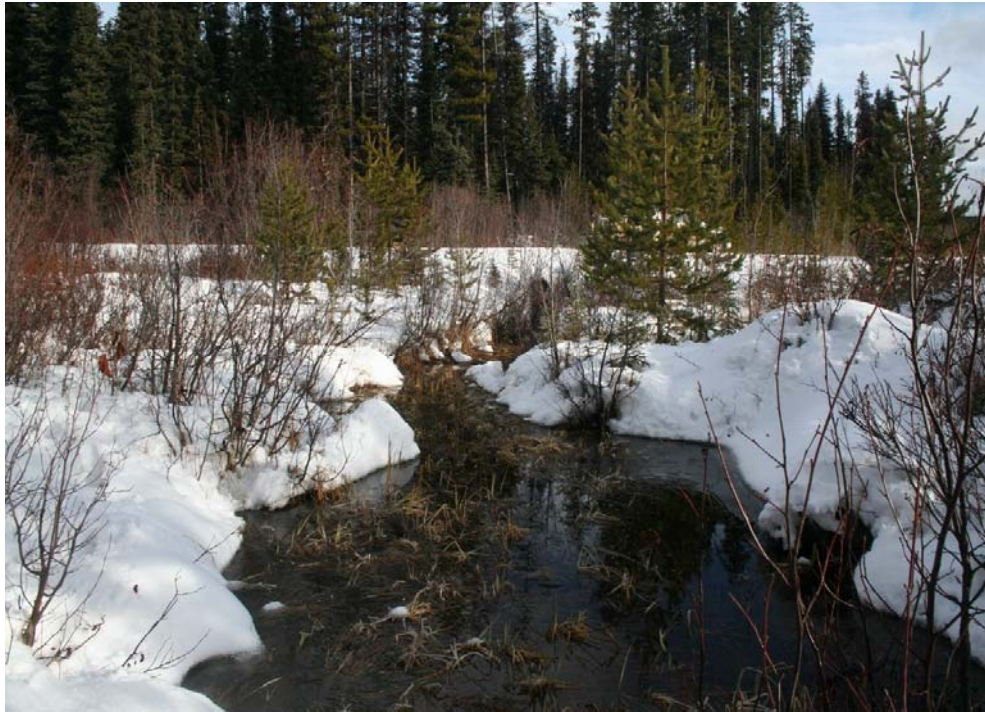
View of the habitat
downstream of the culvert
outlet.

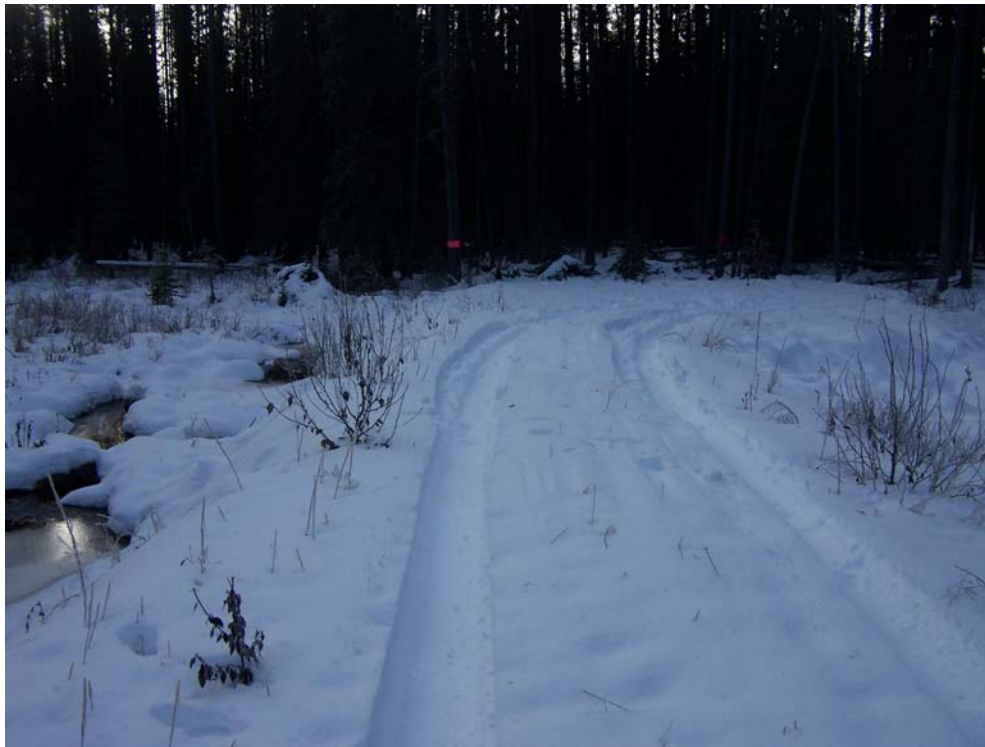
Looking southeast at the end of the built road; this is a wet spruce swampy area with pools of standing water present, but there is no other sign of flowing water or a scoured stream channel. There is no culvert installed at this location, but it will need one if the road is extended for further access or harvesting activities.

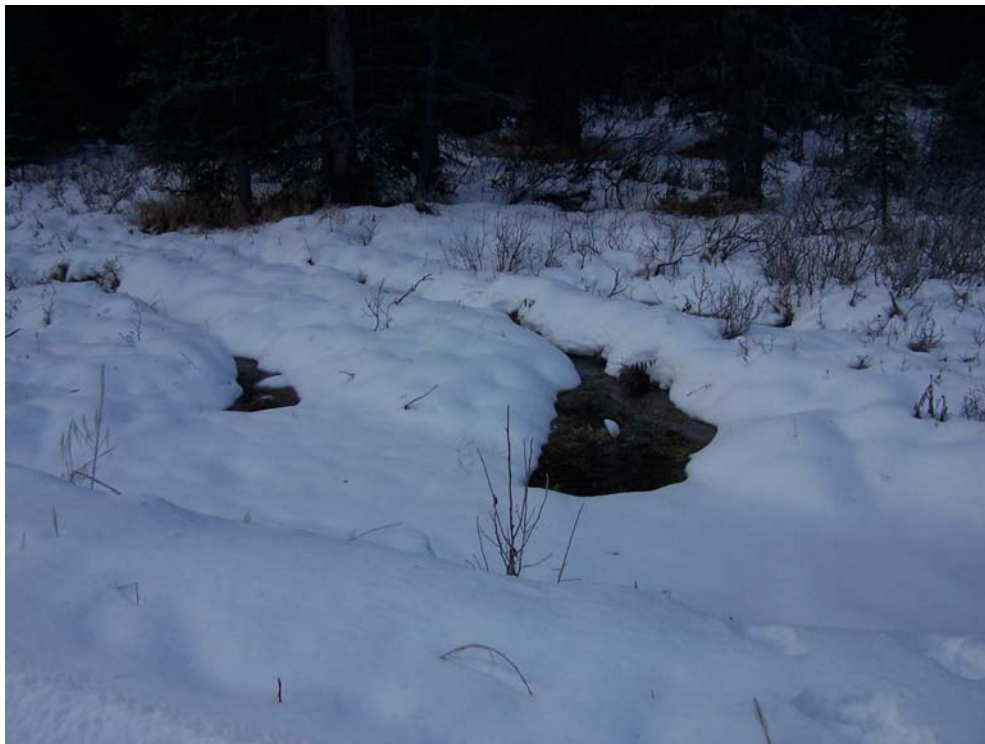
To the west of the road there are some old machinery tracks which have filled with water.

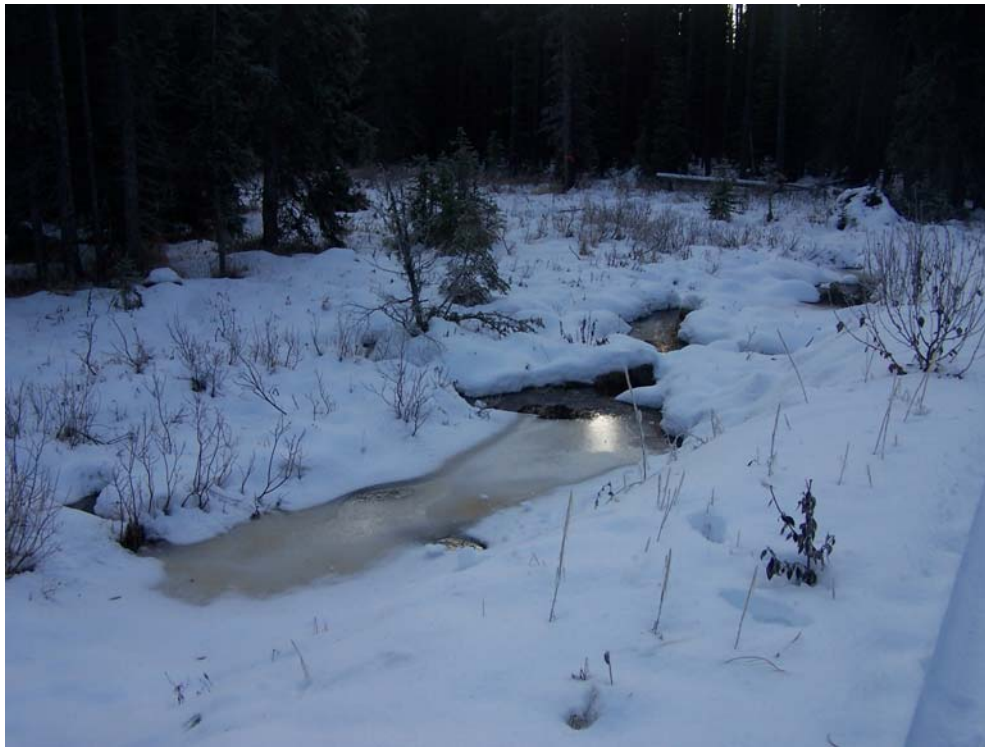
Collection of adjoining pools of standing water along the east side of the road grade. Water accumulations are seepage flows out of the swampy ground; there is no stream at this location.

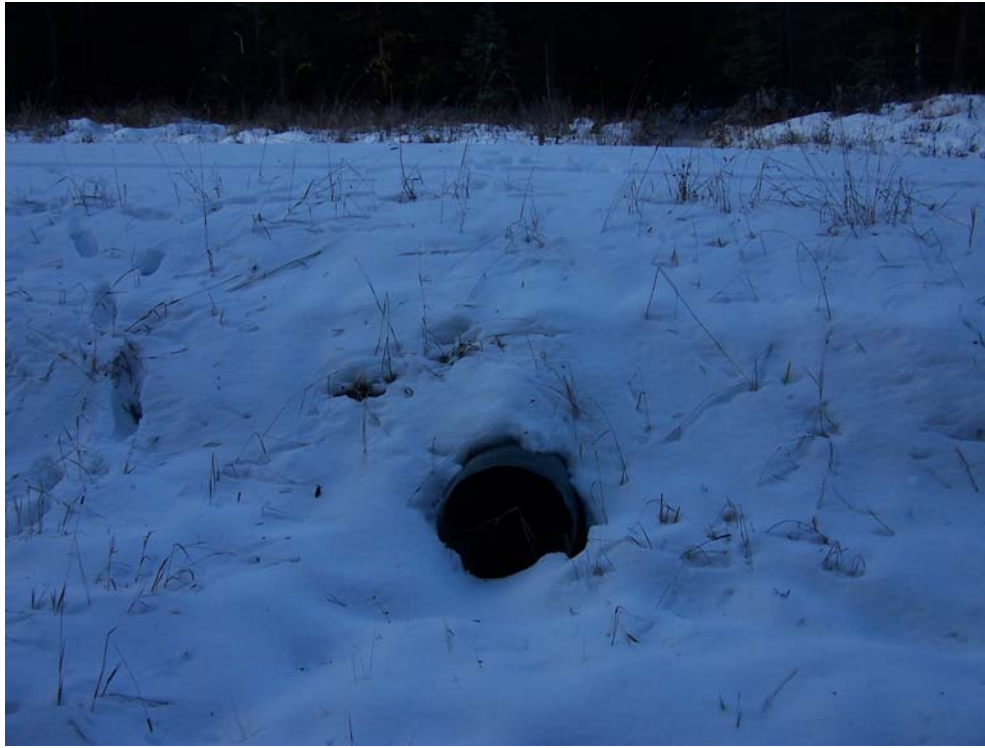
Downstream view of the culvert inlet; culvert only handles ditch run-off. There are no signs of any flowing water or a scoured stream channel.

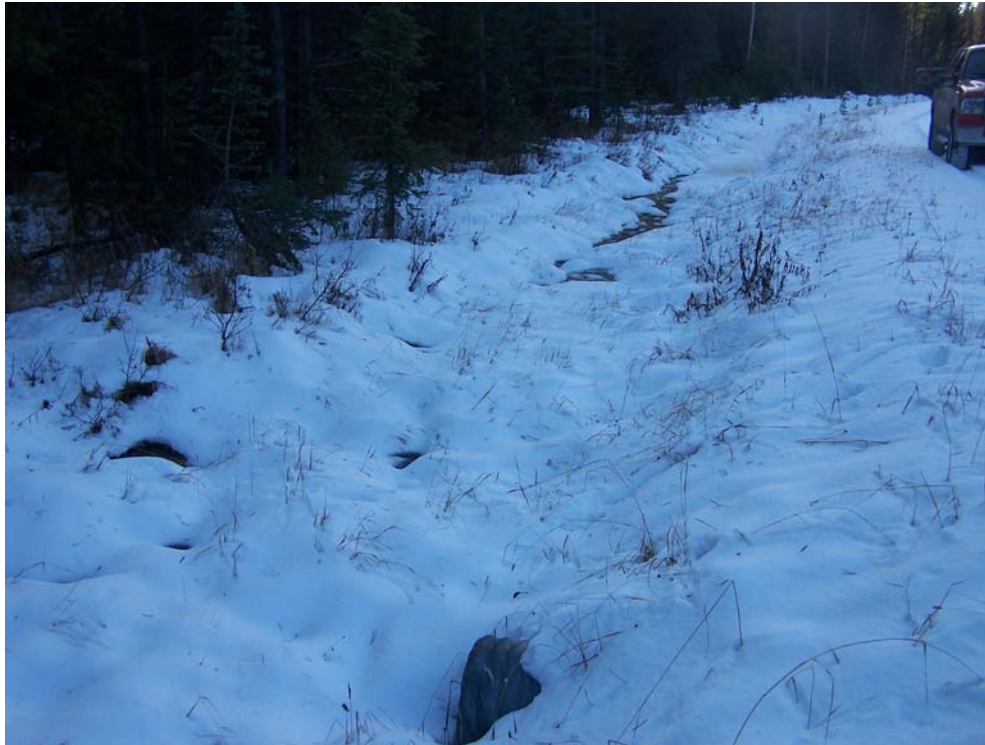
Upstream of the culvert the only water flows are from ditch run-off.

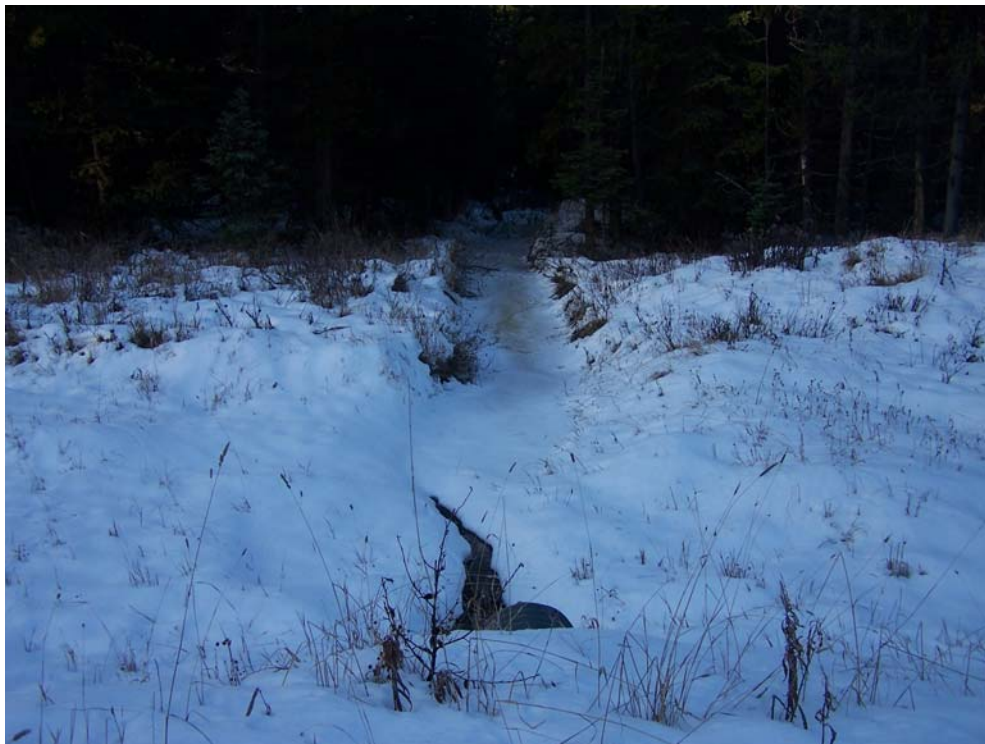
There is a man-made ditch which conveys ditch run-off away from the road. There is no stream at this culvert location.

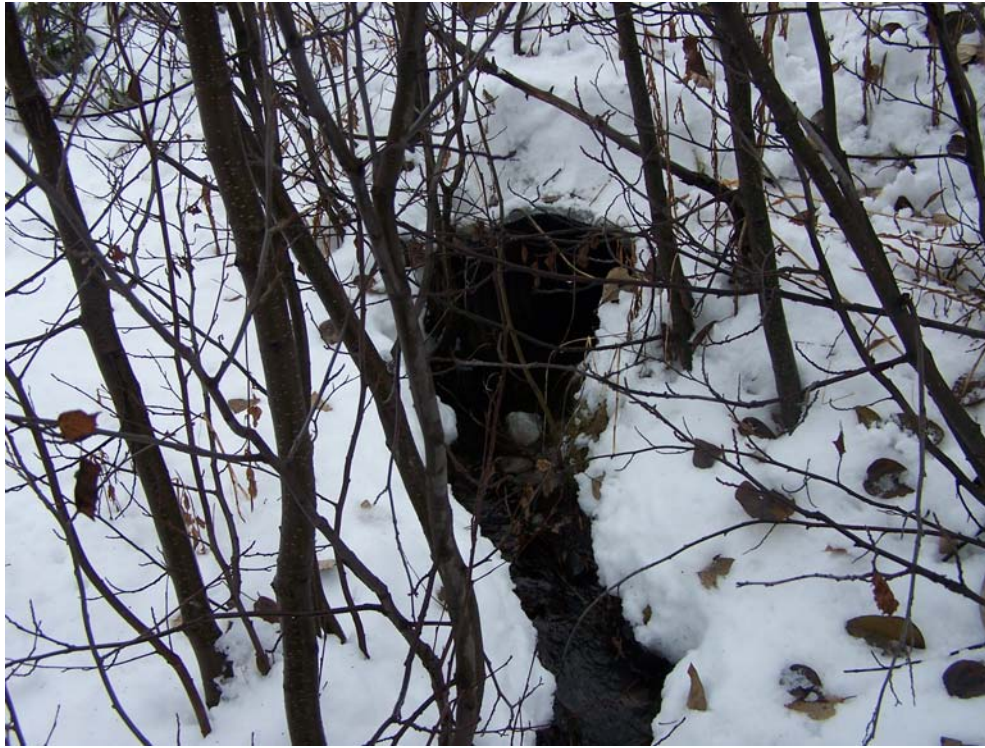
Culvert inlet is overgrown with a heavy cover of alder and willow. There is a small well scoured stream channel present.

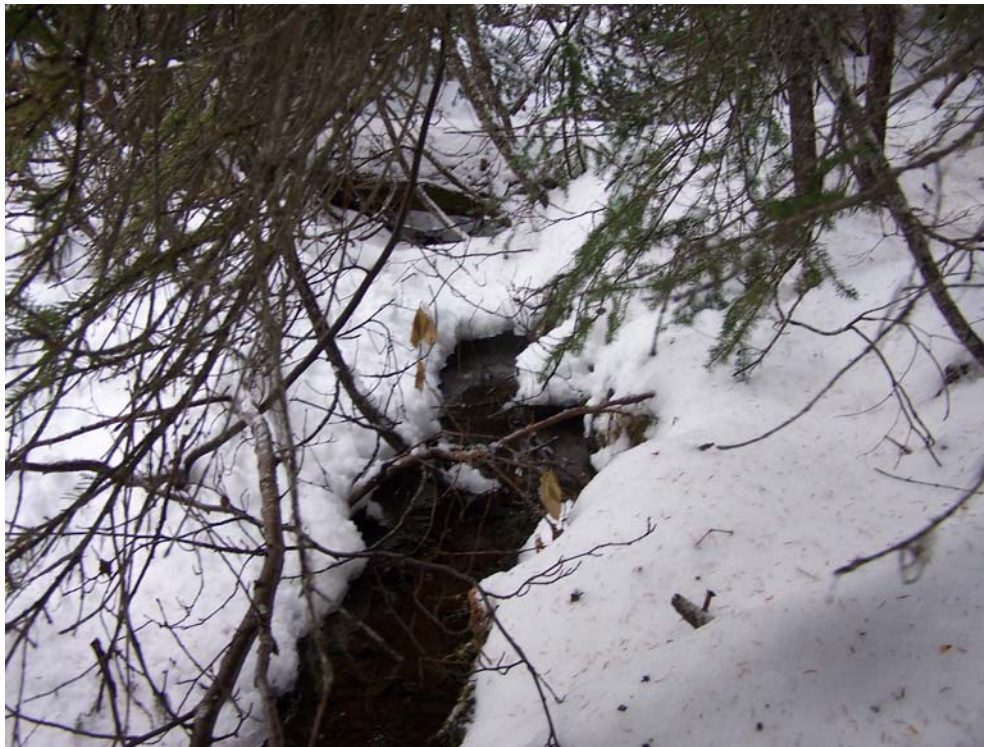
This is a small watercourse; while a scoured channel exists offering limited rearing potential there is no deep pools for overwintering or gravels with sufficient water flows to support spawning. The overall fish habitat value would be low.

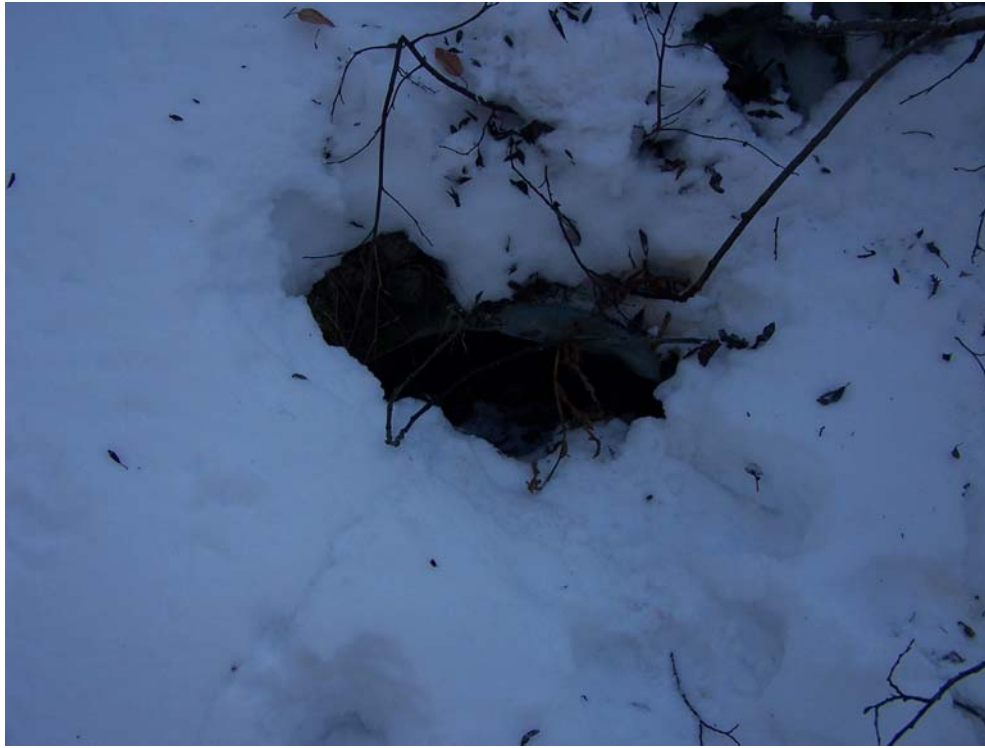
There is no stream at this culvert crossing; culvert inlet is overgrown and obviously only flows when water levels rise sufficiently to enter into the pipe.

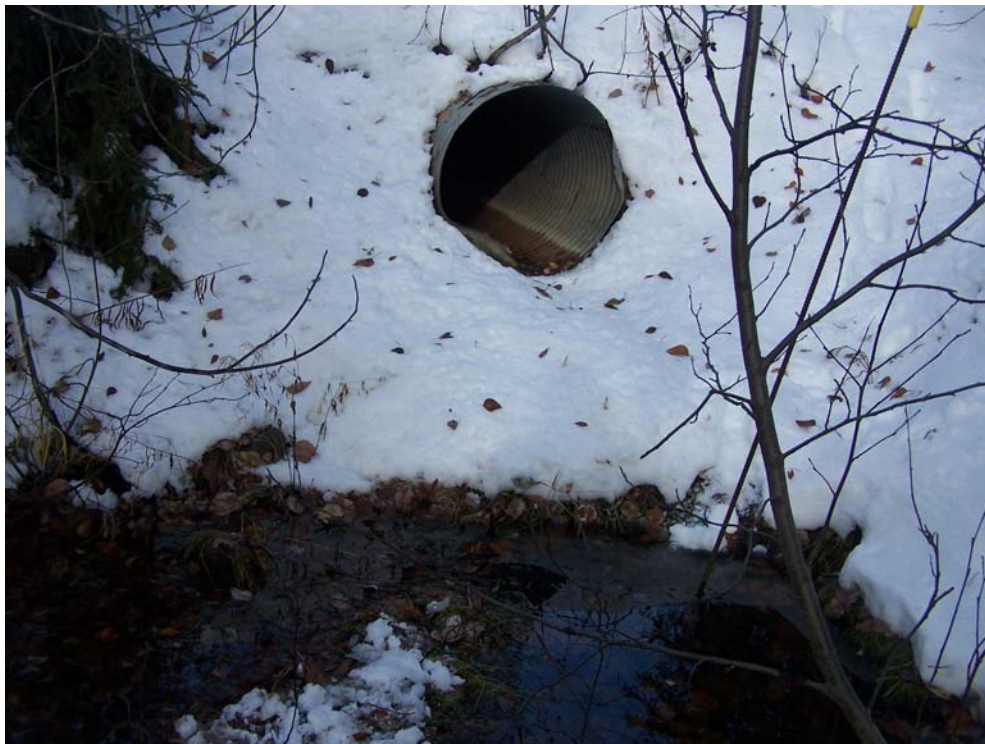
Upstream view of the culvert outlet; culvert only conveys run-off which collects in the draw uphill of the road. There is a large pool of standing water (30*70m ground estimate (GE)) that extends down the draw away from the road.

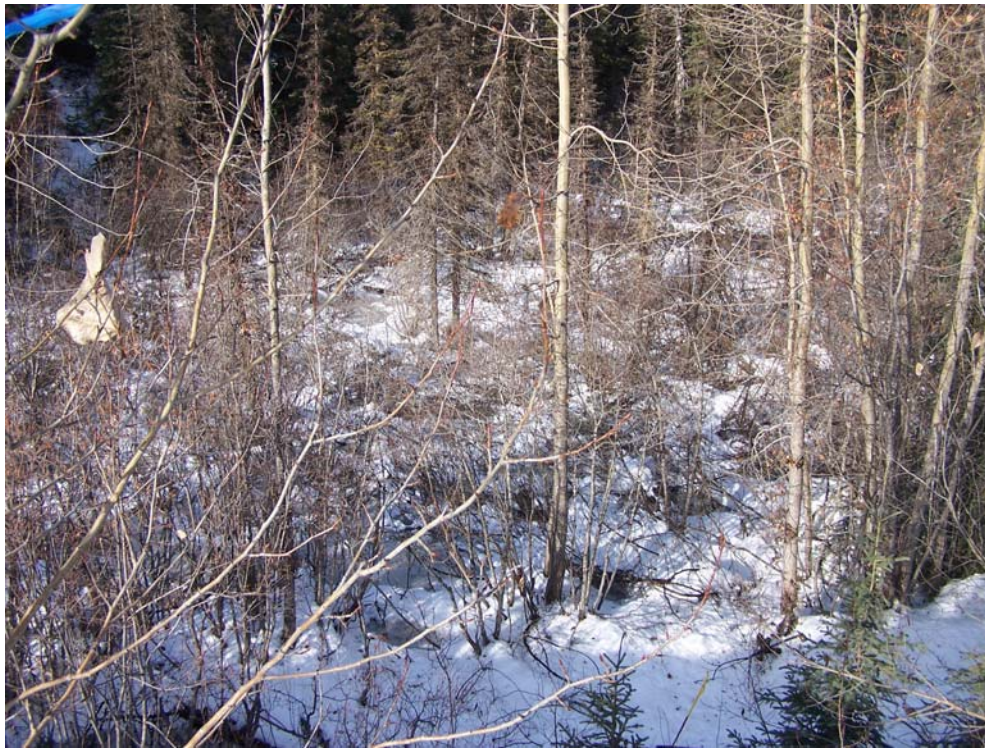
Upstream of the culvert there is a 50-80m wide draw (GE) which collects run-off from the surrounding ridges. There is no evidence of any flowing water or a scoured stream channel.

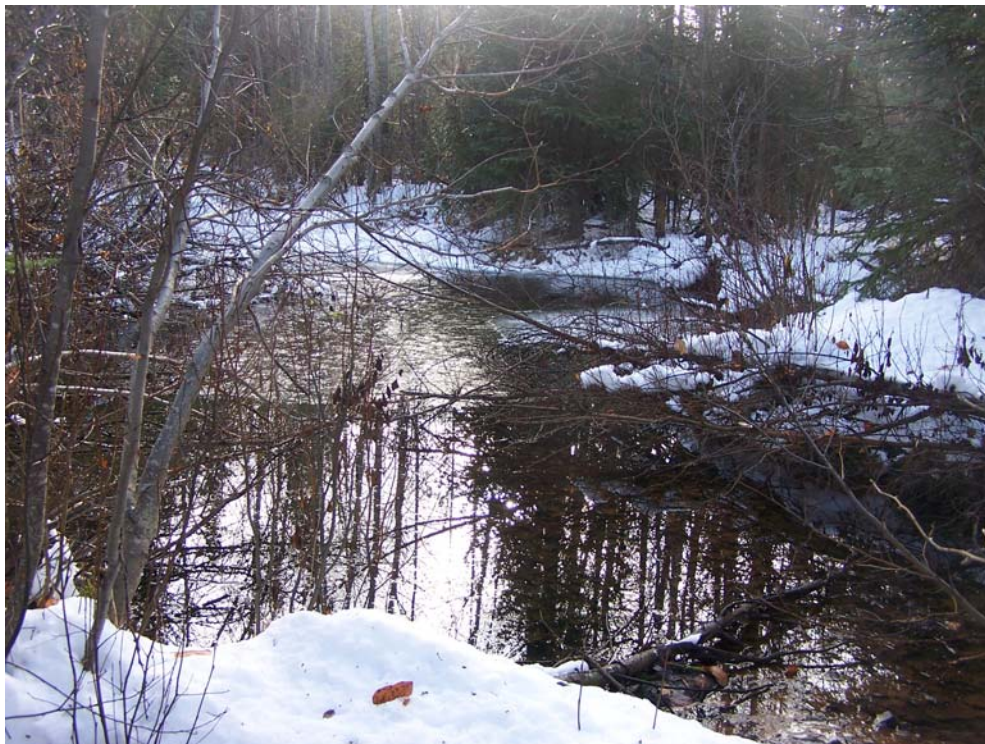
Downstream of the culvert there is a pool of standing water which collects from run-off flows. Beyond that there is no sign of any flowing water or a watercourse.

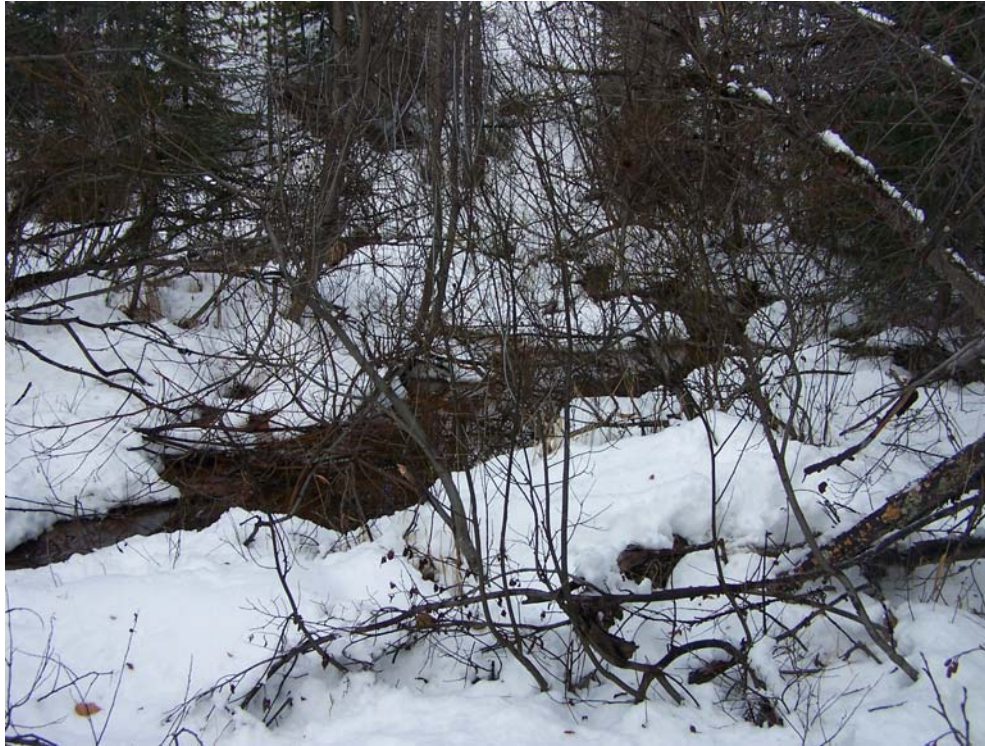
Below the large pool of water there is a long finger that extends away from the road, beyond that last pool of water there is no evidence of any water flows or pooling. It is a wet low-lying draw that absorbs run-off; there is no stream present.

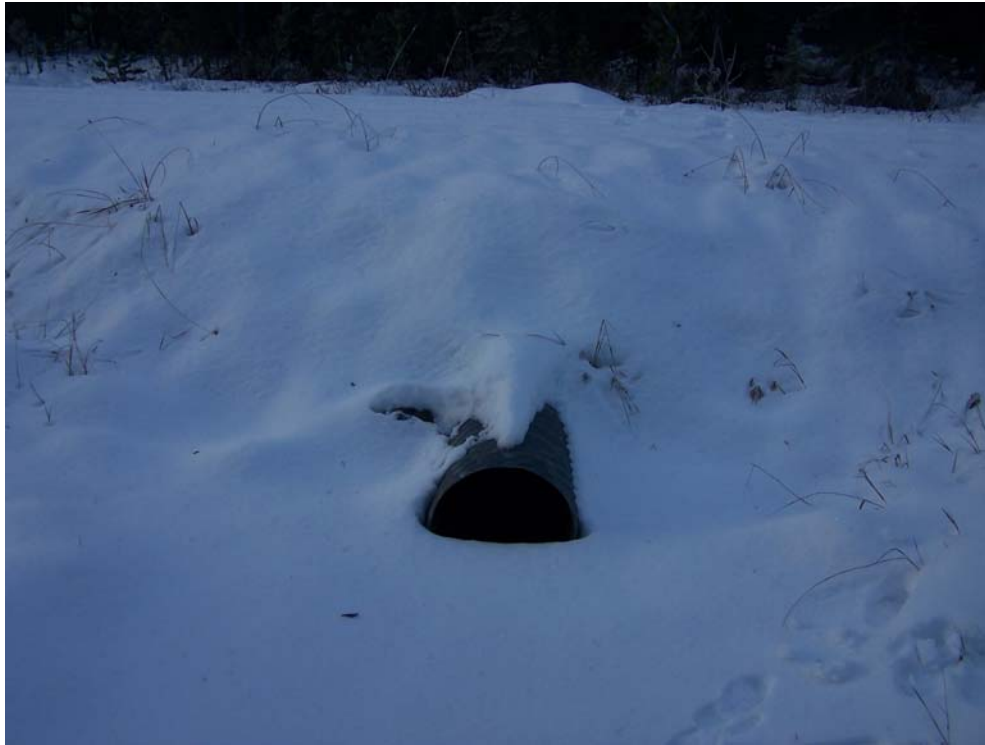
Downstream view of the culvert inlet; there is no scoured stream channel or even flowing water at this location.
