**BULKLEY/FULTON WATERSHED
FISH PASSAGE CULVERT ASSESSMENT PROGRAM**

January 12, 2010

Ecofor Consulting Ltd.
PO Box 1270
Fort Saint James, BC
VOJ 1P0
(250) 996-2151

EPN 2009-2029-001

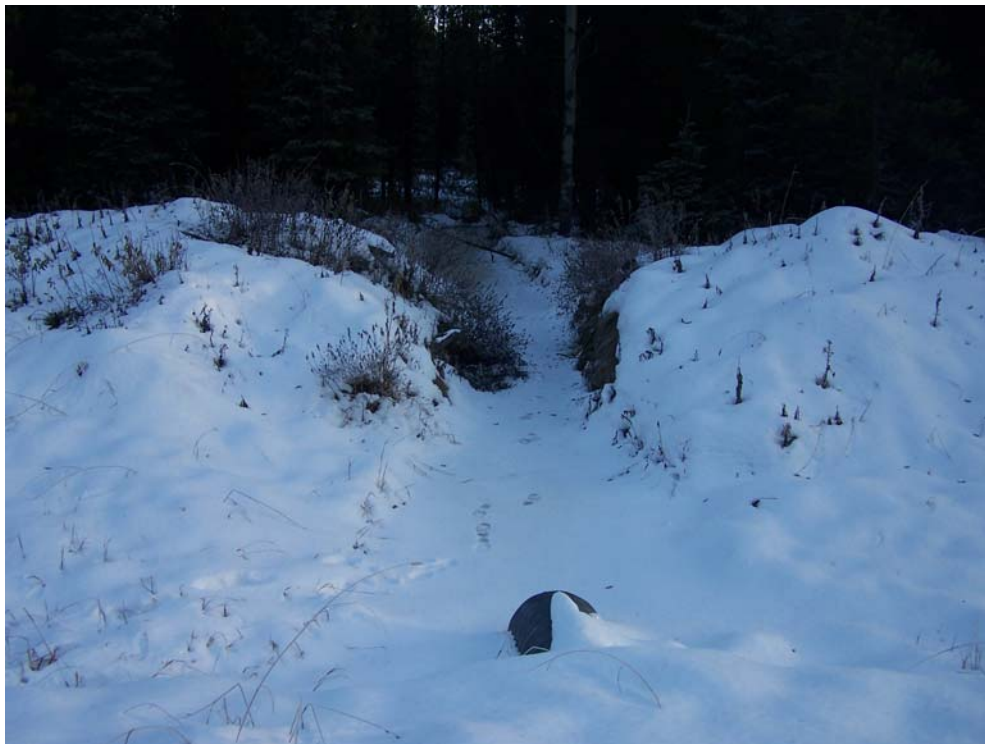
To the north of the road there is a man-made ditch that transports ditch run-off to a wet opening 30-40m from the road.

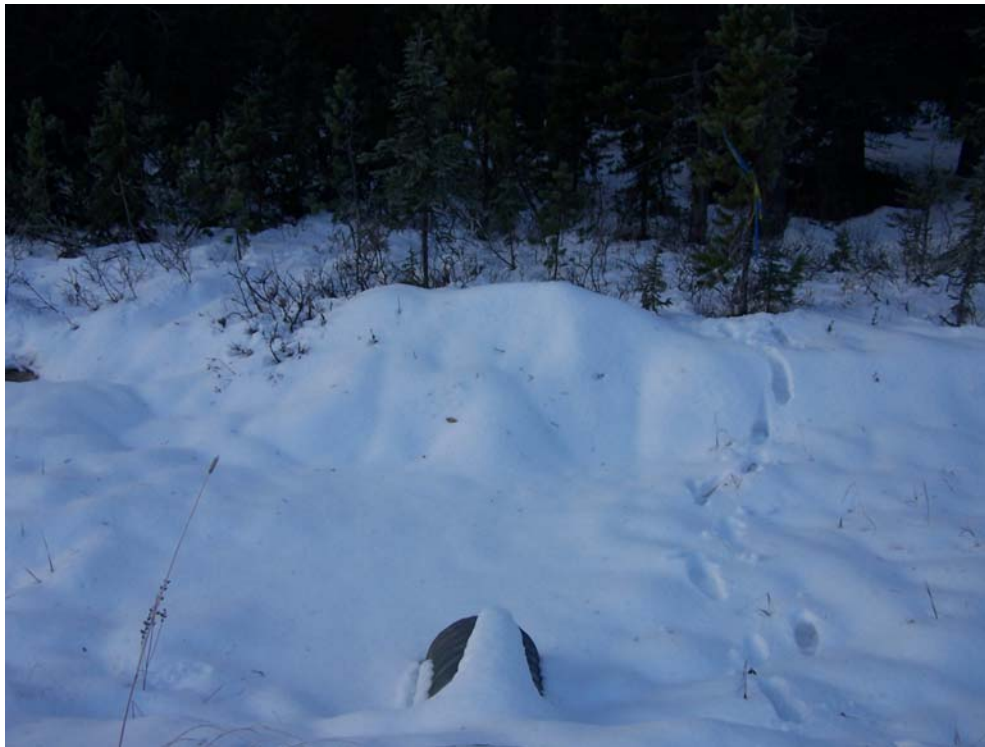
There is no scoured stream channel or signs of any flowing water upstream of the culvert inlet. This culvert conveys ditch flows.

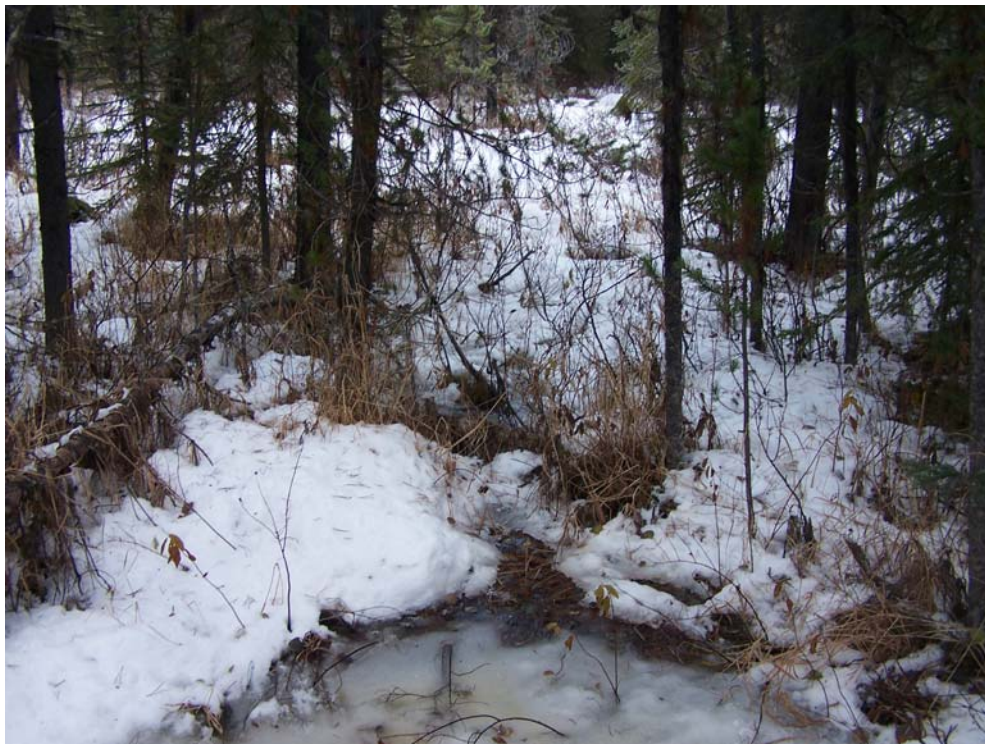
Small accumulation of run-off at the end of the man-made ditch; ditch runs north of the road out into wet swampy opening.

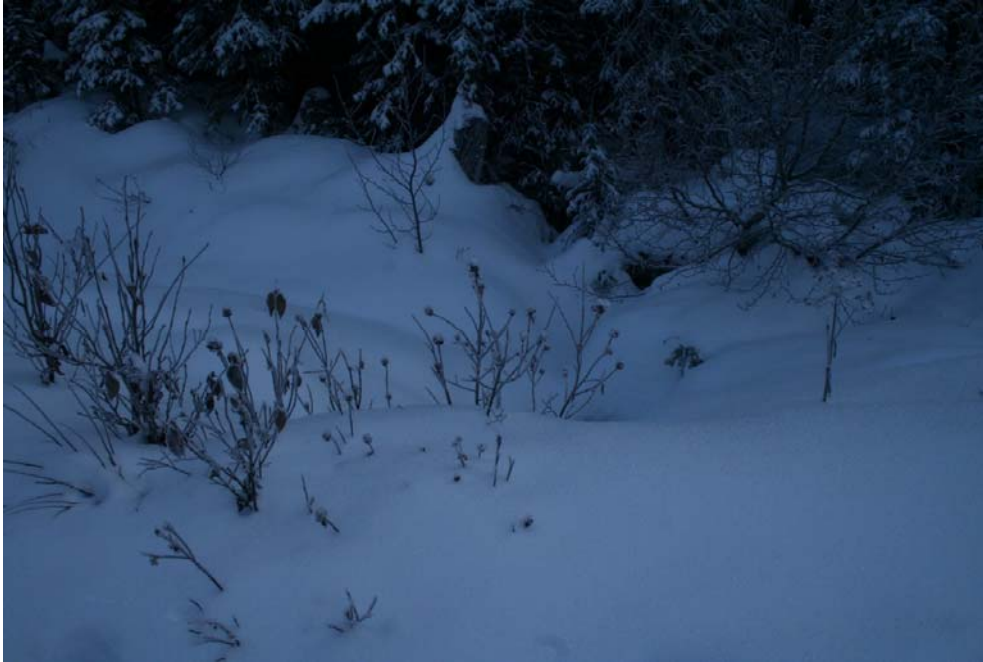
Representative habitat found upstream of the culvert.

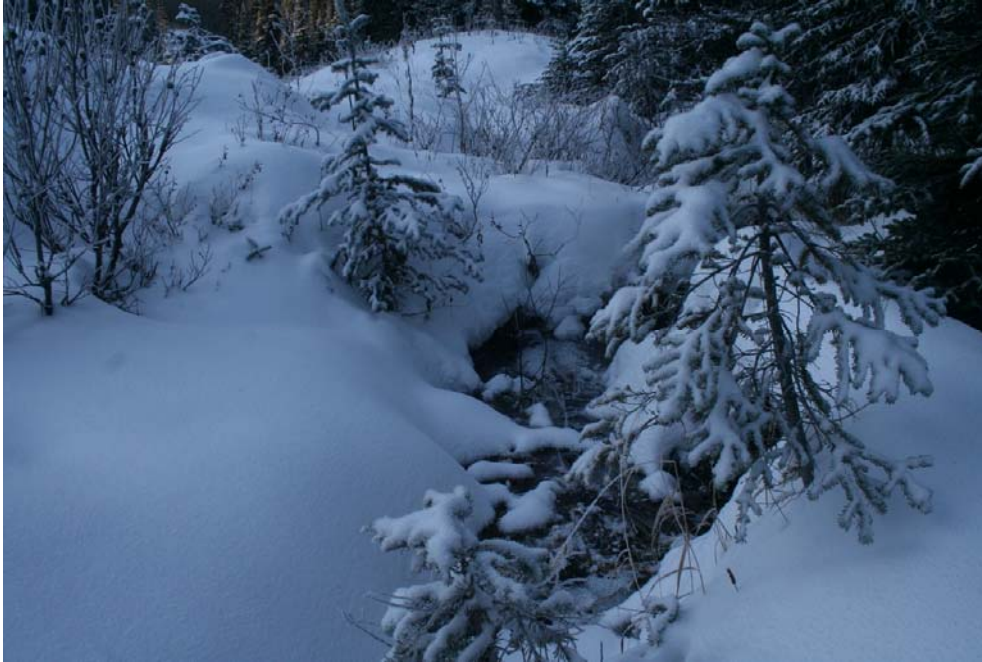
Representative habitat found downstream of the culvert.

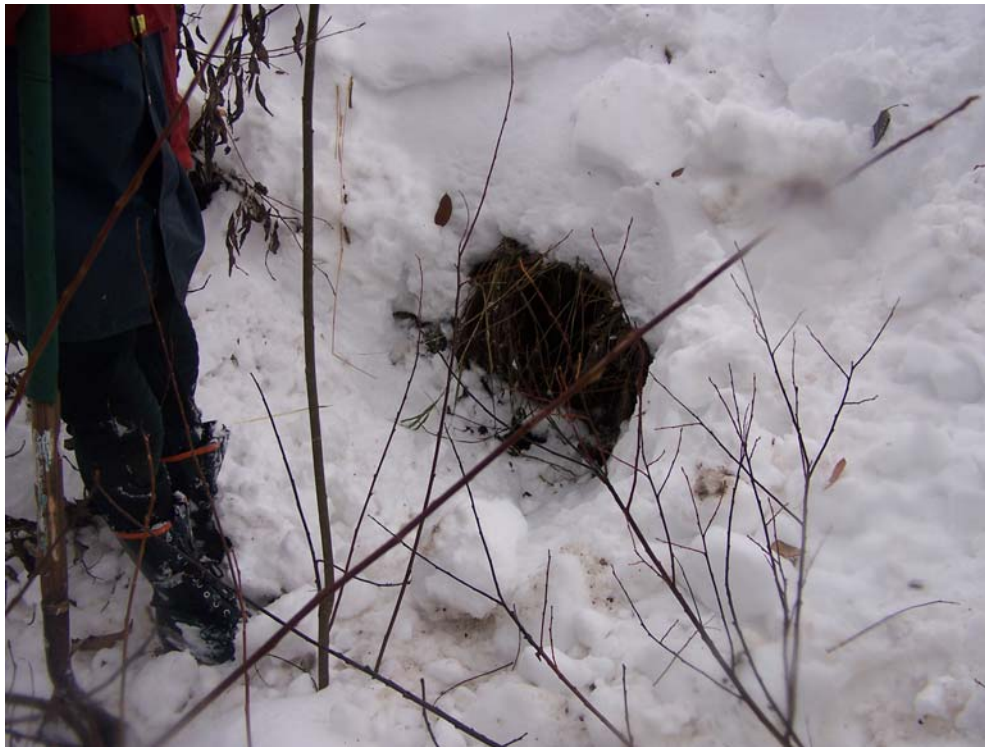
Culvert inlet is overgrown with no sign of any stream at this crossing. Culvert only conveys some ditch flows and runoff from the surrounding cut-block.

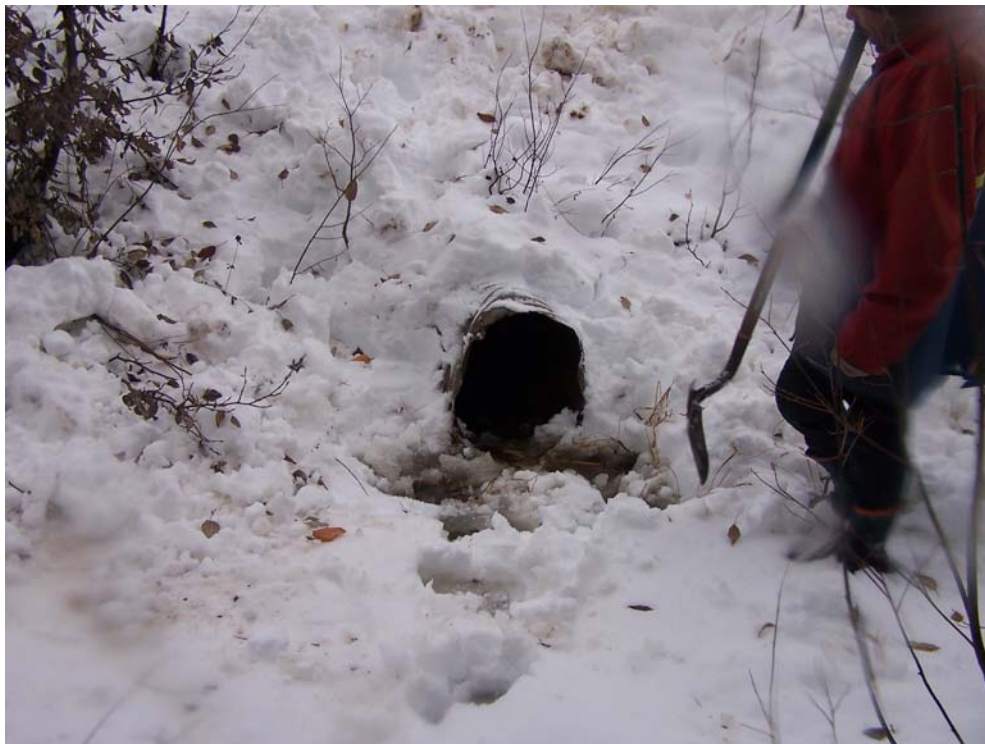
Culvert outlet has a small accumulation of runoff in front of pipe, but there is no stream at this crossing location.

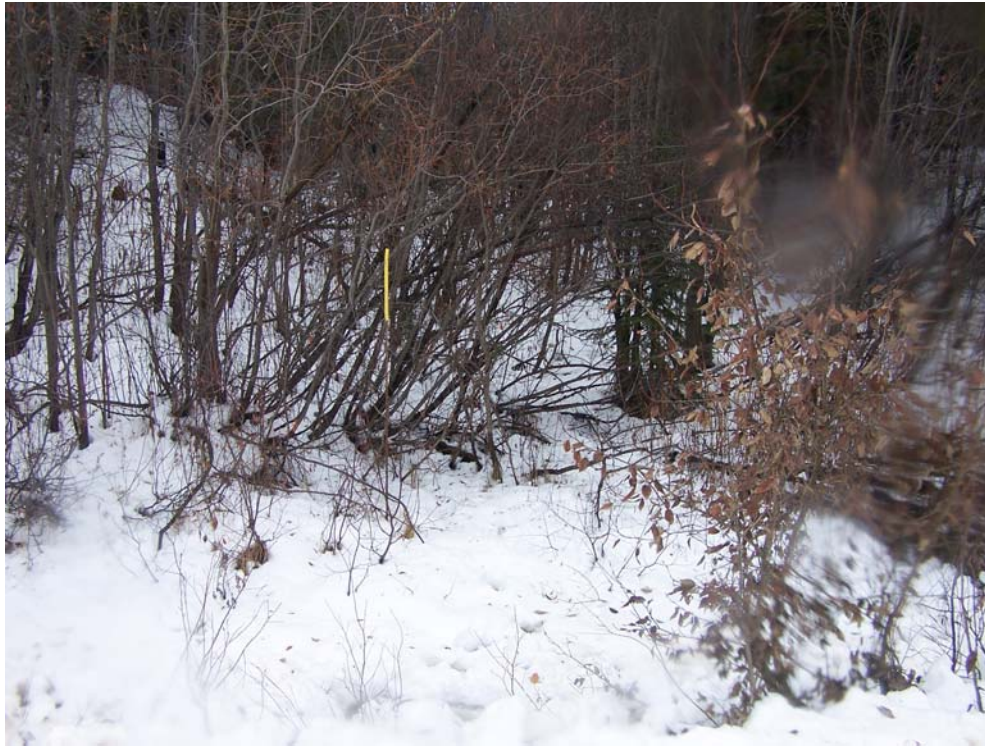
Uphill of the road there is a defined gully in a regenerating pine cut-block. The gully collects some runoff and concentrates some overland flow, but there is no sustained scoured stream channel present.

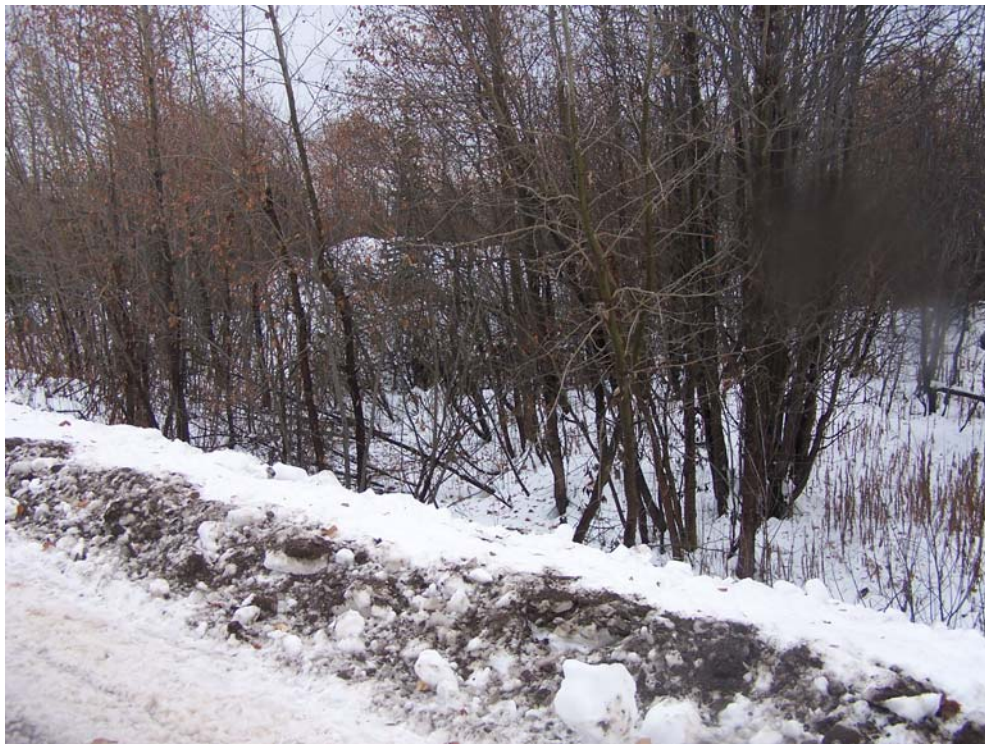
Downhill of the road there is a slight gully in the regenerating cut-block, but no signs of any flowing water or a scoured stream channel.

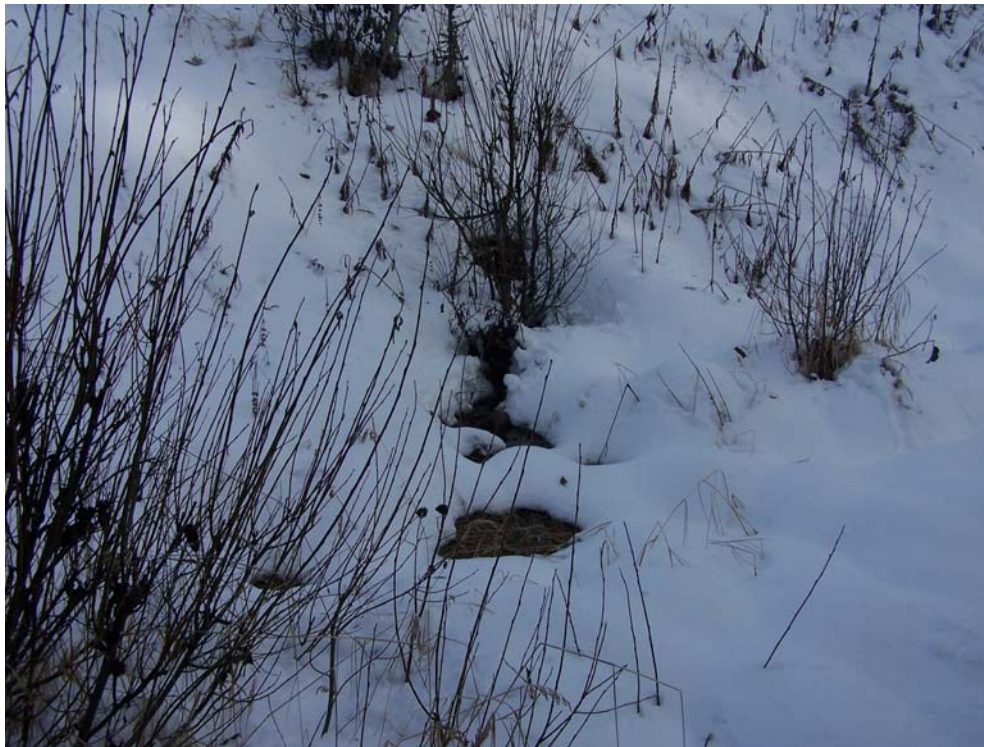
There is no stream at this culvert crossing; culvert inlet is almost totally overgrown (just visible behind willow). Low lying area collects run-off and seepage before moving through culvert.

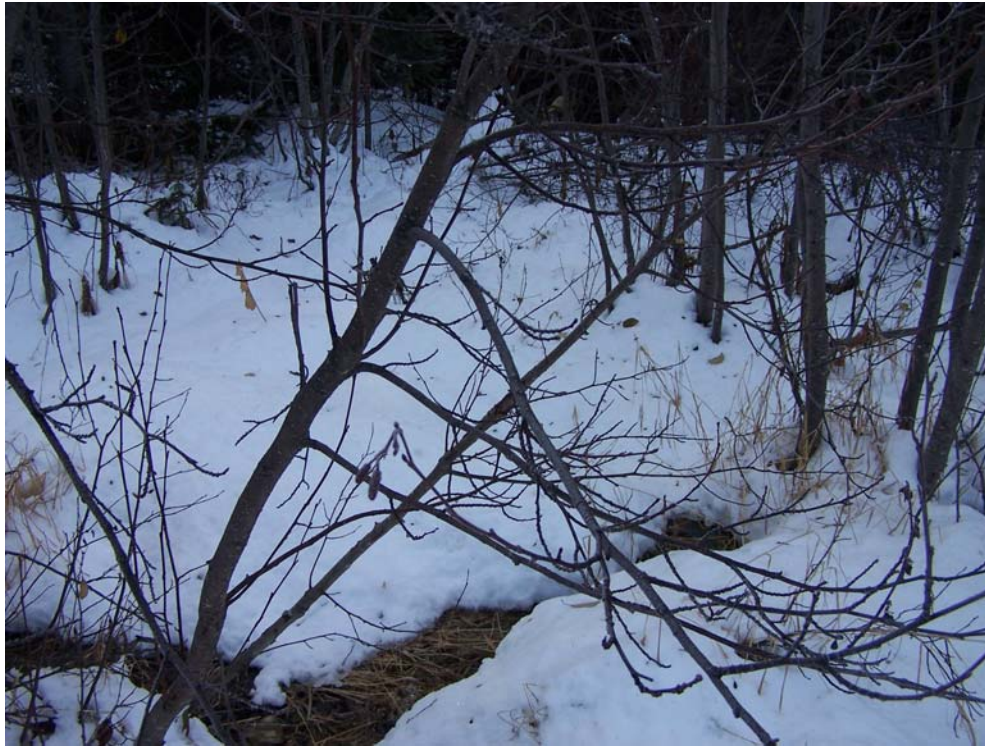
Upstream of the culvert there is no evidence of any flowing water or a scoured stream channel.

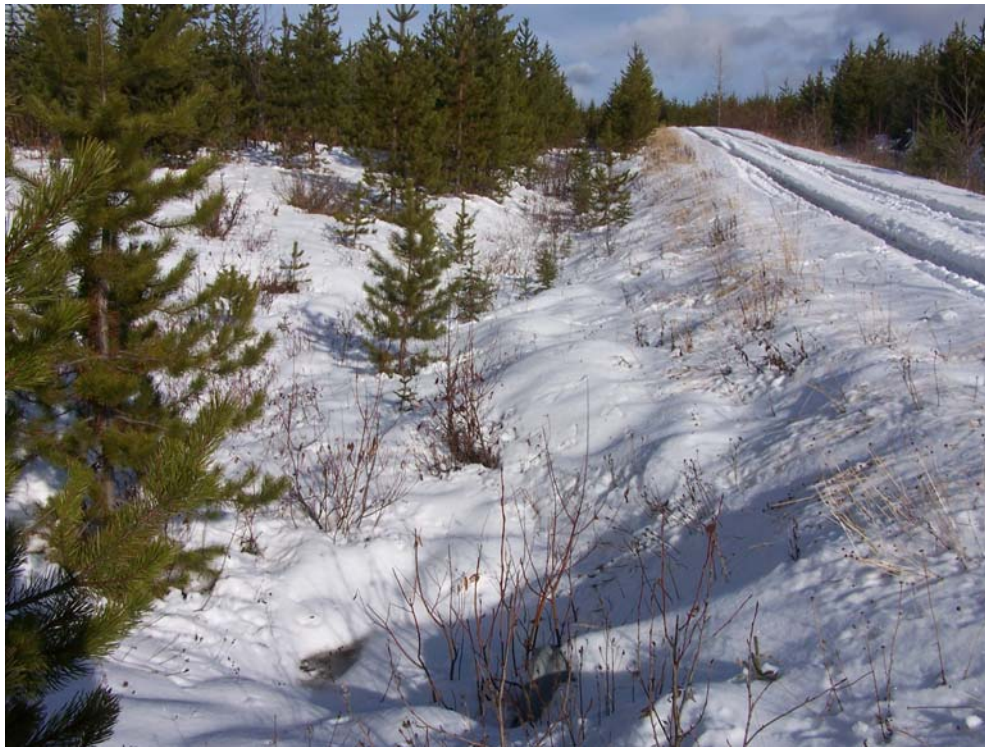
There is no stream entering into this culvert inlet; culvert handles ditch-line run-off.

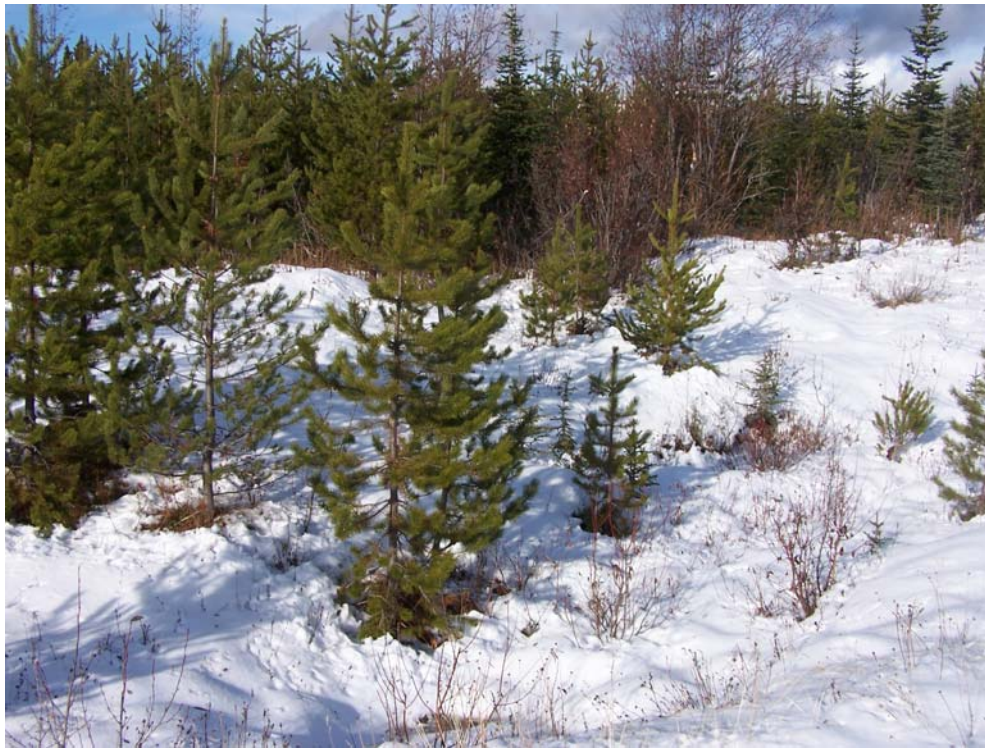
There is no sign of flowing water or scoured stream channel at this culvert crossing location. Any stream would be apparent in this 10-20 year old cut-block.

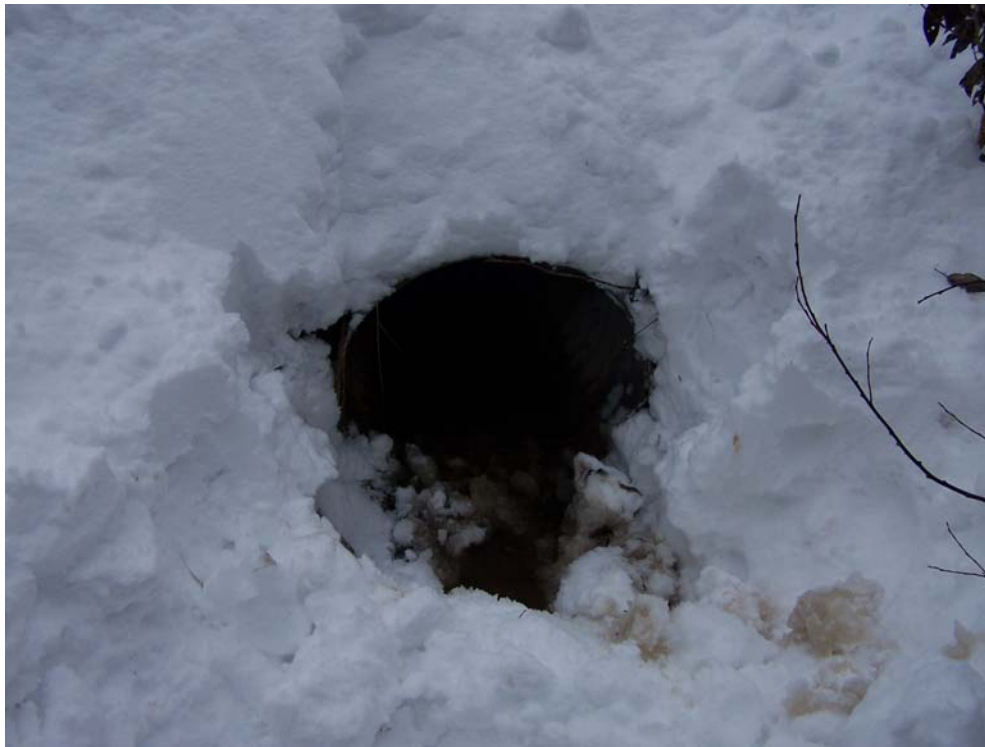
Downstream view of culvert inlet, small watercourse does not generate large water flows. Majority of the flows are during freshet and early summer, minimal water flows at this time.

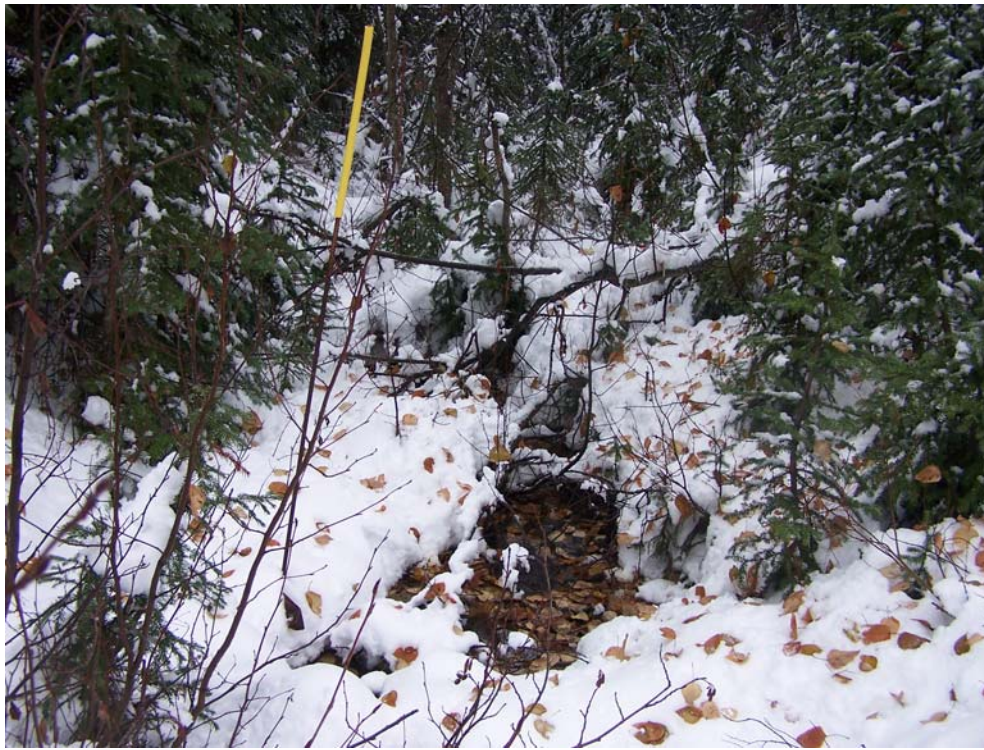
Upstream of the crossing the channel is confined in a small gully. It is a small stream and only offers rearing potential for fish stocks, there is no deep pool habitat for overwintering or gravels for spawning.

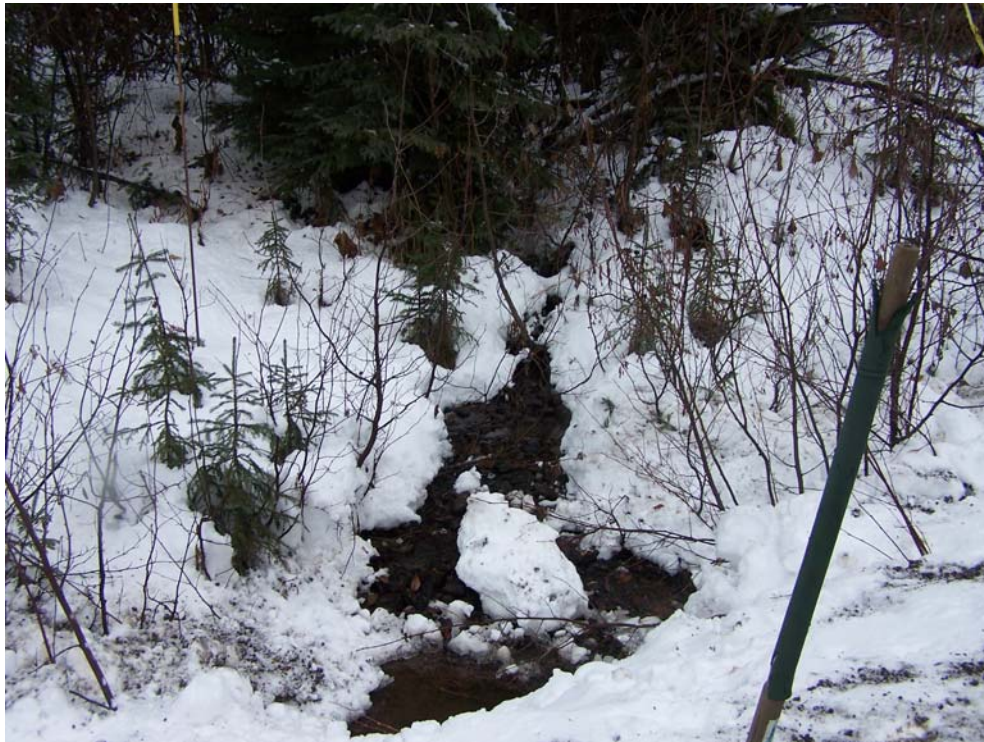
There is a scoured stream channel downstream of the culvert outlet. There is low fish habitat potential in such a small watercourse.

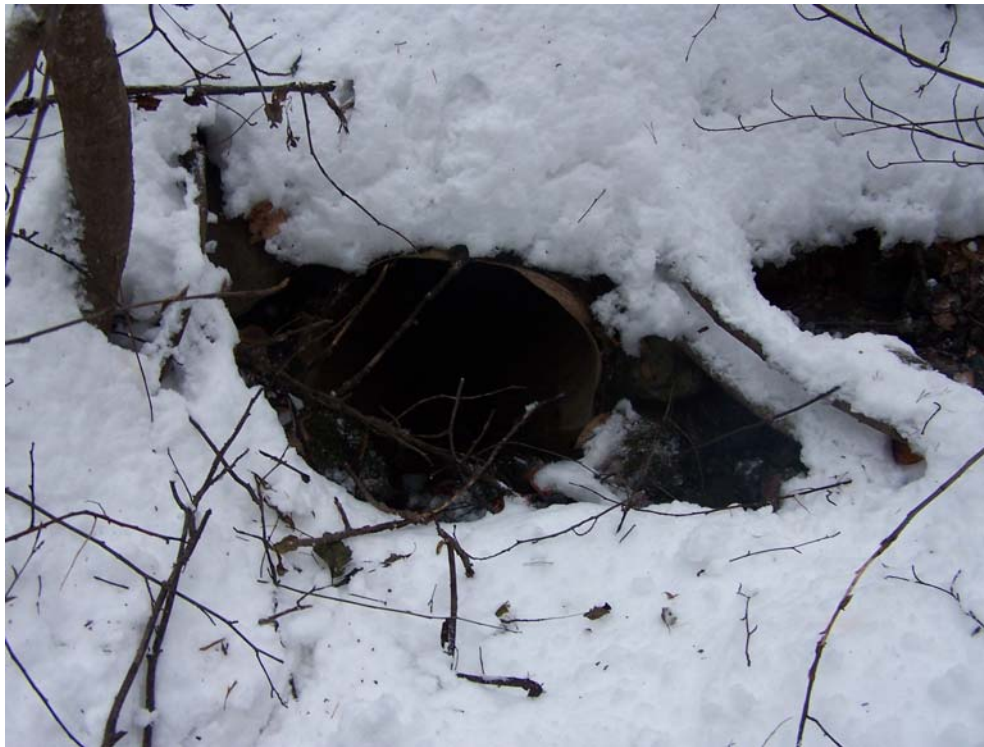
Downstream view of culvert showing flowing water from ditch-line. These flows are from the gully which is further south of the crossing; the second gully that runs directly into the culvert has no run-off flows at this time.

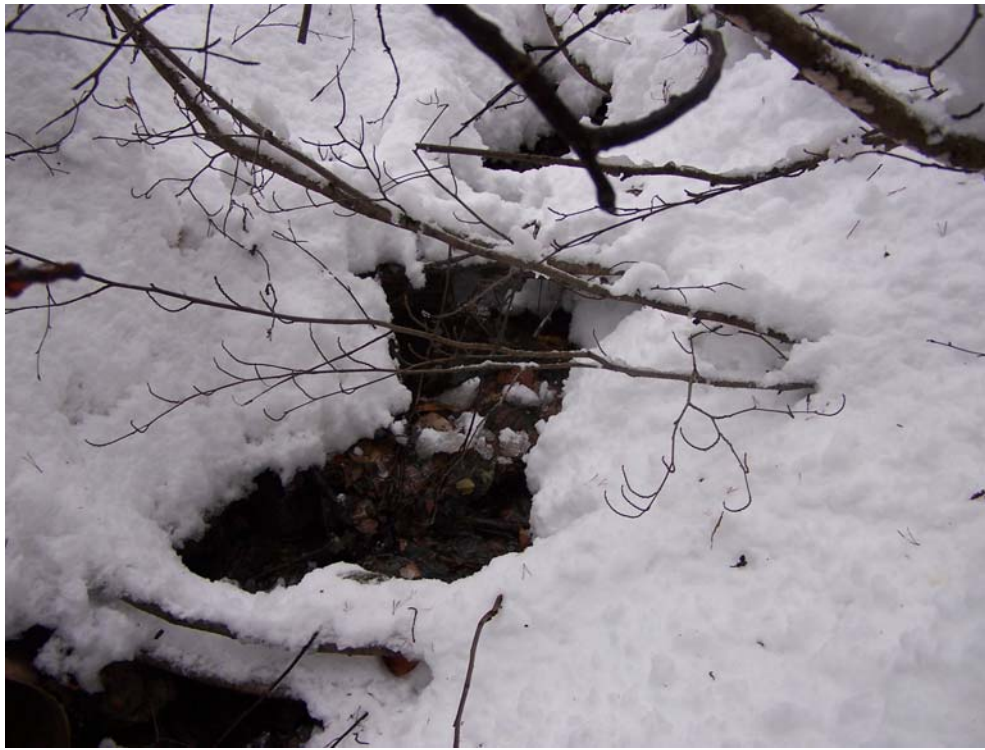
Upstream of the crossing there are two gullies that contribute run-off. The scoured channel from flowing water extends between 50 and 70m uphill in both gullies before there is no sign of flowing water.

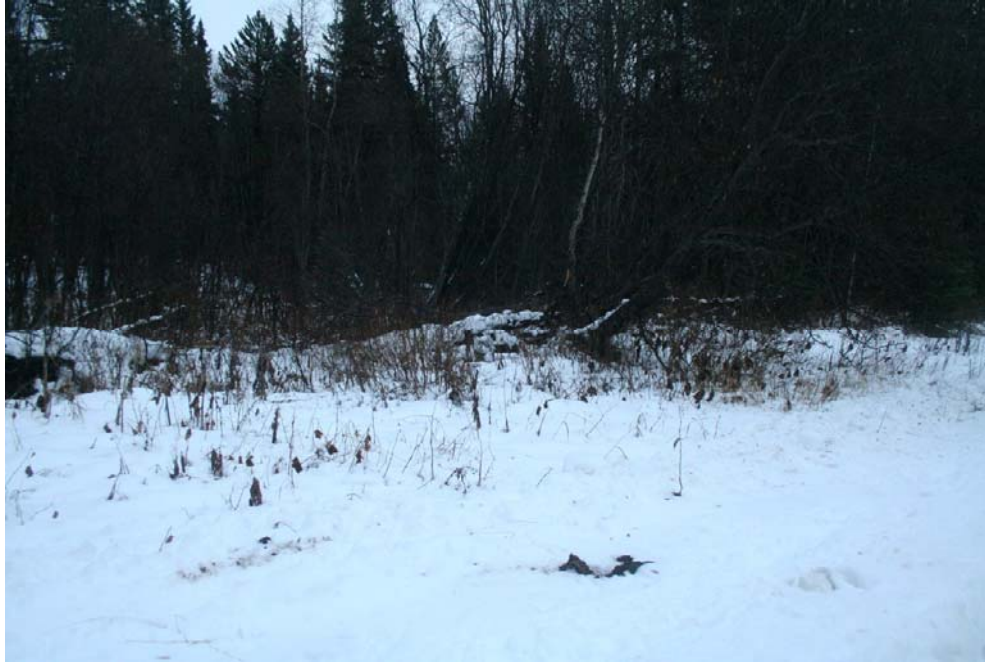
View downstream. No culvert found at this location.

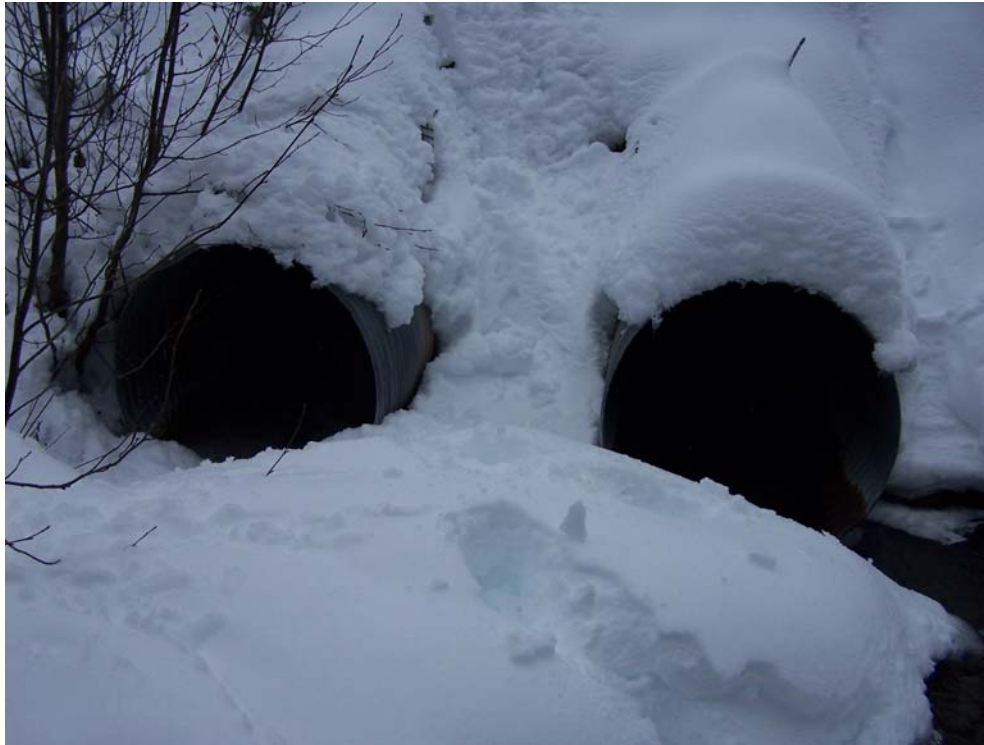
Downstream view of culvert inlets; culvert on right transport majority of stream flows except during freshet or high run-off events. The culvert on the left is set at a higher elevation and is presently dry.

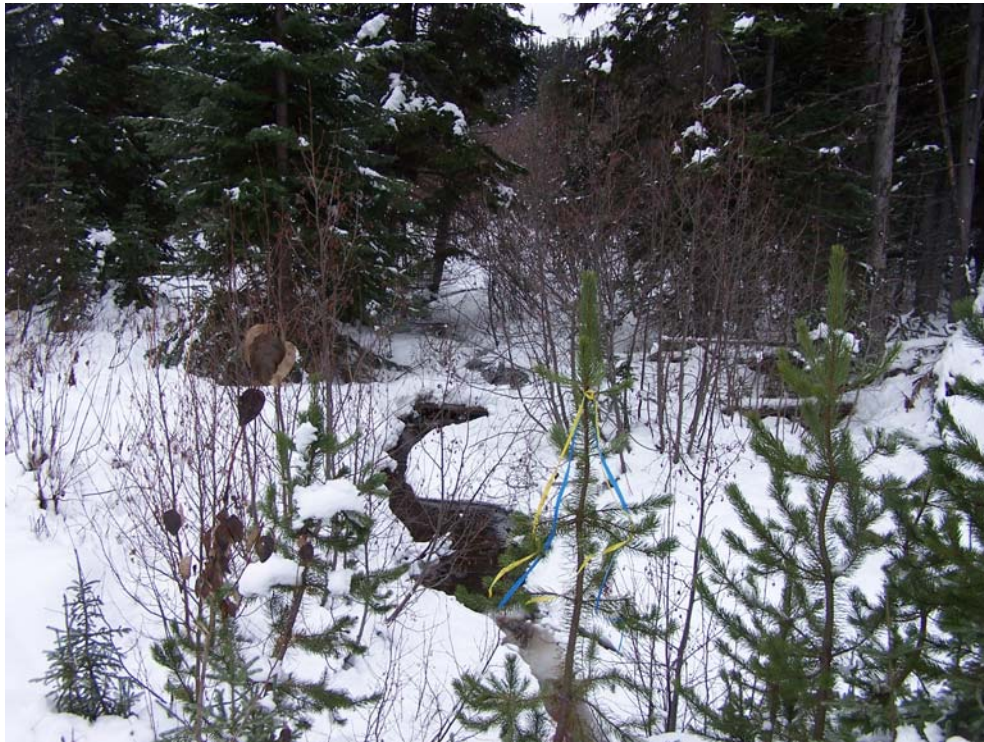
Looking downstream from the road crossing, the stream immediately enters a wetland traveling downstream to a wetland waterbody (≈500m).

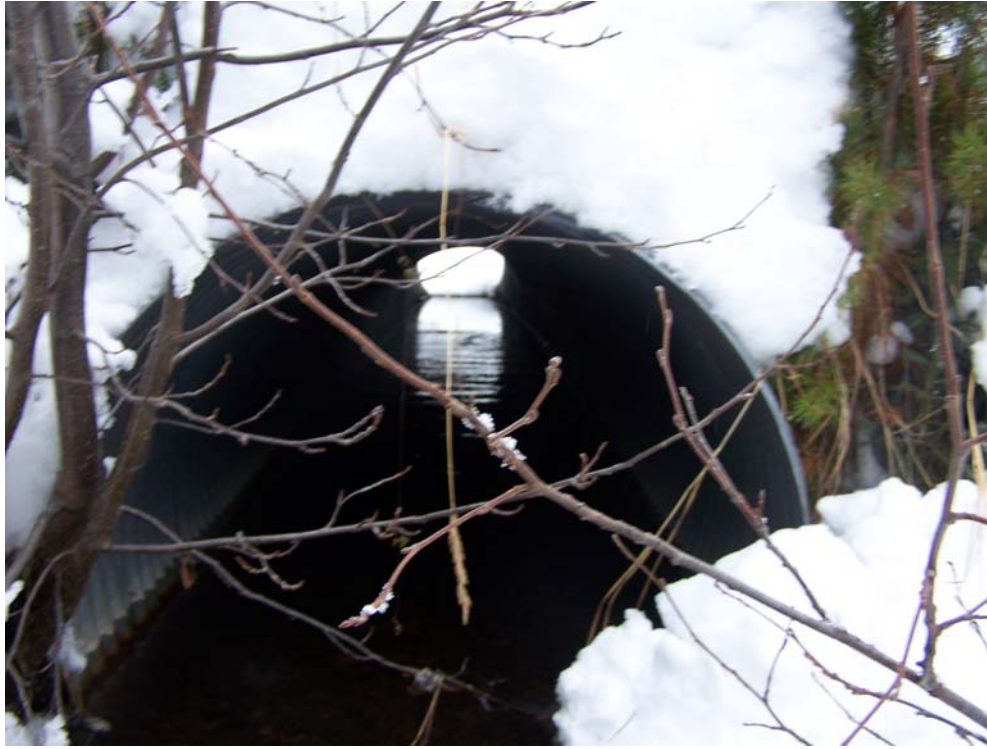
Looking upstream through the barrel of the primary culvert, there are no obstructions in the culvert that would hamper fish passage upstream in this structure. Culvert gradient is minimal creating no apparent velocity barrier.

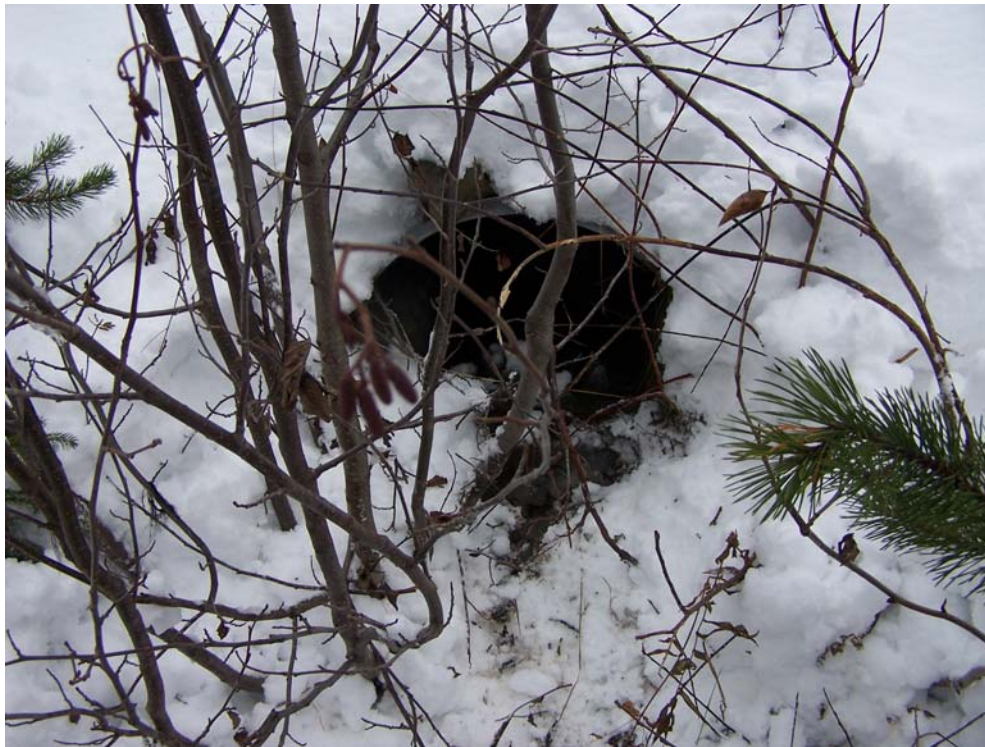
View of heavily overgrown culvert inlet, there is a stream present with clean washed cobbles in front of the inlet.

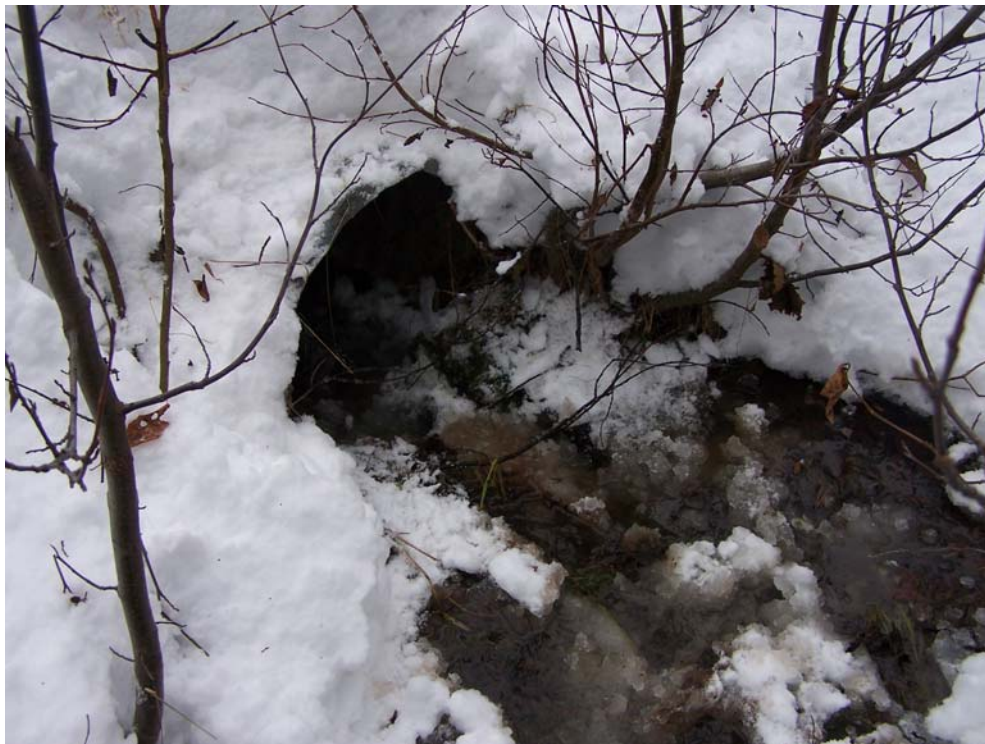
Upstream view of culvert outlet with a small outfall pool. Whole site overgrown with willow and regenerating forest.

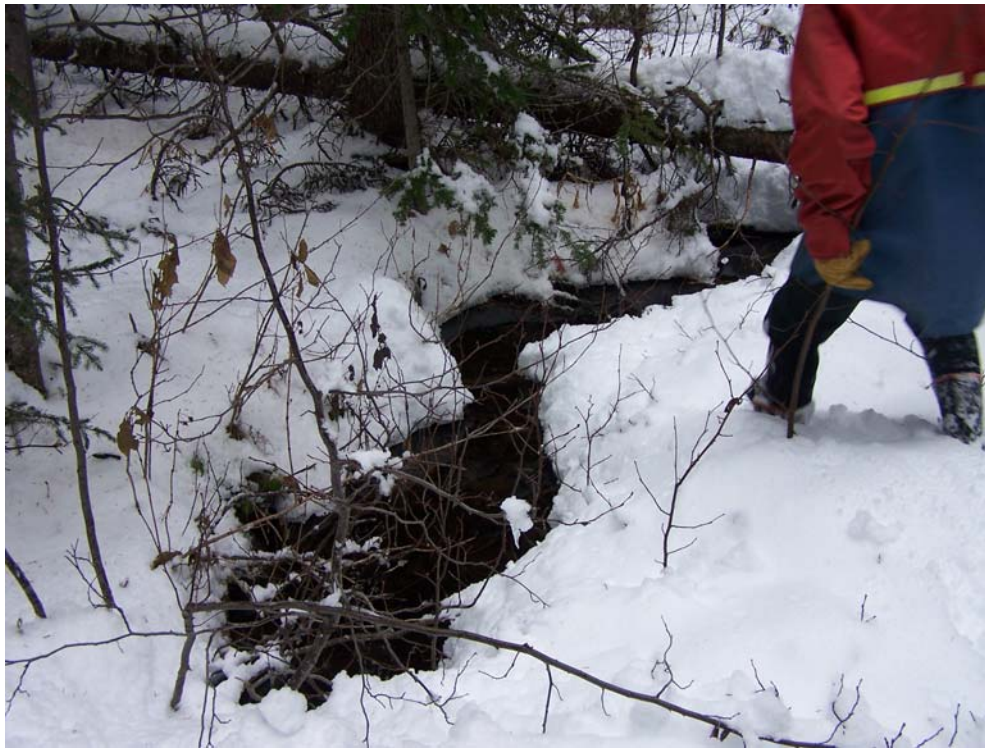
Upstream of the culvert there is a scoured channel present. It is a small watercourse but it provides consistent run-off and has established a continuous scoured stream channel, but its' overall fish habitat value is low.

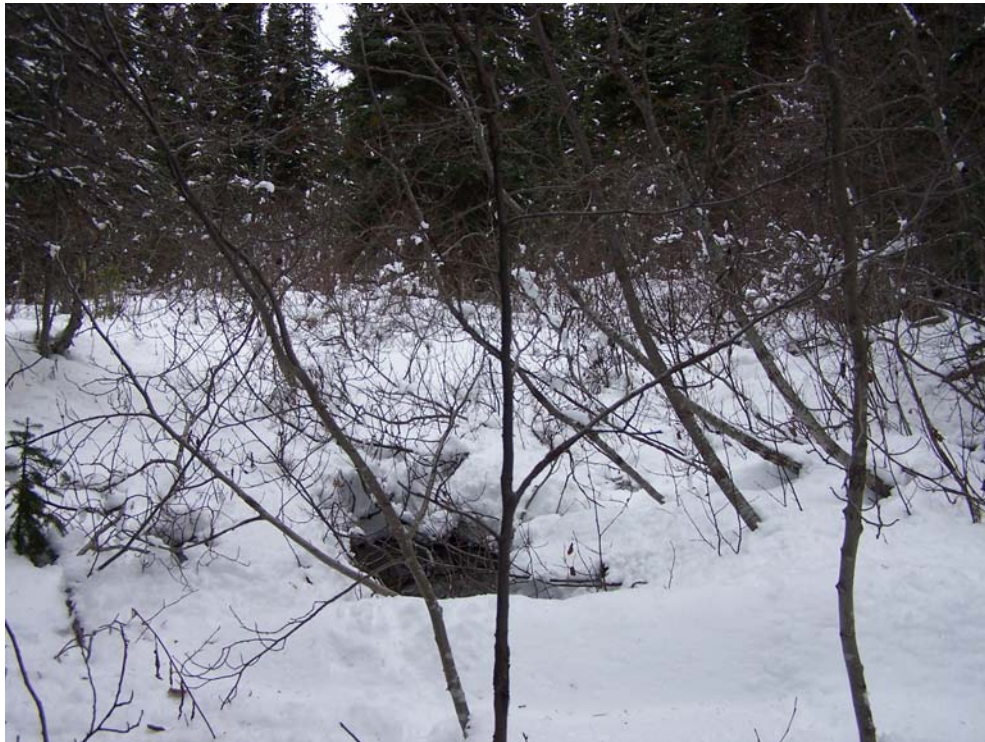
Downstream of the culvert the scoured stream channel continues through a wet willow area before entering into the spruce forest.

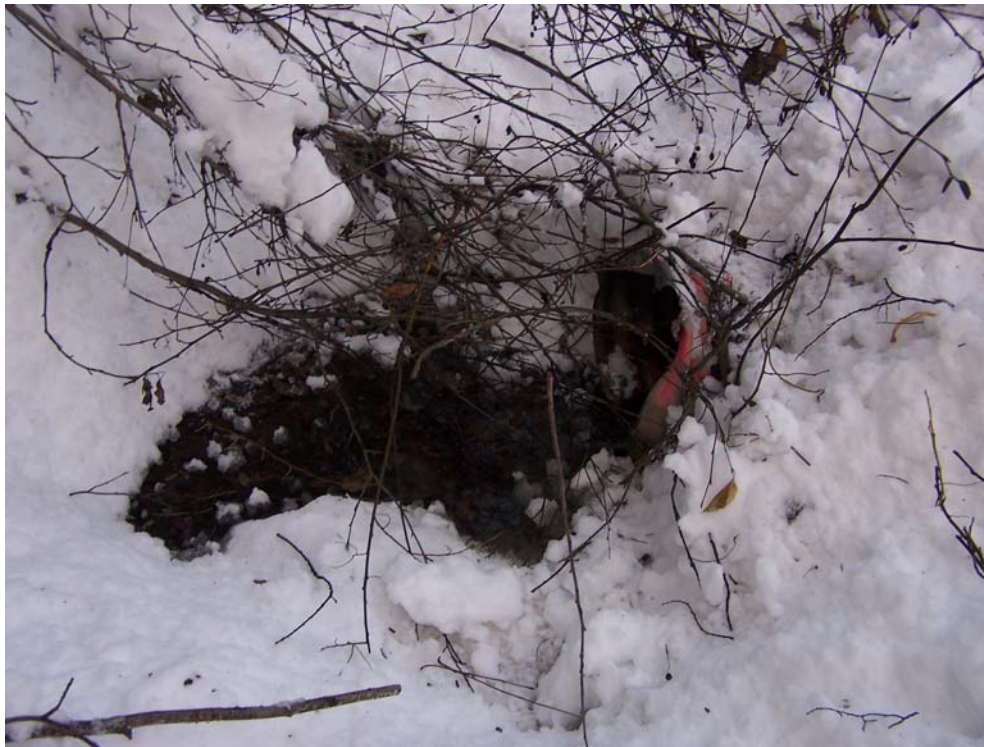
Downstream view of culvert inlet, pipe receives limited run-off during spring melt and from seasonal run-off from ditch-lines. There is no stream at this culvert crossing location.

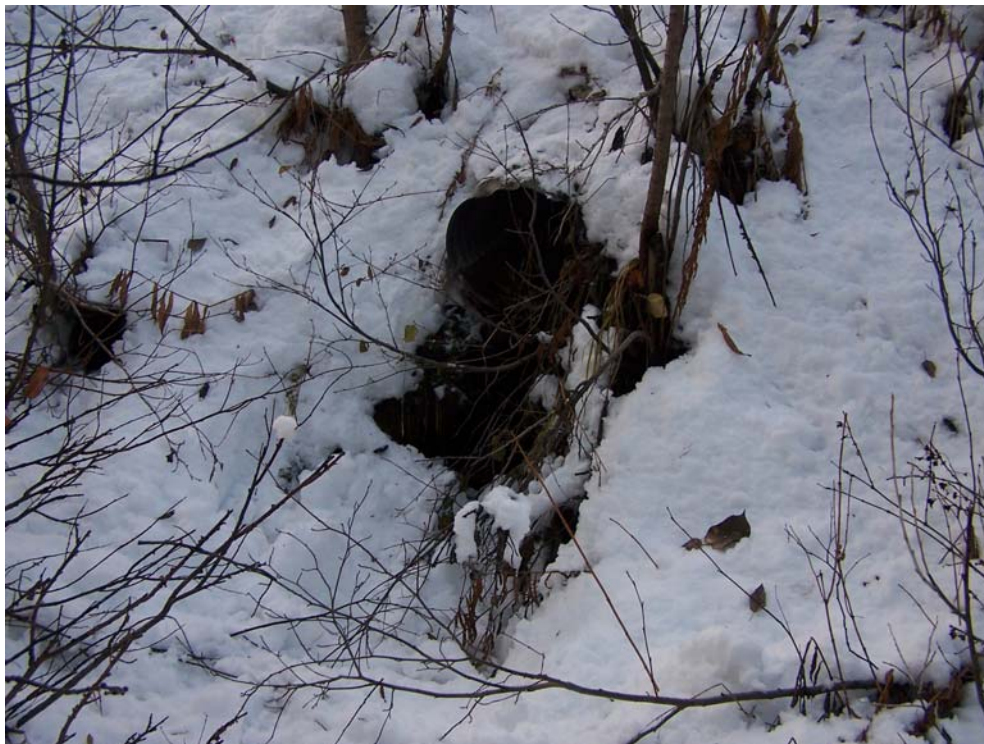
Upstream view of culvert outlet : small outfall drop and no evident scoured channel as water flows are limited and seasonal.

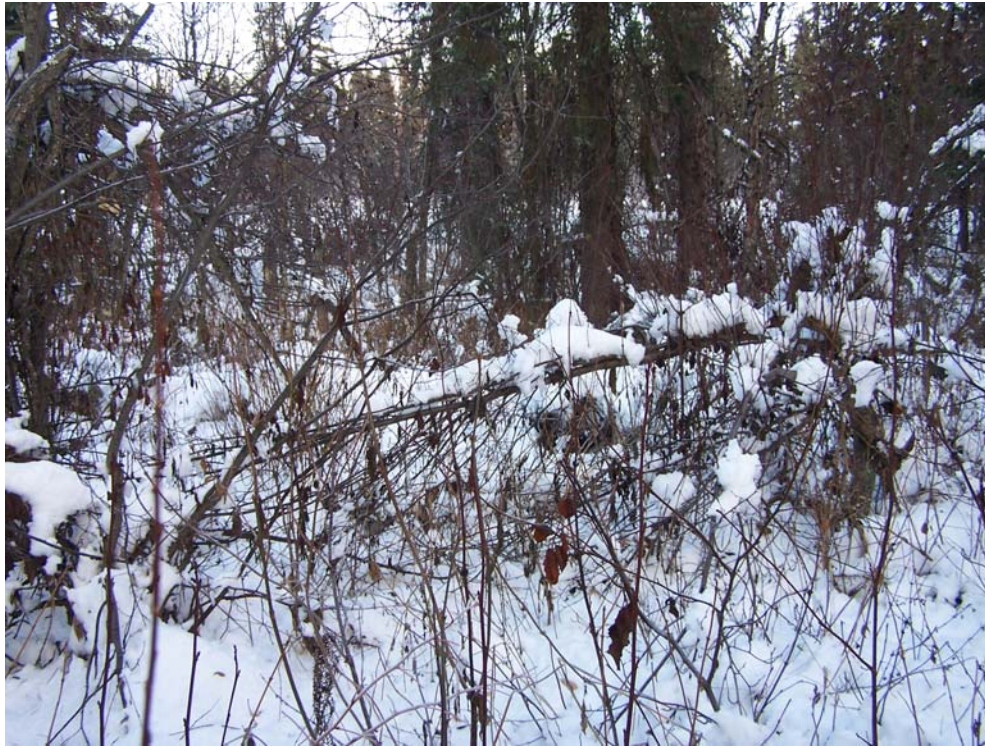
Downstream of the culvert the weak overland water flows dissipate amongst the swamp grass, willow and spruce.

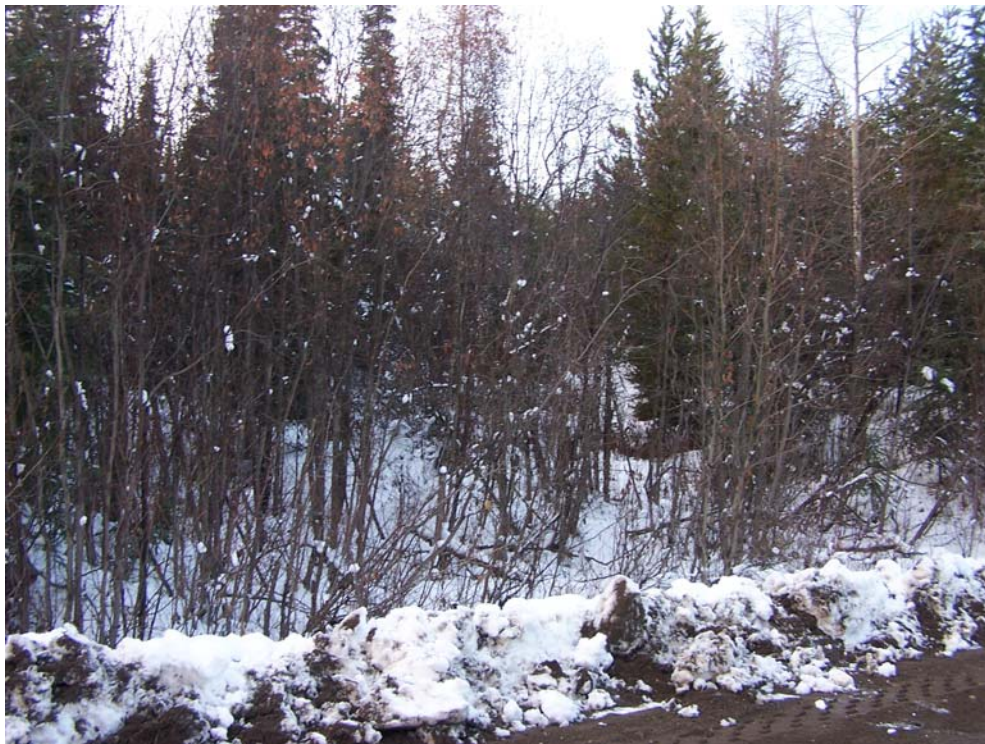
Upstream of the culvert there is a slight draw in a previously logged cut-block that collects some run-off during spring melt. There is no evidence of a stream at this culvert location.
