**BULKLEY/FULTON WATERSHED
FISH PASSAGE CULVERT ASSESSMENT PROGRAM**

January 12, 2010

Ecofor Consulting Ltd.
PO Box 1270
Fort Saint James, BC
VOJ 1P0
(250) 996-2151

EPN 2009-2029-001

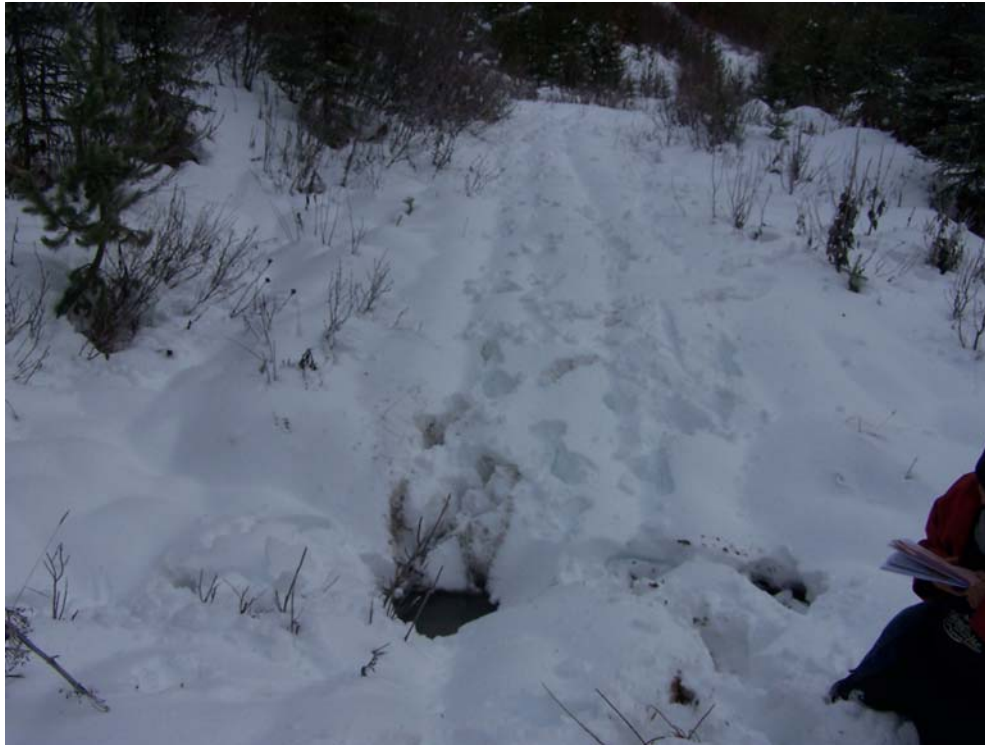
This location had a culvert at this crossing which was removed when the road was deactivated. The culvert only handled ditch run-off, as there was no stream at this location.

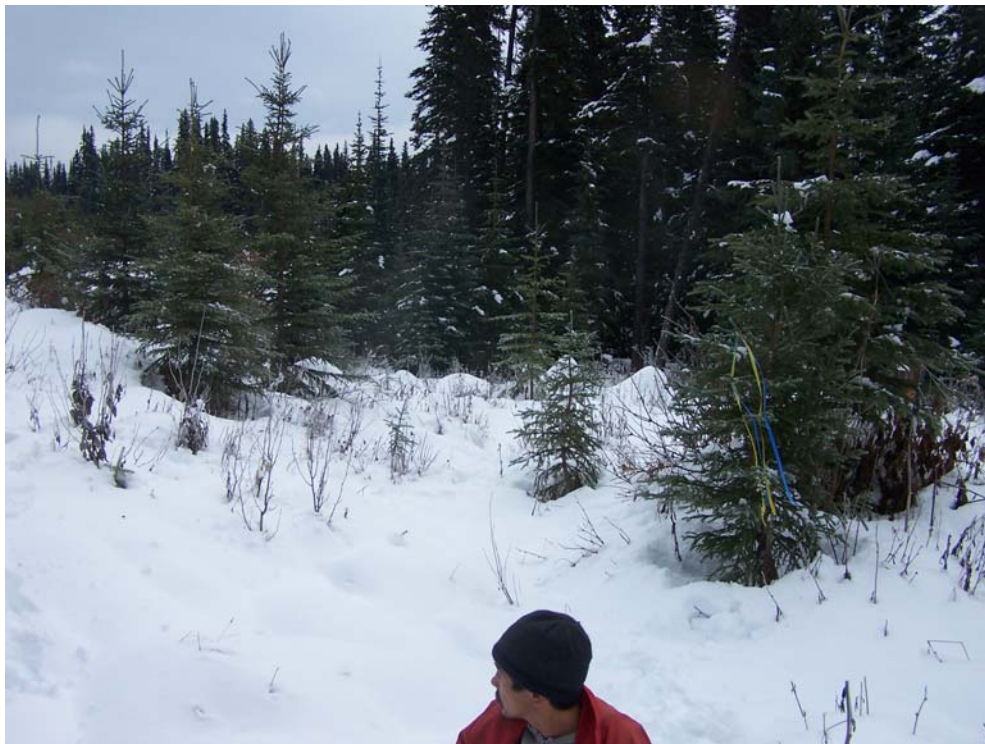
View downhill through cut-block shows no stream channel or signs of flowing water.

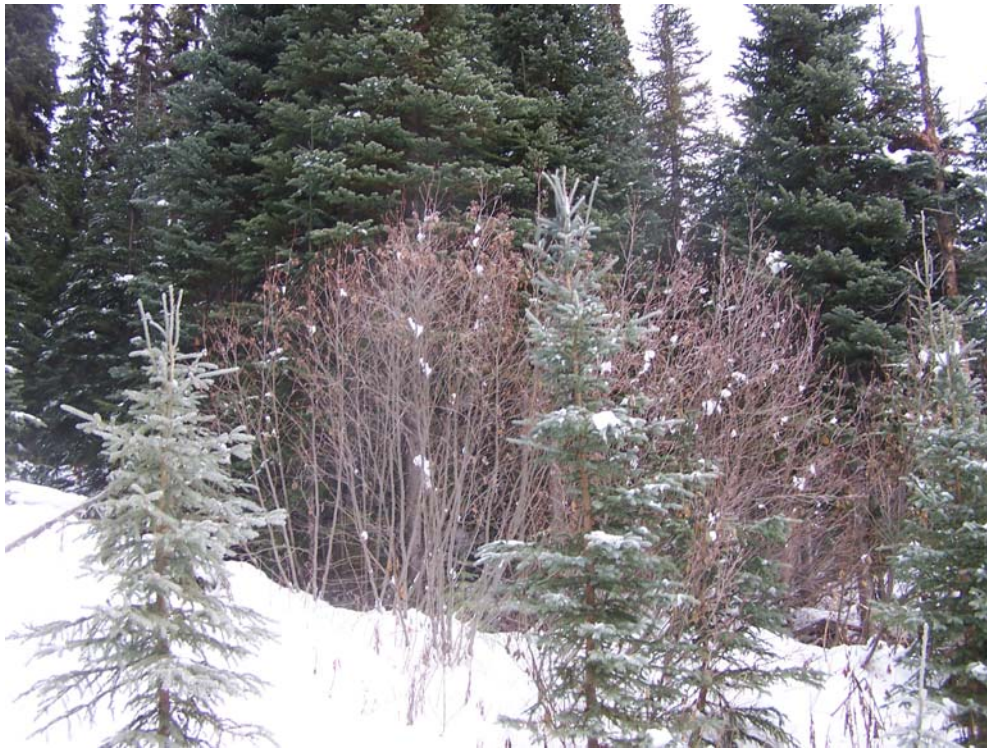
This is a mixed forest with some wet areas with a cover of willow/spruce that contribute limited amounts of run-off.

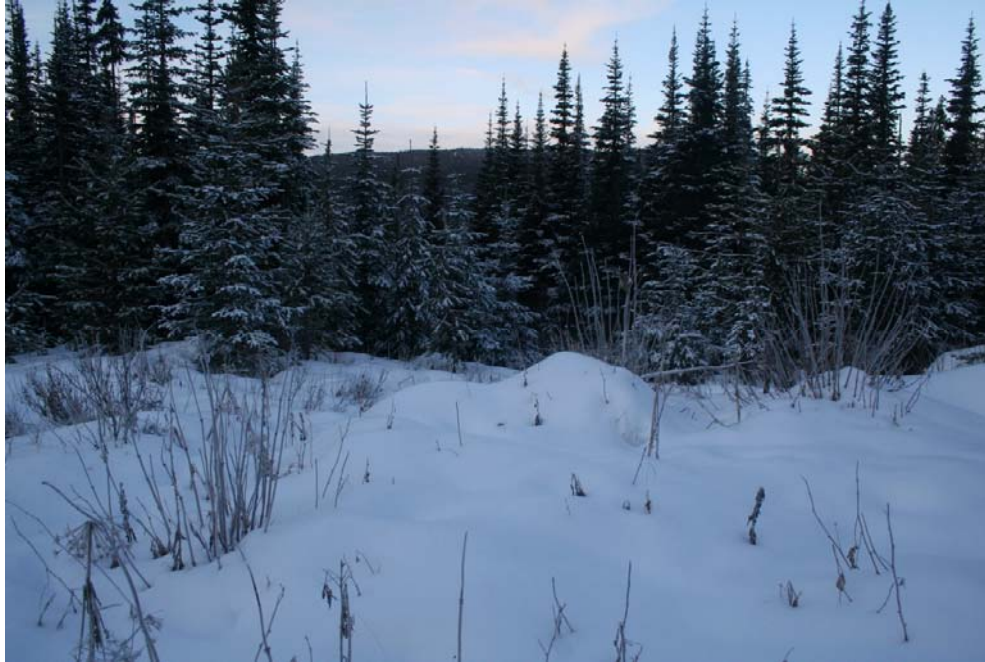
View upstream from the
deactivated crossing.

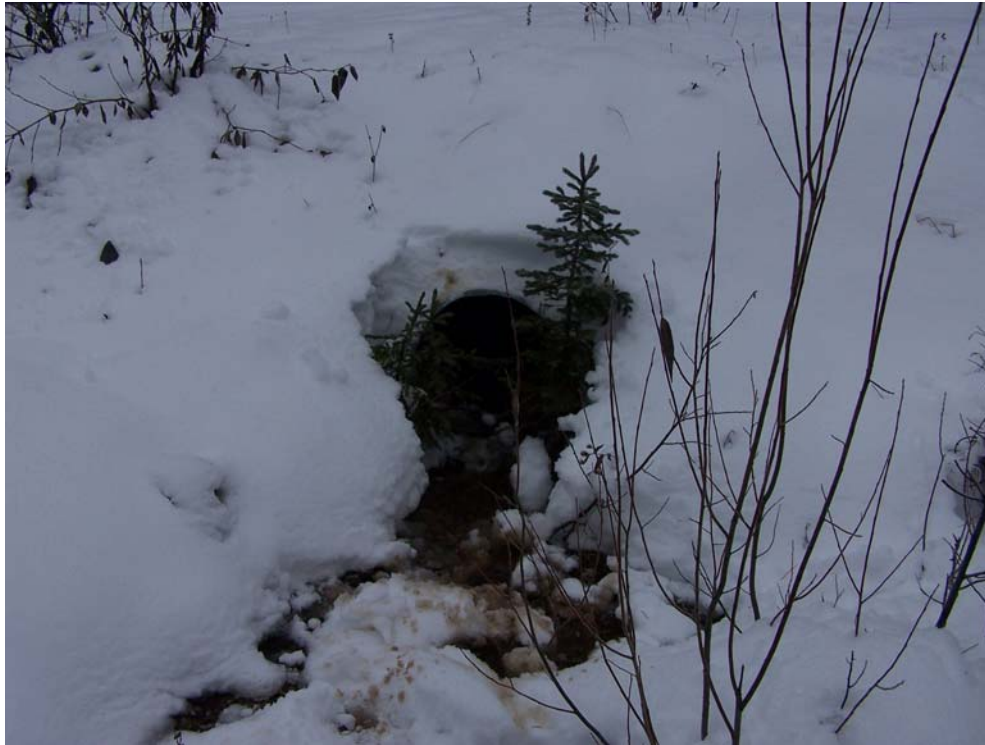
Downstream view of culvert inlet: overland water flows gather in depression before entering culvert inlet. There is no stream at this culvert crossing location.

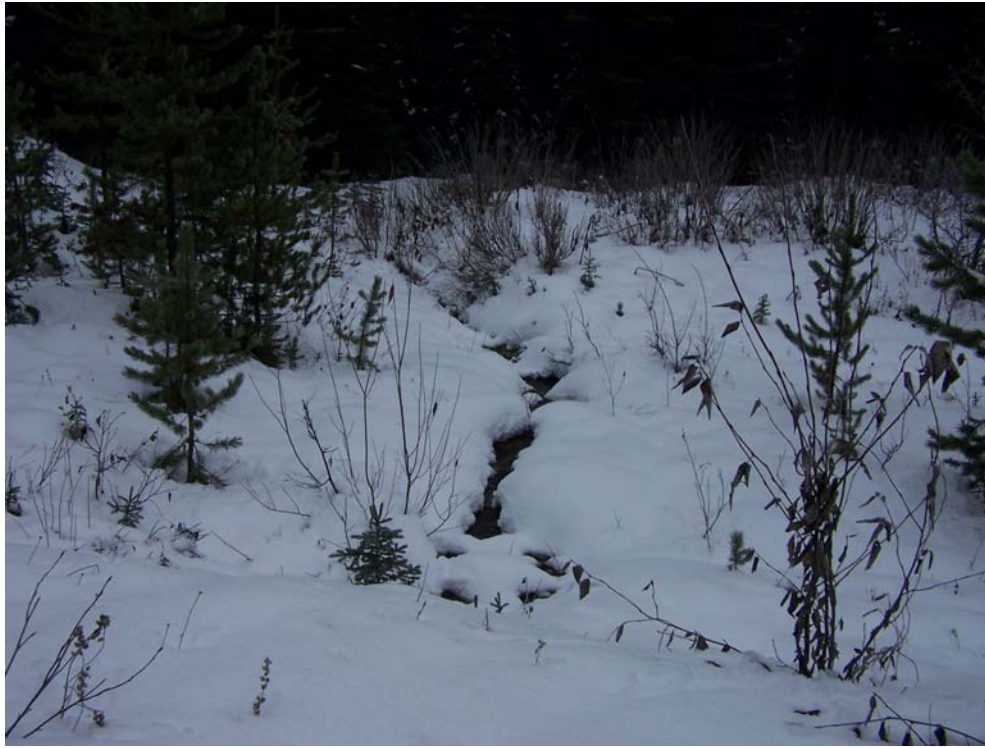
Upstream of the culvert there is a shallow gully that transports some over-land water flows to the culvert, but there is no scoured channel present.

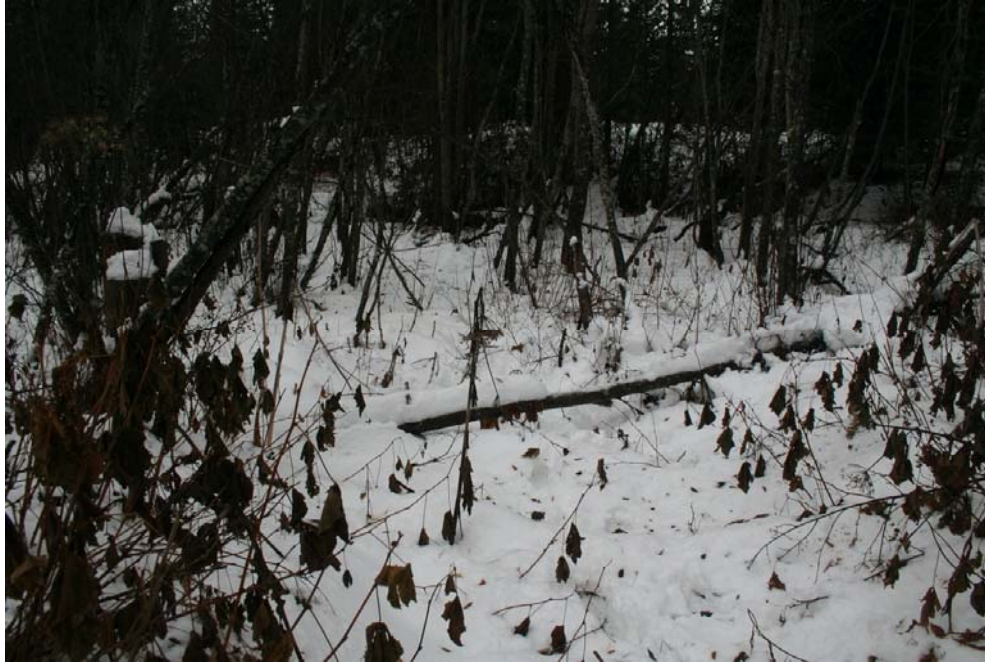
View downstream. Culvert found but no stream NVC.

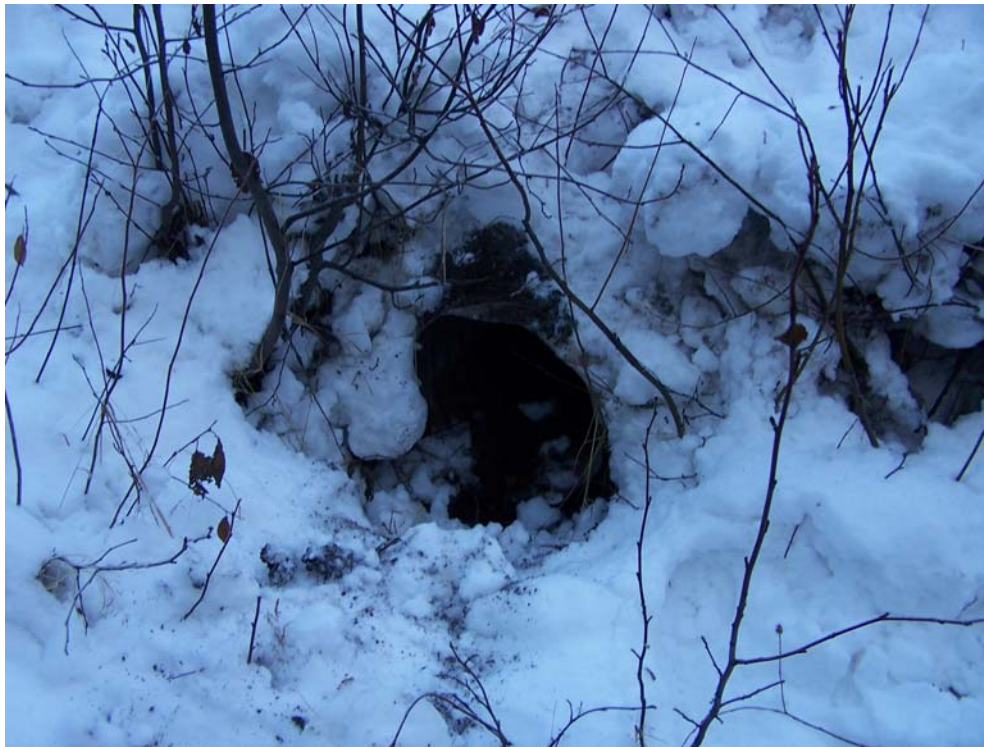
Downstream view of culvert inlet; culvert only handles ditch-line run-off and seepage out of wet willow covered draw adjacent to road.

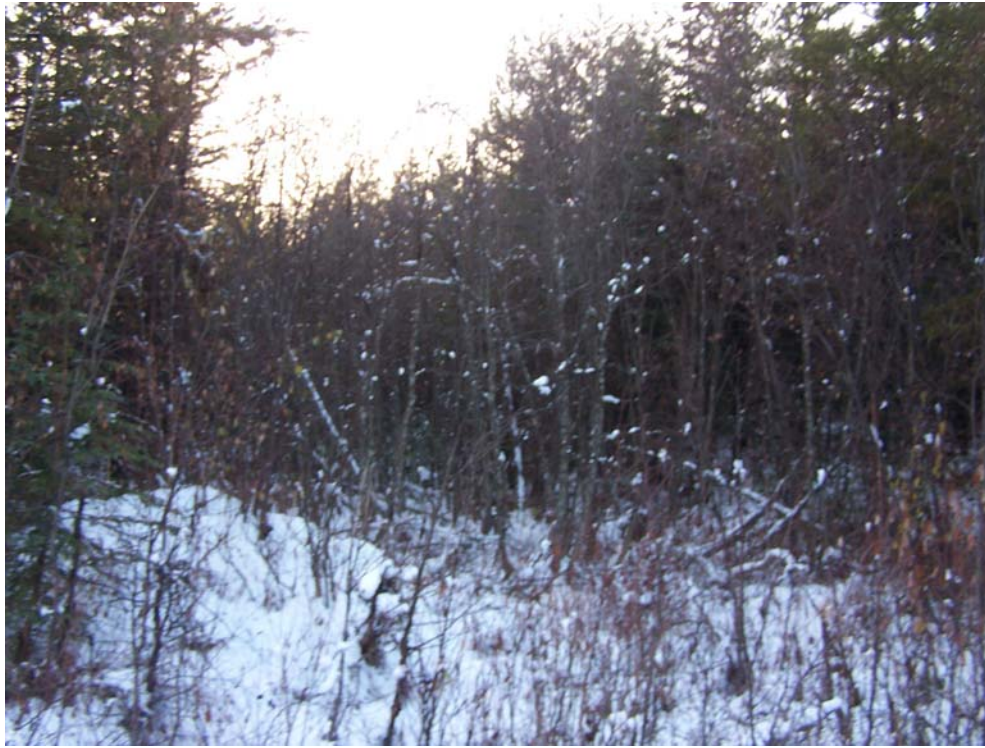
Upstream view from the culvert crossing of wet willow covered draw adjacent to road. This wet area provides seepage and slight run-off during the freshet.

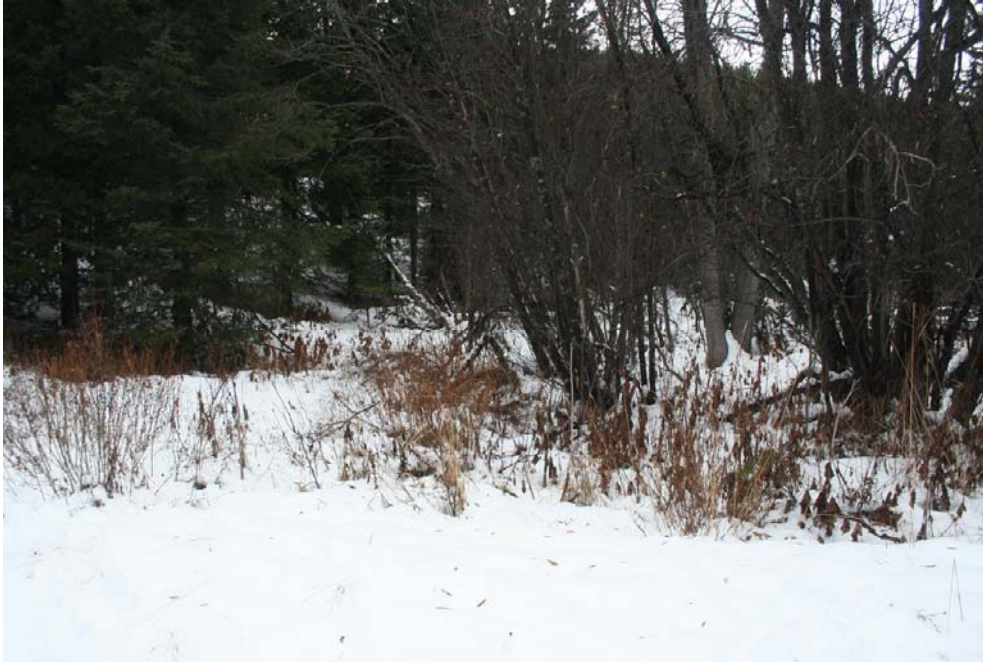
View downstream. No culvert found at this location.

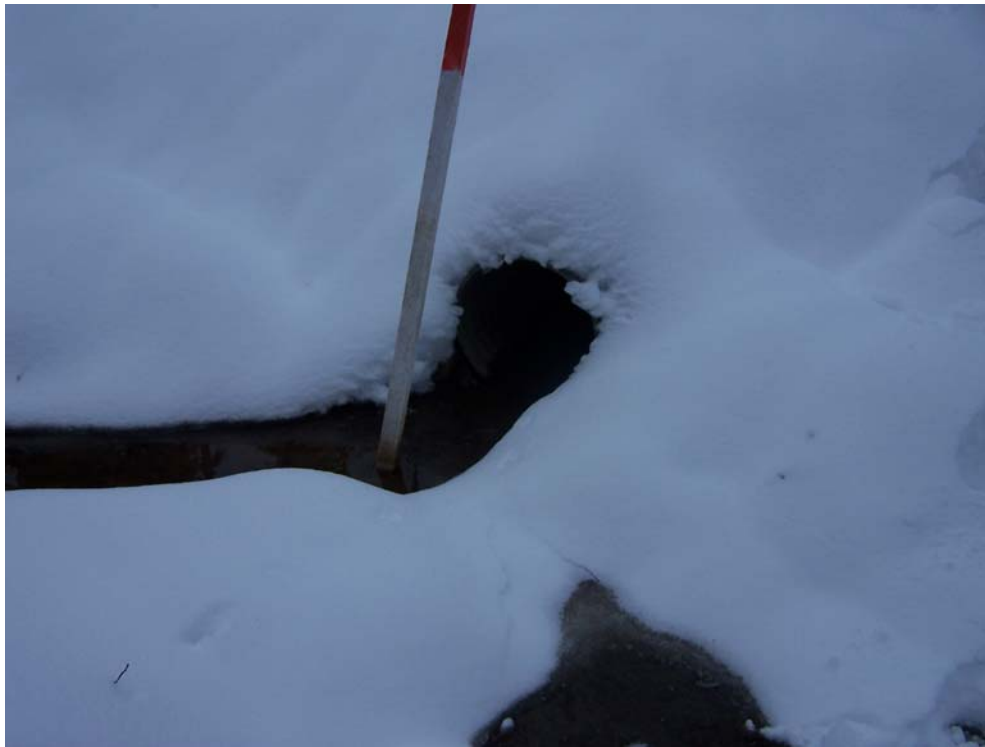
Downstream view of culvert inlet; slight scouring above inlet from ditch-line run-off, but no stream is present at this culvert crossing.

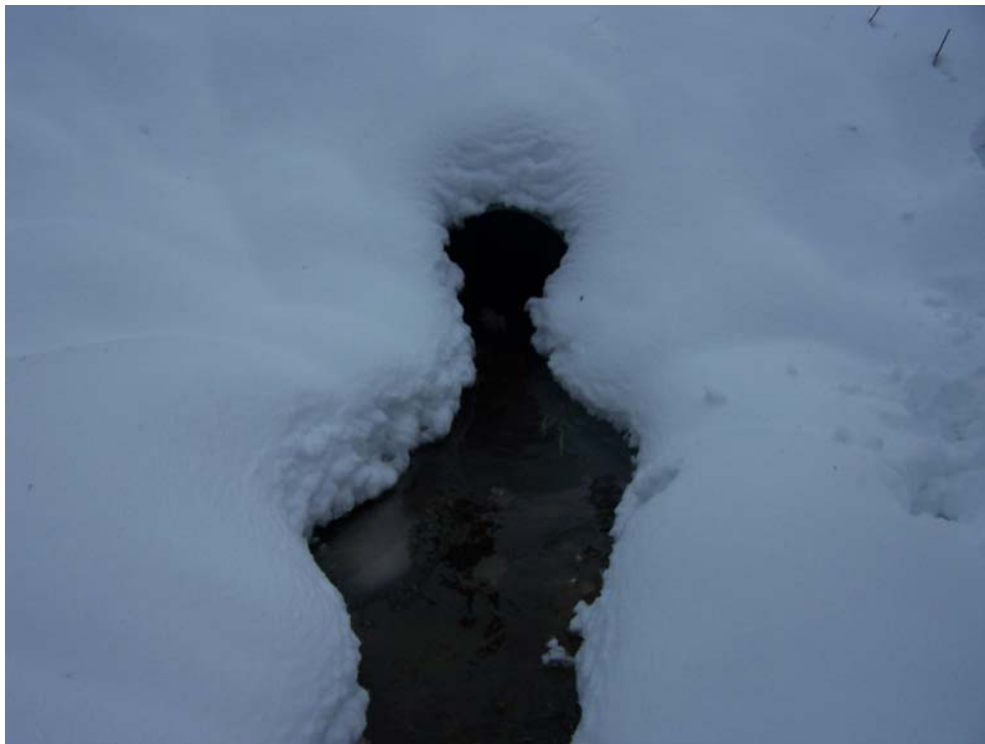
Upstream view of culvert outlet, there is limited overland water flows present from ditch-line flow and seepage upstream.

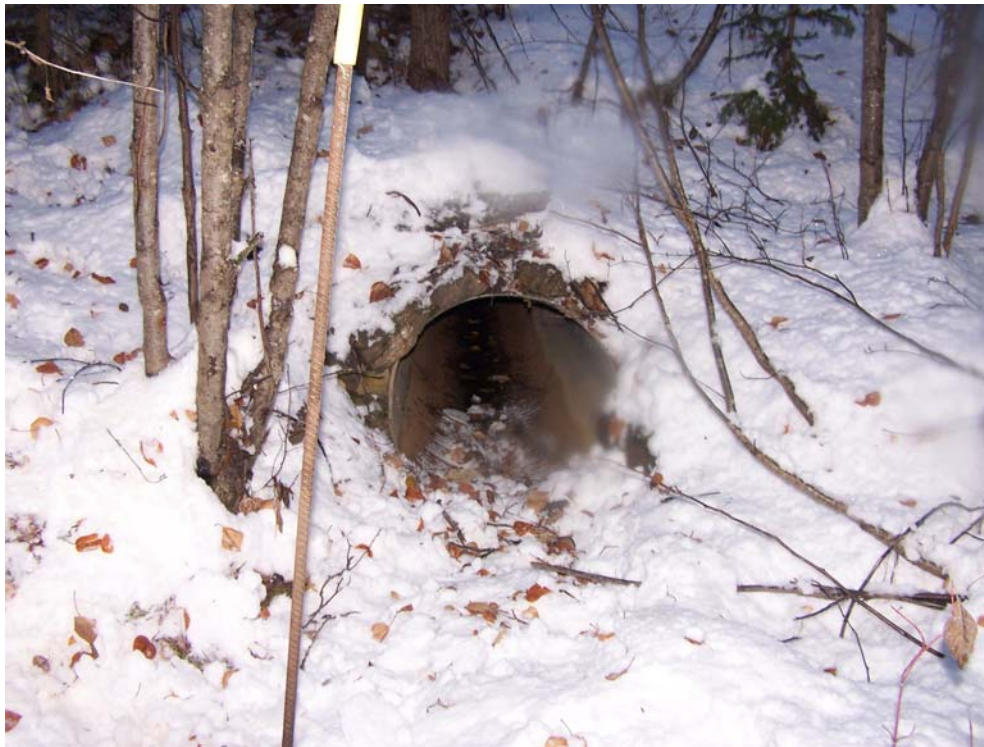
Downstream view of culvert inlet, there is a dry stream channel that is well-scoured that only flows during the freshet. Large diameter pipe has a high water mark 1/3 to 1/2 the way up the pipe.

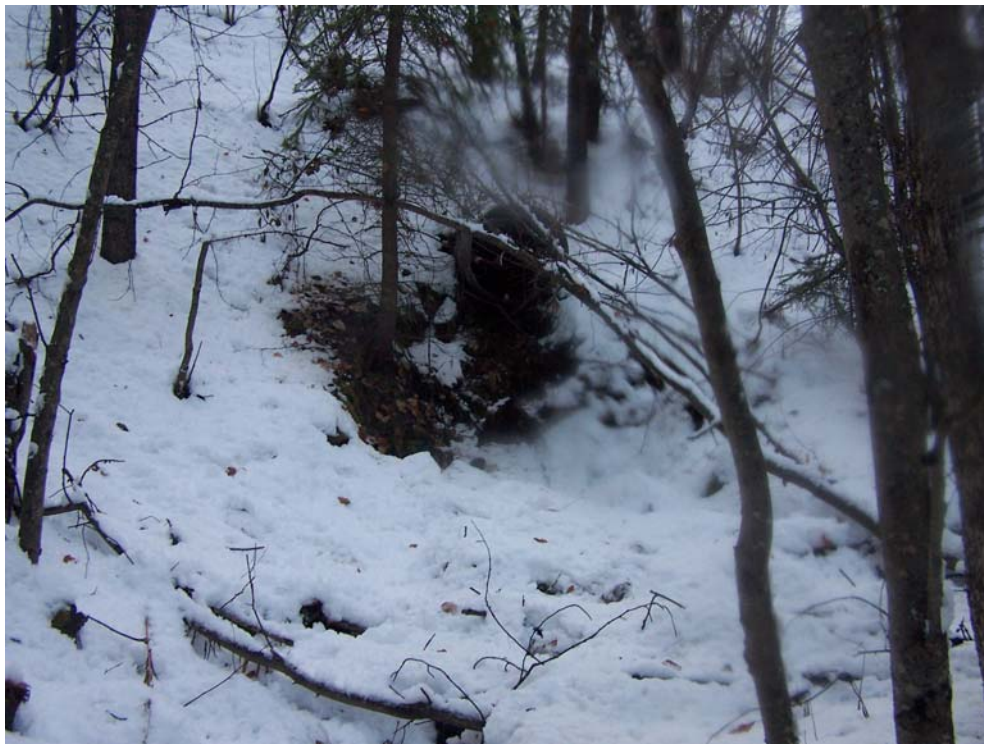
Upstream view of culvert outlet : large outfall drop of 1.4m would not allow fish passage upstream in this culvert.

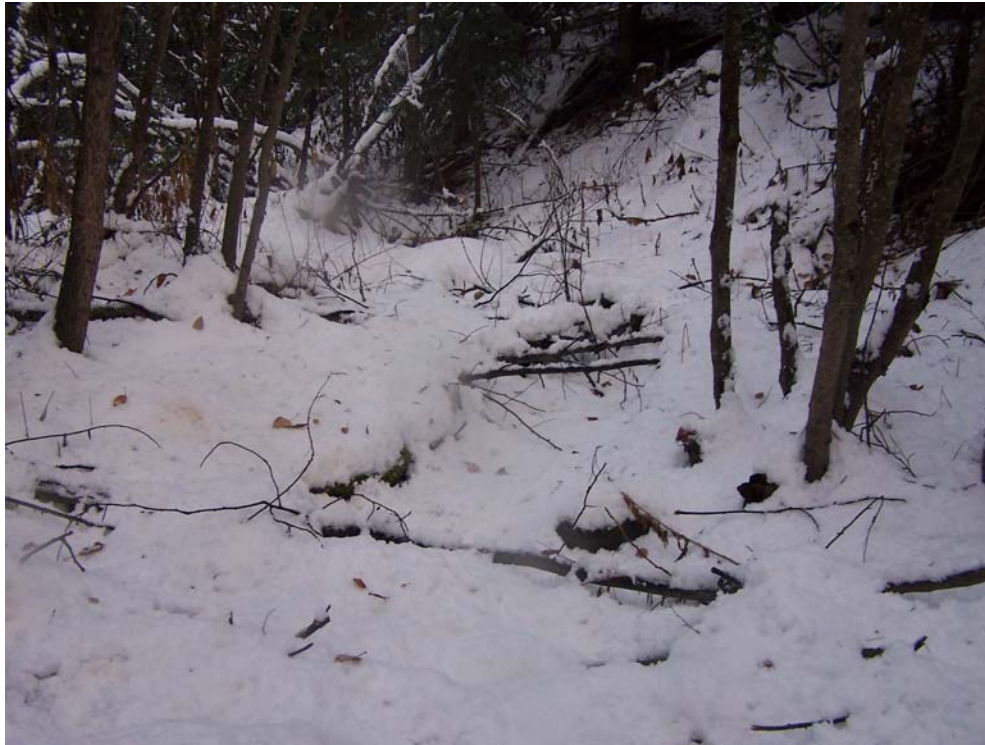
Downstream of the culvert outlet there is a well-scoured channel >1.0m wide and approaching a meter in depth.

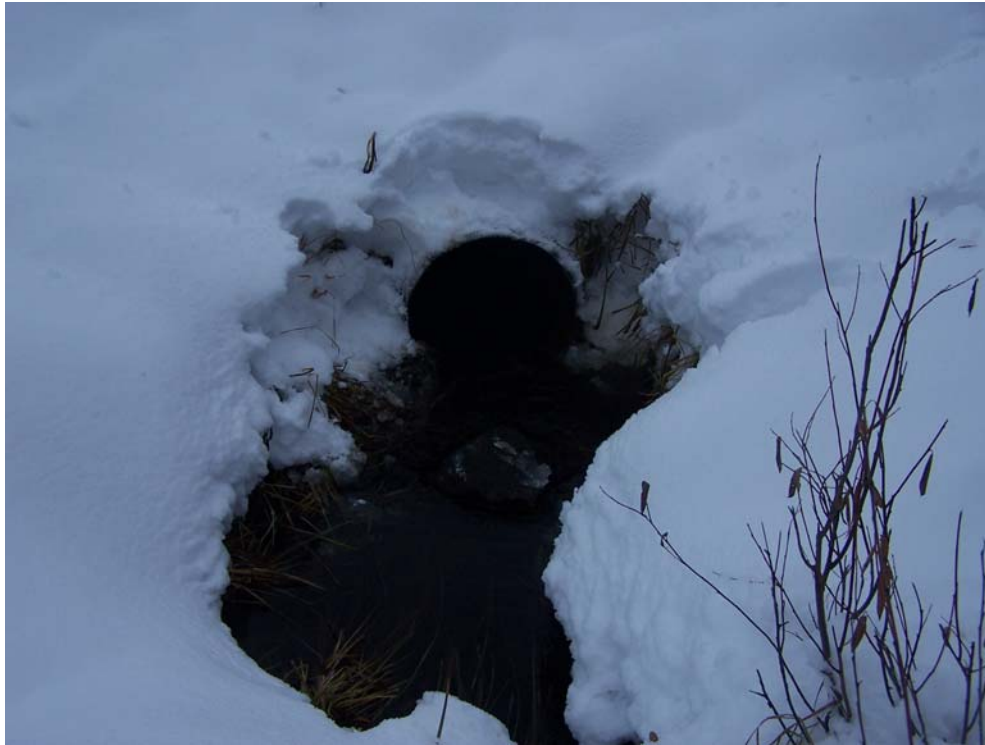
Downstream view of culvert inlet, upstream water flows gather in pool before entering into culvert. No inlet drop noted.

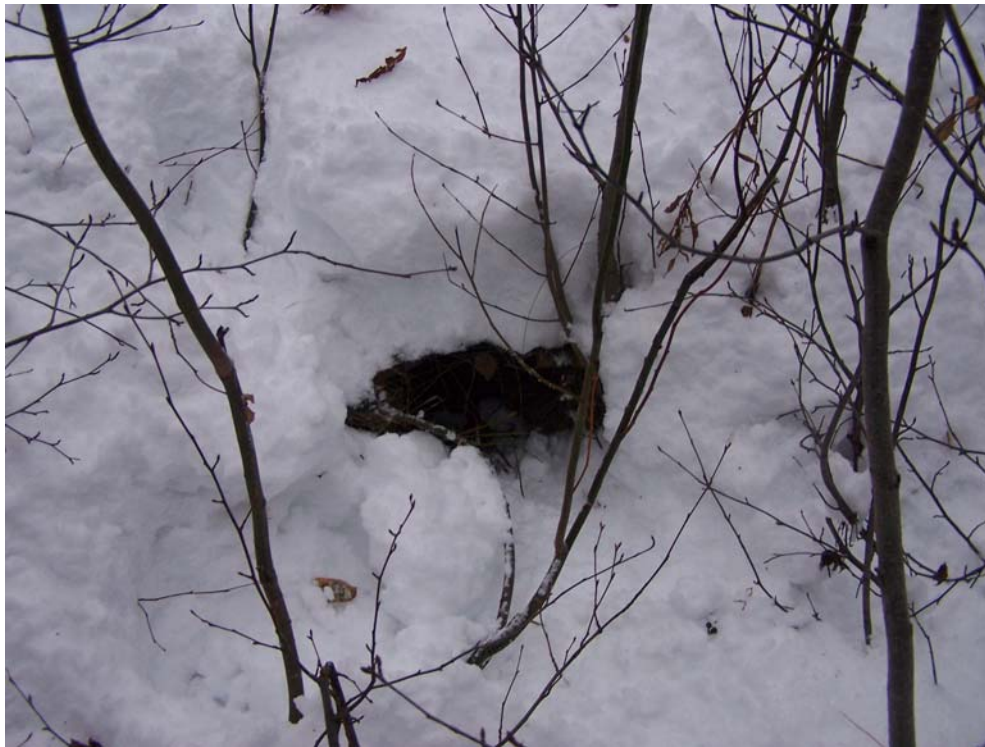
Downstream view of culvert inlet: the pipe is overgrown with vegetation and there is no noticeable scoured channel. This culverts handles ditch run-off in the spring, otherwise it is dry.

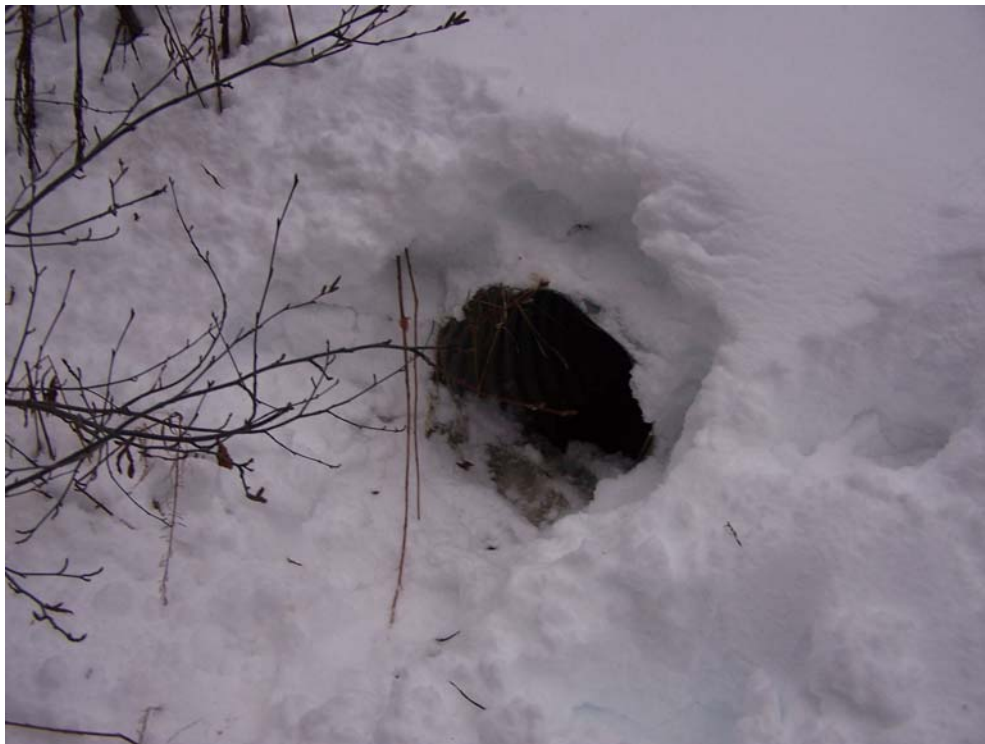
Upstream view of the culvert outlet showing few signs of any significant water flows. There is no scoured channel or outfall pool, as well there is no noticeable high water mark inside the pipe which results from sustained water flows.

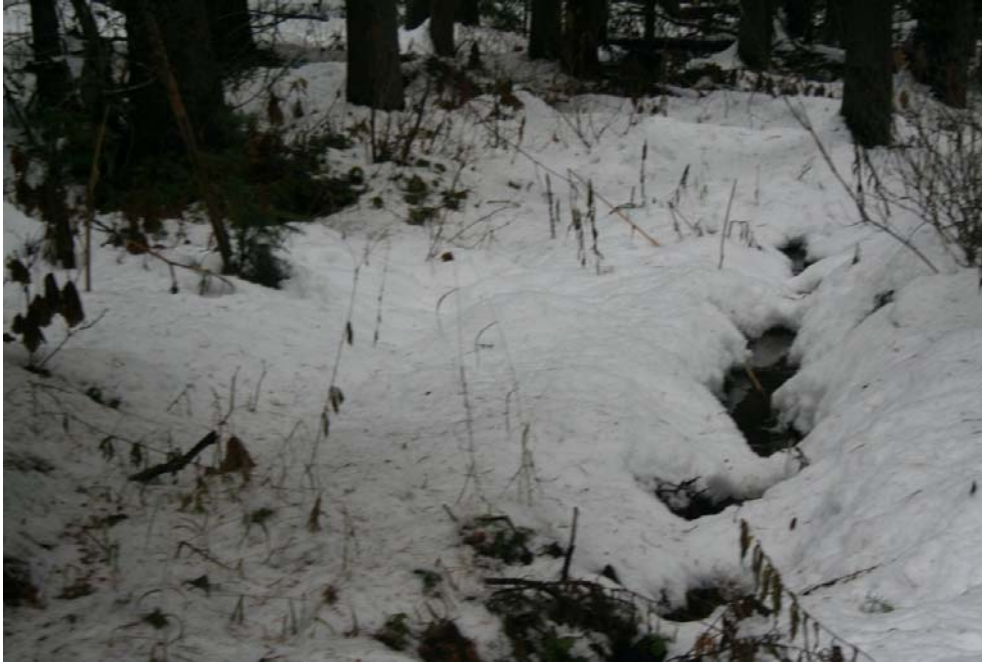
View of the culvert outlet.

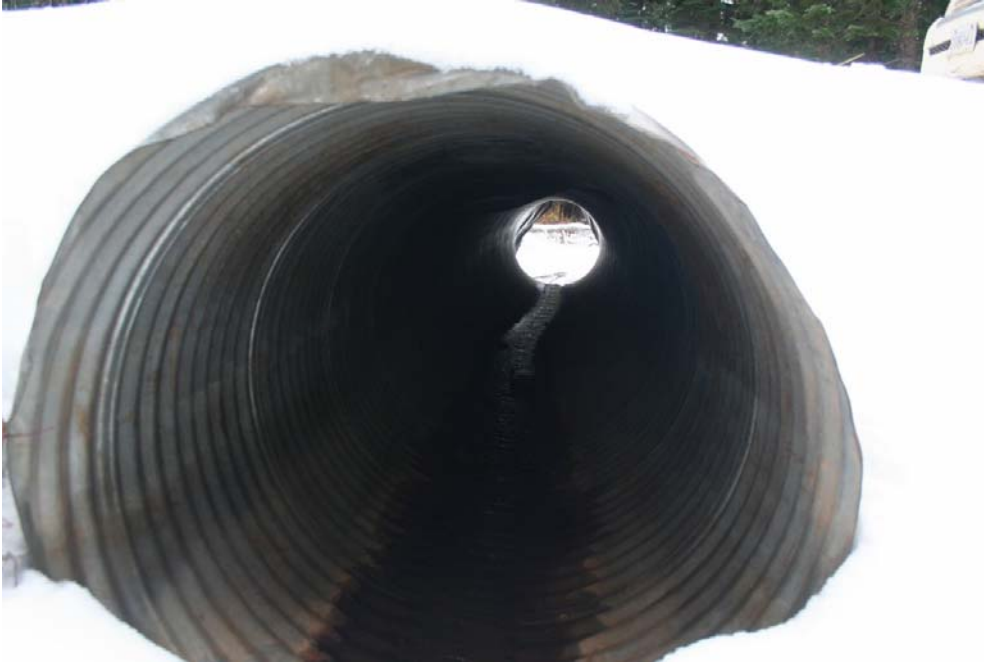
View of the culvert inlet.

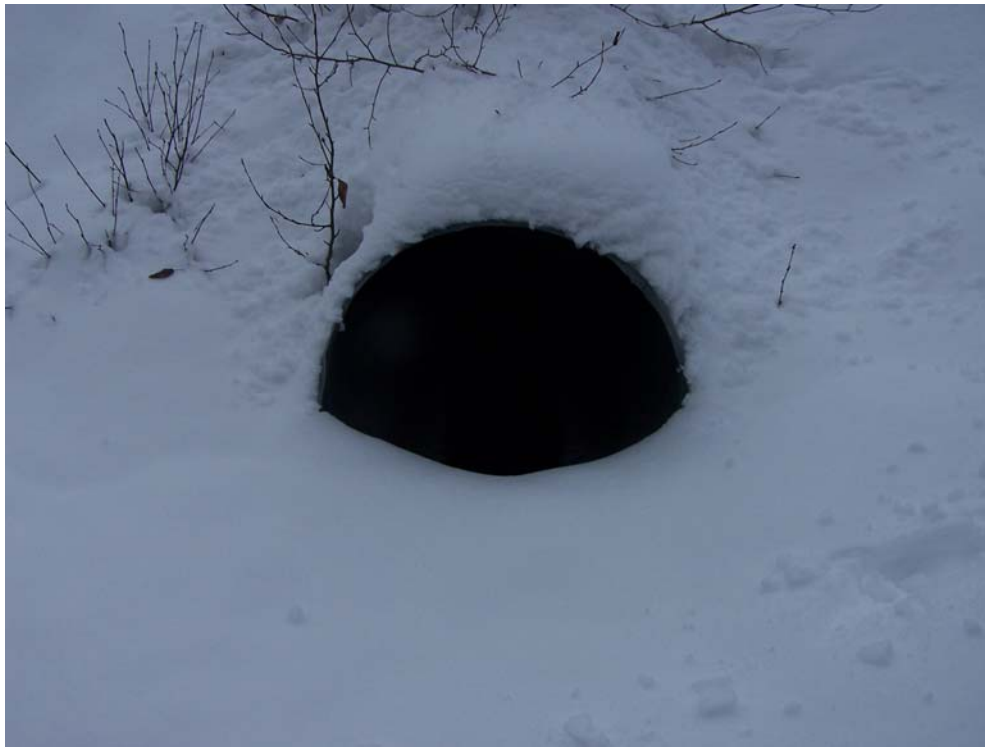
View of the culvert barrel
from the upstream side of
the culvert.

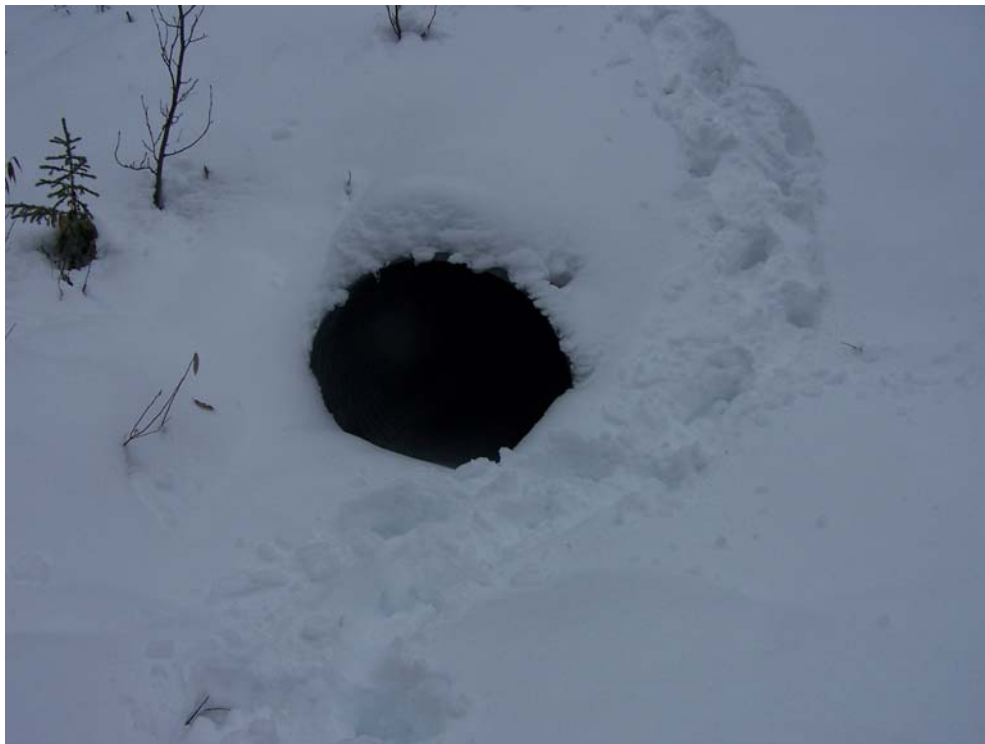
Downstream view of culvert inlet: the pipe handles ditch run-off, there is no well developed scoured channel present.

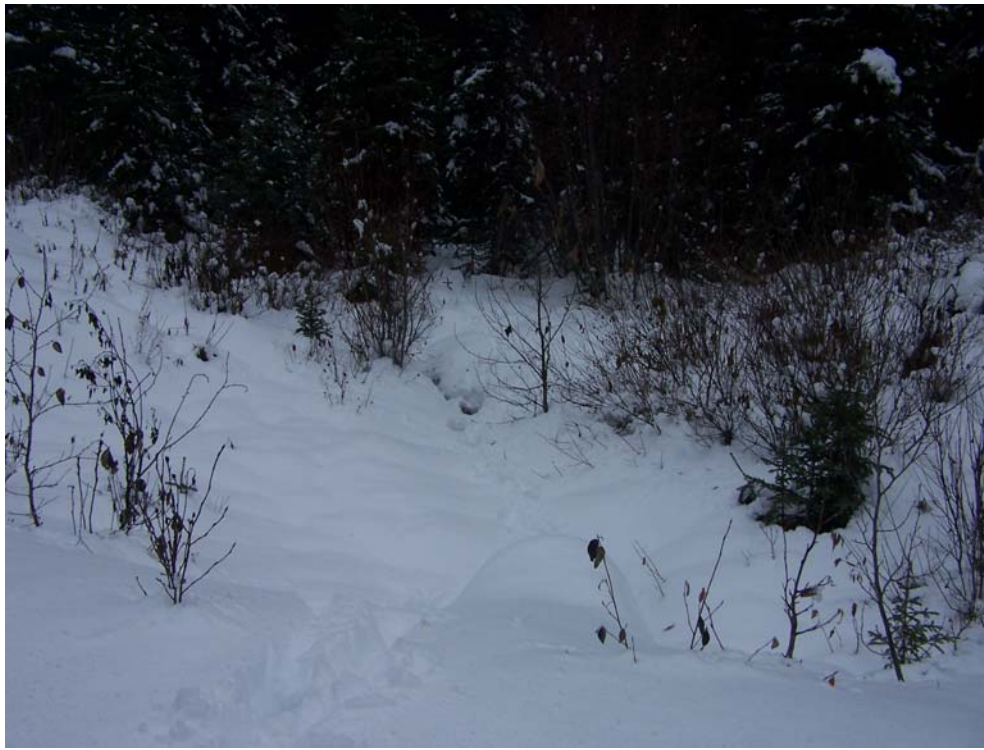
Upstream view of the culvert outlet showing few signs of any significant water flows. There is no scoured channel or outfall pool.

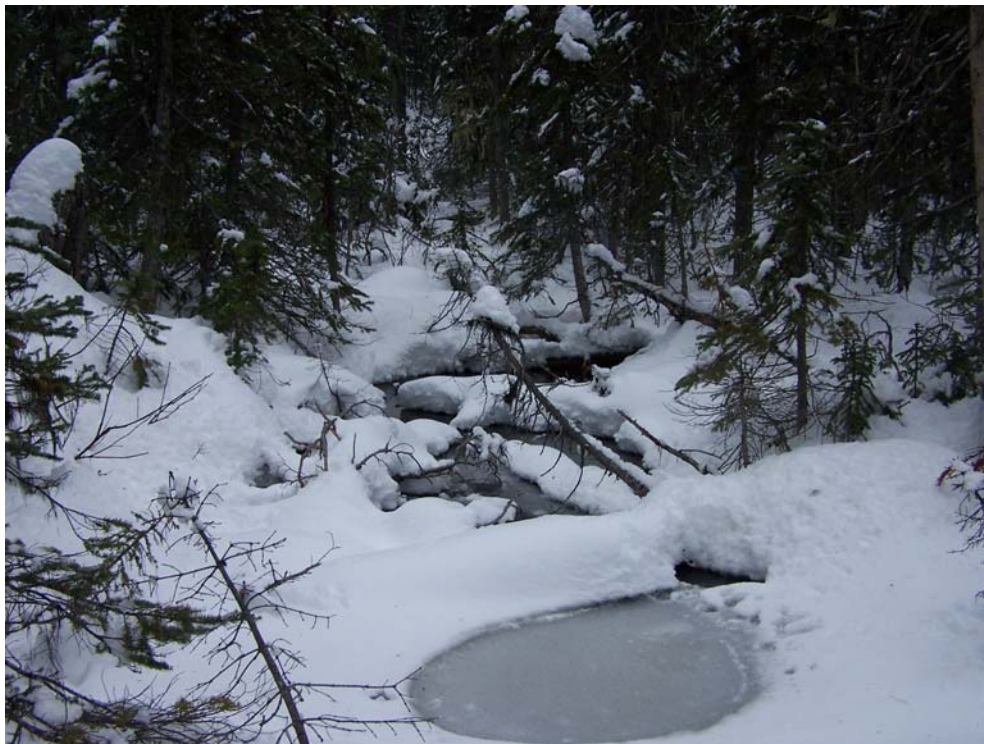
Downstream of the culvert outlet run-off disperses in wet draw. There is no evidence of a scoured stream channel.

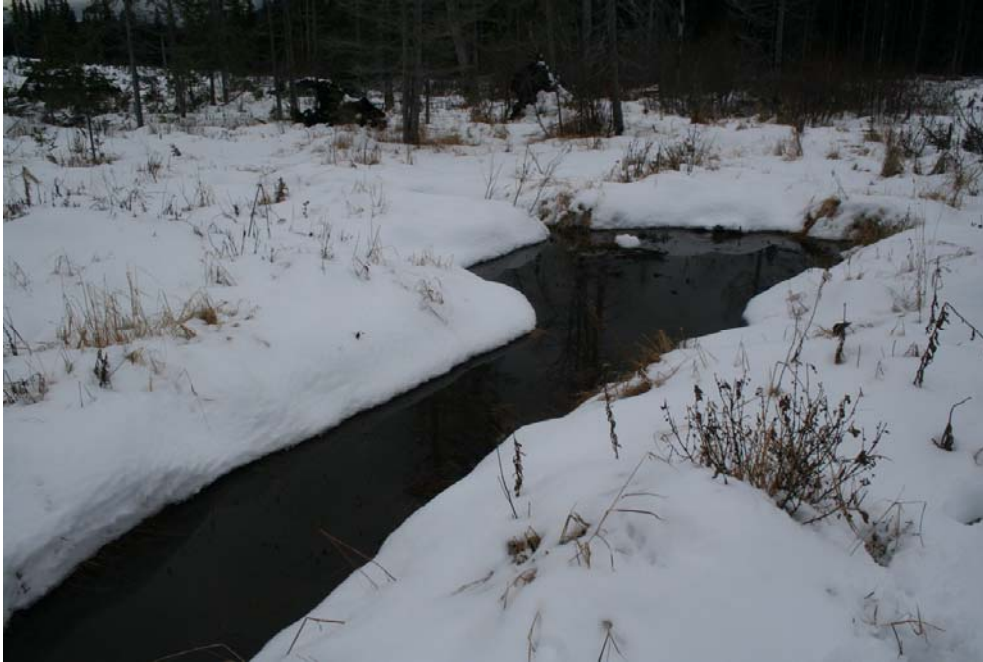
View downstream. Old deactivated crossing in a cutblock.

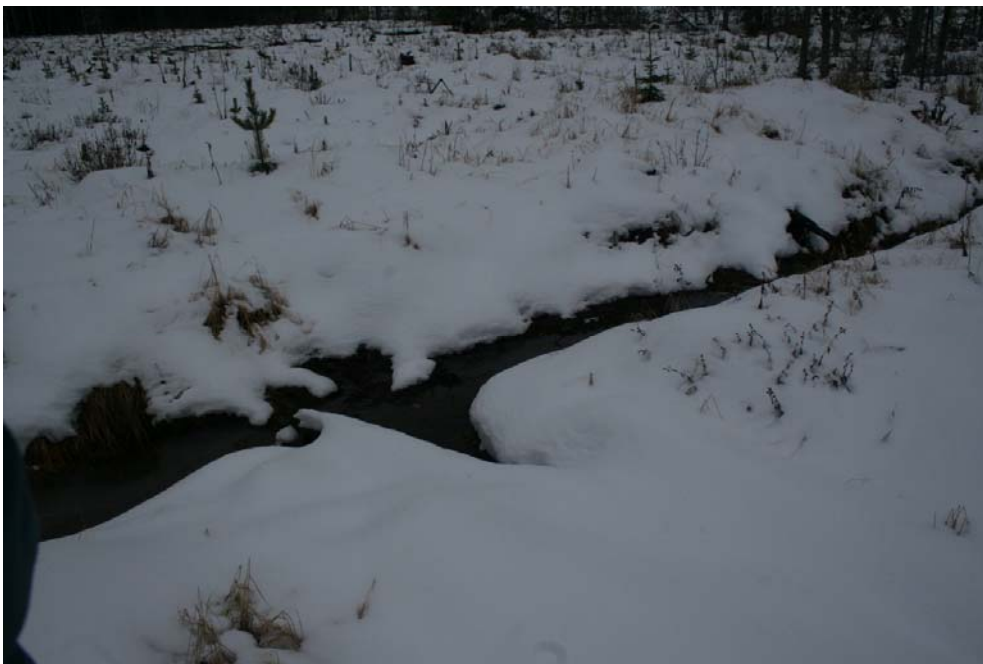
Upstream view of the deactivated road crossing in the cutblock.

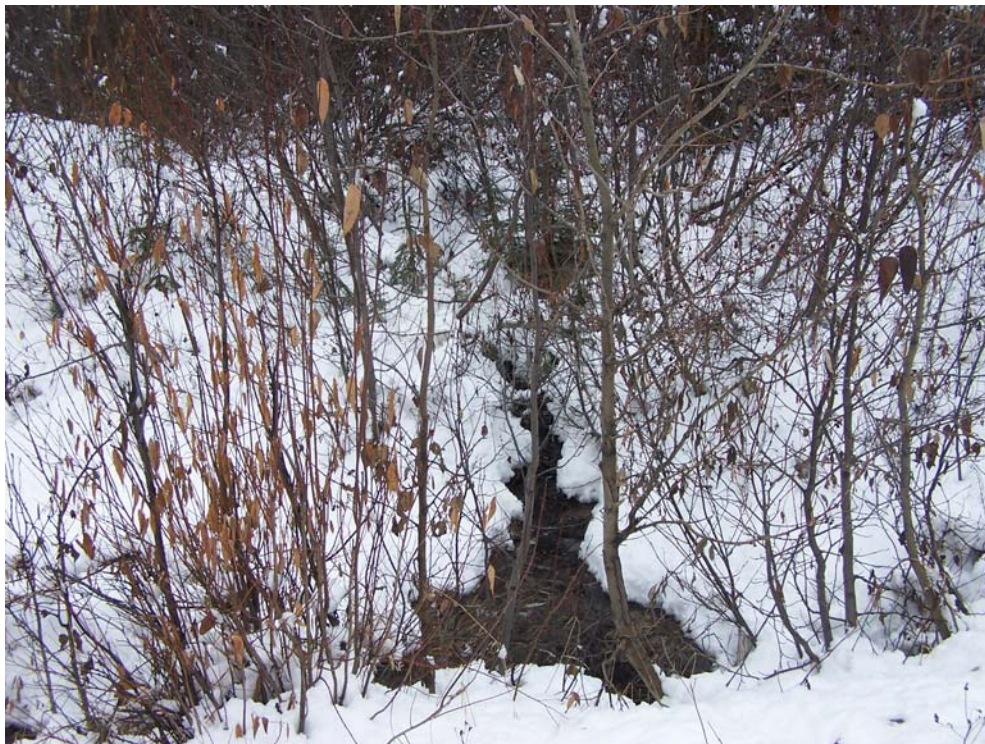
Upstream of the culvert there is weakly scoured channel giving it a stream classification, but the overall fisheries values are low.

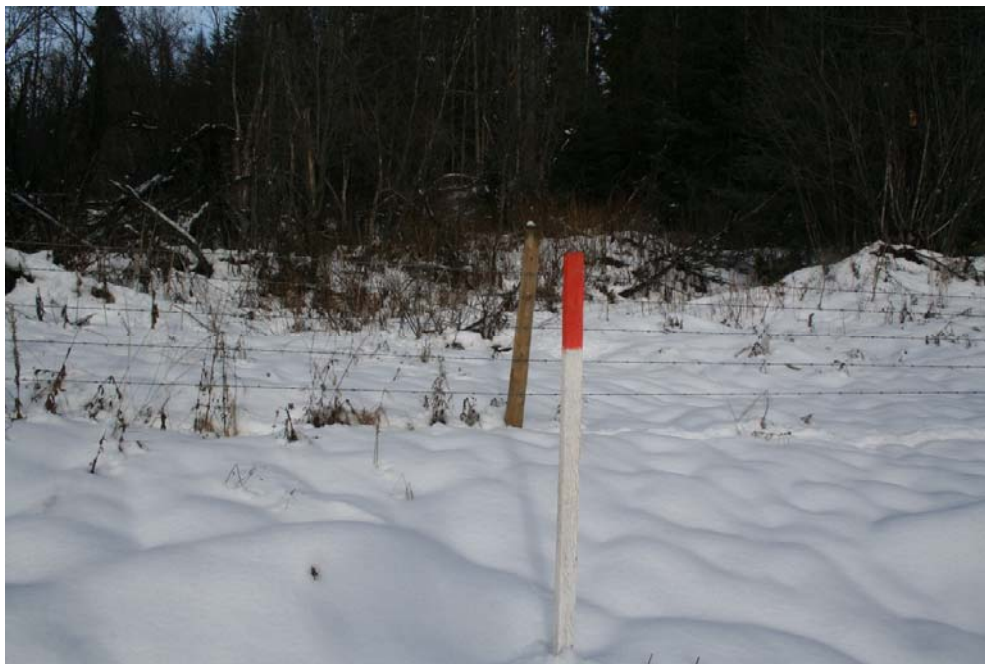
Downstream view from the culvert.

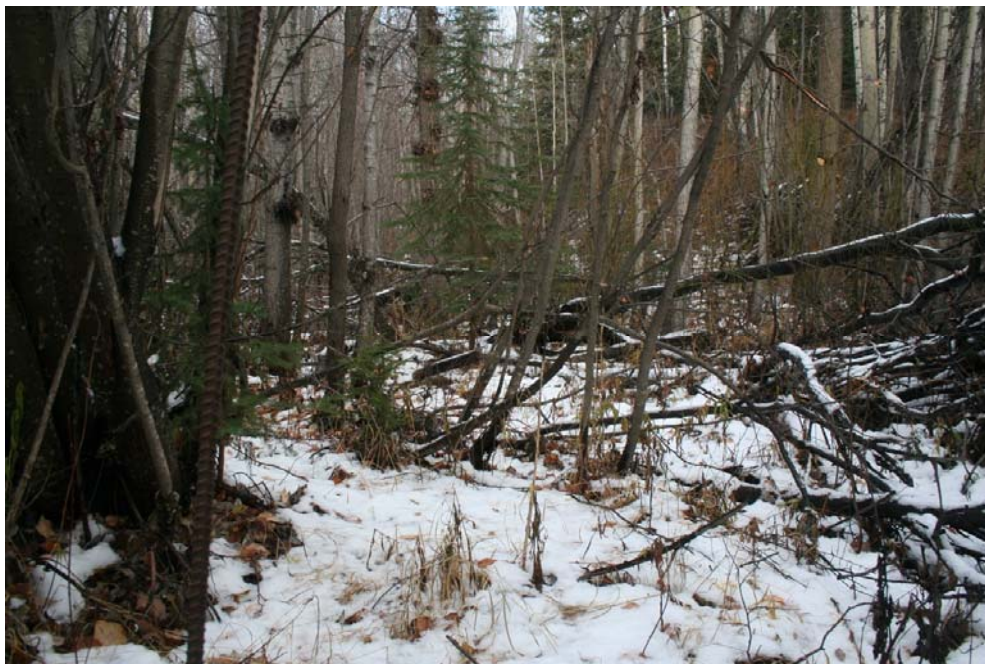
Downstream view from the culvert.

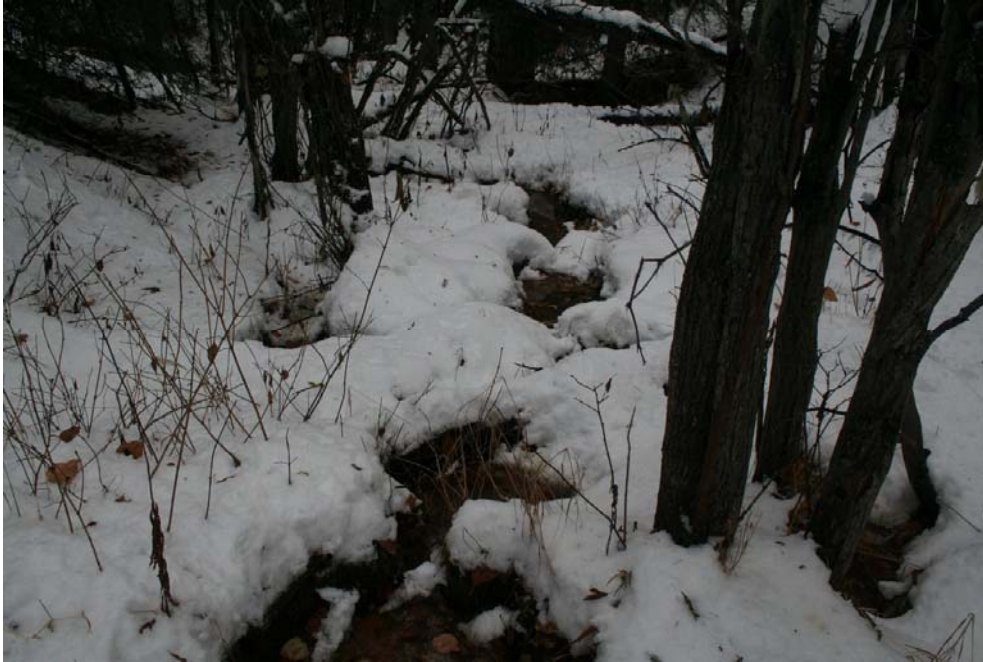
View of the downstream habitat from the road crossing.

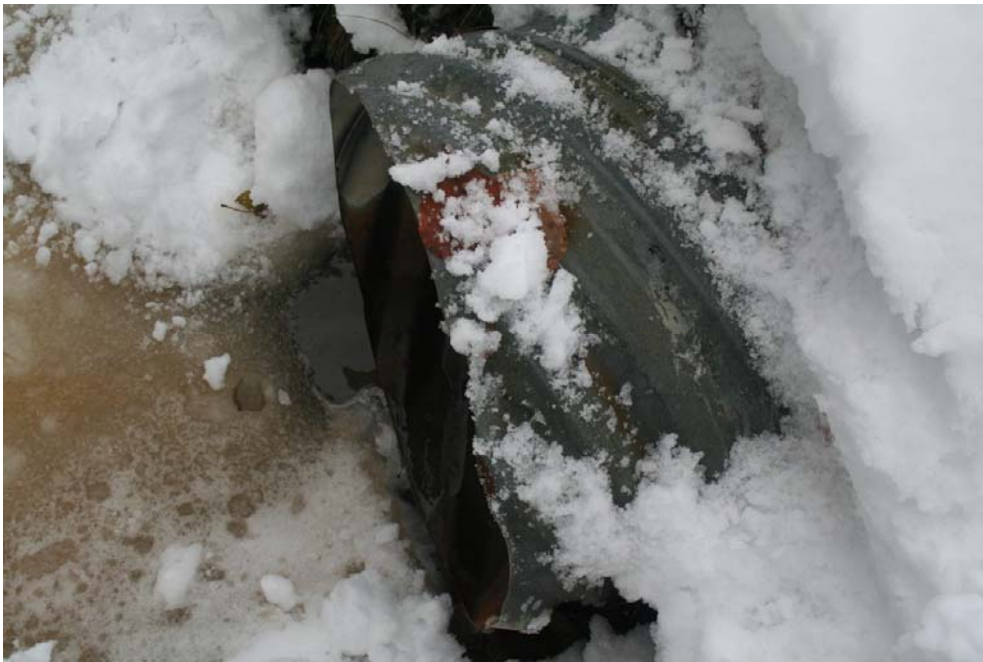
View of the culvert outlet.
