**BULKLEY/FULTON WATERSHED
FISH PASSAGE CULVERT ASSESSMENT PROGRAM**

January 12, 2010

Ecofor Consulting Ltd.
PO Box 1270
Fort Saint James, BC
VOJ 1P0
(250) 996-2151

EPN 2009-2029-001

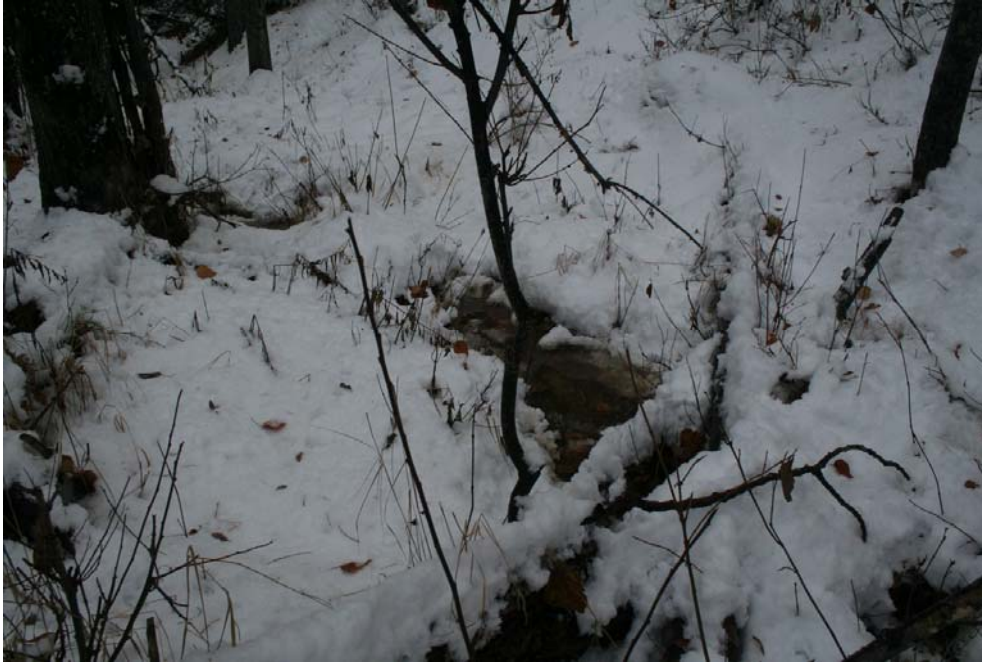
Representative habitat found upstream of the road crossing.

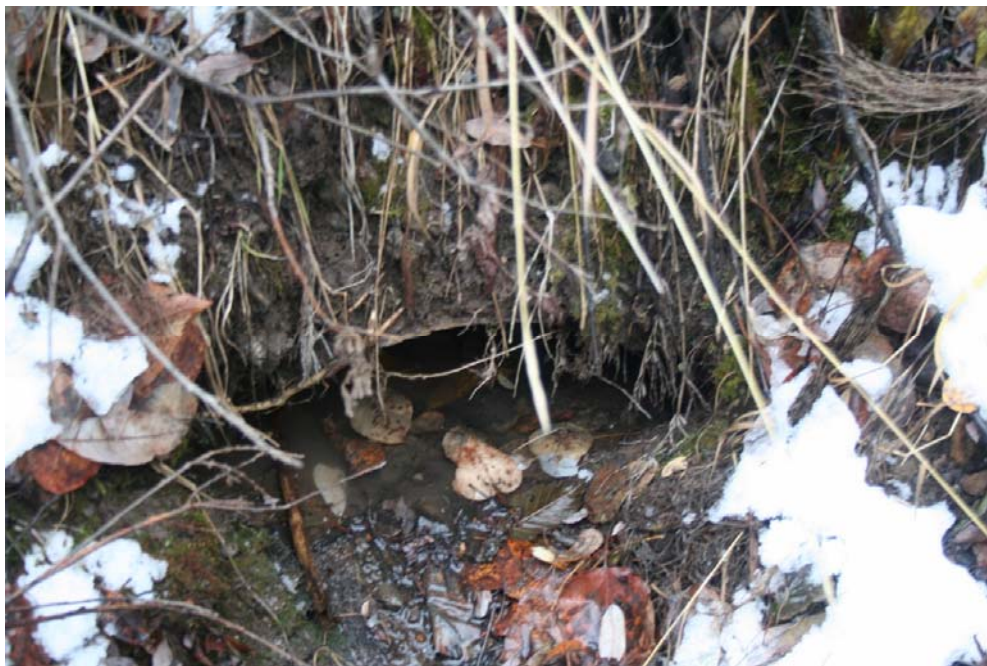
View of the downstream habitat from the road crossing.

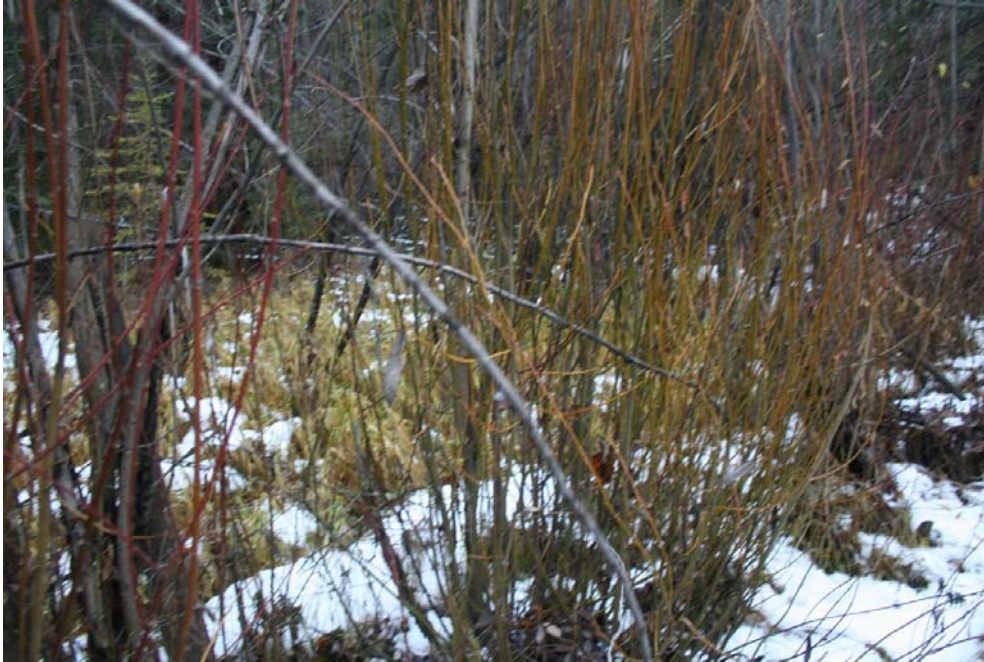
Representative habitat found upstream of the road crossing. Stream may dissipate 100m u/s.

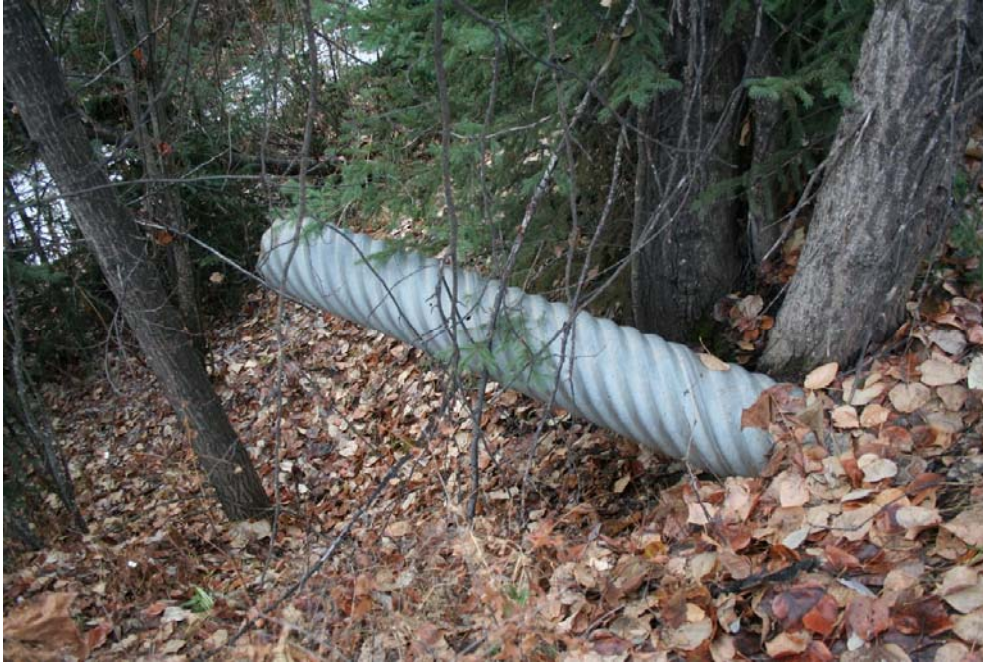
View downstream. Culvert found but no stream NVC.

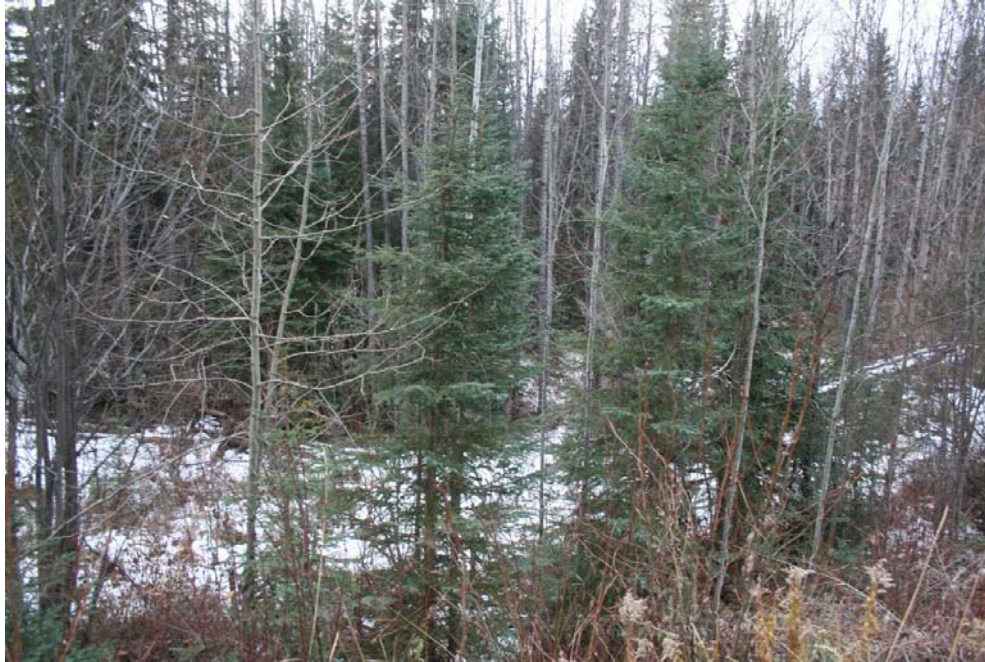
View downstream. Culvert found but no stream NVC.
