**Annual Compendium Of Aquatic Rehabilitation Projects
For The Watershed Restoration Program
1998 - 1999**

Watershed Restoration Project Report No. 13

Watershed Restoration Program
Ministry of Environment, Lands and Parks
2204 Main Mall, UBC
Vancouver, BC V6T 1Z4

1999

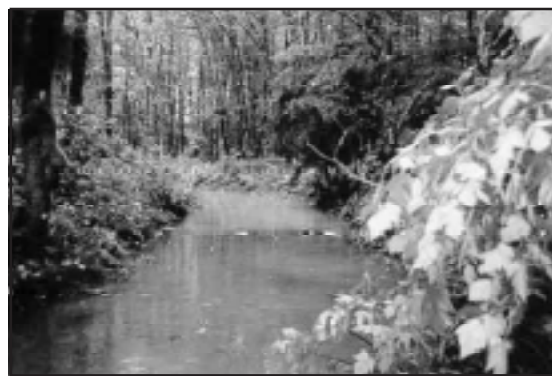
Figure 1-1. The first phase of the project completed in 1997, was 150 m long.

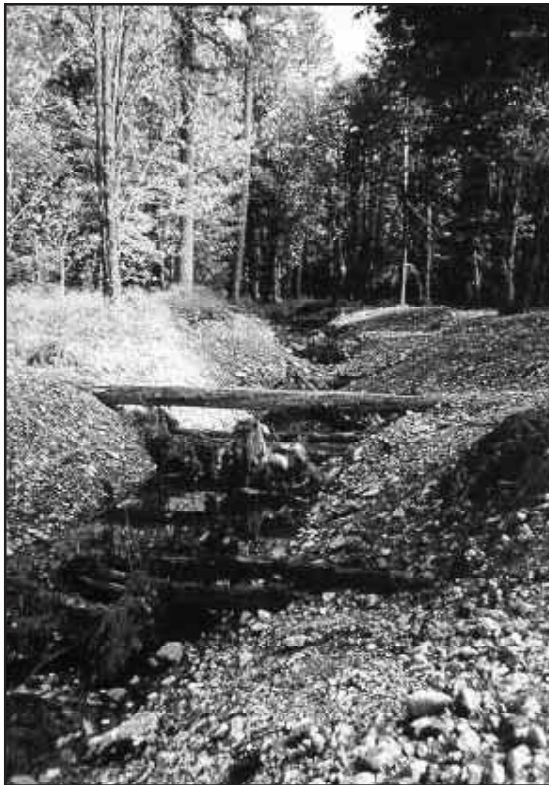
Figure 1-2. A large volume of wood was placed into the main channel to provide cover for adults and rearing salmonids.

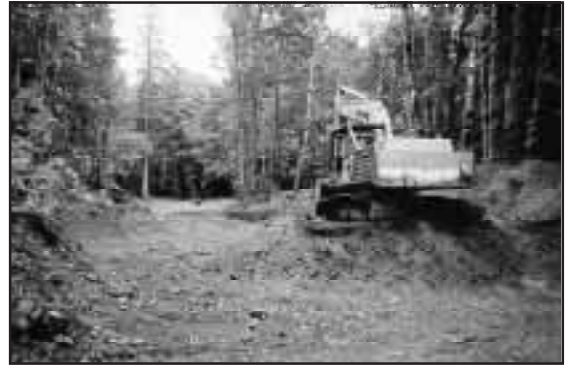
Figure 1-4. A Case 9040 excavator removed the overburden first to reduce the possible sediment load to the channel when it was excavated to grade.

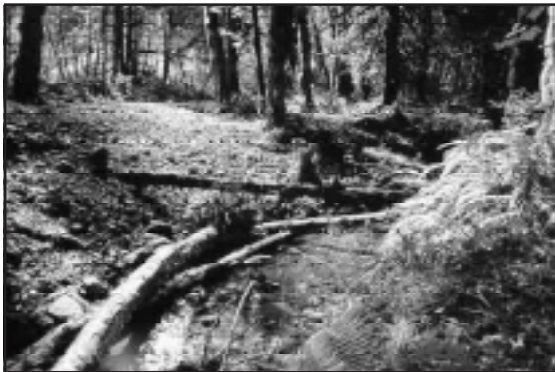
Figure 1-3. The secondary reach is 75 m long and is also heavily loaded with woody debris.

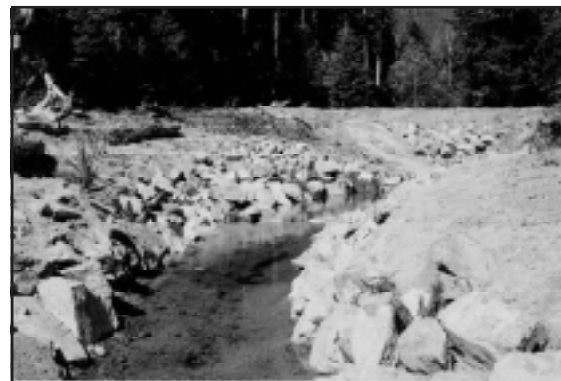
Figure 1-13. Discharge apron and start of the upper Kennedy side channel (looking upstream).

flood protection dykes (Fig. 1-13), (2) intake and flow control structures, (3) excavation of main channel (Fig. 1-14), (4) complexing and function of entire side channel (Fig. 1-15), and (5) site cleanup, revegetation, bank stabilization and signage (Figs. 1-12, 1-16). Construction of the main dyke, intake system, and main channel were initiated in late September 1996 to mid-October 1996, and again in mid-July 1997 to mid-September 1997. The final phases of restoration on the upper Kennedy side channel started on August 12, 1998 and were completed on September 23, 1998.

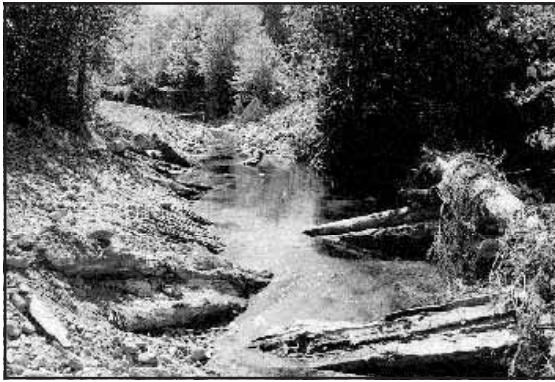
Figure 1-14. LWD structures, pool and riffle structure in the first 100 m of the upper Kennedy side channel.

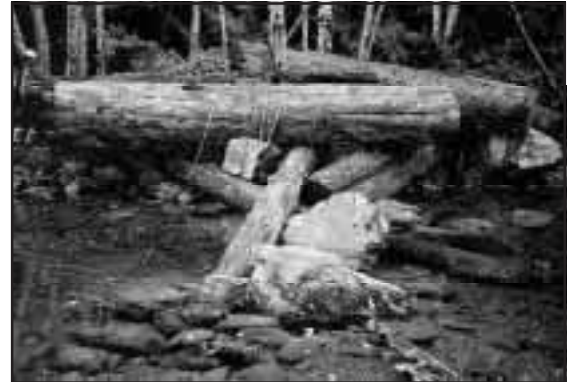
Figure 1-17. Stump Creek side channel LWD structure and excavated pool following first fall flood. Tla-o-qui-aht First Nation crew chief standing beside jam for scale.

A second smaller project was undertaken in 1998. Restoration of the Stump Creek side channel started on September 24, 1998 and was completed on September 25, 1998 (Fig. 1-17). Additional restoration of the Stump Creek side channel will be conducted through a number of phases in following years, but construction began in 1998 with a trial which included the excavation of a pool and placement of LWD structures to help support ongoing scour and sediment aggradation in the pool area.

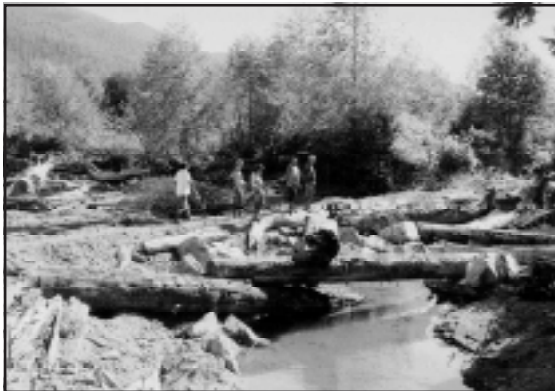
Figure 1-15. Rip-rap banks, LWD structures in the upper Kennedy side channel at 4+90 m.

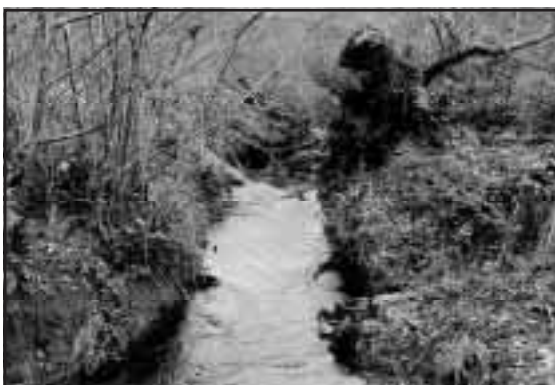
Figure 1-16. Lower portion (8+10 m) of the upper Kennedy side channel 1 year post construction.

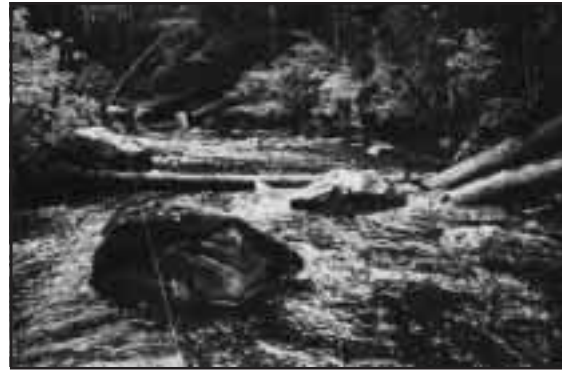
Figure 1-21. Large rootwad added to double deflector log to increase the efficiency of deflector structure. The same treatment was applied to an adjacent structure in an attempt to form a channel constriction to promote bedload scour.

Restoration activities were once again concentrated along the upper 13 km of the mainstem Keogh River, with an additional 1.4 km of stream length receiving restoration treatments. A total of 68 instream restoration structures were built during the 1998/1999 restoration season. A majority of instream restoration work involved the creation of new fish habitat (Figs. 1-18 to 1-20). Furthermore, considerable effort was put forth to either reconstruct, or increase the productive capacity of past restoration efforts (Figs. 1-21, 1-22).

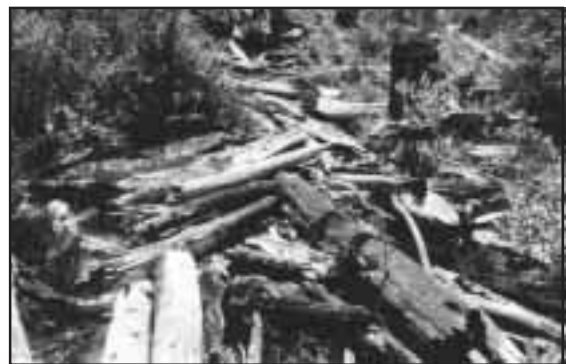
Figure 1-27. Instream work before at 0+149 Ck 2 (jam #4).

- training, access clearing and maintenance;
- removal of 3000 m³ of SWD;
- placement of 3500 pieces of LWD instream anchored with approximately 6000 m of 1/2 inch galvanized cable;
- fry population and water quality surveys at 6 sites in survey area; and
- upgrading of 2 critical creek crossings for fish access (Figs. 1-27 to 1-30).

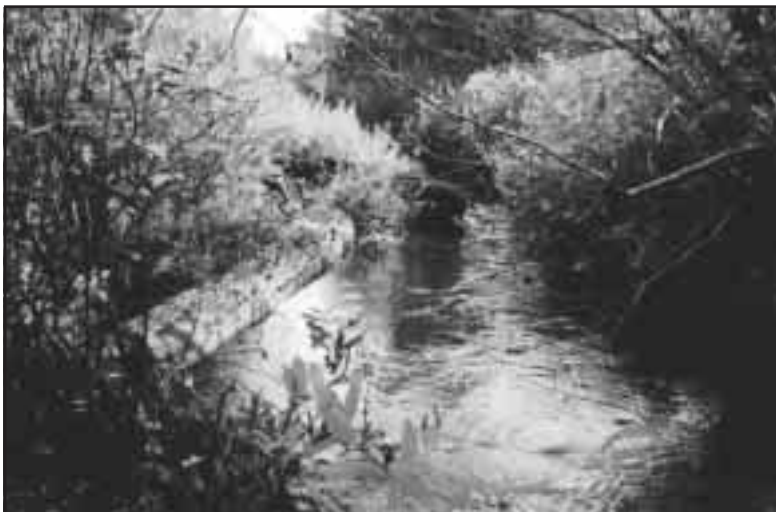
Figure 1-30. Instream work habitat logs at GBM (upstream jam #25).

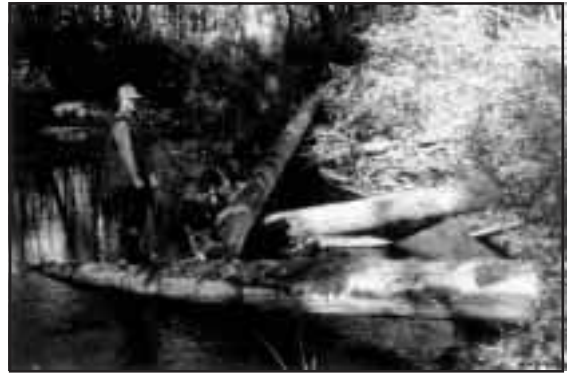
Figure 1-38. Site 6, lower Spirit Creek after LWD placement.

Material was placed in the creek by use of a Sikorsky 61 helicopter (Fig. 1-35). LWD and boulders were then repositioned according to the design prescription (SSHRC 1998) by a ground crew using a chainsaw winch. LWD was cabled to live trees on the bank and to the boulders. Some sites were modified in the field due to differences in wood size at the site compared to the wood in the design plan, ease of installation, or to achieve a different physical and biological effect as determined appropriate by the project biologist. Eighty-four pieces of LWD along with 26 boulders for ballast were added to 19 sites (Figs. 1-36 to 1-40). Another 5 sites were modified.

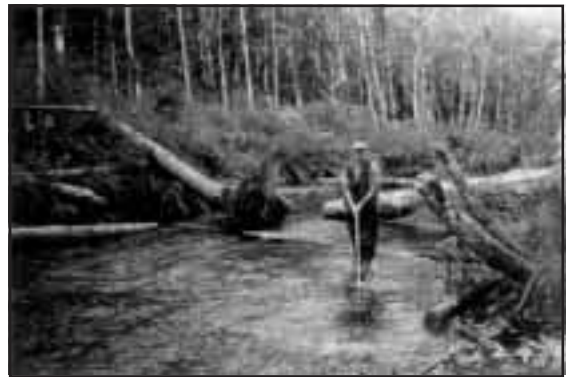
Figure 1-39. Site 8, lower Spirit Creek after LWD placement.

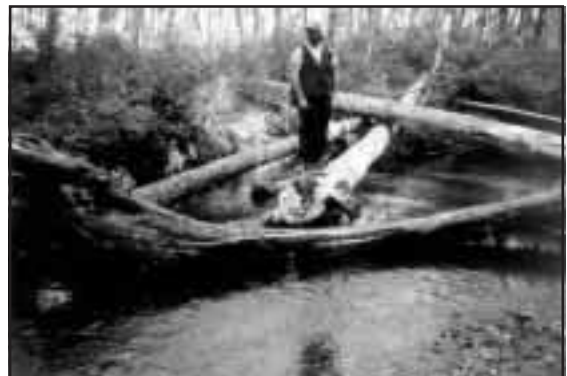
Figure 1-40. Site 13A, upper Spirit Creek after LWD placement.

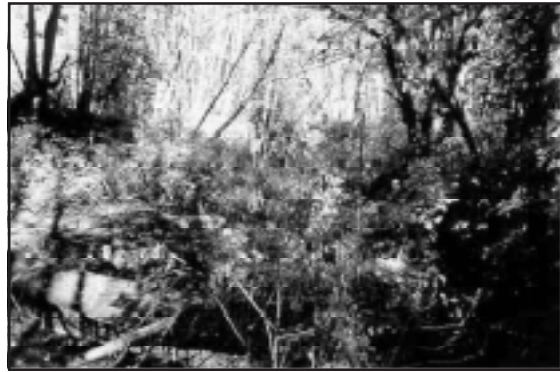
Figure 1-41. Before excavation, the side channel was over grown and filled with sediment.

In total, approximately 1250 m² of coho rearing area was created (250 m length). Estimated production is 1250 coho smolts (i.e., 1 smolt per m²). See Figures 1-41 and 1-42 for before and after representations of the site.

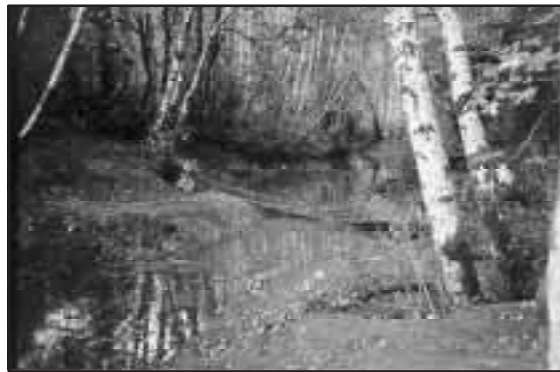
Figure 1-42. After construction, the wetted area of the side channel was greatly increased. Additional LWD still has to be added.

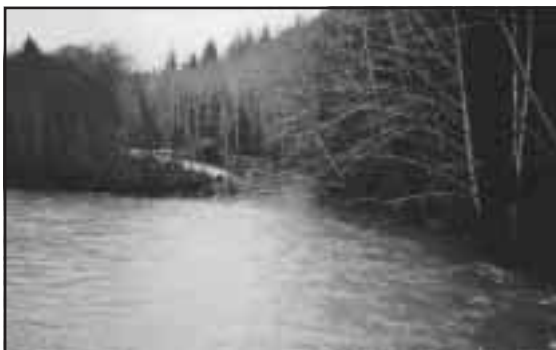
Figure 1-43. Photograph showing the mouth of the side channel constructed at Site 12, Reach 20, South Sarita River. Photo was taken during high river flows. A willow weave was installed on the sides of the set-back dyke to control erosion.

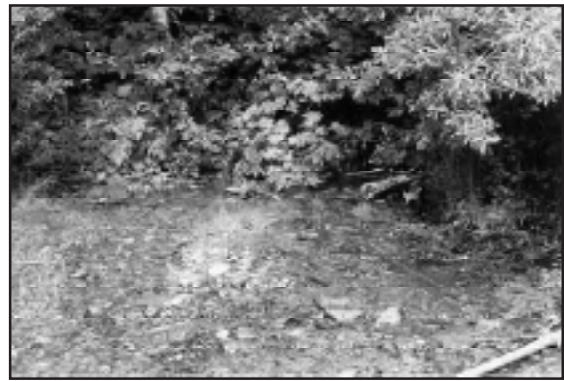
The primary objective of the project is to develop an existing borrow pit to increase the productive capacity of this off-channel habitat. In its present state the borrow pit has a good groundwater supply, but lacks depth and complexity for rearing habitat (Figs. 1-48 to 1-56).

Figure 1-48. Pre-construction view of one of the groundwater sources at Borrow Pit #2, 1998.

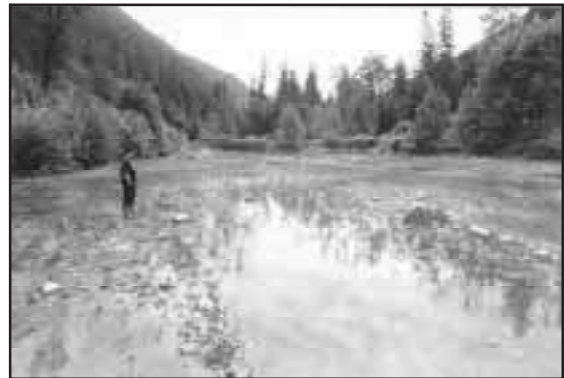
Figure 1-49. Pre-construction view (looking downstream) of Borrow Pit #2, 1998.

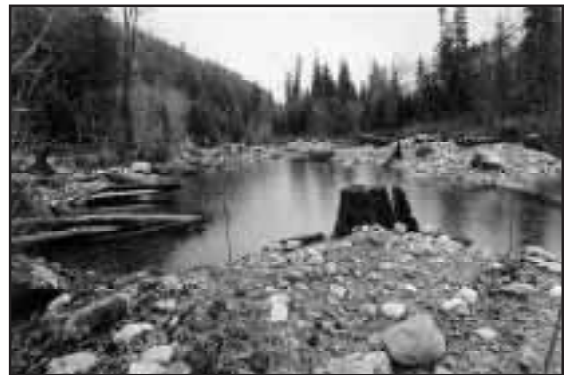
Figure 1-50. Post-construction view (looking downstream) of Borrow Pit #2, 1998.

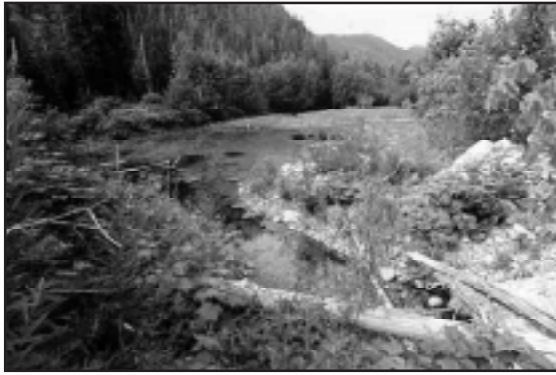
Figure 1-51. Pre-construction view (looking upstream) of Borrow Pit #2, 1998.

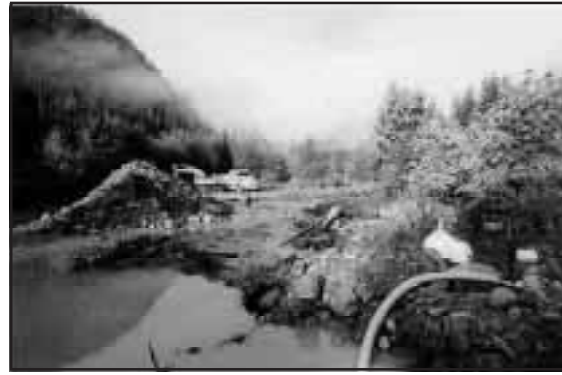
Figure 1-54. Construction of Borrow Pit #2, showing environmental protection measures, 1998.

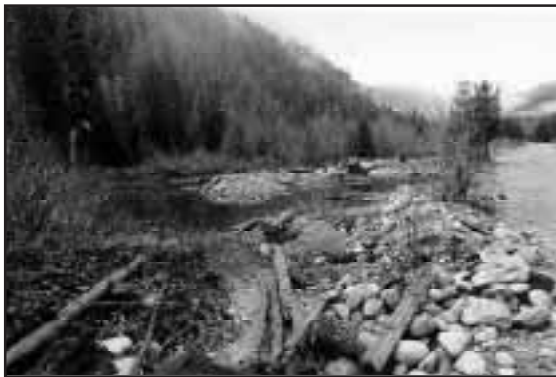
Figure 1-52. Post-construction view (looking upstream) of Borrow Pit #2, 1998.

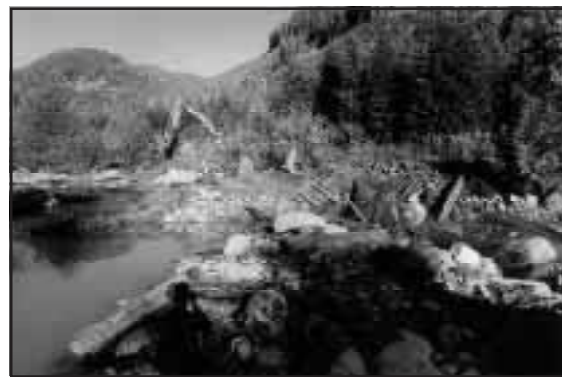
Figure 1-55. Post-construction of Borrow Pit #2, showing complexing of Island #1 and peninsula, 1998.

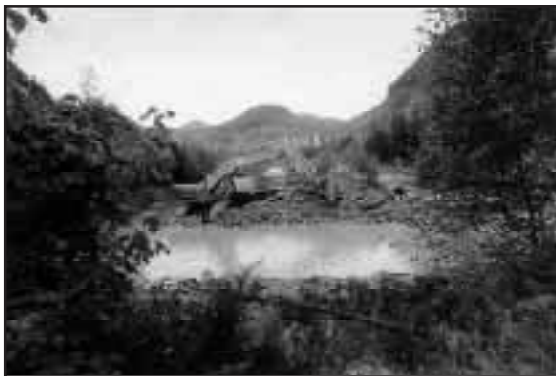
Figure 1-53. Construction of Island #2, Borrow Pit #2, 1998.

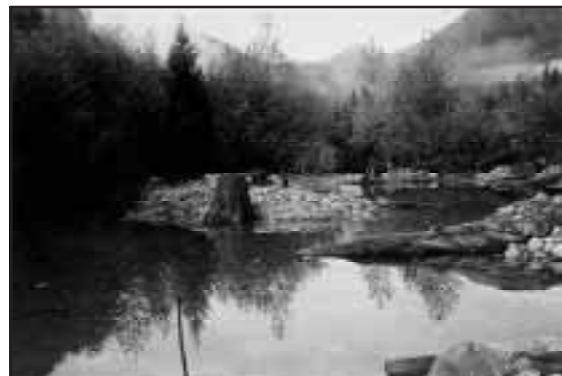
Figure 1-56. Post-construction of Borrow Pit #2, showing complexing, 1998.

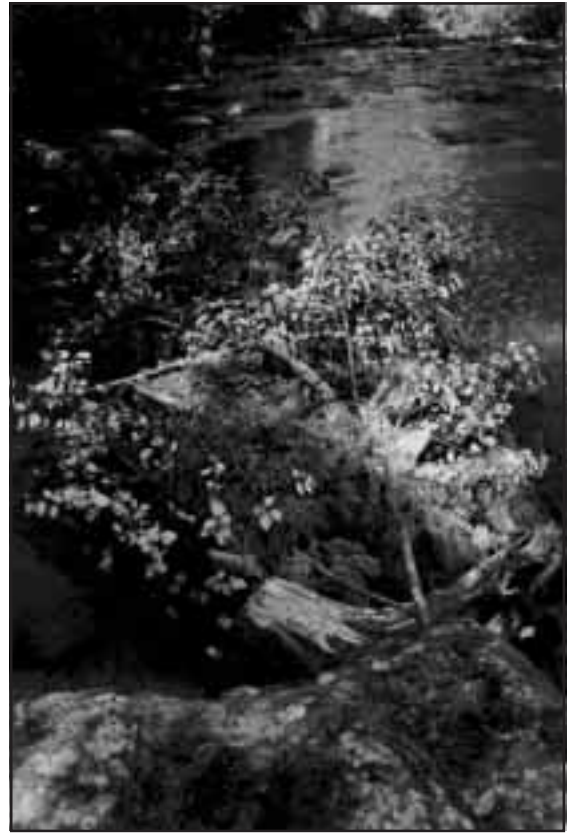
Figure 2-6. A LWD/boulder complex loaded with alder and cedar tops and branches to increase complexity.

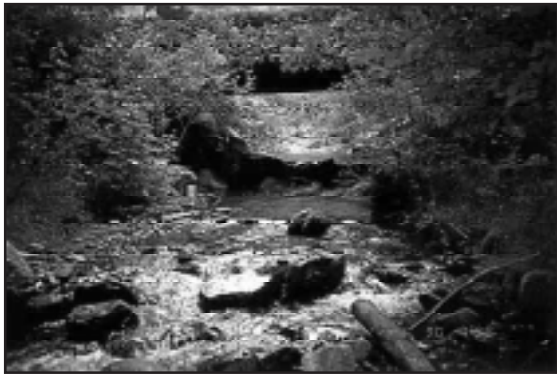
The restoration of Little Tamihi Creek occurred largely at the section below the Tamihi-Liumchen Forest Service Road bridge. This section of the creek appeared to have been channelized and severely lacked habitat diversity (Fig. 2-23).

Figure 2-23. Pre-construction view of Little Tamihi Creek (upstream view, below bridge).

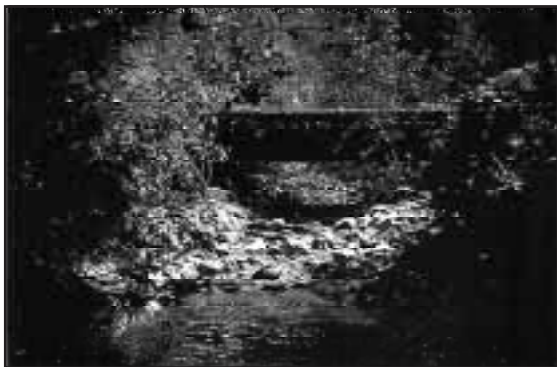
Figure 2-24. Post-construction view of Little Tamihi Creek (upstream view, below bridge).

Reconfiguring the stream profile into a stepped pattern has created more diverse hydraulic and habitat conditions (Fig. 2-24). It also provides more water depth during low flow periods. The constructed riffles will enhance pools, recruit gravel, re-aerate flows, and assist fish passage. The pools will provide holding cover for spawners and rearing habitat for juvenile and resident salmonids.

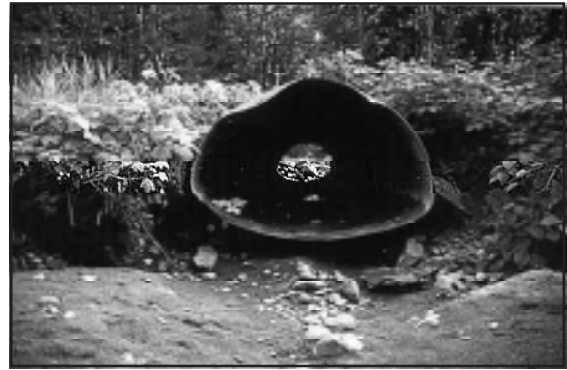
During this time, the lower channelized section of the creek was identified as having two different areas suitable for restoration. At this time, the reach provided no overwintering or rearing habitat and consisted of one long riffle with an average slope of 4.2%. Furthermore, the culvert under the Chilliwack Valley Road was a potential barrier to fish at low flows (Fig. 2-30).

Figure 2-30. Outlet of culvert on Young Creek before construction.

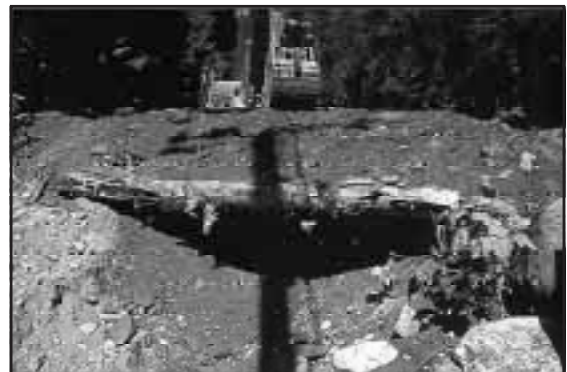
Figure 2-31. Construction of undercut bank at Young Creek.

Additional cover was created during reconfiguration of the creek with the construction of an undercut bank immediately downstream of the culvert passing under the Chilliwack Valley Road (Fig. 2-31).

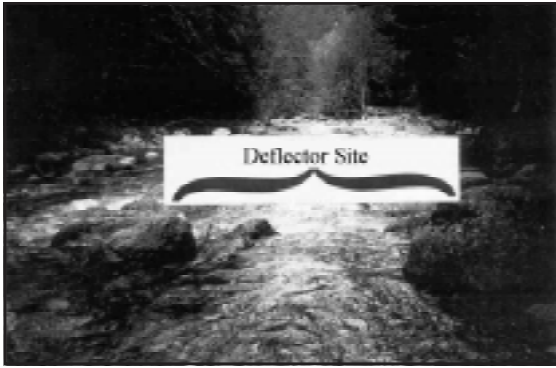
Figure 2-41. Downstream view of Yola Creek rock deflector.

The project was completed on the date of September 5, 1998. Construction of the rock deflector consisted of the placement of four 0.7 m boulders within a 15 m² area between existing stable boulders. The boulders were placed in two rows approximately 1.25 m apart extending downstream at a 30 to 40 degree angle out from the right bank. A 5-6 m log, with a diameter of approximately 0.6 m, was cabled in between the two rows of boulders. All materials were found locally (Figs. 2-41 to 2-44).

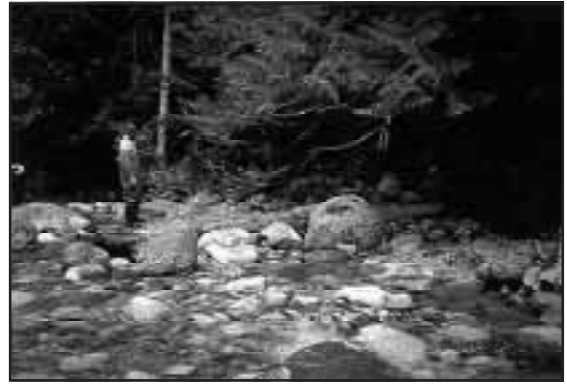
Figure 2-44. Downstream view of constructed rock deflector.

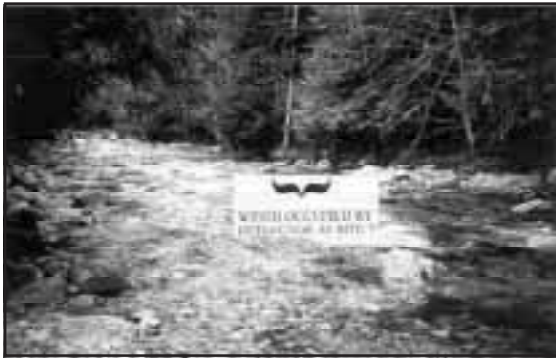
Figure 2-42. Downstream view of Yola Creek rock deflector site.

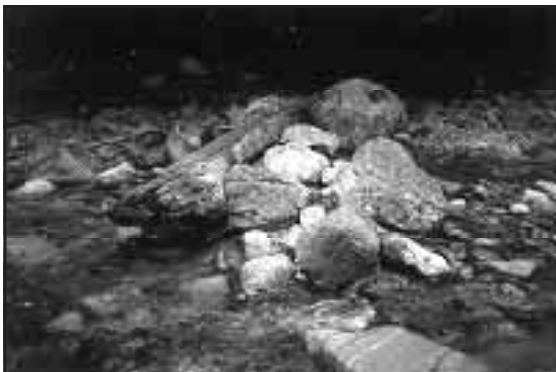
Figure 2-43. Side view of rock deflector.

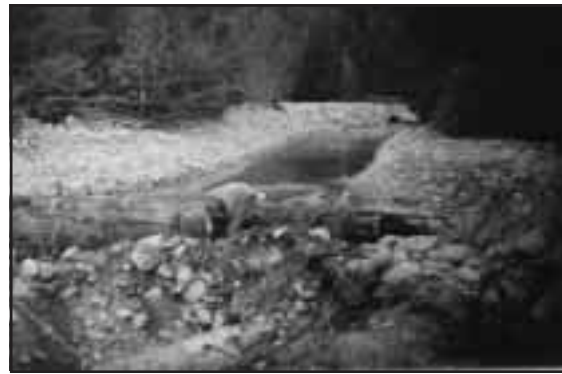
Figure 2-47. Constructed connecting channel and deadman anchoring of LWD.

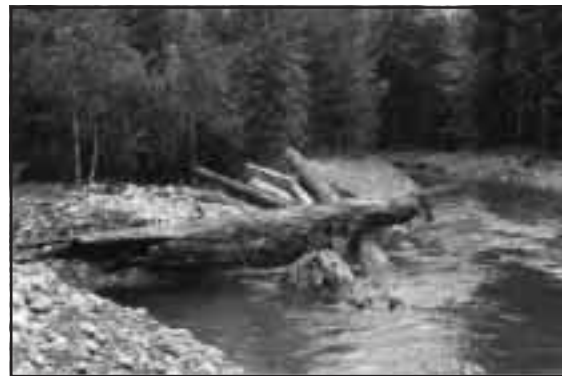
Figure 2-48. LWD structure on the outside of a meander bend.

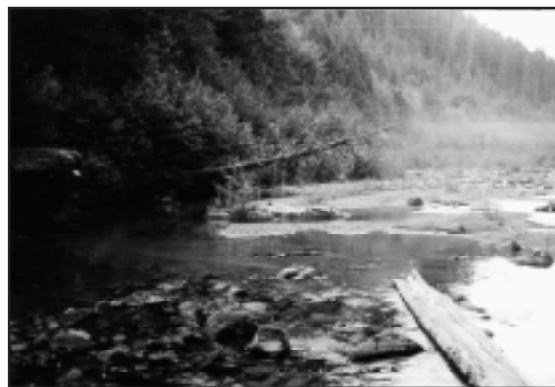
Figure 2-49. Upstream pool location prior to excavation (looking downstream).

Construction of the meanders involved stream substrate excavation resulting in the formation of pools (Figs. 2-49 to 2-52). The excavated material was used to construct point bars on the

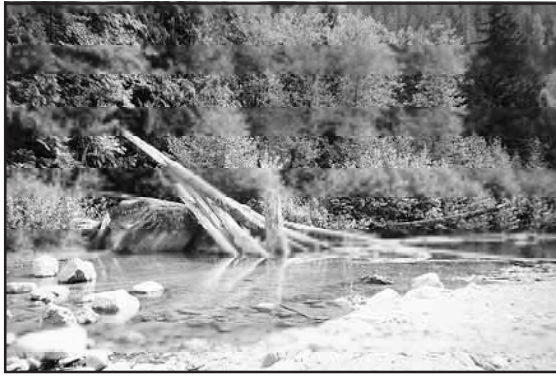
Figure 2-50. Upstream pool as-built.

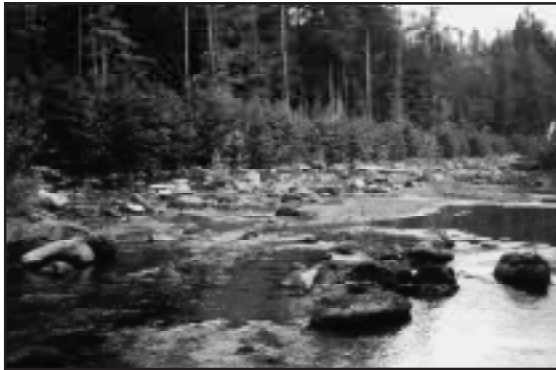
Figure 2-51. Middle pool location prior to excavation (looking upstream).

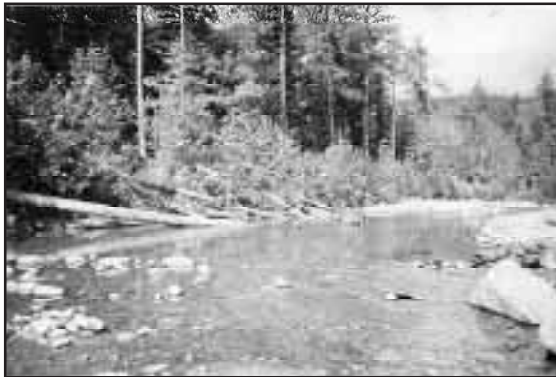
Figure 2-52. Middle pool as-built (looking upstream).

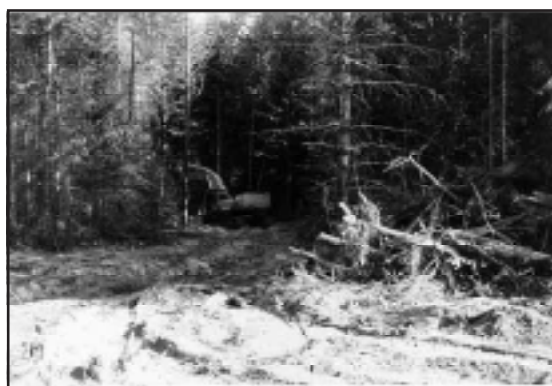
Figure 2-55. Clearing of the outlet channel.

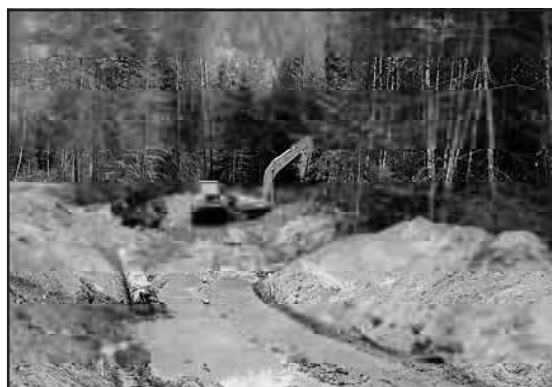
Figure 2-56. Outlet channel during construction.

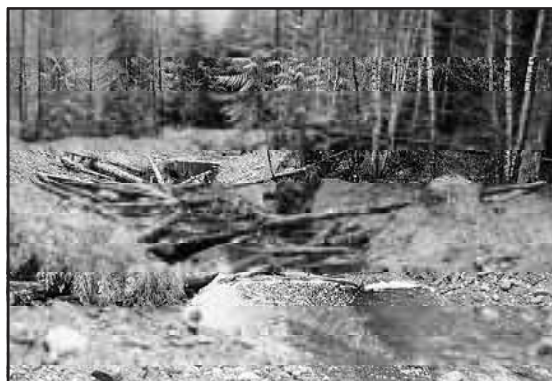
Figure 2-57. Outlet channel as-built.

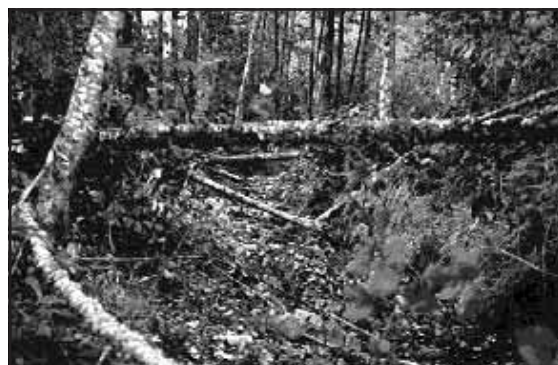
Figure 2-60. Outlet channel prior to restoration.

The existing outlet channel was widened to 6 m (Figs. 2-60, 2-61). Three riffles were constructed at appropriate elevations (0.5 m drop between each). The riffles have a 15:1 slope on the downstream face and were constructed to the standards in WRP Technical Circular No. 9. Angular rock from a nearby quarry site was used to construct the riffles. Minimum diameter of the rock used for the riffle construction is 250 mm. Rocks of approximately the same size were used to armour the banks of the channel. Approximately 60 m³ of rock was used in construction of the riffles and to armour the banks.

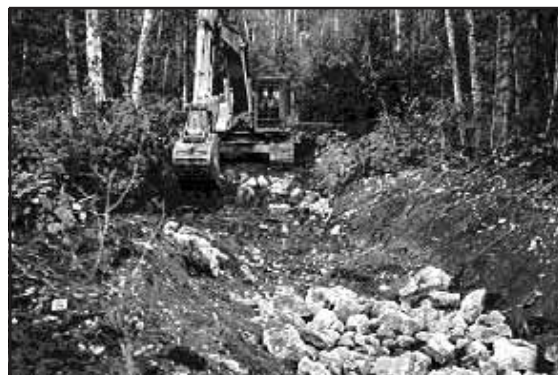
Figure 2-61. Outlet channel during restoration.

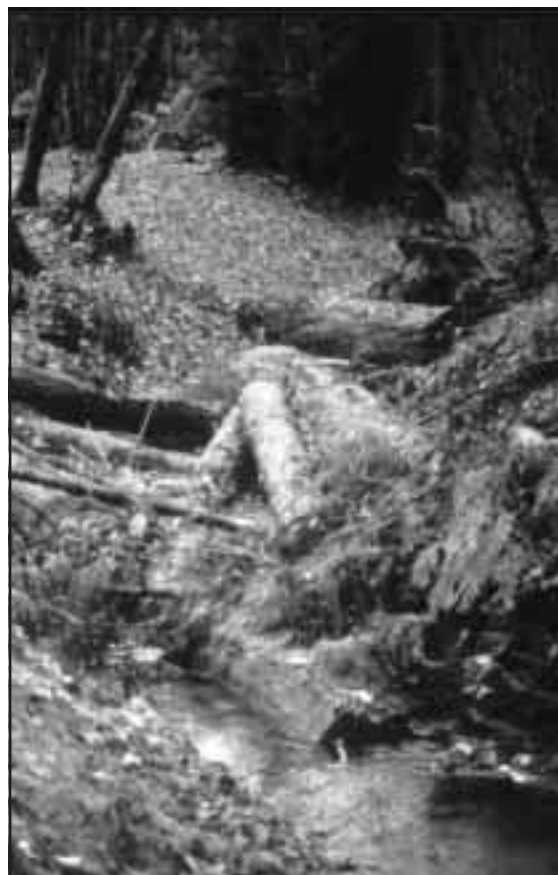
Figure 2-62. LWD placed in upper portion of channel below intake.

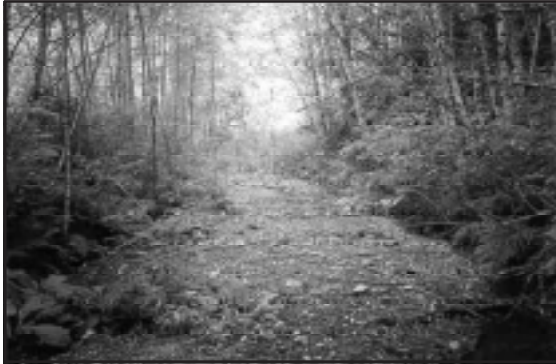
Figure 2-65. Groundwater channel pre-construction.

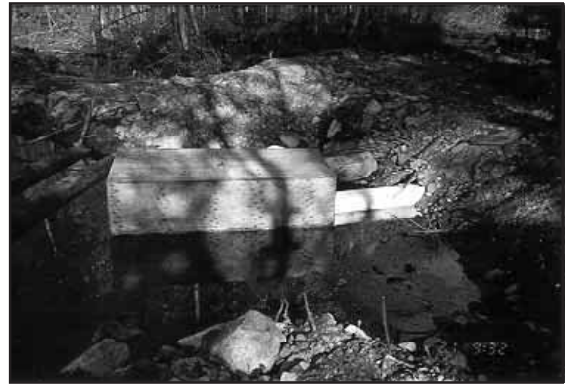
The resulting pond area is approximately 6000 m² of varying depths (half of which is >2 m). The ponds were constructed by a combination of excavation of material below the groundwater table and construction of berms to detain water. The lower-most pond was designed to be the same level as the existing beaver pond and the two were connected. Connecting channels between the different pond levels were protected from damming by beavers with a culvert/beaver box structure (Fig. 2-67).

Figure 2-67. Installed beaver box.

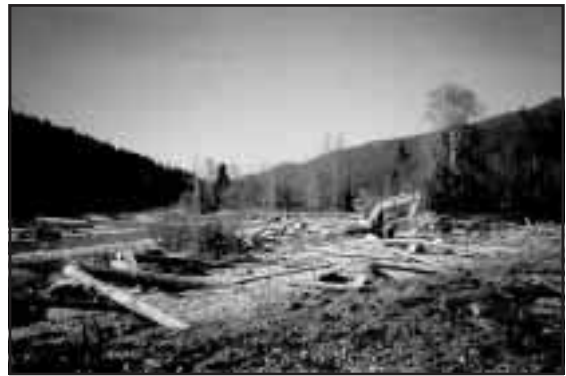
Figure 3-4. Chase Creek bar stabilization structures under construction, spring 1998.

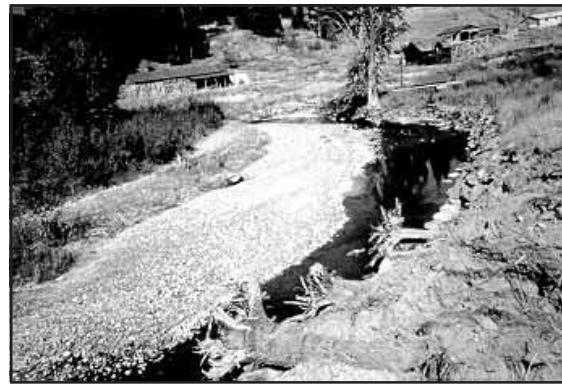
Figure 3-7. Rock weir within new channel.

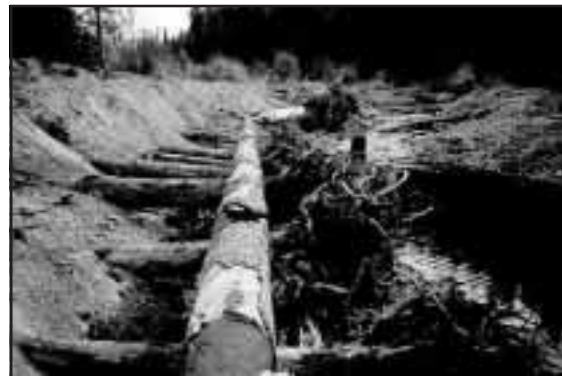
Figure 3-9. Log crib wall.

At a separate location, the stream curves sharply and impacts against a section of steep slopes, which are subject to continual raveling and surficial sloughing of loose material. Prescriptions were created to construct a series of whole tree revetments along the length (50 m) of the stream curve (Figs. 3-8, 3-9).

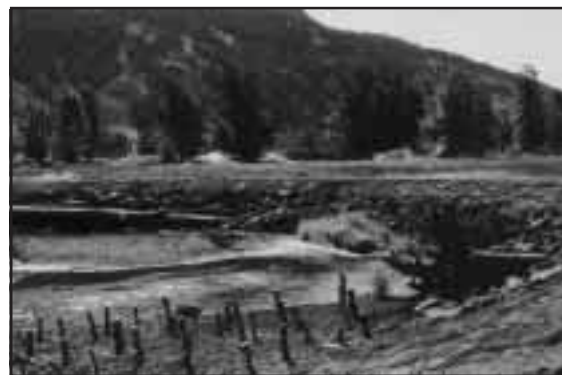
Figure 3-11. Tree revetments and live pole riparian restoration on Deadman River.

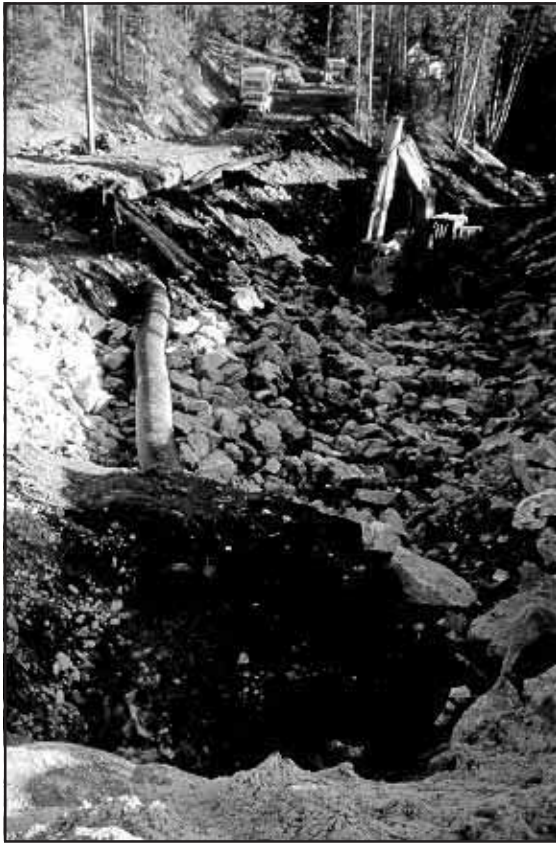
Figure 3-15. Streamflow bypass pipe in Hudson Creek, February 1998.

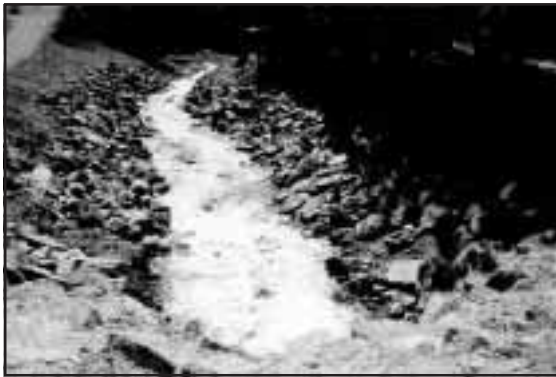
The works were monitored during the freshet in May 1998 to confirm project effectiveness (Fig. 3-16).

Figure 3-16. Freshet flow Hudson Creek, Anglemont May 1998.

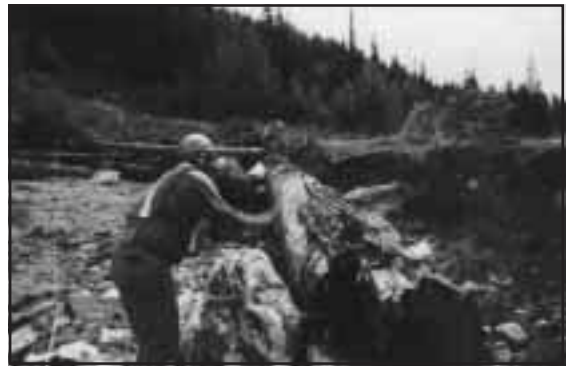
Figure 3-20. Lateral debris jam construction on Danforth Creek (Kingfisher).

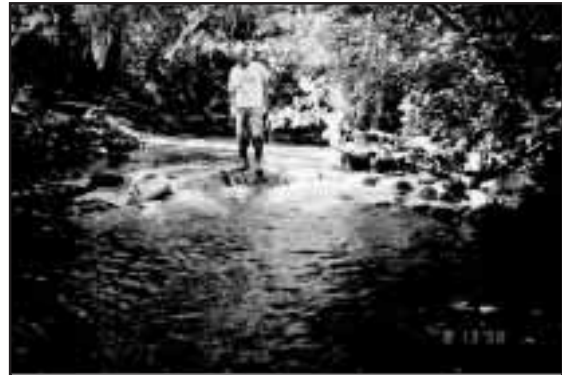
Figure 3-21. Boulder weir to create scour pool and central thalweg.

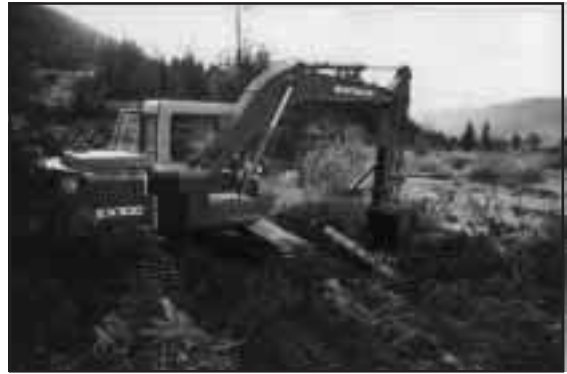
Figure 3-28. Excavator used to tighten and place deadman logs into T-trenches.

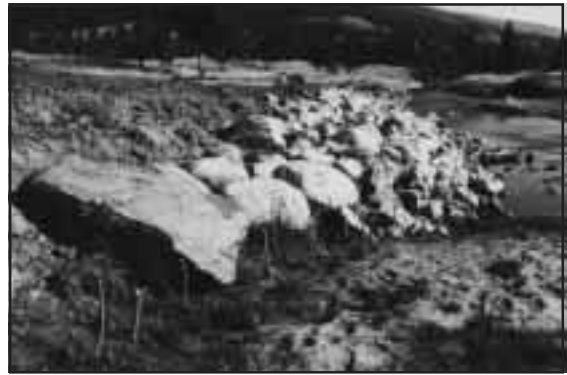
Figure 3-29. Channel manipulation using graded rip-rap and supplemented with planting willow stakes.

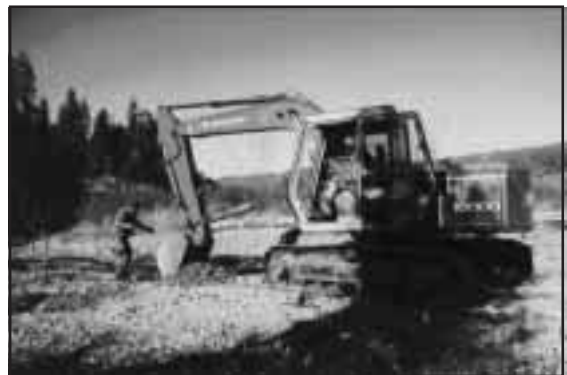
Figure 3-30. Bar planting using excavator. Willow stakes (3-4) were planted per bucket, up to 1 m deep.

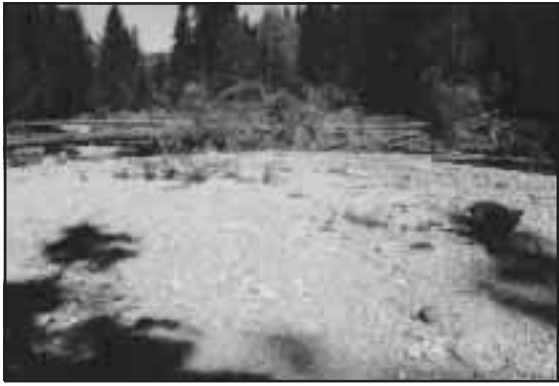
Figure 3-31. View in a northerly direction of Granite Creek at the log jam at 8.3 km Arrastra Cr. Road. Note: partial clearing (west) and fortification (east). (24 September, 1998).

- Five large rootwads were placed into a void in the log jam (8.3 km Arrastra Creek Road) adjacent to the east bank to fortify the east portion of the log jam so that flows would be encouraged to pass under the log jam at the west portion of the log jam (Fig. 3-31). Three large logs in the west portion of the log jam were cut and placed along the east bank immediately upstream for bank protection. Branches were removed from the logs which spanned the flow in the western portion of the log jam to allow flows to pass through and to minimize entrapment of woody debris.

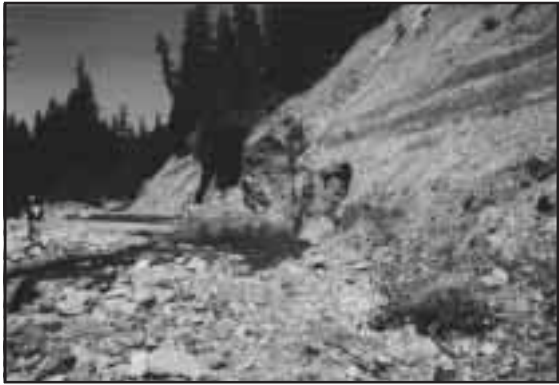
Figure 3-32. View in a northerly direction of Granite Creek facing downstream before installation of the Bendway Rock Weirs (21 July, 1998).

- A total of 130 boulders (approx. 1 m dia.) were used to construct four Bendway Rock Weirs and to protect the toe of the eroding bank between, and upstream of, the base of the four weirs (Figs. 3-32, 3-33). The Bendway Weirs were designed to divert high flows away from the toe of the slope and into the middle of the channel. Four trenches, approx. 0.8 - 1.2 m deep and 6 - 7 m long, were excavated in the creek at an upstream angle of 10 - 15° from perpendicular to the eroding bank. Six to eight boulders were placed within the trench contiguously and the trench was back filled with previously excavated substrate. The next two parallel rows of six boulders each were placed on the creek bed contiguous to, and on either side of, the first row. The last row of boulders was placed on top of the two parallel rows.

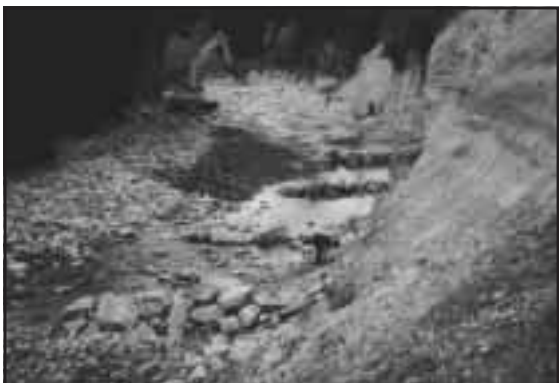
Figure 3-33. View in a northerly direction of Granite Creek facing downstream after installation of the Bendway Rock Weirs (24 September, 1998).

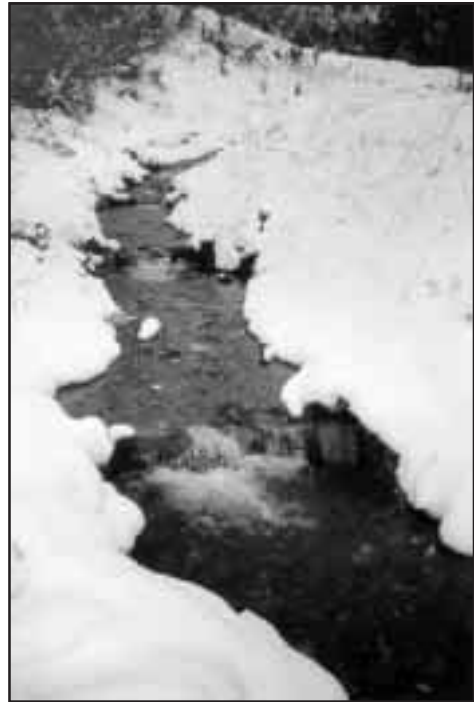
Figure 4-4. Main pond outlet channel after supplemental water and new vortex weirs.

Visual monitoring during 1998 suggested that the log vortex weirs within the main pond outlet channel were a barrier to juvenile fish. Fish observed in the main pond were all greater than 10 cm while the lower pond (which still had mainstem connection) contained numerous fish that were less than 10 cm. Based on the above, it was decided that a reduction in the outlet channel gradient and reconstruction of the log vortex weirs using rock would allow juvenile fish to access the main pond.

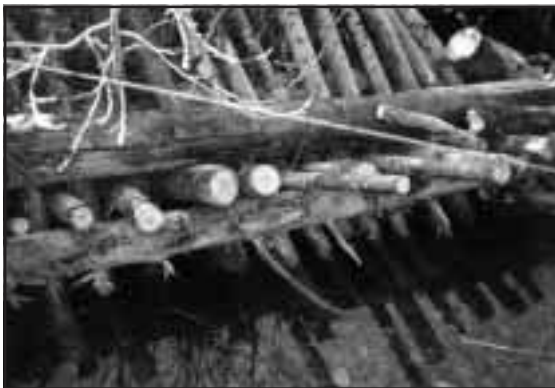
Figure 4-13. Structure #8 on Buckworth Creek, a revetment designed to minimize further undercutting of the stream bank and provide instream cover.

A total of 15 structures were placed in Reach 3 (Figs. 4-13 to 4-16). The structures were comprised of single and multiple log/rootwad placements comprised of triangular log structures and LWD bank revetments. These structures are designed to dissipate energy, promote scour in certain locations, increase habitat complexity and maintain bank stability. In all 49 logs, 38 rootwads, 32 boulders, 4 whole trees and 47m of cable were incorporated into the 15 structures.

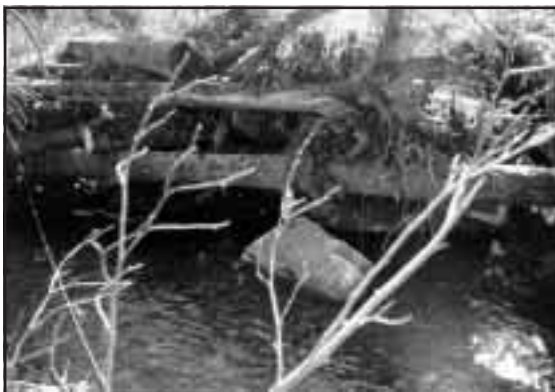
Figure 4-14. A log/rootwad structure on Buckworth Creek.

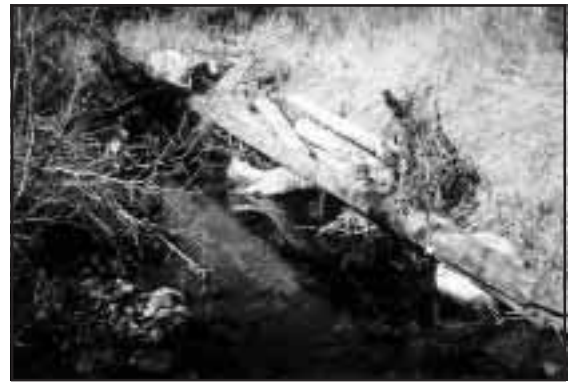
Figure 4-15. A log/rootwad structure on Buckworth Creek provides instream cover and protection to the stream bank.

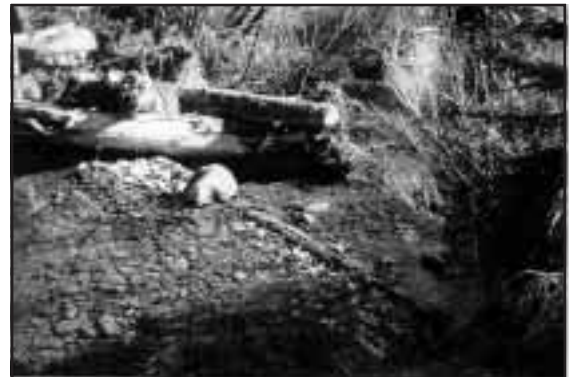
Figure 4-16. A stoplog/rootwad structure on Buckworth Creek.

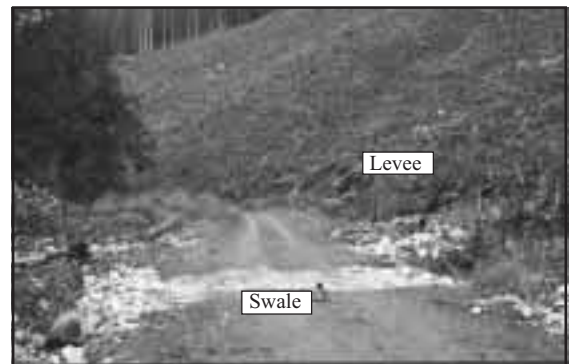
Figure 4-32. Post-work view of cobble swale and ditch block levee at the North Downie FSR crossing of “Shake Block Creek”.

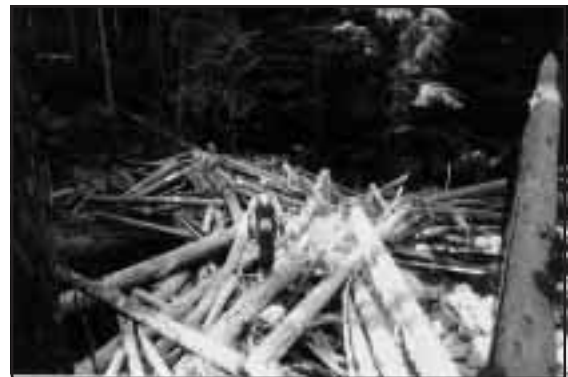
Figure 4-56. The beginning of removal of the debris jam on Sanca Creek.

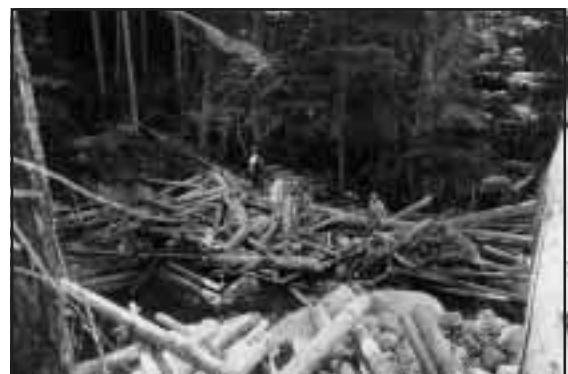
Figure 4-57. The Sanca Creek channel opened at the site of the debris jam.

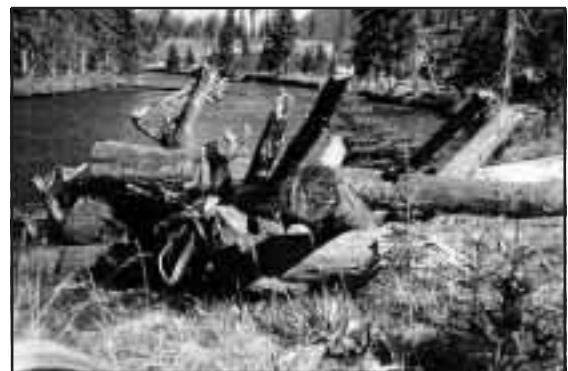
Figure 4-63. One of the large LWD structures constructed and also illustrates the impacts from harvesting on the riparian zone.

Prescriptions were developed to target two primary objectives. They were to increase habitat and pool complexity at the two locations and stabilize one large eroding bank that was at risk of catastrophic failure. The objectives at Site 1 were to build three large triangular lateral log jams (Fig. 4-63) and a large LWD revetment to stabilize the eroding bank. Two large triangular lateral log jams were constructed at Site 2. Placement of the five structures was to encourage scour, create pool habitat associated with overhead cover for sub-adult and adult trout (Oliver 1998 a). Recruitment of natural LWD at both sites would not occur for at least 30-40 years.

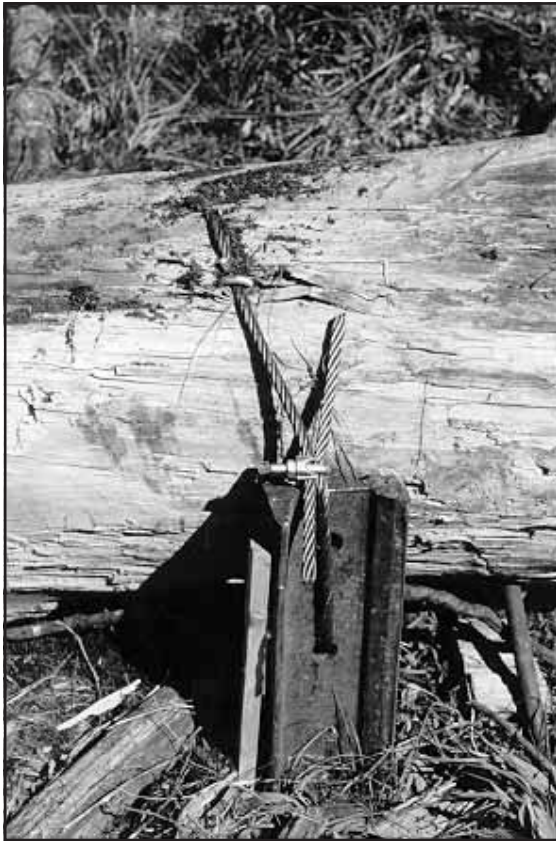
Figure 4-64. Typical placement of anchor “piers” used to supplement boulder ballasting.

to the rock types found in the Rocky Mountains. To reduce the amount of boulders used, and cost, metal railway line was used as “stakes” or “piers” to anchor the bank ends of the structures (Fig. 4-64). These “stakes” are pounded into the bank a minimum of 3 m leaving at maximum 30 cm of the stake exposed. The exposed part of the “stake” has holes to allow for cabling.

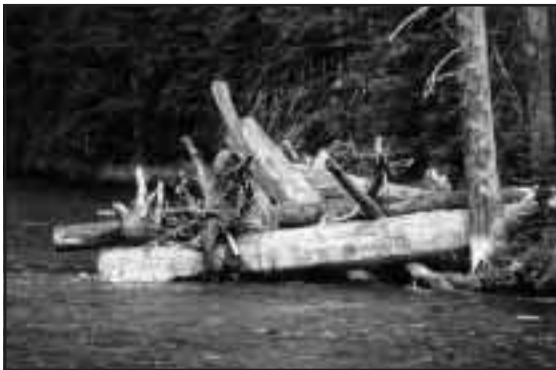
Figure 4-65. Large LWD structure. Note the use of a variety of sized LWD and rootwads for added complexity and strength.

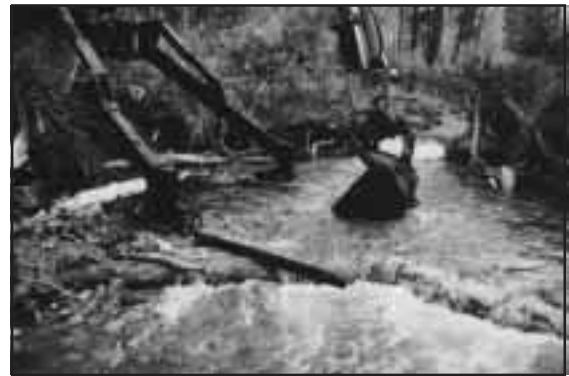
Figure 4-68. Placement of a log V-weir will provide gradient control following debris removal.

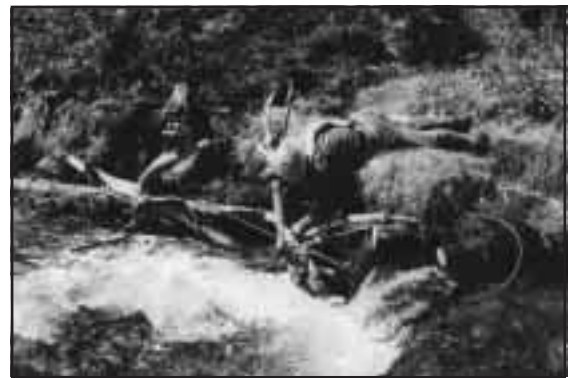
Figure 4-69. Rootwad LWD placement will provide bank stability and create habitat.

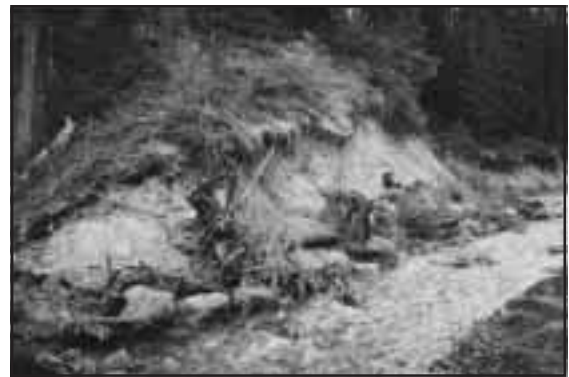
Figure 4-70. Eroding bank stabilization using displaced forest workers.
