**Annual Compendium Of Aquatic Rehabilitation Projects
For The Watershed Restoration Program
1998 - 1999**

Watershed Restoration Project Report No. 13

Watershed Restoration Program
Ministry of Environment, Lands and Parks
2204 Main Mall, UBC
Vancouver, BC V6T 1Z4

1999

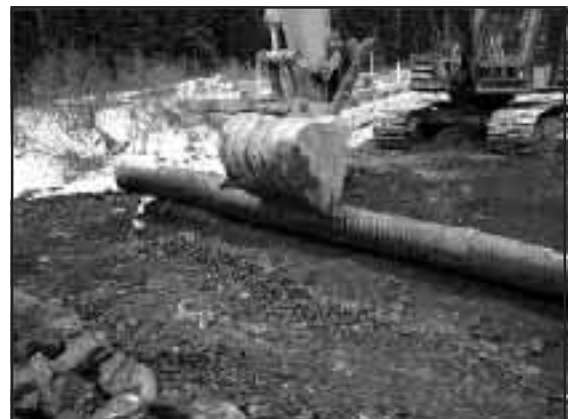
Figure 5-6. Channel bypass.

Water was diverted into the smaller of the two existing culverts while the larger one was removed and the channel reconstructed (Fig. 5-6). Silt fences were placed downstream during all phases of construction to maintain water quality during installation.

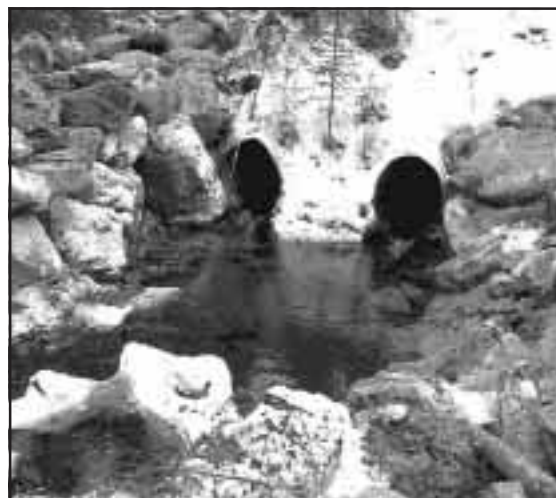
This barrier to fish was identified during a field inspection by Weldwood staff. It was determined during the site plan preparation that the existing culverts were sufficiently large to accommodate the Q100 flows. The primary barrier to fish was caused by the 20 cm outfall at the downstream end of the culverts and increased water velocity during high flow periods (Fig. 5-11). Constructing weirs to eliminate the outfall drop barrier was determined to be the most cost effective solution.

Figure 5-11. Culverts prior to weir construction.

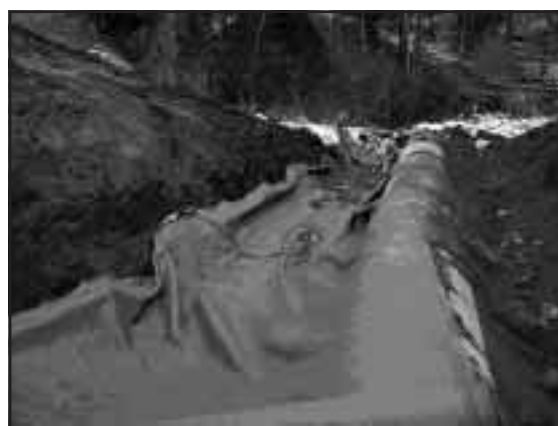
Figure 5-25. Preparing bypass channel.

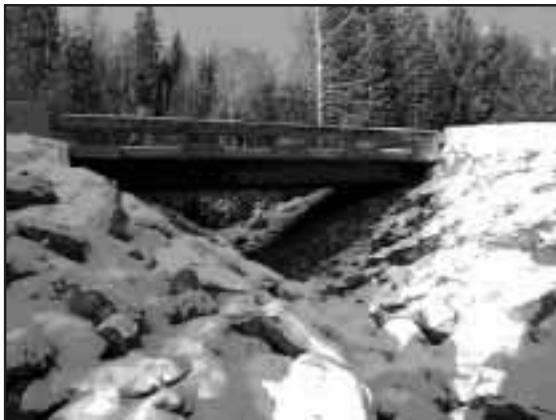
- Concrete deck composite design (9.1 m) (Fig. 5-28).
- Pre-cast concrete footing with 8 inch steel towers.
- Bridge deck at 3% slope.
- Reconstructed channel width 2.5 m.

Figure 5-28. Completed 8200 Road bridge installation.

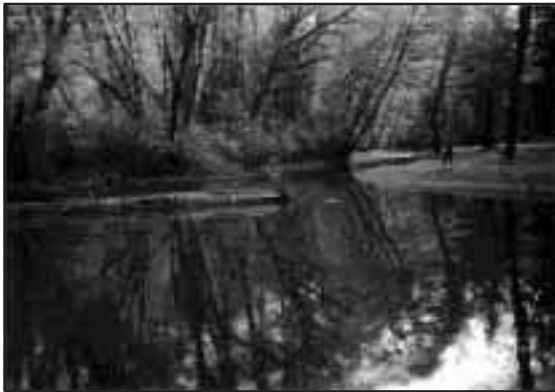
Figure 5-29. Off-channel rearing pond excavated along Kwatna River mainstem prior to LWD complexing and planting of broadcast overburden materials.

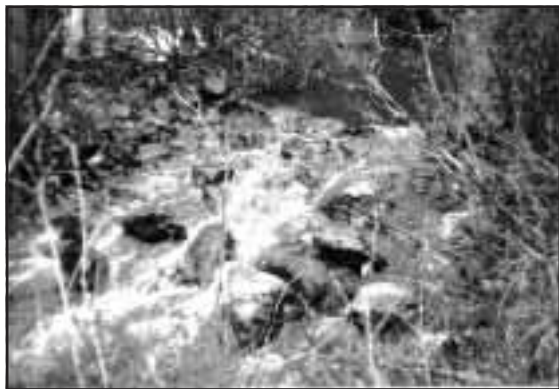
Figure 5-30. Hand constructed rock riffle completed on Rebman Creek mainstem.

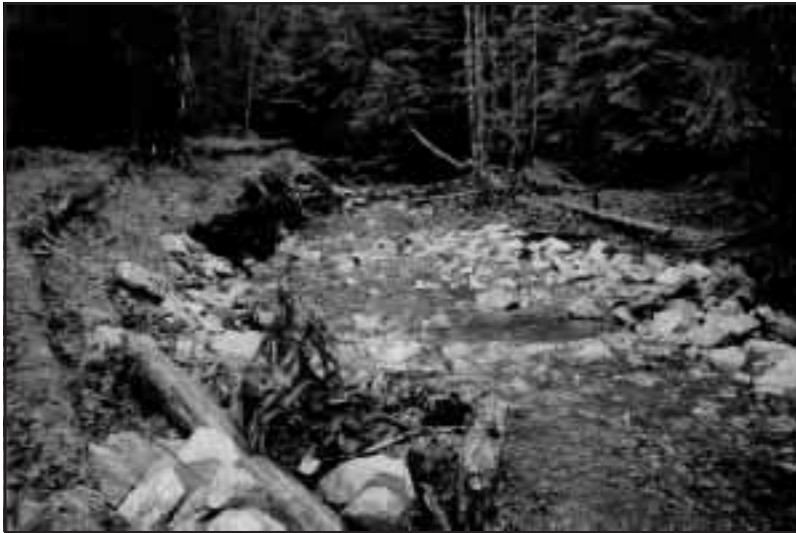
Figure 6-3. Reach 2C3 V-shaped deflector installed under a bridge to protect an eroding bank and promote channel scouring

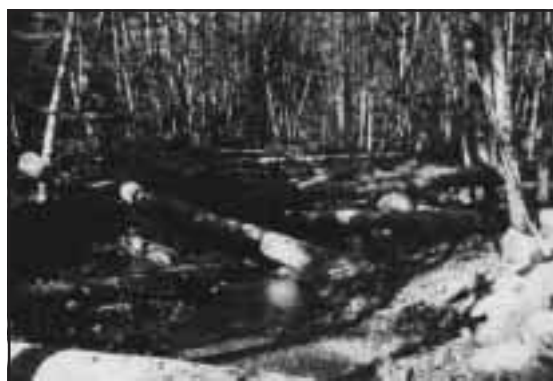
Figure 6-5. LWD added to Reach 6 in Ginlulak Creek to promote scour, improve channel definition and provide cover for coho salmon.

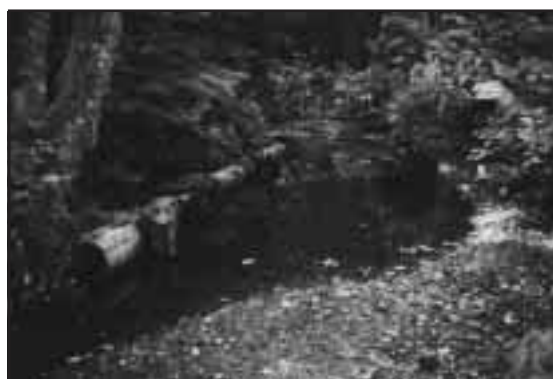
Figure 6-7. One section of Reach 7 after stream cleaning and placement of LWD for cover.

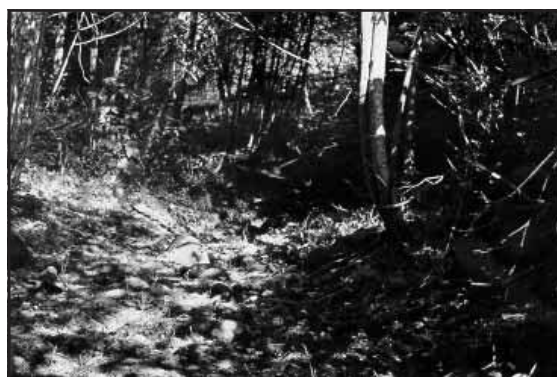
The side channel construction began in August 1997 with the excavation of a dry area 383 m² by a 490E John Deere excavator (Figs. 6-11, 6-12). A log cribbing berm was built adjacent to Deep Creek and some of the excavated material and large rocks were used as ballast (Fig. 6-13). A deep pool was dug immediately behind the cribbing to create a head pond behind a control structure. Three spawning pads were created in the channel with the existing gravel that was graded by hand using a mesh grader with aluminum pipe grates spaced 3.5 cm apart to regulate the water flow through the channel. A flow control structure was constructed using treated lumber 15 m downstream from the cribbing (Fig. 6-14). The structure is a stop-log design with an opening 120 cm wide by 80 cm deep with slotted sides that 2"x6" planks fit into to control the flow of water. Upon completion of the channel construction, 3 Big 'O' pipes with a diameter of 15 cm and a length of 3 m were placed in the berm to provide, along with the opening through the rocks, an intake for the creek water to flow into the side channel. Following completion of the intake, woody debris and large rocks were installed at key locations in the channel.

Figure 6-11. Abandoned side channel on Deep Creek prior to off-channel habitat rehabilitation.

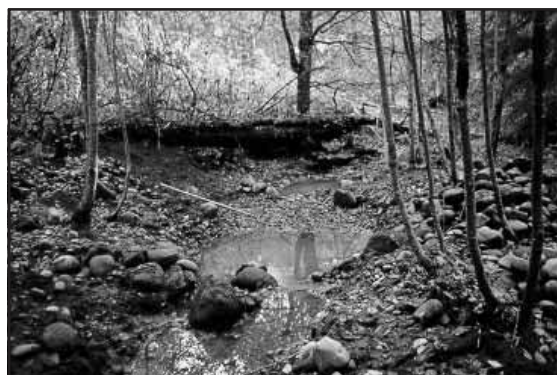
Figure 6-12. Abandoned side channel after excavation without water intake open.

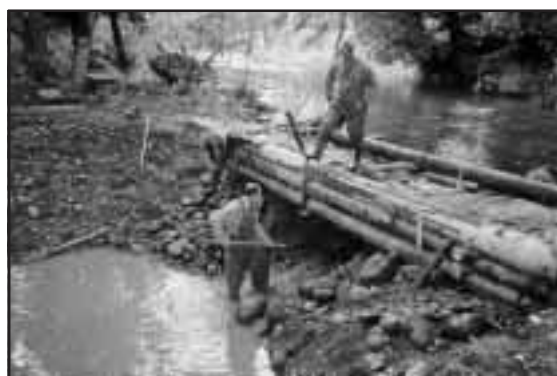
Figure 6-13. Construction of a berm to protect off-channel development.

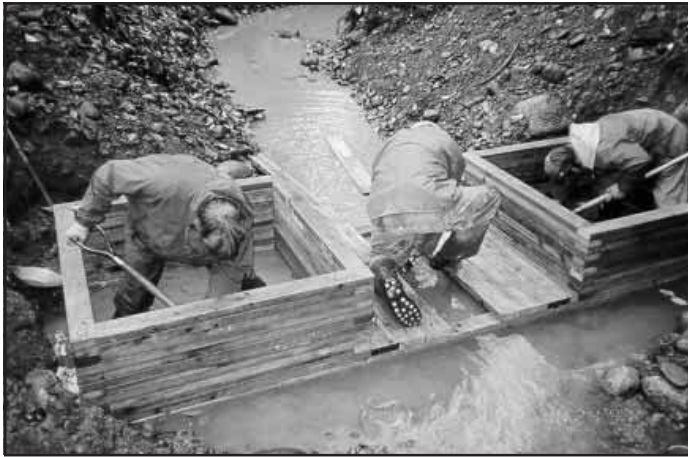
Figure 6-14. Box culvert construction; controls flow into side channel.

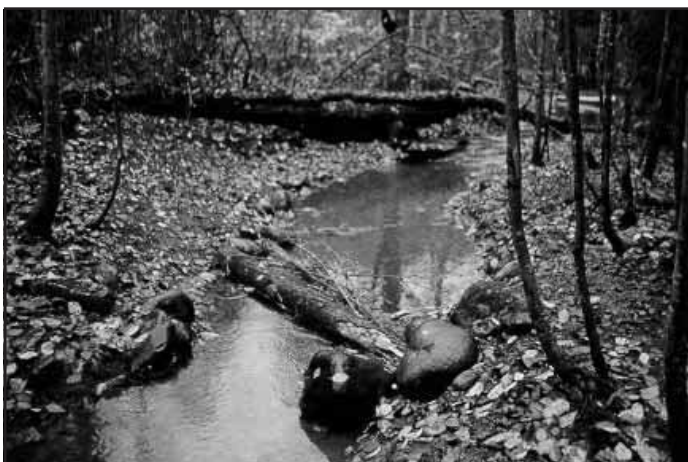
Figure 6-16. Deep Creek side channel water levels during low flows.

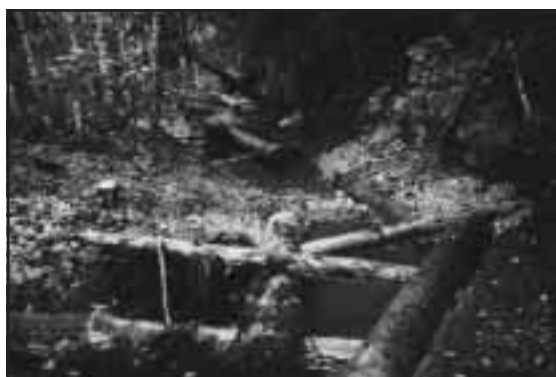
Figure 6-17. Groundwater channel constructed along valley wall of Kwinyarh Creek alluvial fan.

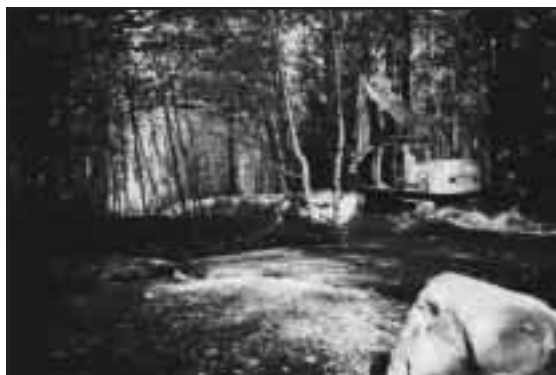
Figure 6-18. Construction of protective berm along right bank of Kwinyarh mainstem to protect newly constructed channel.

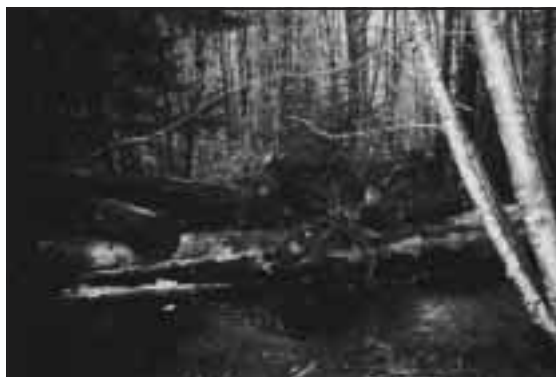
Figure 6-19. LWD jam constructed along left bank of Kwinyarh mainstem to close off an avulsion channel.

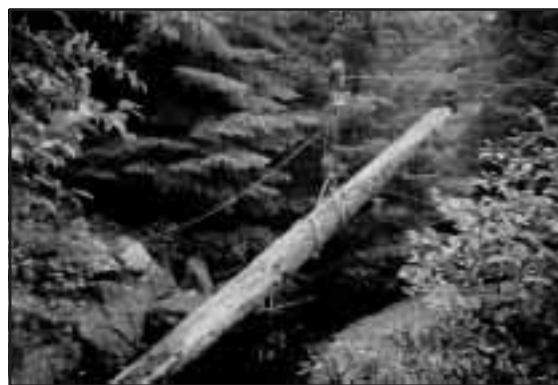
Figure 6-20. A large Western red cedar log being moved from the road to the creek using a skyline and chainsaw winch.

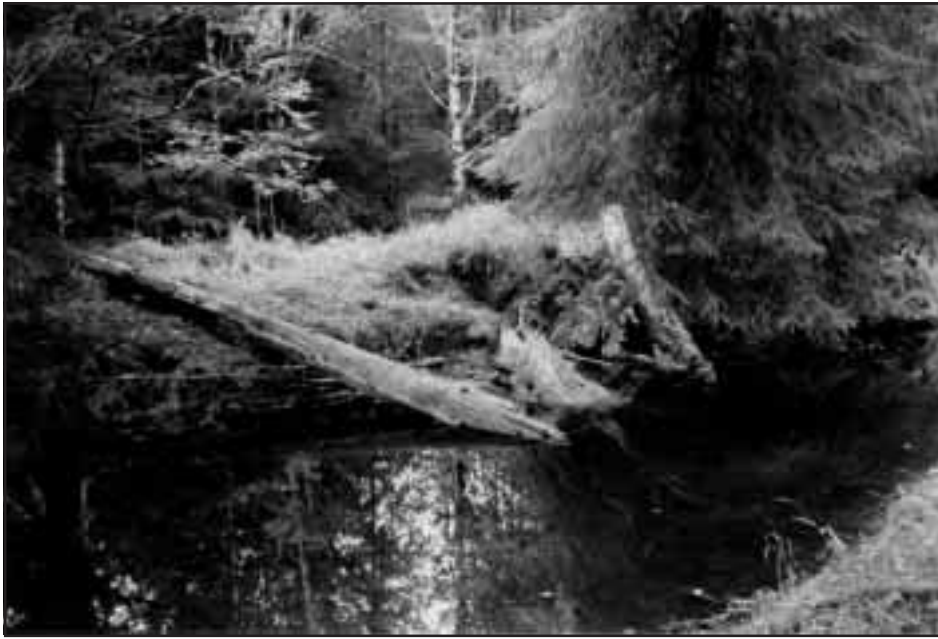
- On the second day of the rigging course, another skyline, spanning approximately 50 m of stream channel, was established to move material further along the stream. Logs and boulders were moved to the third site located approximately 57 m downstream of the road crossing and placed using blocks with the chainsaw winch and turfer jack.
- A fisheries biologist from the US Forest Service, Brian Bair, participated in the workshop. He demonstrated the weaving of small diameter trees (<10 cm dbh) into the streambank, both to provide cover for fish and natural armouring from erosive forces.
- Rigging work continued for 8 days after the workshop with a crew of 3 to 4 people. In total, 7 of the 8 LWD structures were in place and another day was spent cabling the structures (Fig. 6-21).

Figure 6-21. Completed wood structure at the lower wood placement site.

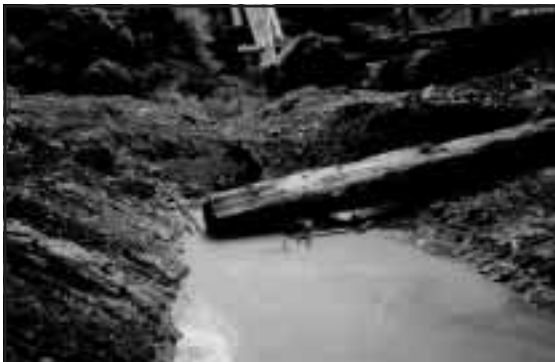
- Four cross-spanning logs structures placed approximately 8m apart along the excavated channel were prescribed (Fig. 6-22).
- Large cobble-sized and larger material was required to armour the bed for the logs to prevent undermining of the log structures.

Figure 6-22. Excavation of channel in preparation for the installation of the second upstream log.

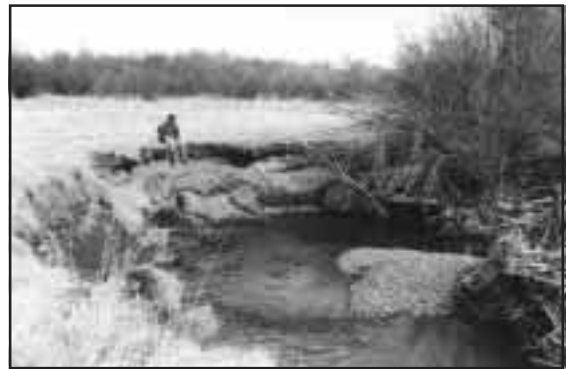
Figure 7-21a. Before restoration of an eroding bank.

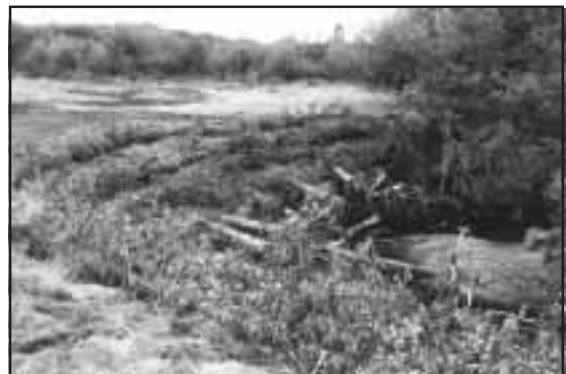
Figure 7-21b. After restoration of an eroding bank.

In these same reaches of Corkscrew Creek, 200 linear m of streambank were stabilized, covering an area of 0.42 ha. Bioengineered slope stabilization strategies were designed after Babakaiff et al. (1997) to re-establish willow and cottonwood on riparian banks and to stop further erosion. Willow wattles, brush layers, live stakes and willow mattresses were assembled and put in place by a crew of six Saik'uz First Nation technicians through August and part of September (Figs. 7-21b and 7-25). Additionally, a riparian planting program, carried out by nine Saik'uz First Nation students, planted 20,000 spruce and 88 alder seedlings, as well as 16,185 willow and 15,519 cottonwood whips. These were planted throughout the watershed specifically, in areas where past logging practices

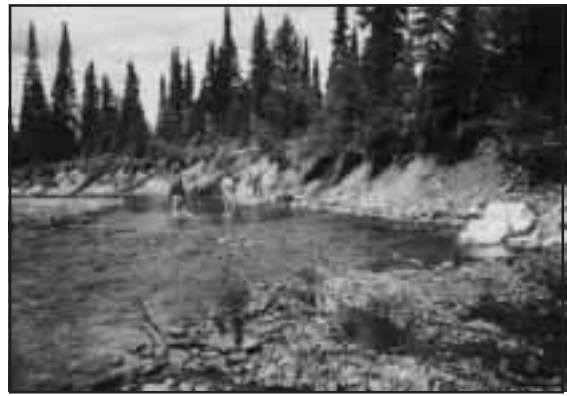
Figure 7-31. Pre-restoration downstream view of large eroding bank along Narrowlake Creek mainstem.

- rock groynes/deflectors (Figs. 7-31 to 7-33);
- LWD revetments (Figs. 7-31 to 7-33), and
- an LWD/rip-rap combination to be constructed in winter 1999.

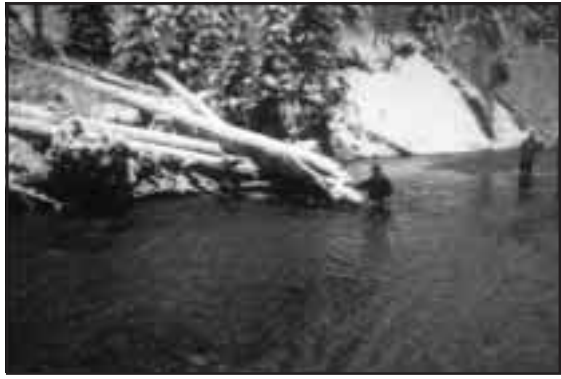
The LWD structures placed in the wetted channel were colonized by rainbow trout, bull trout, and whitefish almost immediately following installation. These structures, when constructed in existing pools or placed in pool-forming areas provide an immediate benefit to fish habitat as the percentage of woody debris cover in pools increases by approximately 20% following restoration (Fig. 7-34). From production

Figure 7-34. Post-restoration view of lateral LWD jam. Note depth of pool scoured out after October rainstorms. Large woody debris cover in pools is increased on average 20% following restoration.
