Watershed Restoration Program
Ministry of Environment, Lands and Parks
and Ministry of Forests

**Annual Compendium Of Aquatic Rehabilitation Projects
For The Watershed Restoration Program
1998 - 1999**

Watershed Restoration Project Report No. 13

1999

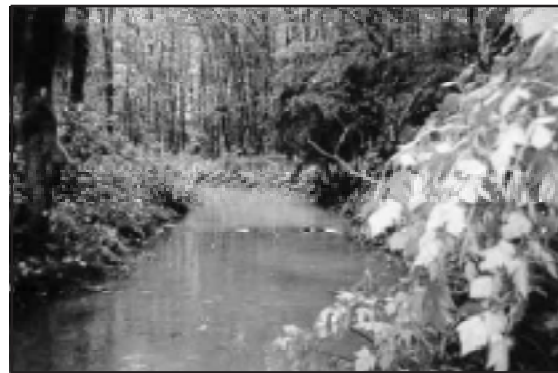
Figure 1-1. The first phase of the project completed in 1997, was 150 m long.

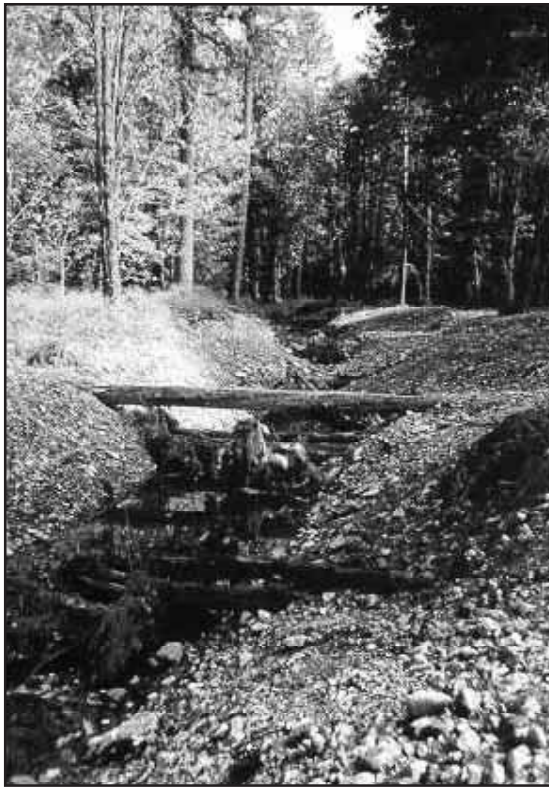
Figure 1-2. A large volume of wood was placed into the main channel to provide cover for adults and rearing salmonids.

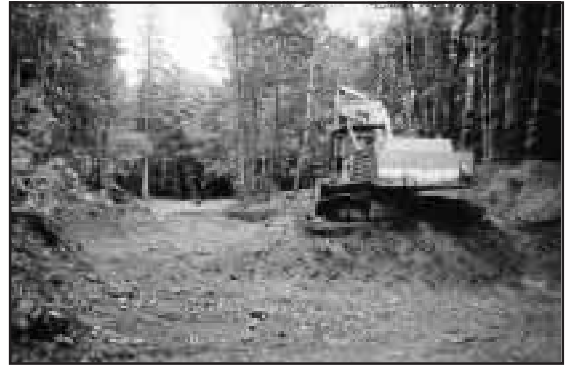
Figure 1-4. A Case 9040 excavator removed the overburden first to reduce the possible sediment load to the channel when it was excavated to grade.

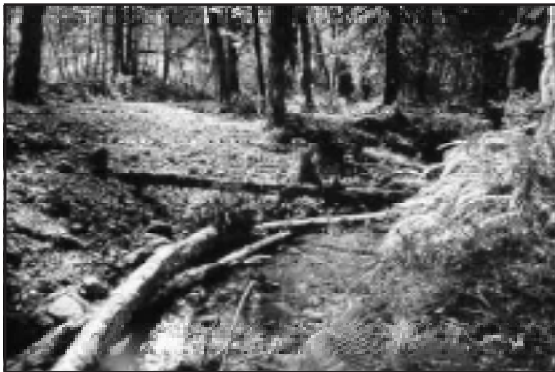
Figure 1-3. The secondary reach is 75 m long and is also heavily loaded with woody debris.

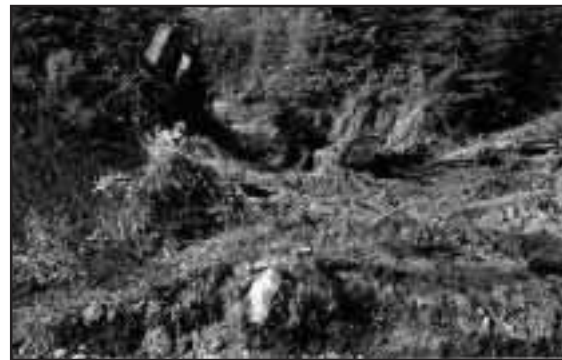
Figure 1-5. First pass overburden removal in the lower portion of the Cypre side channel.

The completed channel added approximately 690 m to the existing side channel, providing an additional 4420 m² of wetted area. Channel excavation required 5 passes, in each case working in an upstream direction. The first of these was a shallow cut to remove top soil (Fig. 1-5). This material was saved for use as a top cover on the set-back dyke. During preliminary excavation care was taken to preserve the existing coniferous forest on the southeast bank (Fig. 1-6). The second cut reached almost to the water table, removing mixed gravels and soils. This material was used for construction of the set-back dyke as were the subsequent cuts to a final grade level of 74.5 m. The final bed grade approximated 0%. Average channel width was 4 to 7 m with a side slope of 2:1 on the single disturbed bank. Discharge at the upper end of the channel exceeded the anticipated 5cfs.

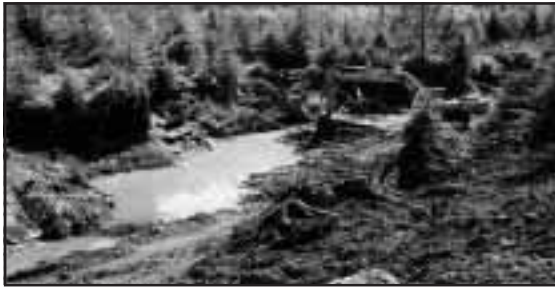
Figure 1-6. Site 18 in the upper portion of the Cypre side channel, with completion of the fourth pass to grade. As much of the southeast bankside vegetation as possible was retained during channel construction.

The set-back dyke was constructed from two or more lifts of channel material and varied in width at the top from 3 to 10 m with an average slope of 1.5:1. The final dyke height was 82 m, providing protection from 1:100 year floods. An access road was constructed along the dyke, also from side-cast channel material. This originated as a 4 - 6 m wide construction bench which was created between the base of the dyke and the top of the western bank (Fig. 1-6).

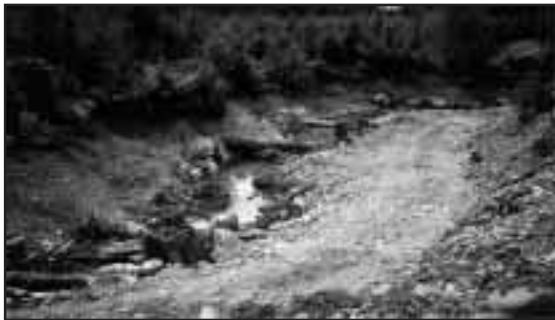
Figure 1-7. Site 18 following completion of the access road. The channel sides have been armoured with rip-rap, and complexing with wood is largely finished.

Eight alcoves and 5 pond areas were incorporated into the channel. Five shallow inverts were created to provide approximately 35 m of riffle habitat. Additional habitat for juvenile salmonids was provided through channel complexing (Figs. 1-7 and 1-8). General training in the techniques of channel complexing were provided by John Ebell in conjunction with on-site visits from an

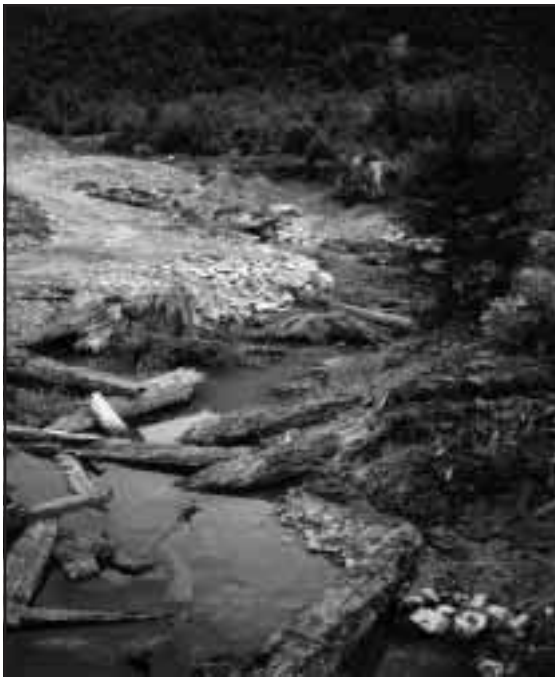
Figure 1-8. Channel complexing using rootwads, lateral revetments and LWD piles.

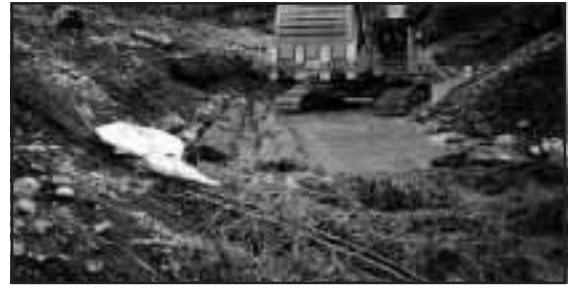
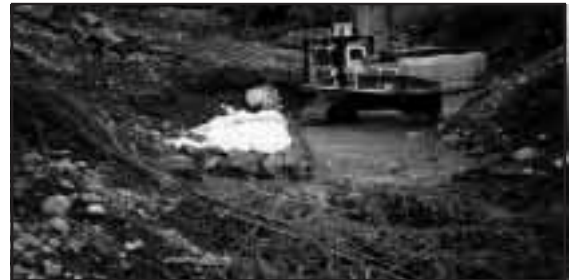
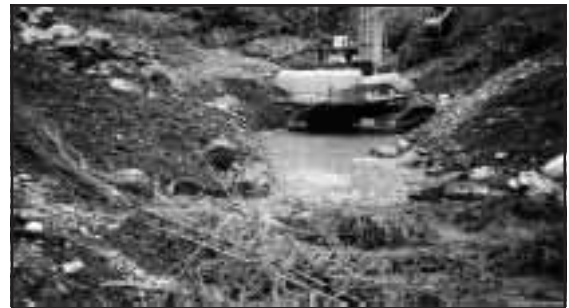
Figure 1-9a,b,c. Construction of an undercut bank using logs supported on boulders, covered with landscape fabric to minimize infilling and backfilled.

- Two concrete undercuts and 8 log cut banks were installed for a total of 55 m of channel bank. Each concrete undercut provided an area of 6 m² while log structures averaged approximately 4 m². Installation of a log undercut is illustrated in Figure 1-9.

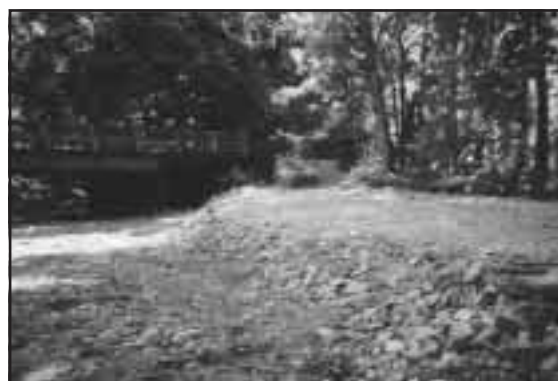
Figure 1-10 . Photograph of Site 2 in Reach 1 of the Goldstream River where the left bank was reconstructed using logs, rip-rap and gravel.

- Bank reconstruction to effectively narrow a 30 m section of the mainstem channel in Reach 1 to a normal bankfull width. This was accomplished by placing several 0.6 m logs end to end and backfilling with rip-rap and coarse gravel (Fig. 1-10). The instream face of the logs was covered with rip-rap to reduce erosion.
- Construction of 3 large woody debris structures, each consisting of 5-10 pieces of LWD (Fig. 1-11). Additional single log

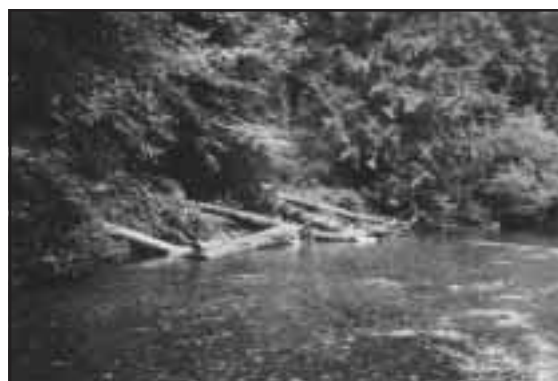
Figure 1-11 . Photograph of Site 7 where a typical lateral log spur was constructed along the right bank.

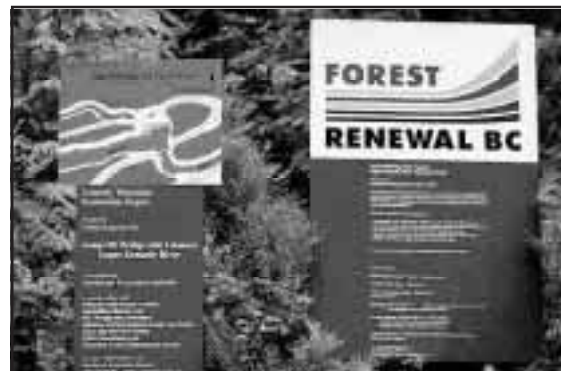
Figure 1-12. Signage developed on the upper Kennedy side channel.

flood protection dykes (Fig. 1-13), (2) intake and flow control structures, (3) excavation of main channel (Fig. 1-14), (4) complexing and function of entire side channel (Fig. 1-15), and (5) site cleanup, revegetation, bank stabilization and signage (Figs. 1-12, 1-16). Construction of the main dyke, intake system, and main channel were initiated in late September 1996 to mid-October 1996, and again in mid-July 1997 to mid-September 1997. The final phases of restoration on the upper Kennedy side channel started on August 12, 1998 and were completed on September 23, 1998.

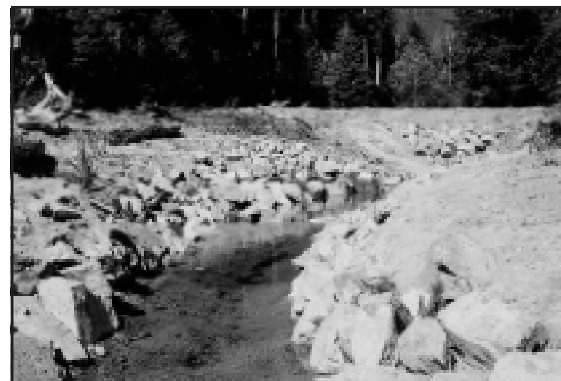
Figure 1-13. Discharge apron and start of the upper Kennedy side channel (looking upstream).

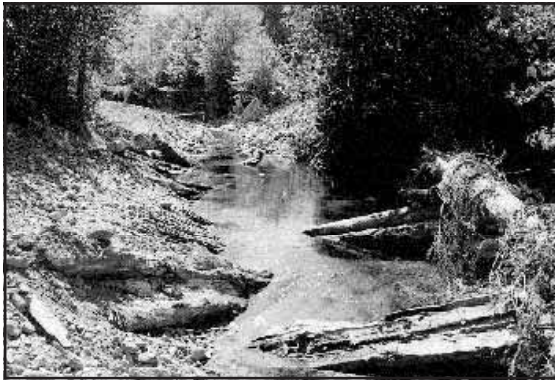
Figure 1-14. LWD structures, pool and riffle structure in the first 100 m of the upper Kennedy side channel.

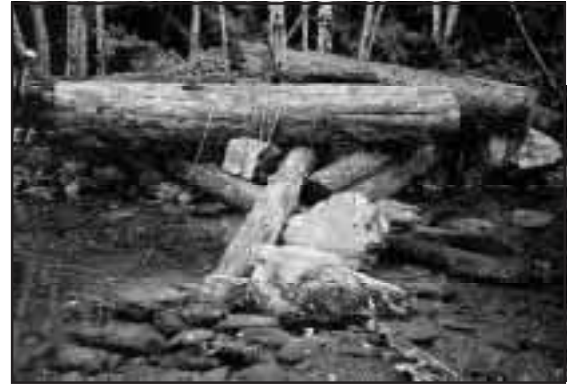
Figure 1-17. Stump Creek side channel LWD structure and excavated pool following first fall flood. Tla-o-qui-aht First Nation crew chief standing beside jam for scale.

A second smaller project was undertaken in 1998. Restoration of the Stump Creek side channel started on September 24, 1998 and was completed on September 25, 1998 (Fig. 1-17). Additional restoration of the Stump Creek side channel will be conducted through a number of phases in following years, but construction began in 1998 with a trial which included the excavation of a pool and placement of LWD structures to help support ongoing scour and sediment aggradation in the pool area.

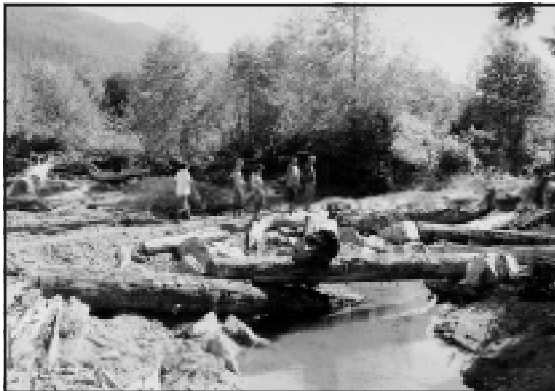
Figure 1-15. Rip-rap banks, LWD structures in the upper Kennedy side channel at 4+90 m.

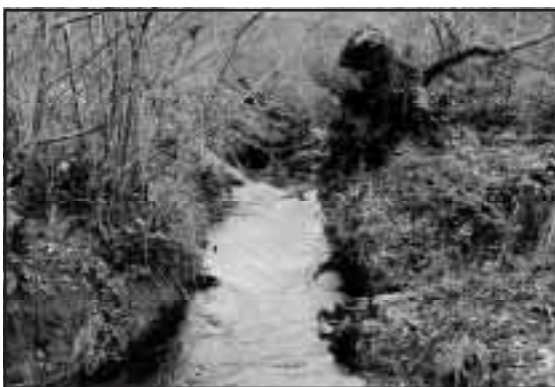
Figure 1-16. Lower portion (8+10 m) of the upper Kennedy side channel 1 year post construction.

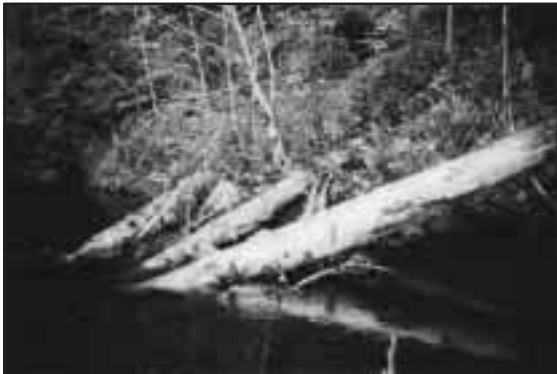
Figure 1-19. Bank protection /debris jam structure placed to protect an eroding bank, scour pool habitat and provide protective cover habitat.

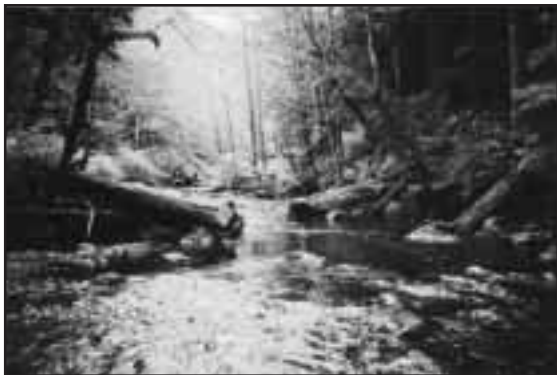
Figure 1-20. Lateral debris jam placed to scour pool, aggrade spawning gravel and provide protective cover habitat.

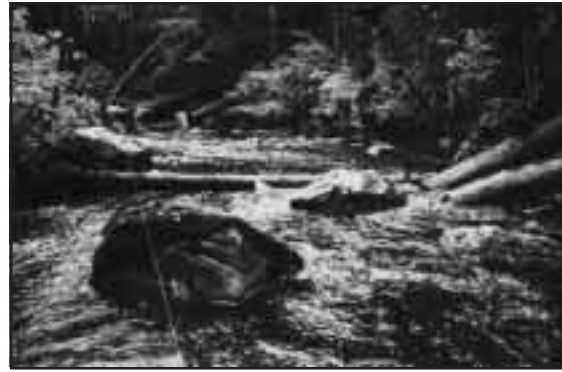
Figure 1-21. Large rootwad added to double deflector log to increase the efficiency of deflector structure. The same treatment was applied to an adjacent structure in an attempt to form a channel constriction to promote bedload scour.

Restoration activities were once again concentrated along the upper 13 km of the mainstem Keogh River, with an additional 1.4 km of stream length receiving restoration treatments. A total of 68 instream restoration structures were built during the 1998/1999 restoration season. A majority of instream restoration work involved the creation of new fish habitat (Figs. 1-18 to 1-20). Furthermore, considerable effort was put forth to either reconstruct, or increase the productive capacity of past restoration efforts (Figs. 1-21, 1-22).

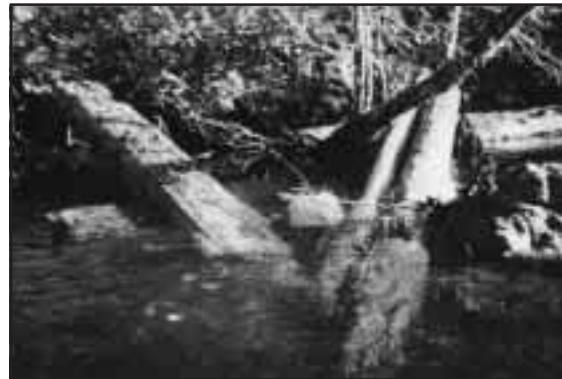
Figure 1-22. Lateral debris jam structure created by combining 2 double floating log structures, placed in 1996, with a new LWD piece and extra boulders. Structure was placed to provide protective cover element to an existing pool. (Note: structure is built around an existing natural log.)

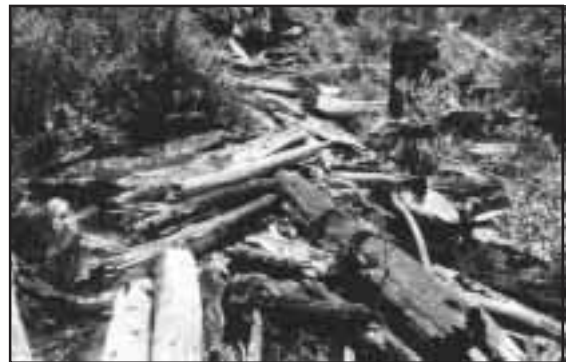
Figure 1-27. Instream work before at 0+149 Ck 2 (jam #4).

- training, access clearing and maintenance;
- removal of 3000 m³ of SWD;
- placement of 3500 pieces of LWD instream anchored with approximately 6000 m of 1/2 inch galvanized cable;
- fry population and water quality surveys at 6 sites in survey area; and
- upgrading of 2 critical creek crossings for fish access (Figs. 1-27 to 1-30).

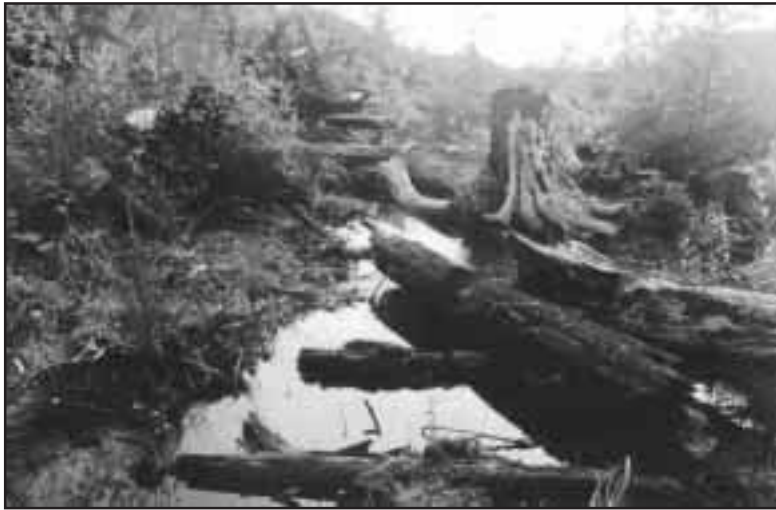
Figure 1-28. Instream work after at 0+149 Ck 2 (jam #4).

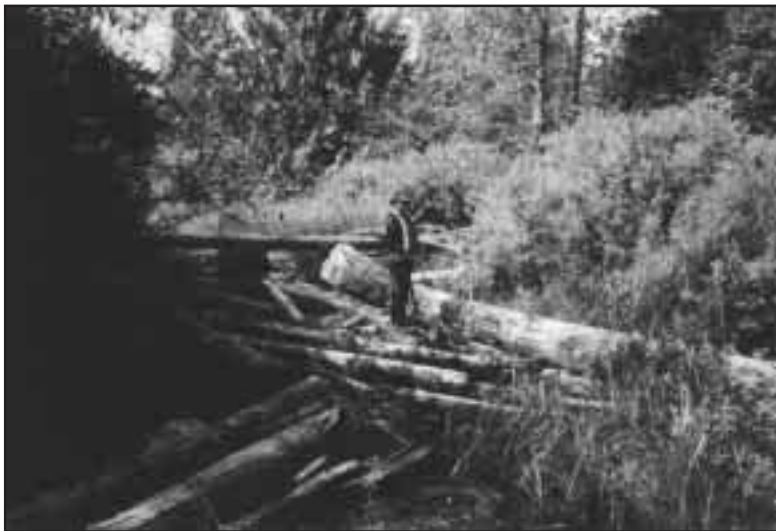
Figure 1-29. Instream work before at 2+430 GBM (jam #25).

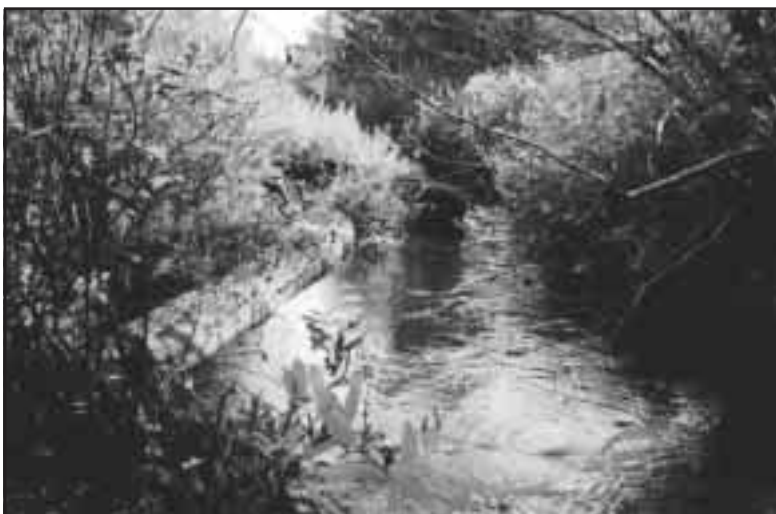
Figure 1-30. Instream work habitat logs at GBM (upstream jam #25).

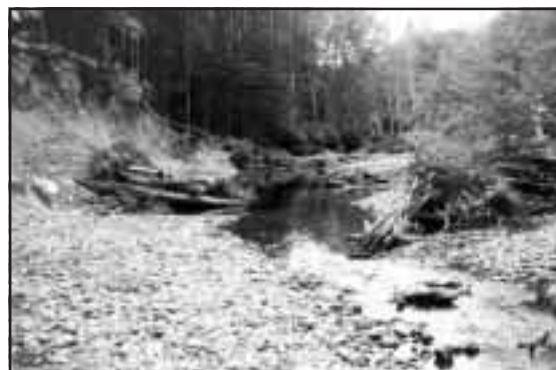
Figure 1-31. Downstream view showing four small LWD structures positioned to protect a steep eroding gravel cutbank. The left structure is 2 m high at the bank.

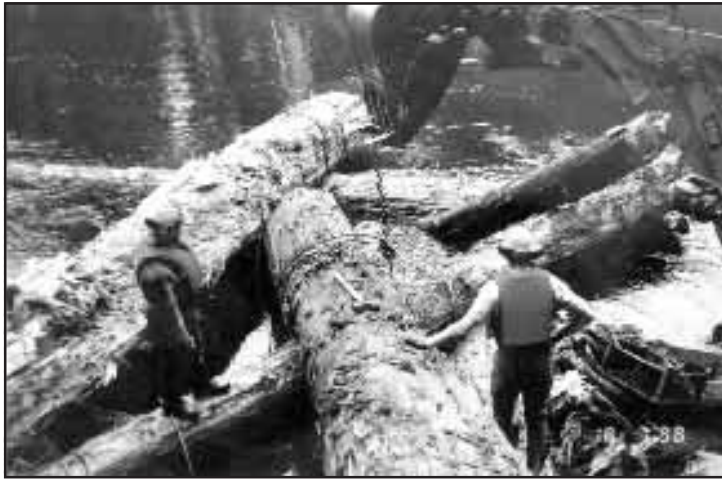
Figure 1-32. Constructing a large log jam on the Mahatta River. Logs are cabled across the structure to stiffen the log jam.

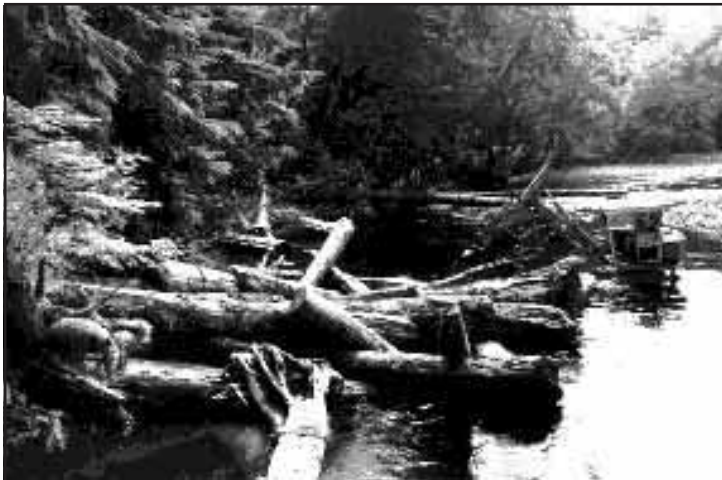
Figure 1-33. Upstream view on the Mahatta River showing two large log jams constructed to protect a gravel cutbank from erosion. A scour pool 20 m long by 12 m wide by 3.5 m deep has formed between the two log jams.

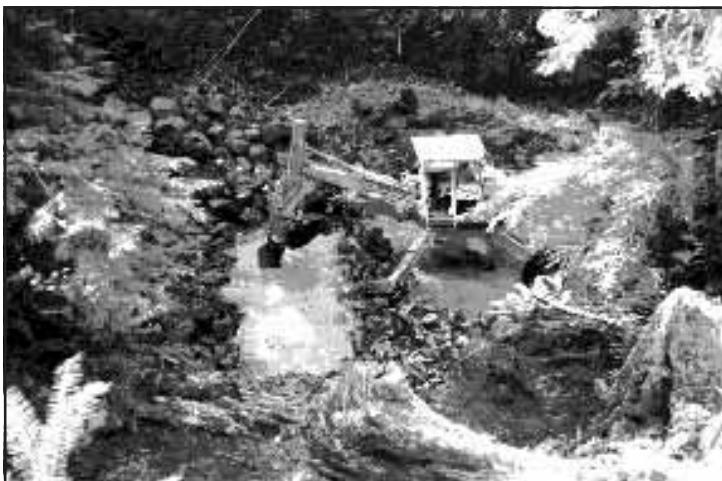
Figure 1-34. Constructing a rock riffle on the North Tributary. The “spider” is excavating a trough across the channel to key the riffle 1 m into the bed.

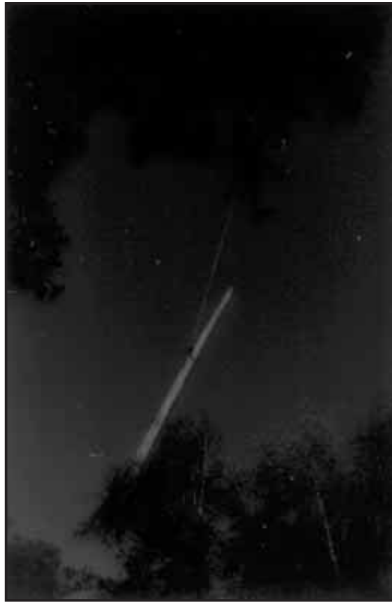
Figure 1-35. Helicopter placing LWD into Spirit Creek.

Material was placed in the creek by use of a Sikorsky 61 helicopter (Fig. 1-35). LWD and boulders were then repositioned according to the design prescription (SSHRC 1998) by a ground crew using a chainsaw winch. LWD was cabled to live trees on the bank and to the boulders. Some sites were modified in the field due to differences in wood size at the site compared to the wood in the design plan, ease of installation, or to achieve a different physical and biological effect as determined appropriate by the project biologist. Eighty-four pieces of LWD along with 26 boulders for ballast were added to 19 sites (Figs. 1-36 to 1-40). Another 5 sites were modified.

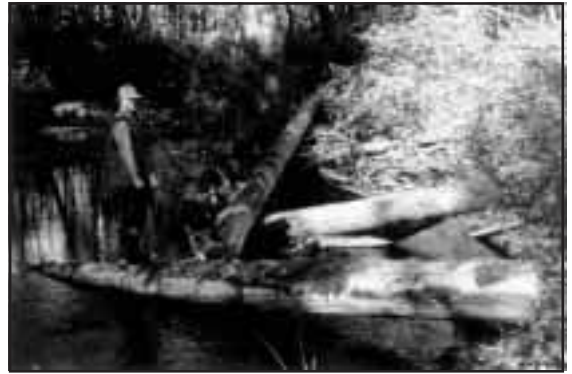
Figure 1-38. Site 6, lower Spirit Creek after LWD placement.

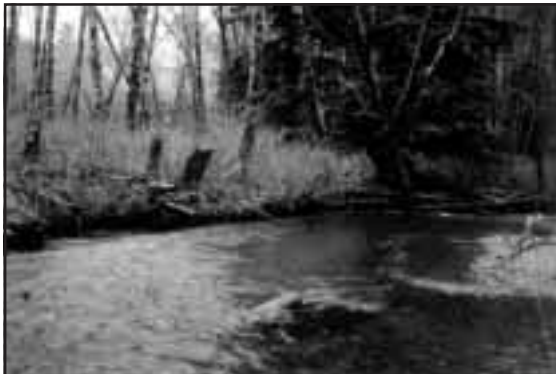
Figure 1-36. Site 20, upper Spirit Creek prior to LWD placement.

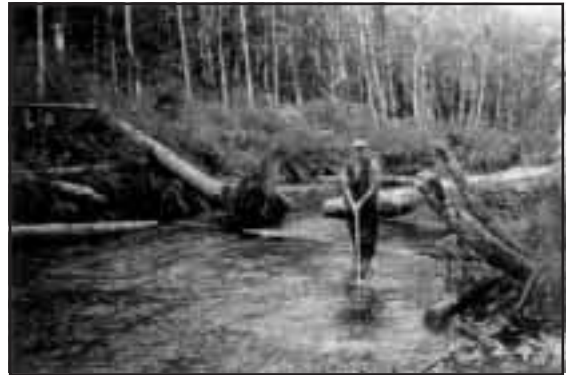
Figure 1-39. Site 8, lower Spirit Creek after LWD placement.

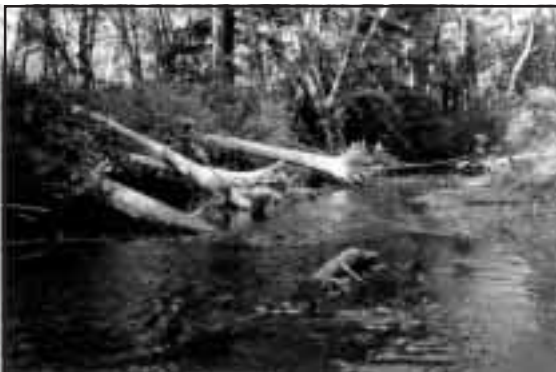
Figure 1-37. Site 20, upper Spirit Creek after LWD placement.

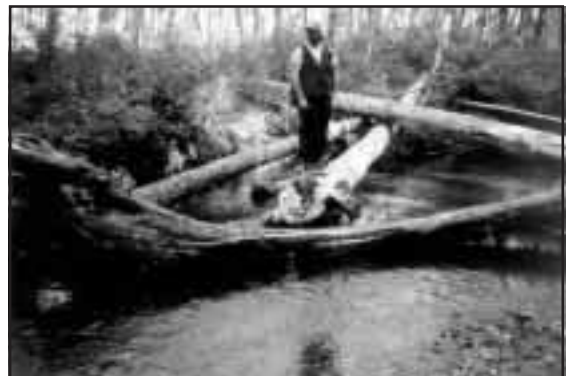
Figure 1-40. Site 13A, upper Spirit Creek after LWD placement.

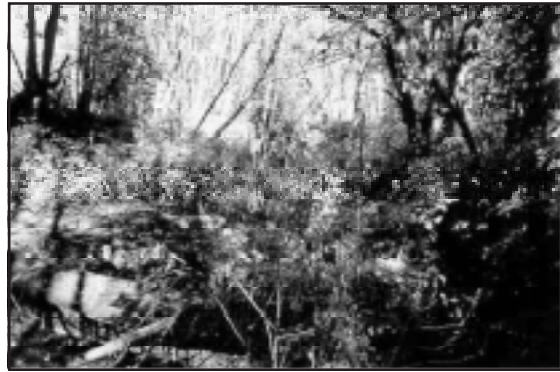
Figure 1-41. Before excavation, the side channel was over grown and filled with sediment.

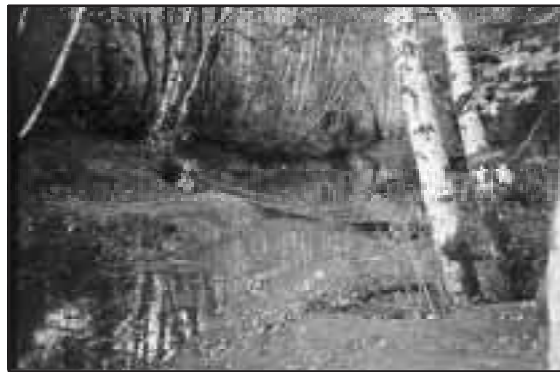
Figure 1-42. After construction, the wetted area of the side channel was greatly increased. Additional LWD still has to be added.

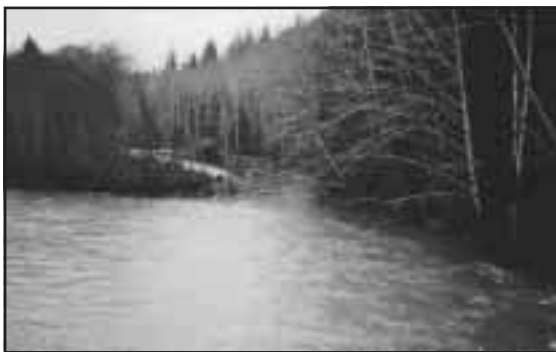
Figure 1-43. Photograph showing the mouth of the side channel constructed at Site 12, Reach 20, South Sarita River. Photo was taken during high river flows. A willow weave was installed on the sides of the set-back dyke to control erosion.

- Construction of a 150 m side channel in Reach 20, the South Sarita River (Fig. 1-43). Test pits were dug during the spring along a

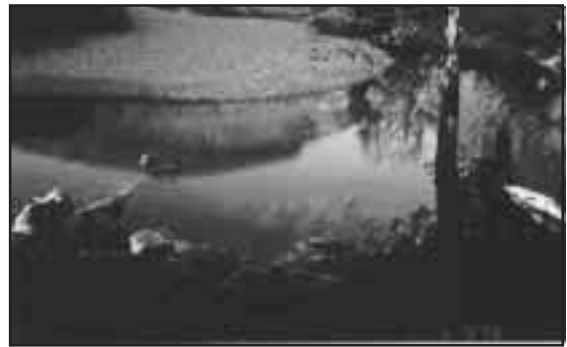
Figure 1-44 . LWD structure at Site 7, Reach 3, Sarita River. Photo shows rooted ends extending into a deep pool.

- Construction of four LWD structures. Each was designed and oriented differently to enable future comparison of effectiveness. At Site 7, in Reach 3 of the Sarita River, six large logs with roots attached, were individually placed (roughly parallel to each other) so that the roots extended into a large pool, and the 'cut' ends could be anchored to the bank (Fig. 1-44). Anchoring was accomplished by epoxying each log to a bedrock outcrop along this bank, and by cabling anchor rocks to the instream end and the nearshore end of each piece.

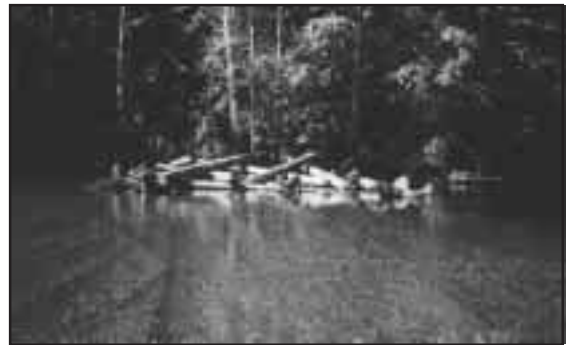
Figure 1-45. LWD crib structure at Site 8, Reach 3, Sarita River. Photo taken at extreme low flows.

- At Site 8, in Reach 3, immediately downstream from the confluence of the Sarita and the South Sarita Rivers, 12 large logs some with roots attached, were cabled in a criss-cross fashion, to each other and to two large rootwads, to create a large crib (Fig. 1-45). This was anchored to the streambank and extended into a large pool, with additional anchoring provided by ballast rocks.

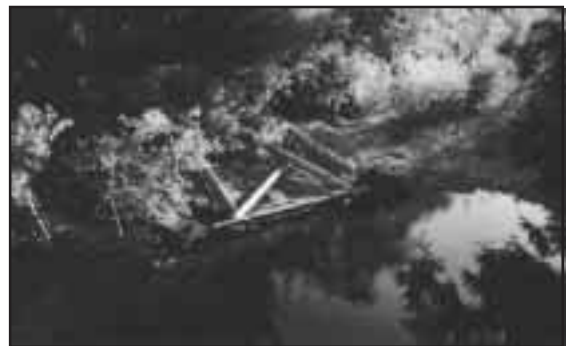
Figure 1-46. Modified crib structure at Site 9, Reach 3, Sarita River. Photo taken at extreme low flows.

- At Site 9, a modified crib was constructed in Reach 3 of the Sarita River, immediately downstream from the Blenheim mainline bridge (Fig. 1-46). Four large logs with roots, and two logs without roots, were arranged and cabled into a loose crib structure to provide stability during high flows. The rooted ends were extended into the adjacent pool, where they could promote scour. The structure was anchored by cabling the logs to large ballast rocks on both the streambank and instream ends.

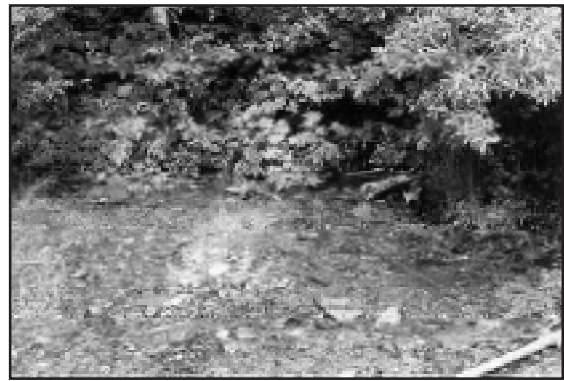
The primary objective of the project is to develop an existing borrow pit to increase the productive capacity of this off-channel habitat. In its present state the borrow pit has a good groundwater supply, but lacks depth and complexity for rearing habitat (Figs. 1-48 to 1-56).

Figure 1-48. Pre-construction view of one of the groundwater sources at Borrow Pit #2, 1998.

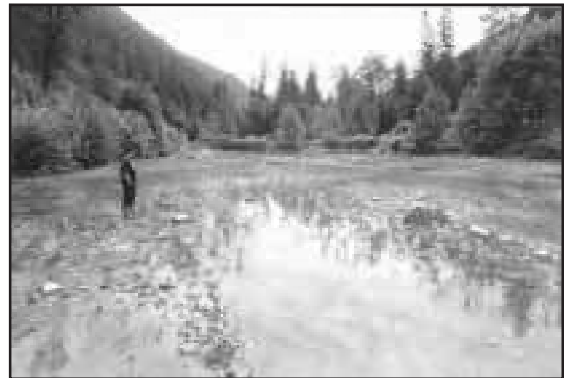
Figure 1-49. Pre-construction view (looking downstream) of Borrow Pit #2, 1998.

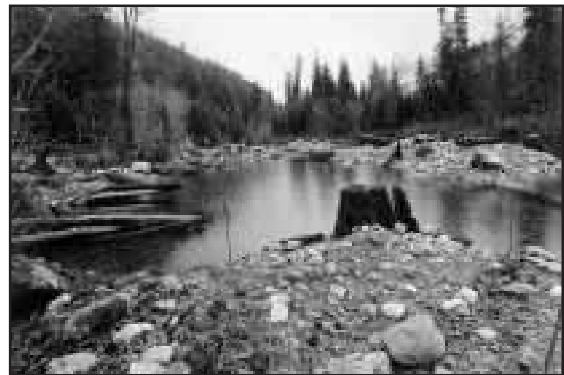
Figure 1-50. Post-construction view (looking downstream) of Borrow Pit #2, 1998.

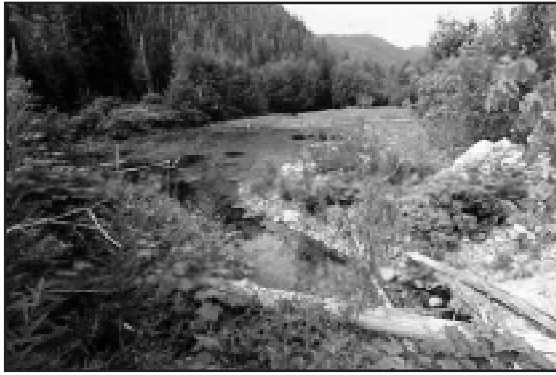
Figure 1-51. Pre-construction view (looking upstream) of Borrow Pit #2, 1998.

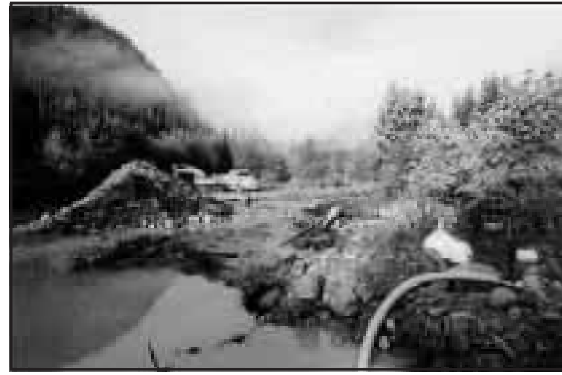
Figure 1-54. Construction of Borrow Pit #2, showing environmental protection measures, 1998.

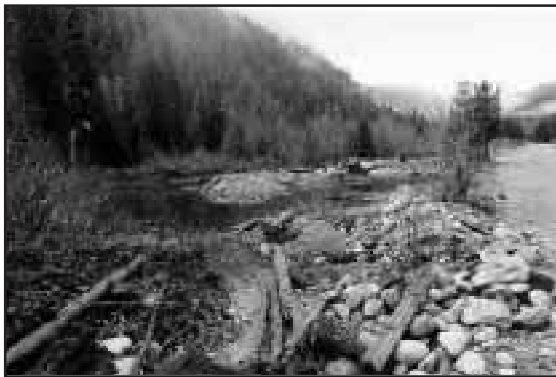
Figure 1-52. Post-construction view (looking upstream) of Borrow Pit #2, 1998.

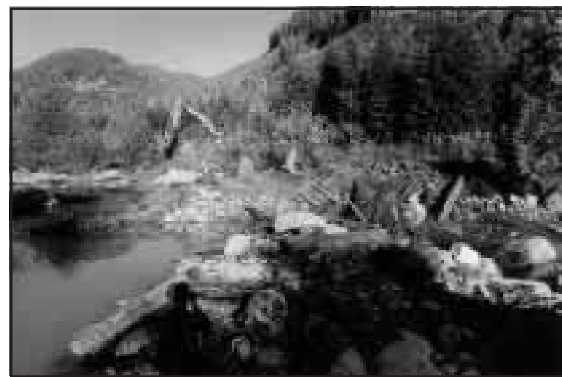
Figure 1-55. Post-construction of Borrow Pit #2, showing complexing of Island #1 and peninsula, 1998.

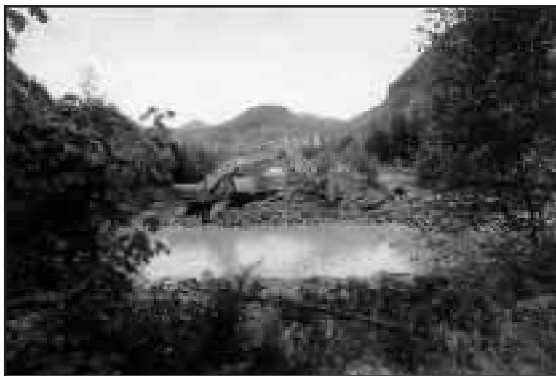
Figure 1-53. Construction of Island #2, Borrow Pit #2, 1998.

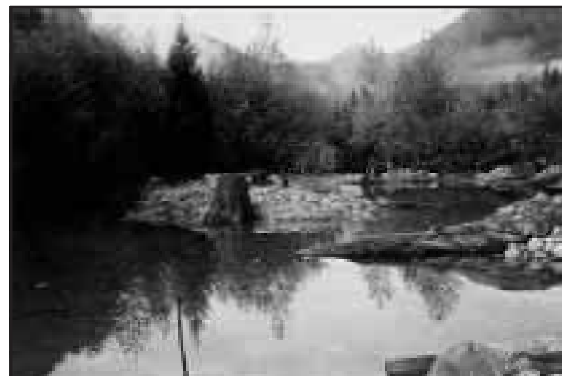
Figure 1-56. Post-construction of Borrow Pit #2, showing complexing, 1998.

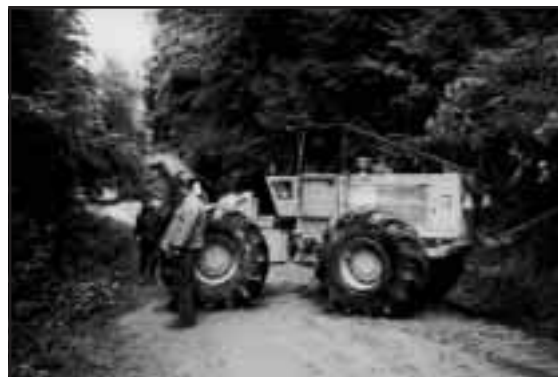
Figure 2-1. A skidder with fork adaptation was used for moving logs and rootwads from the storage site to the river sites. A 20-ton winch on the back end was the skyline donkey.

In 1998, forty structures were constructed at 6 sites along a 5 km section of river (4 reaches). A skidder was used to move the logs and rootwads from the storage site to the river sites (Fig. 2-1). Once access to a site was cleared, a heel block was rigged up in a tree next to the road, above the site. The heel block anchored the skyline used to transport the LWD and rootwads down to the site on the river. The cable was run through a block tied to a stout tree on the far bank of the river. Chokers were placed around each end of the log and fastened to a pulley on the skyline. The skidder pulled the mainline tight and gravity moved the logs and rootwads down the line to the river site (Fig. 2-2). A rope was rigged to act as a haulback line.

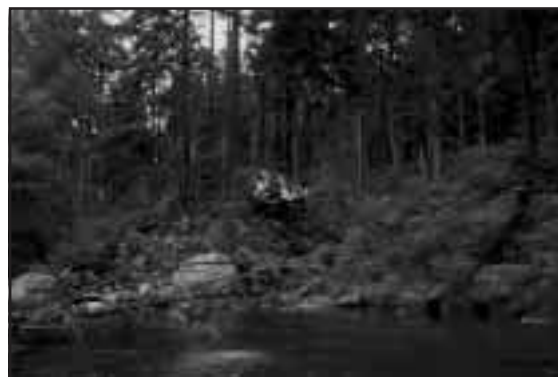
Figure 2-2. Live skyline rigging to swing logs and rootwads from road to the river site in Reach 4.

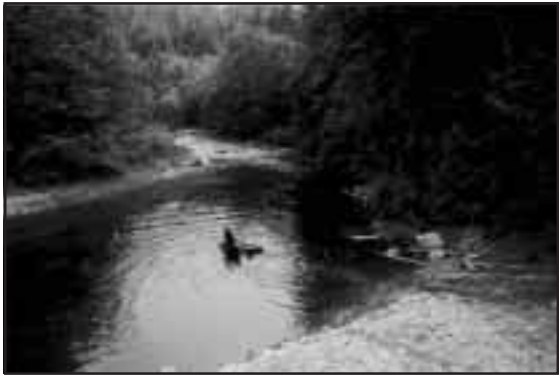
Figure 2-3. A deep pool in Reach 2 before bank stabilization and construction of LWD/boulder complexes.

Turmaster grip hoists and peaveys were used to move the logs into their final positions with the butt ends on the bank and close to boulders for ballasting (Figs. 2-3 to 2-5). Fastening specifications for lateral triangular log jams, as outlined in Slaney et al. 1997 were utilized, with instream ballasting and bank attachments, similar to Millar 1997.

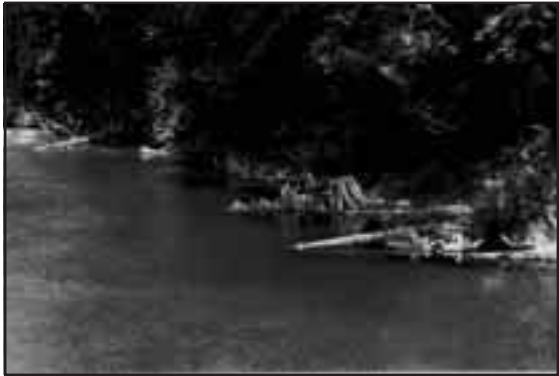
Figure 2-4. A deep pool in Reach 2 after bank stabilization and construction of LWD/boulder complexes.

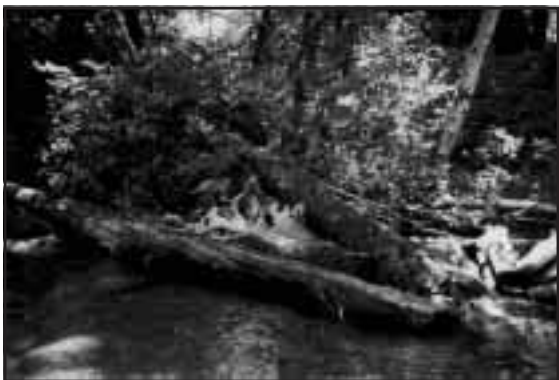
Figure 2-5. A LWD/boulder complex (triangular) in Reach 1, Structure #1-12.

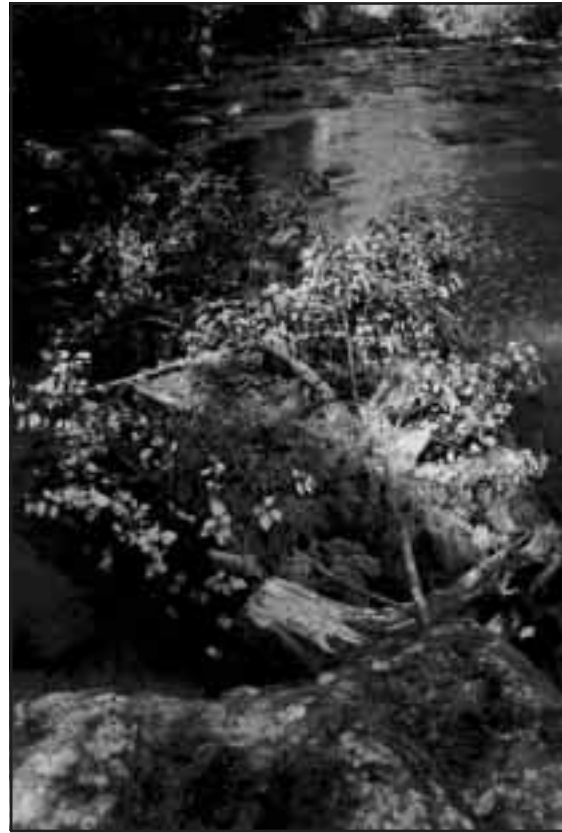
Figure 2-6. A LWD/boulder complex loaded with alder and cedar tops and branches to increase complexity.

Alder and cedar tops and branches were added to the structures to provide additional habitat complexity and to begin trapping SOD because the reservoir prevents inputs of wood (Fig. 2-6). The structure types and number of each type constructed are detailed in the following table.

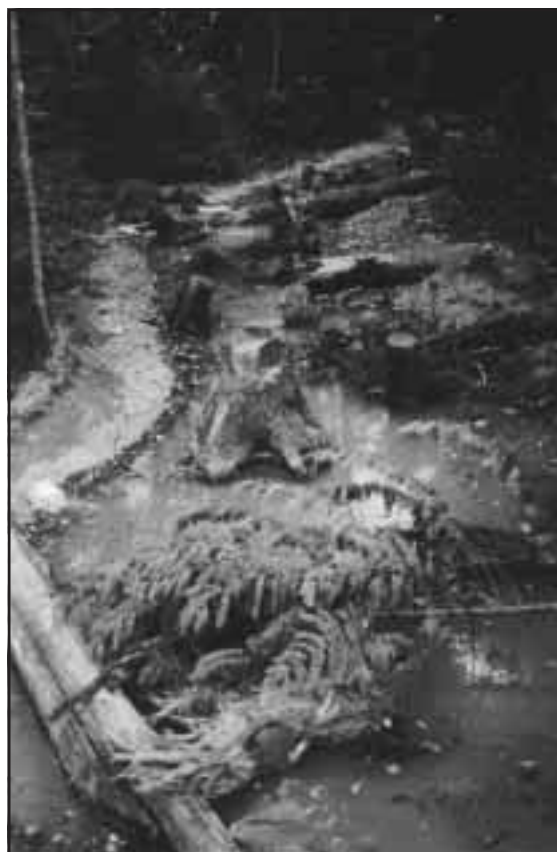
Figure 2-7. Logs placed in channel which followed an unused skidder road.

- Construction of a 420 m long spawning and rearing channel. The channel alignment followed an unused skidder road (Fig. 2-7). This habitat featured large woody debris, pools, spawning and insect-producing riffles, off-channel pools, and several different flow velocities.

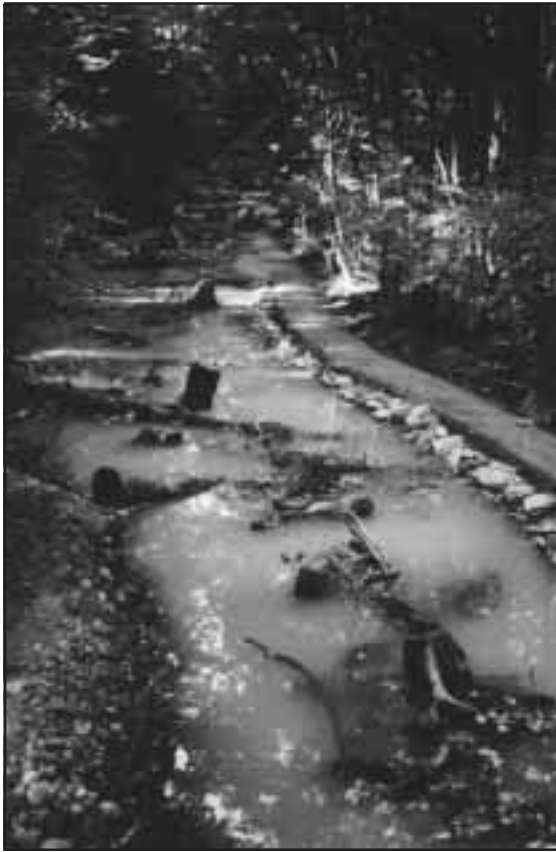
Figure 2-8. Stream complexing and interpretative trail.

- Discussion stations and a trail along 300 m of the channel were constructed in conjunction with the NVOS to provide study opportunities for users of the facility (Fig. 2-8). This trail will also be used to monitor salmonid populations and provide access for maintenance activities.

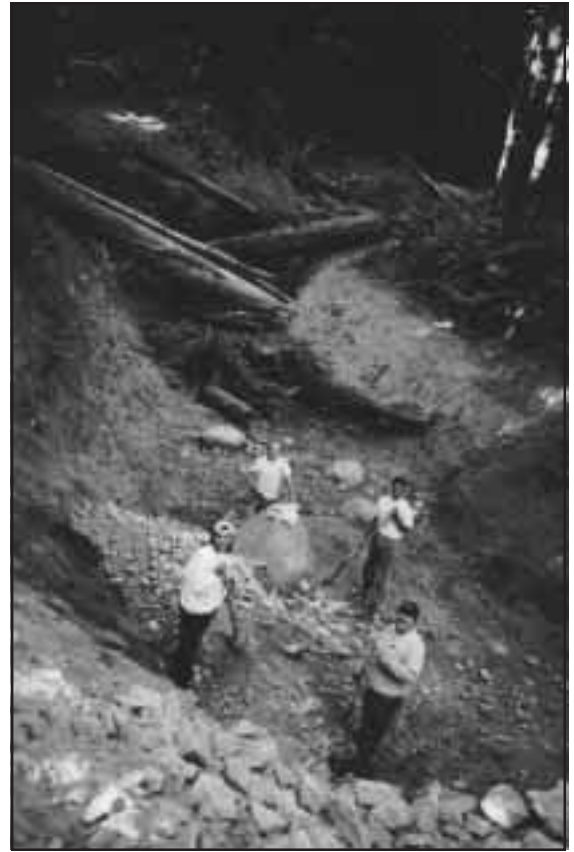
Figure 2-9. CFCD crew placing finishing touches on culvert outlet (below photographer).

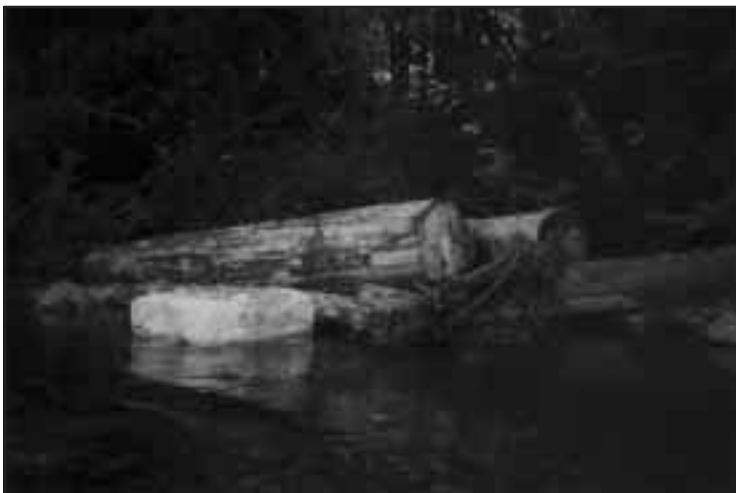
Figure 2-11. One of the completed log jam structures.

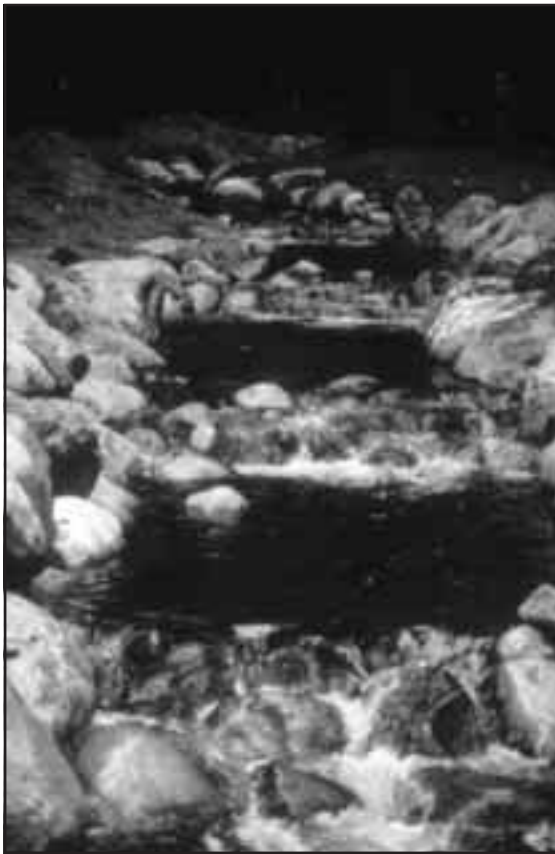
Figure 2-15. Riffle/pool entrance to Anglewing from the Chilliwack River.

1998/1999 and provides 10-20 cfs of flow into the top end of the Angelwing pond and side channel (Fig. 2-15).

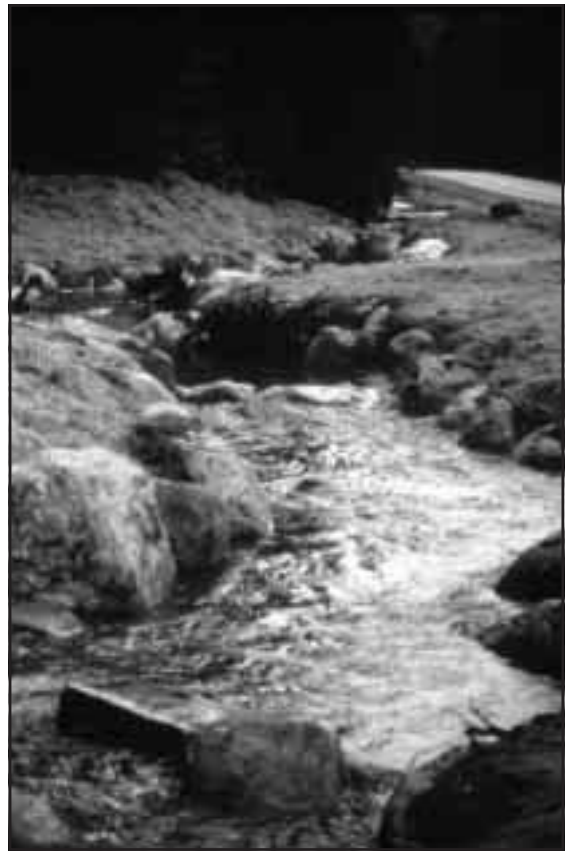
Figure 2-16. Roadside channel spawning habitat.

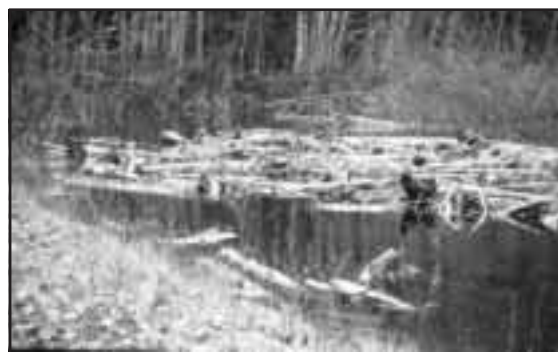
- Flooding old flood channels of the river created the beaver ponds (Fig. 2-17). The side channels were abandoned or cut off during construction of the logging road.

Figure 2-17. Flooding old channels of the river created the beaver ponds.

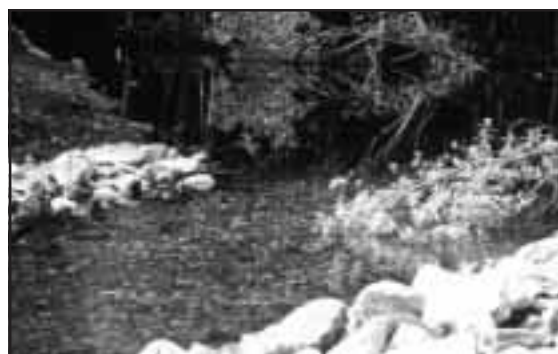
Figure 2-18. Outlet streams were constructed between the ponds to provide spawning and rearing habitat.

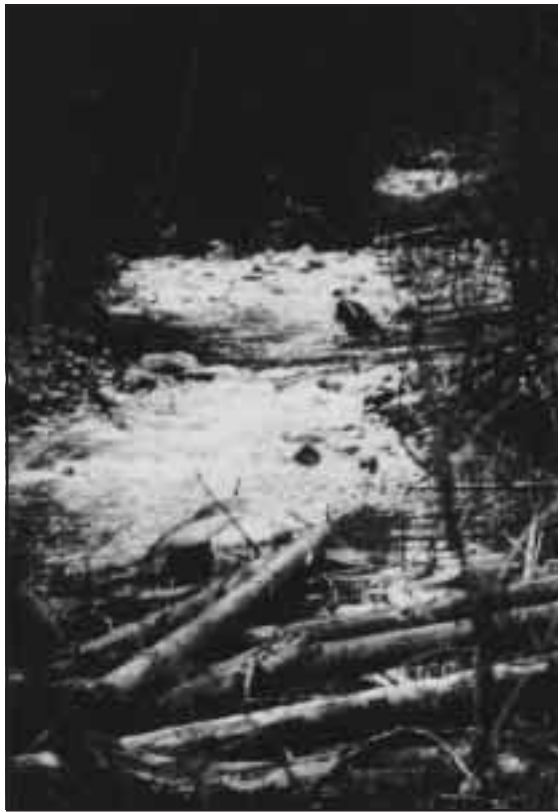
Figure 2-19. New pool/riffle ratio add complexity to the channel.

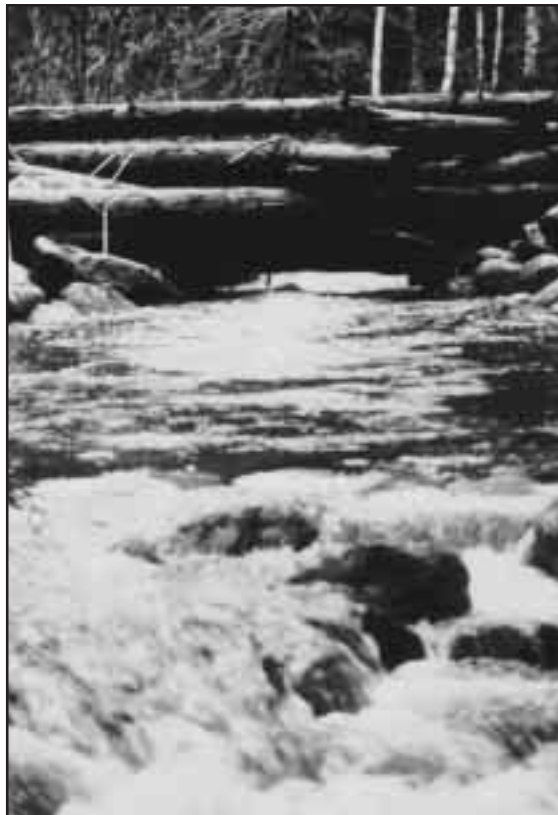
Figure 2-20. LWD and boulders were used to “cap” maximum flows entering the channel.

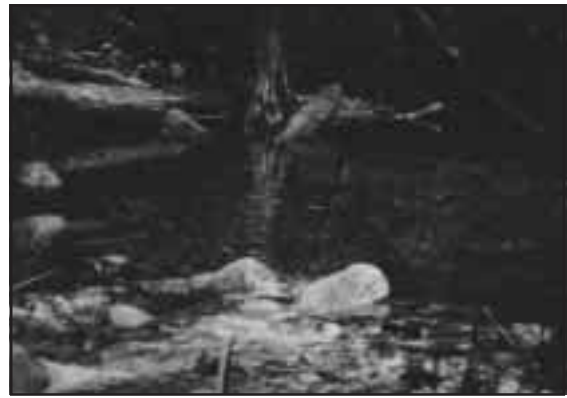
Figure 2-21. Spawning gravel was placed at the outfall of pools.
