Watershed Restoration Program
Ministry of Environment, Lands and Parks
and Ministry of Forests

**Annual Compendium Of Aquatic Rehabilitation Projects
For The Watershed Restoration Program
1998 - 1999**

Watershed Restoration Project Report No. 13

1999

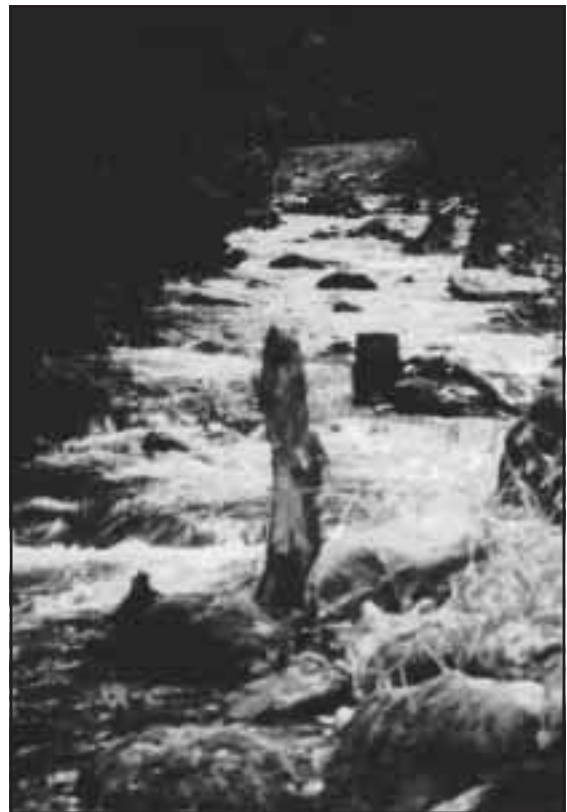
Figure 2-22. Single rootwads were anchored to single boulders to increase complexity. This also shows homogeneity of boulder riffle pattern prior to construction.

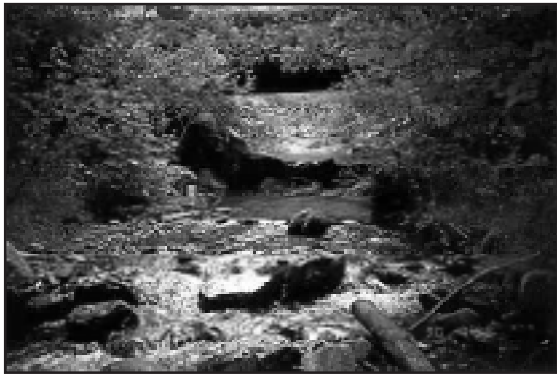
The restoration of Little Tamihi Creek occurred largely at the section below the Tamihi-Liumchen Forest Service Road bridge. This section of the creek appeared to have been channelized and severely lacked habitat diversity (Fig. 2-23).

Figure 2-23. Pre-construction view of Little Tamihi Creek (upstream view, below bridge).

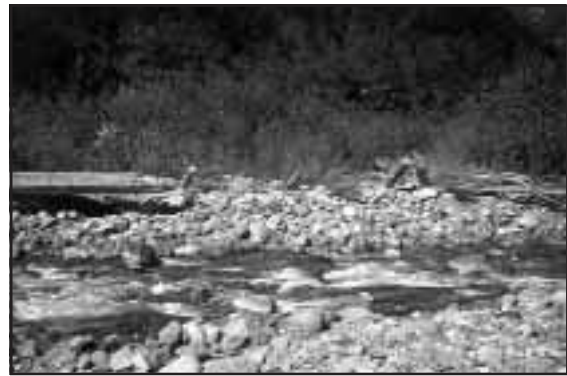
Figure 2-26. Construction of Site 1 log jam.

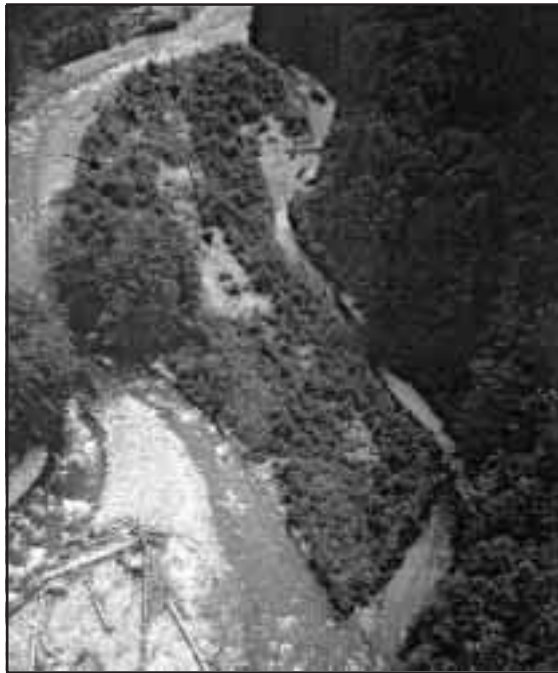
- to reduce stream power within a flood channel that splits a bar (Fig. 2-25), and
- to increase the likelihood of natural "capture" of additional LWD for the bar head.

Figure 2-25. Bar to be stabilized by Site 1 log jam.

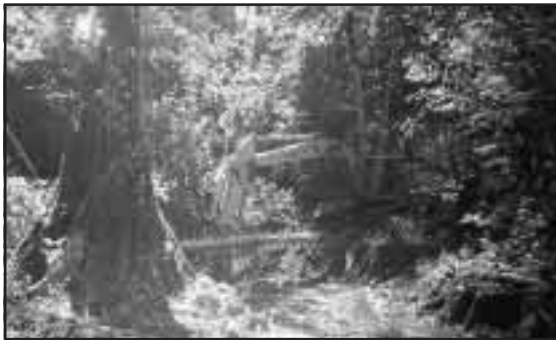
Figure 2-27. Construction of upper pond.

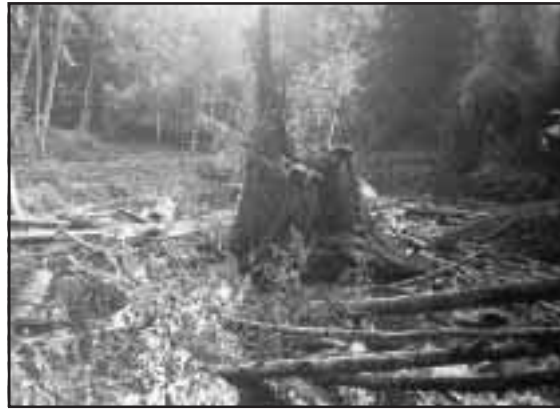
Figure 2-28. View of completed upper pond.

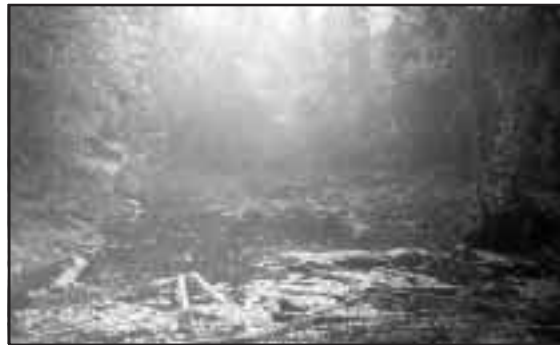
Figure 2-29. View of completed lower pond.

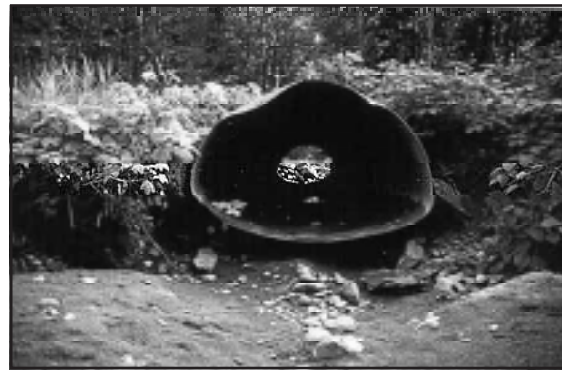
During this time, the lower channelized section of the creek was identified as having two different areas suitable for restoration. At this time, the reach provided no overwintering or rearing habitat and consisted of one long riffle with an average slope of 4.2%. Furthermore, the culvert under the Chilliwack Valley Road was a potential barrier to fish at low flows (Fig. 2-30).

Figure 2-30. Outlet of culvert on Young Creek before construction.

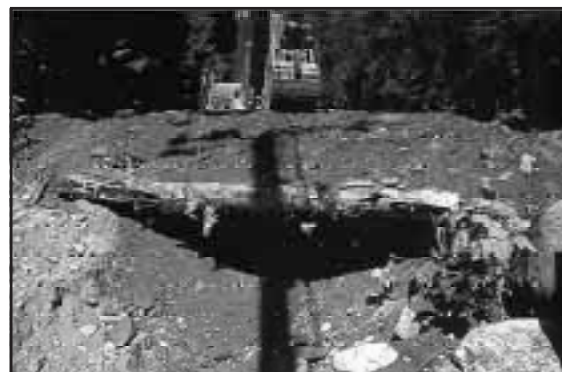
Additional cover was created during reconfiguration of the creek with the construction of an undercut bank immediately downstream of the culvert passing under the Chilliwack Valley Road (Fig. 2-31).

Figure 2-31. Construction of undercut bank at Young Creek.

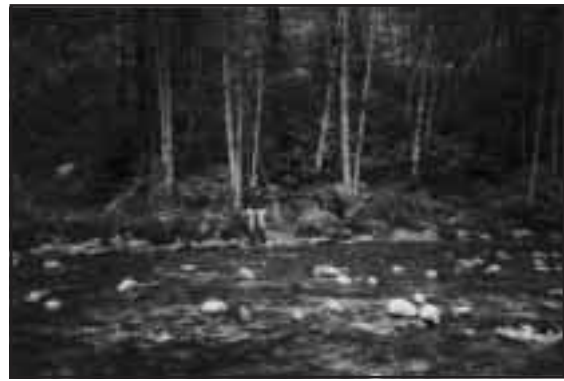
Figure 2-33. Site selected for LWD structure prior to placement.

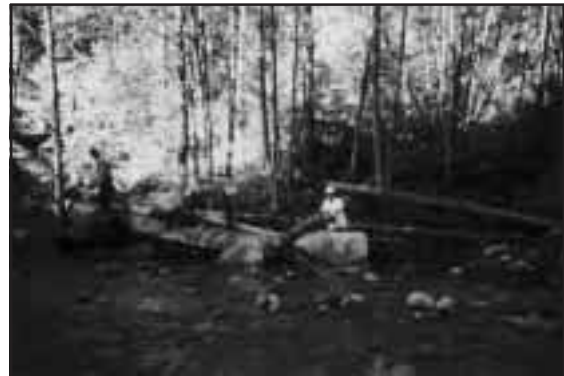
Figure 2-34. Same site as Fig. 2-33 near completion of debris catcher.

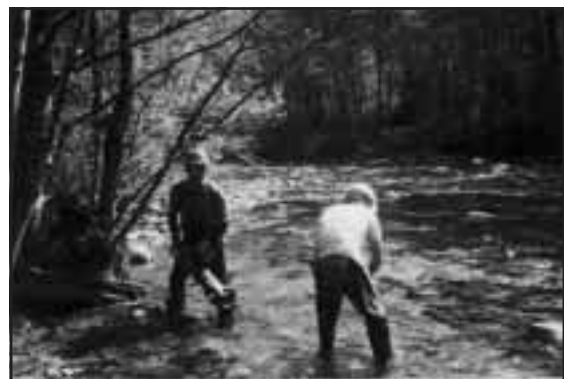
Figure 2-35. Chainsaw winch used to move logs into position in the river.

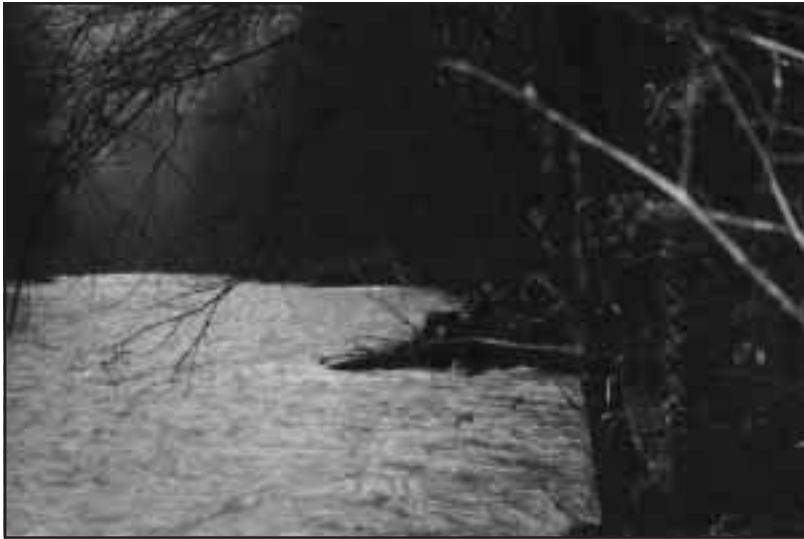
Figure 2-36. Downstream view of three structures with debris accumulation.

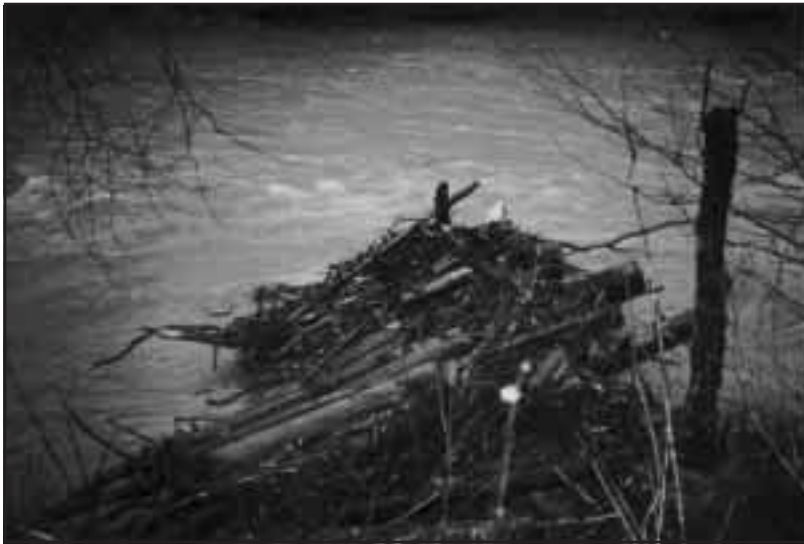
Figure 2-37. Debris accumulated on one structure following a moderate November 1998 flood.

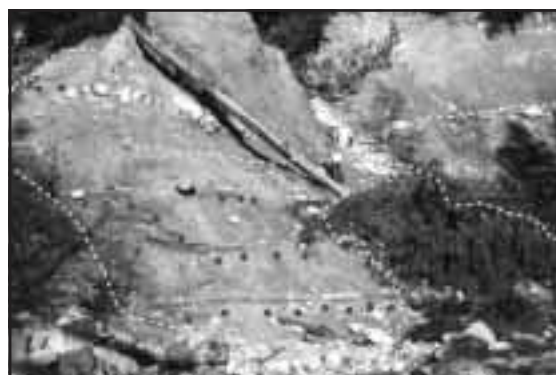
Figure 2-38. Site photo showing completed and proposed treatments.

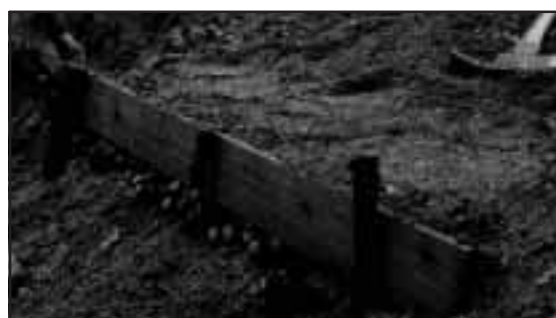
Figure 2-39. Modified brush layer.

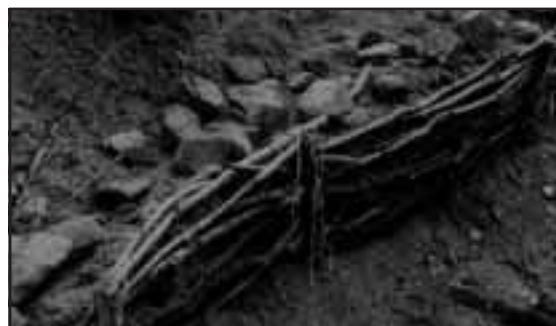
Figure 2-40. Wattle fence.

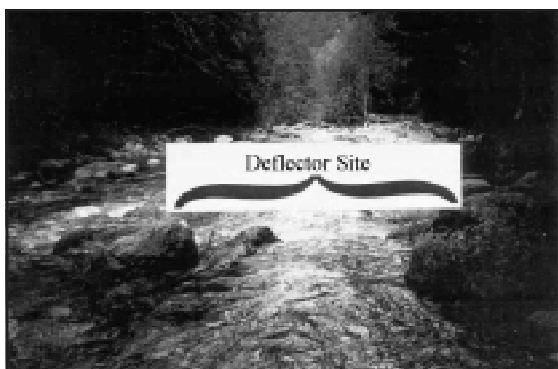
Figure 2-41. Downstream view of Yola Creek rock deflector.

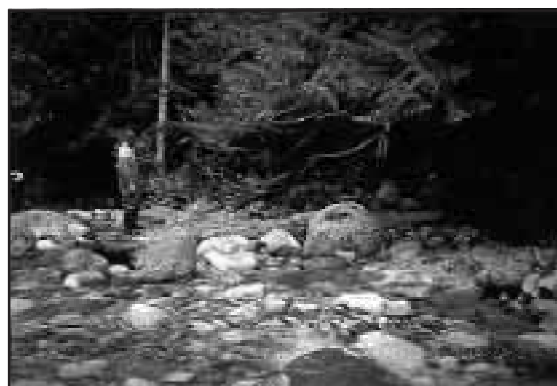
Figure 2-44. Downstream view of constructed rock deflector.

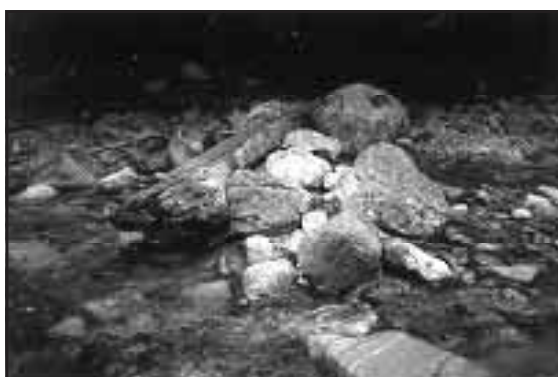
Figure 2-43. Side view of rock deflector.

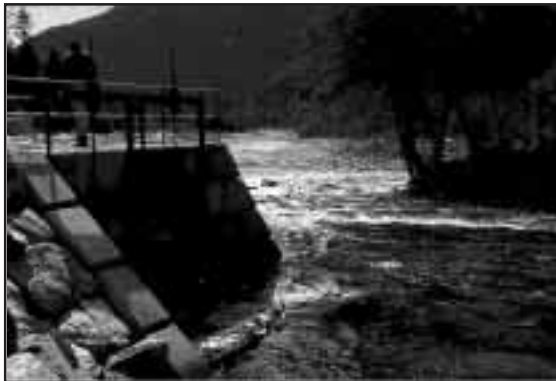
Figure 2-45. Intake structure on the Ashlu mainstem.

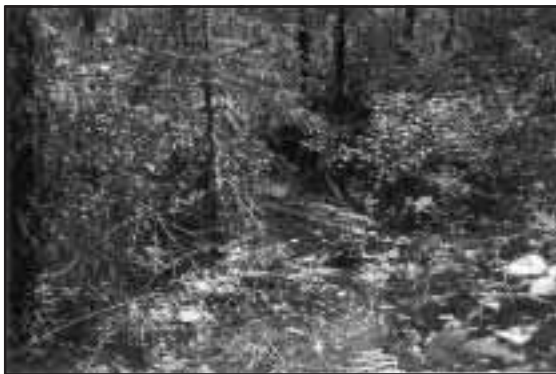
Figure 2-46. Unmodified section of channel.

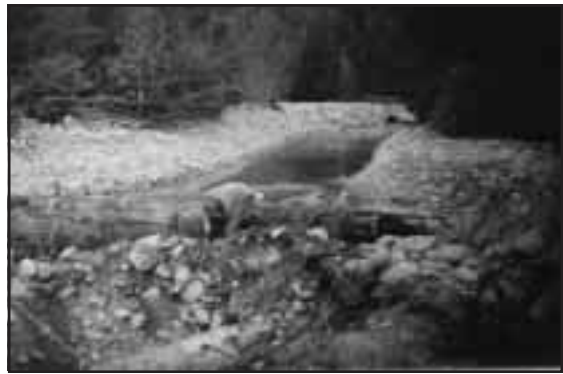
Figure 2-47. Constructed connecting channel and deadman anchoring of LWD.

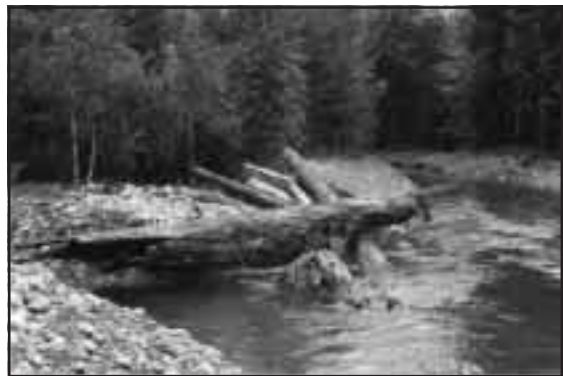
Figure 2-48. LWD structure on the outside of a meander bend.

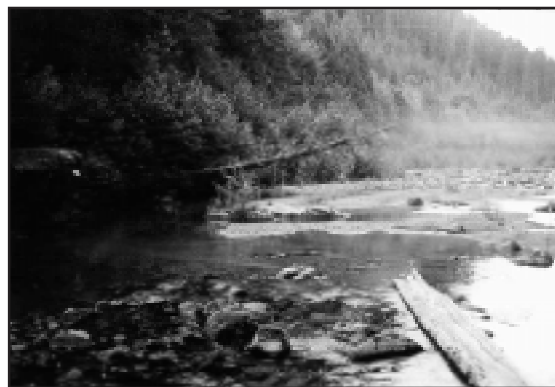
Figure 2-49. Upstream pool location prior to excavation (looking downstream).

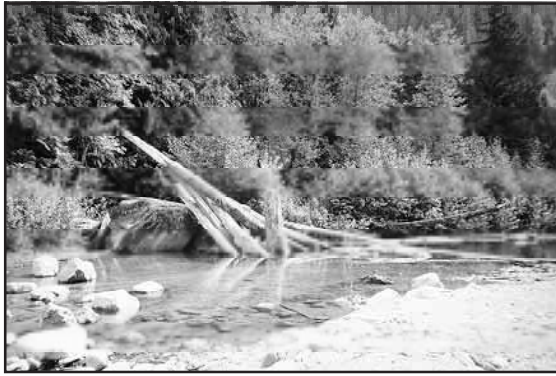
Figure 2-50. Upstream pool as-built.

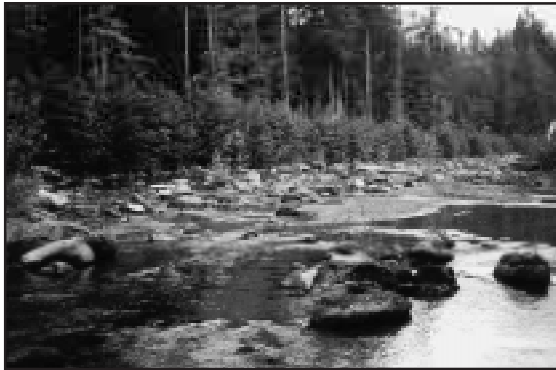
Figure 2-51. Middle pool location prior to excavation (looking upstream).

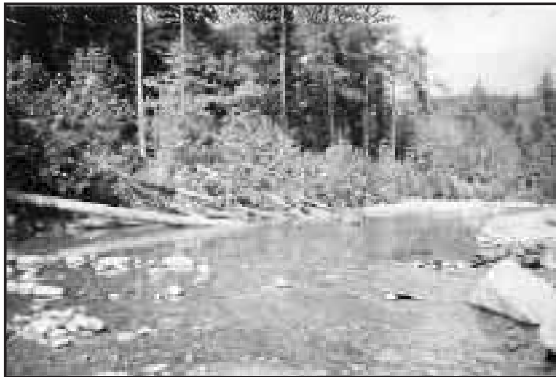
Figure 2-52. Middle pool as-built (looking upstream).

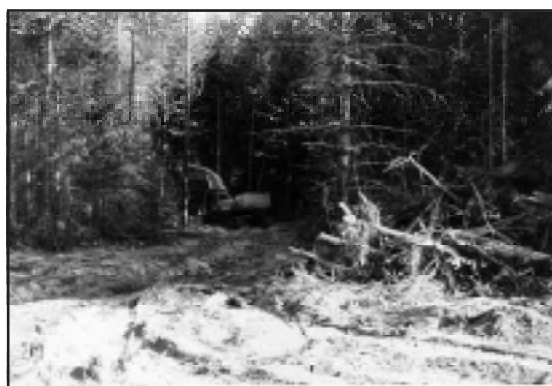
Figure 2-55. Clearing of the outlet channel.

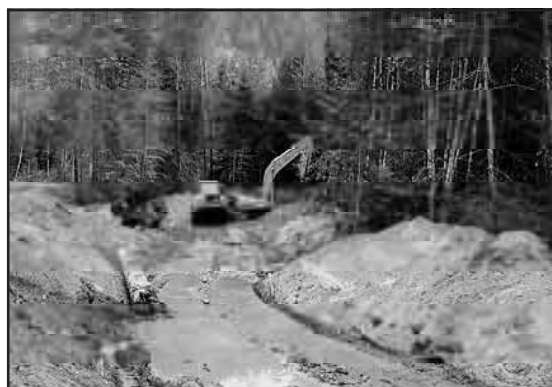
Figure 2-56. Outlet channel during construction.

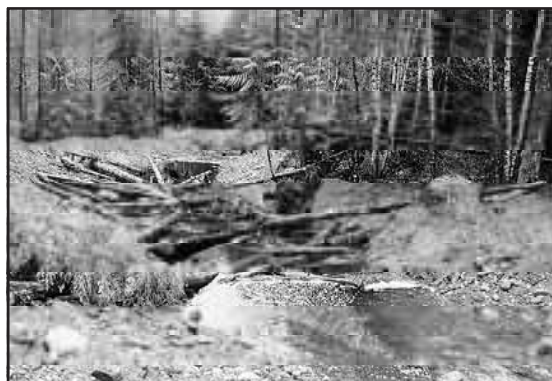
Figure 2-57. Outlet channel as-built.

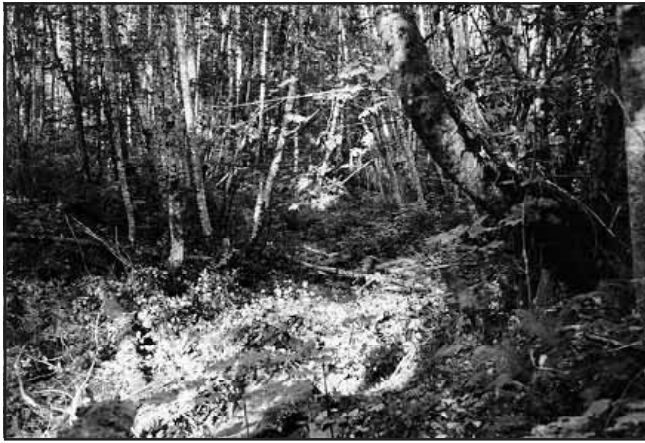
contained large amounts of LWD (Fig. 2-58). The LWD was removed for the excavation to proceed and later returned to the alcove to provide cover (Fig. 2-59).

Figure 2-58. Alcove before excavation.

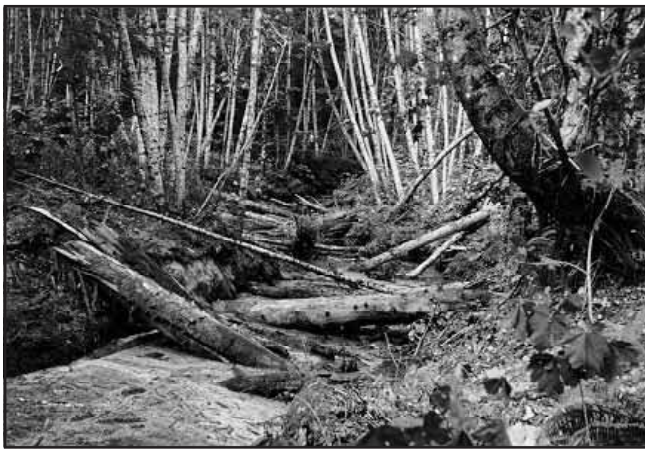
Figure 2-59. Alcove as-built.

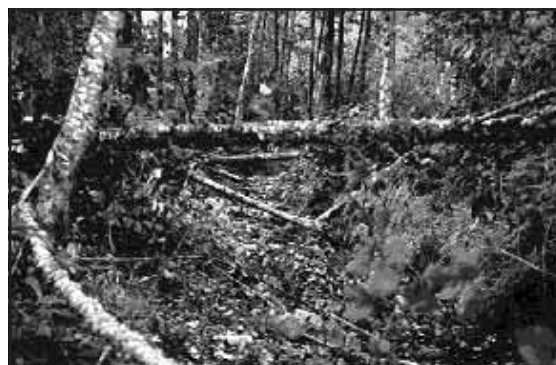
Figure 2-60. Outlet channel prior to restoration.

The existing outlet channel was widened to 6 m (Figs. 2-60, 2-61). Three riffles were constructed at appropriate elevations (0.5 m drop between each). The riffles have a 15:1 slope on the downstream face and were constructed to the standards in WRP Technical Circular No. 9. Angular rock from a nearby quarry site was used to construct the riffles. Minimum diameter of the rock used for the riffle construction is 250 mm. Rocks of approximately the same size were used to armour the banks of the channel. Approximately 60 m³ of rock was used in construction of the riffles and to armour the banks.

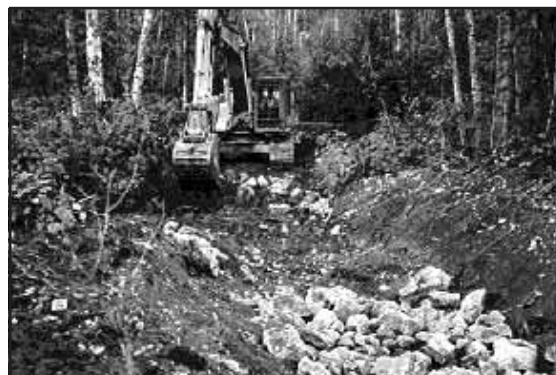
Figure 2-61. Outlet channel during restoration.

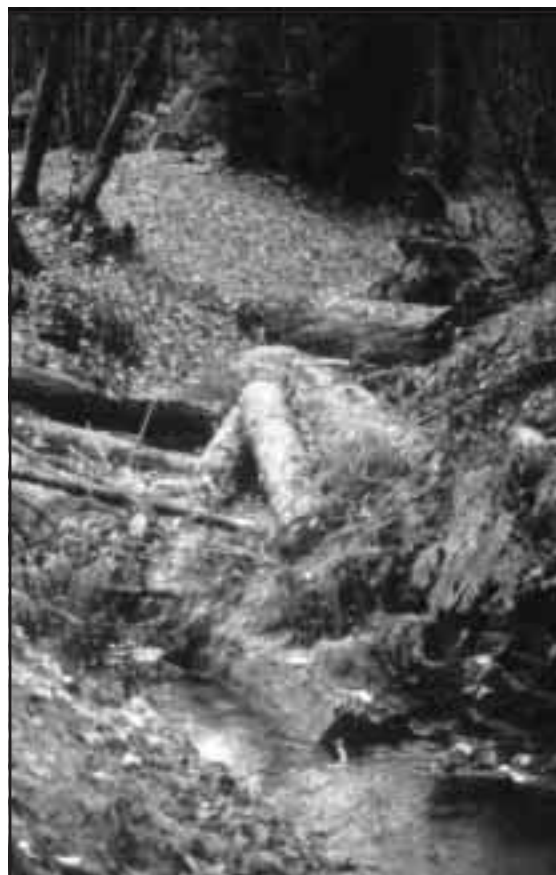
Figure 2-62. LWD placed in upper portion of channel below intake.

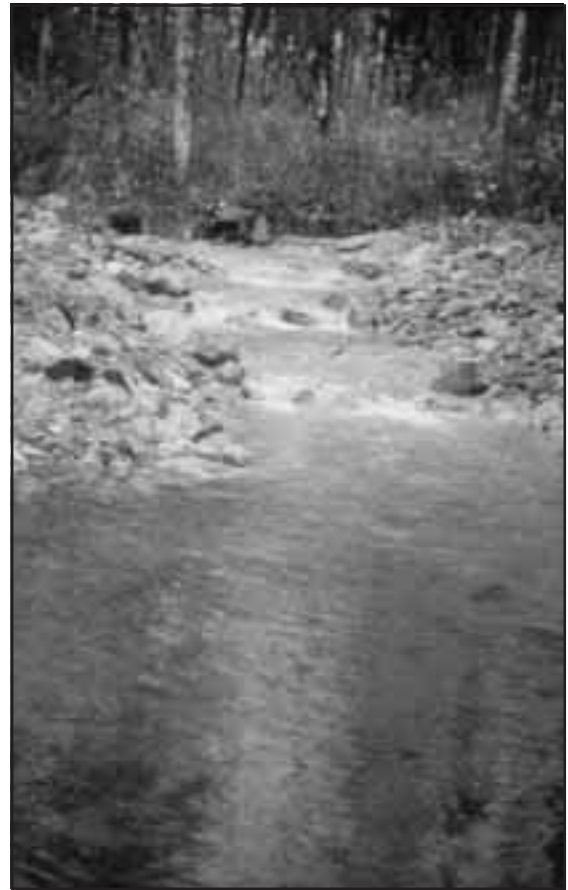
Figure 2-64. Large overwintering pond built on lower end of project.

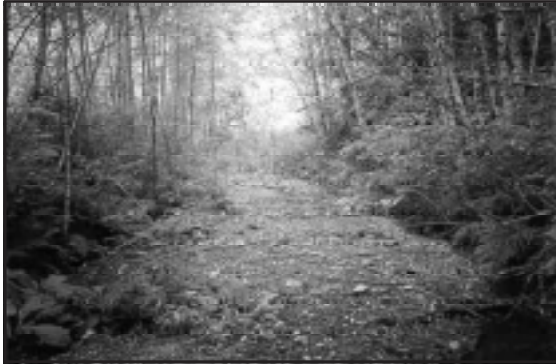
Figure 2-65. Groundwater channel pre-construction.

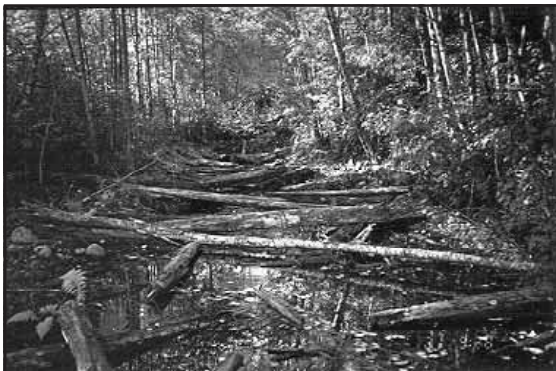
Figure 2-66. Groundwater channel post-construction.

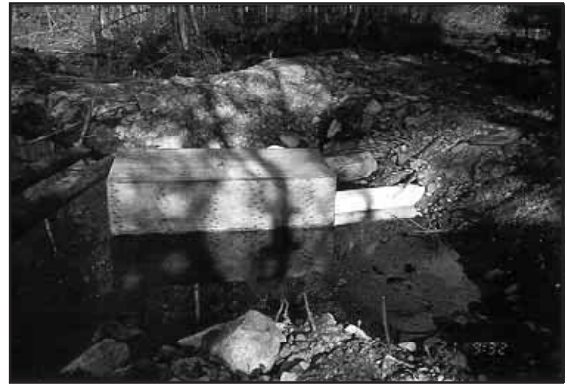
Figure 2-67. Installed beaver box.

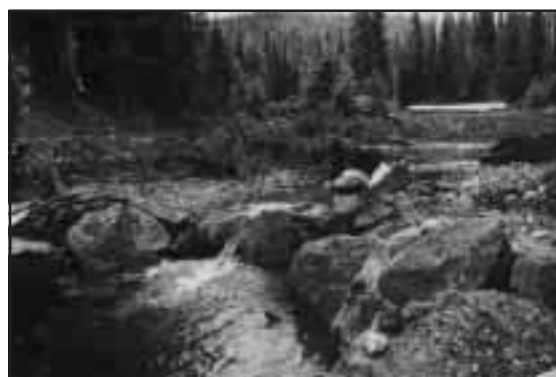
Figure 3-3. Upstream "V" structure to create pool habitat on Arrastra Creek.

- In areas of channel aggradation, LWD was used to protect eroding banks, encourage point bar development to create a channel with a higher width:depth ratio and increased hydraulic complexity.
- In areas of channel degradation, LWD was used to create low profile, cross-channel structures which promote the local deposition of mobile sediment and create downstream plunge pool features.
- In areas with channel avulsions, LWD was used to create lateral debris jams which provide protection to unstable banks.
- An upstream “V” structure was constructed 50 m downstream of the bridge crossing to provide a large (>1.0 m depth), stable plunge pool feature for overwintering habitat (Fig. 3-3).

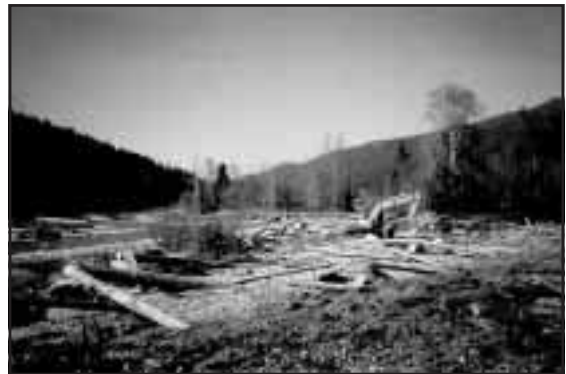
Figure 3-4. Chase Creek bar stabilization structures under construction, spring 1998.

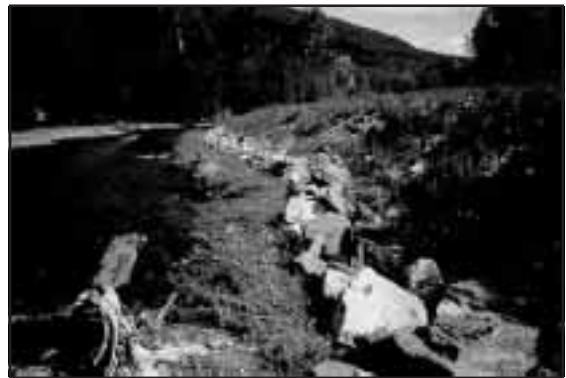
Figure 3-5. Chase Creek brush layer following construction, summer 1998.

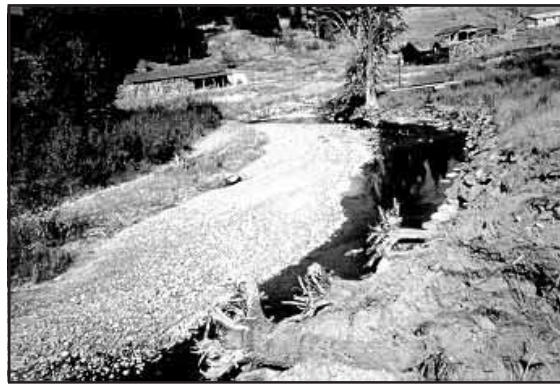
Figure 3-7. Rock weir within new channel.

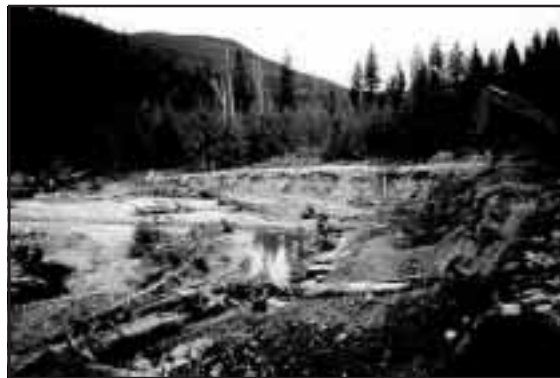
At a separate location, the stream curves sharply and impacts against a section of steep slopes, which are subject to continual raveling and surficial sloughing of loose material. Prescriptions were created to construct a series of whole tree revetments along the length (50 m) of the stream curve (Figs. 3-8, 3-9).

Figure 3-8. Constructing log crib wall along toe of slide.

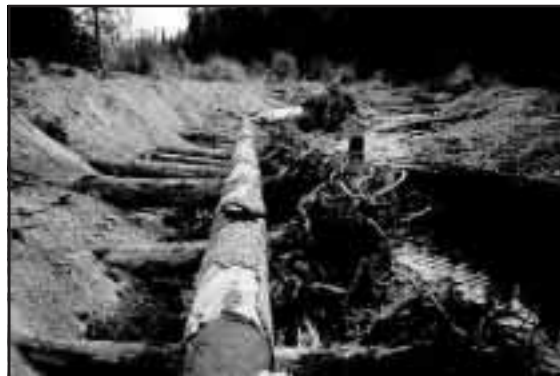
Figure 3-9. Log crib wall.

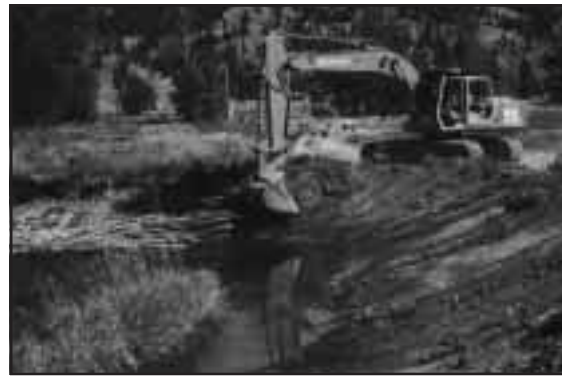
Figure 3-10. Bank stabilization on Deadman River.

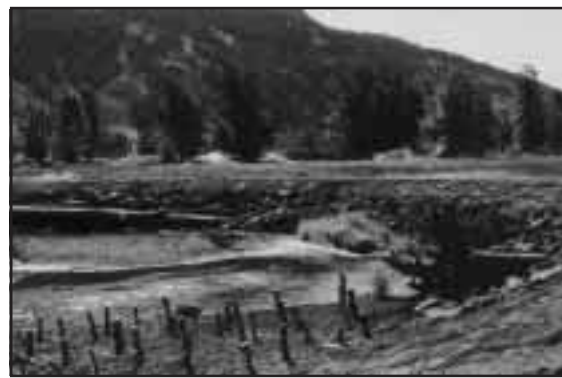
Figure 3-11. Tree revetments and live pole riparian restoration on Deadman River.

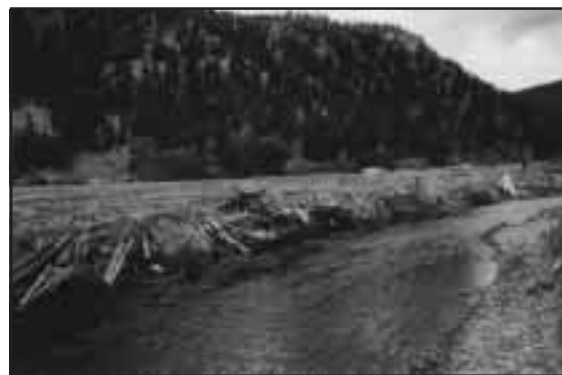
Figure 3-12. Tree revetments to stabilize banks on Deadman River.

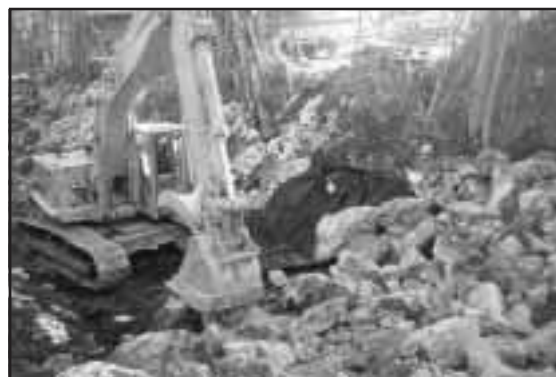
Figure 3-13. Cat 235 C placing heavy rock rip-rap to prevent down-cutting of channel, February 1998.

- Heavy armouring of 160 m of channel downstream of Airstrip Road, adjacent to the two affected residences (Figs. 3-13, 3-14).
- Armouring of the channel immediately upstream of the highway crossing to prevent further channel degradation and subsequent obstruction of the highway culverts.
- Restoration of the natural channel width upstream of Airstrip Road for approximately 140 m, and reconstruction of 60 m of rip-rap.
- Debris removal from channel banks, restoration of a 3 m bottom width, and resloping banks to a 1:1, preferably 1.5:1 slope where armouring was not proposed.

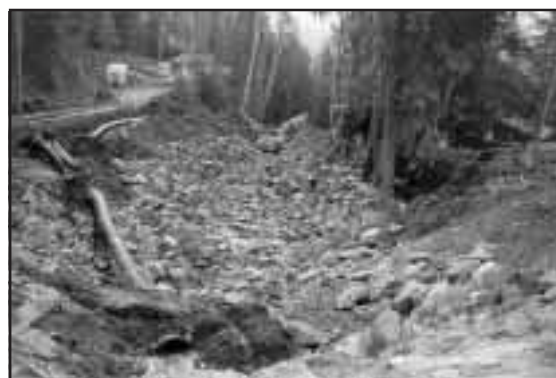
Figure 3-14. Hudson Creek channel reconstruction, February 1998. Note houses left and right of excavator.

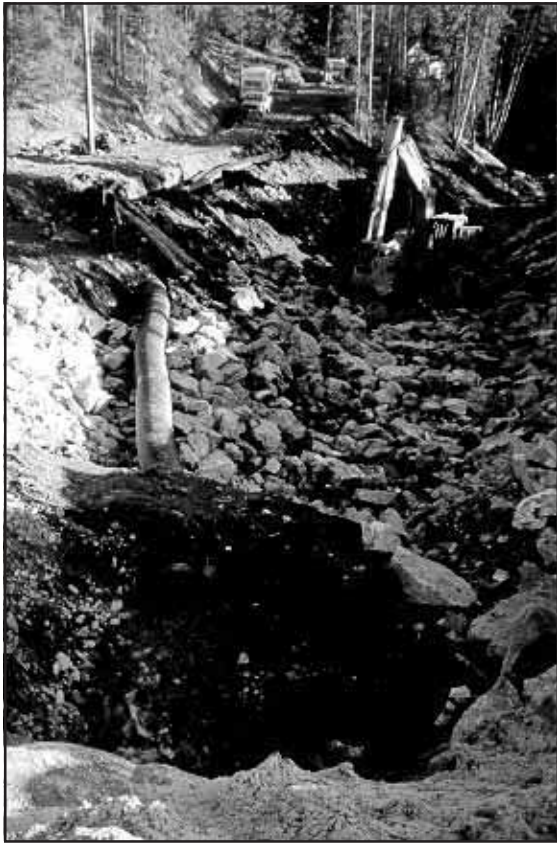
Figure 3-15. Streamflow bypass pipe in Hudson Creek, February 1998.

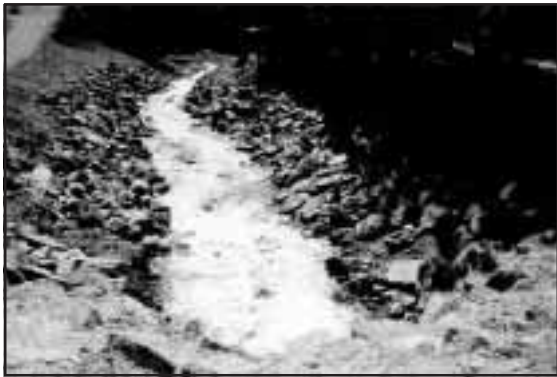
The works were monitored during the freshet in May 1998 to confirm project effectiveness (Fig. 3-16).

Figure 3-16. Freshet flow Hudson Creek, Anglemont May 1998.

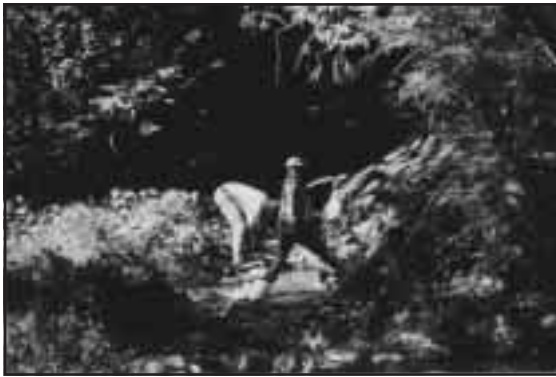
Figure 3-17. Hand placement of rock on Kingfisher Creek side channel.

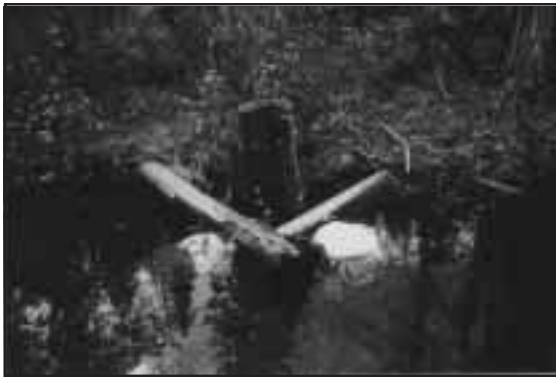
Figure 3-18. Triangular debris catcher on Danforth Creek (Kingfisher).

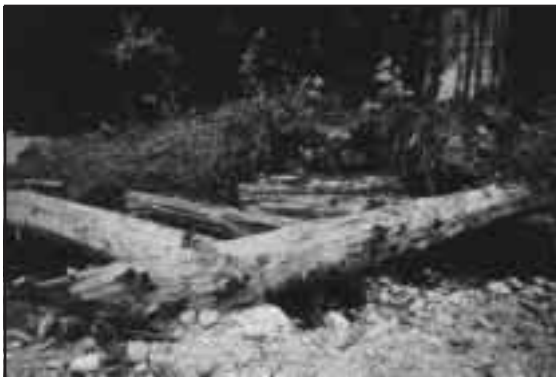
Figure 3-19. Triangular debris catcher on Danforth Creek (Kingfisher).

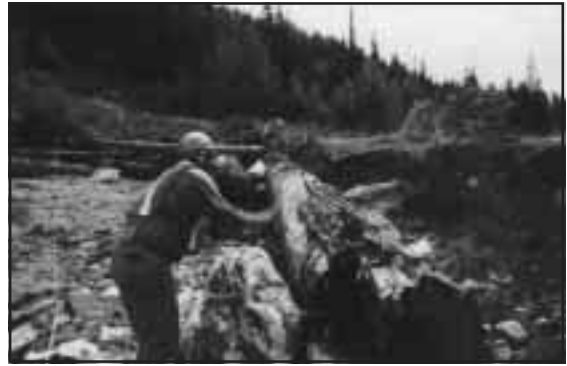
Figure 3-20. Lateral debris jam construction on Danforth Creek (Kingfisher).

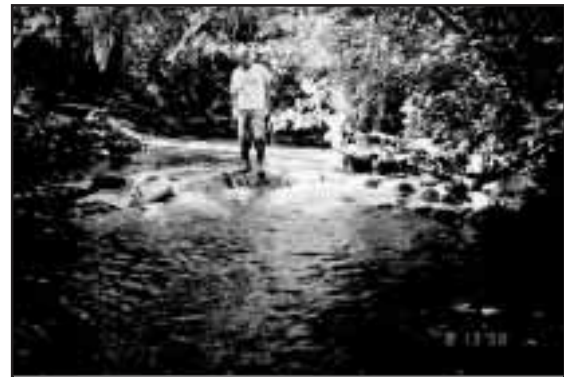
Figure 3-21. Boulder weir to create scour pool and central thalweg.

The rock weirs were constructed from rock blasted from a local quarry. The weirs were constructed in "wet" conditions, which made establishment of a footing difficult. Equi-dimensional rocks with flat surfaces were selected for use to facilitate easy placement in the stream. Rock sizes ranged from 0.125 m³ to 1 m³. The rock weir required a row of footer rocks, underlying an upper row of scour rocks. The rocks were positioned in an upstream "V" to deflect flows to the center of the channel (Fig. 3-21).

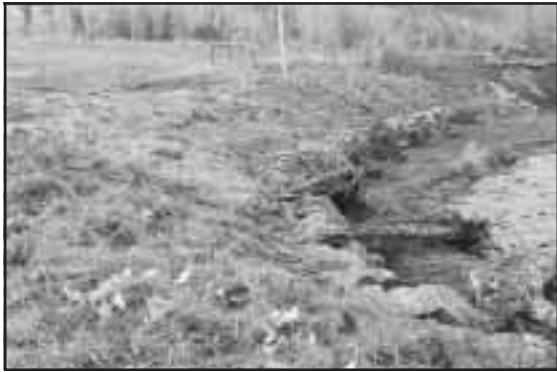
Figure 3-24. Site A on Sinmax Creek. Upstream view of channel rehabilitation.

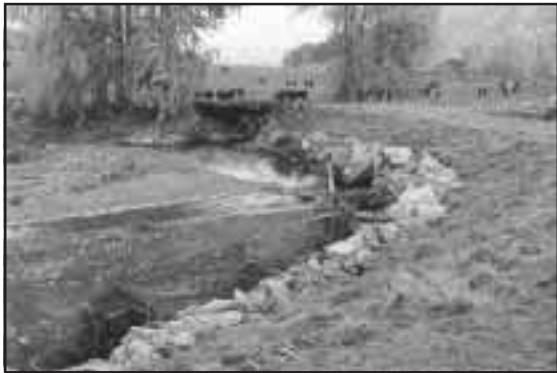
Figure 3-25. Site E on Sinmax Creek. Downstream view of channel rehabilitation.

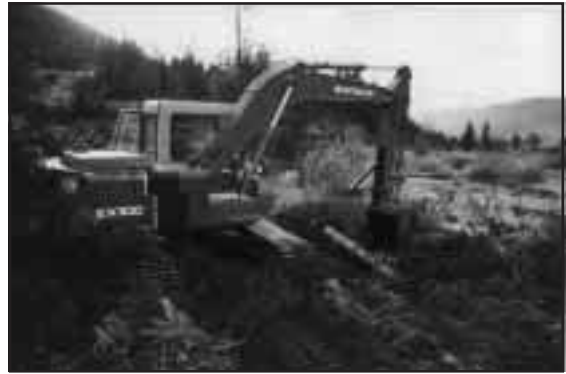
Figure 3-28. Excavator used to tighten and place deadman logs into T-trenches.

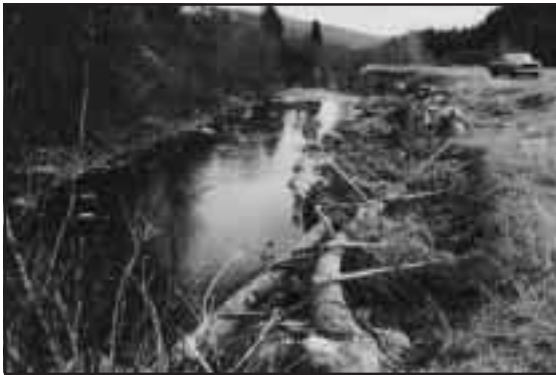
Figure 3-26. Typical river spur structure using large wood pieces, thinned trees, rootwads and boulders; supplemented by planting willow stakes.

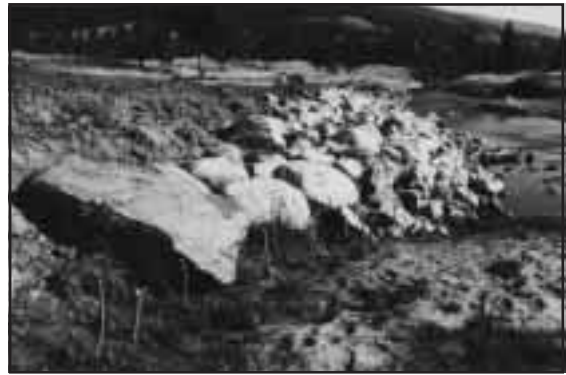
Figure 3-29. Channel manipulation using graded rip-rap and supplemented with planting willow stakes.

At the remaining two bank protection sites, subject banks were pulled back to a more natural configuration and alignment and armored with graded rip-rap to above the bankfull height. The banks were further stabilized with supplemental planting of willow stakes to promote the establishment of riparian vegetation (Fig. 3-29).

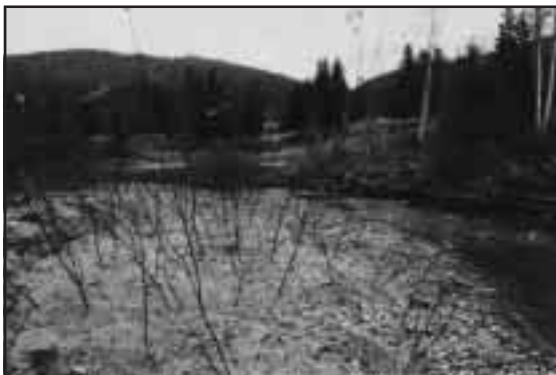
Figure 3-27. Typical river spur on outside bend. Note: large wood pieces, thinned trees and extensive bar planting with willow stakes.

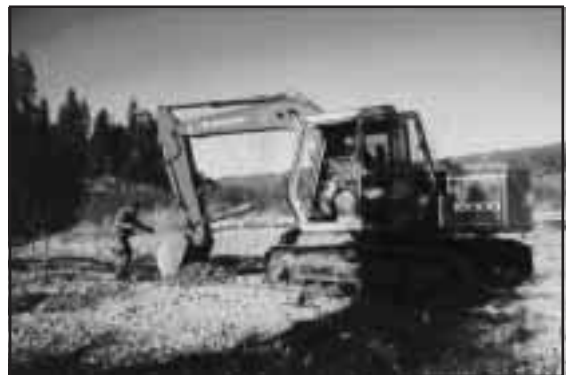
Figure 3-30. Bar planting using excavator. Willow stakes (3-4) were planted per bucket, up to 1 m deep.

Willow stakes were also planted on two large point bars using the excavator. The excavator was used to dig a vertical walled pit up to 1 m deep. Three or four willow stakes were placed into each pit and then infilled (Fig. 3-30).

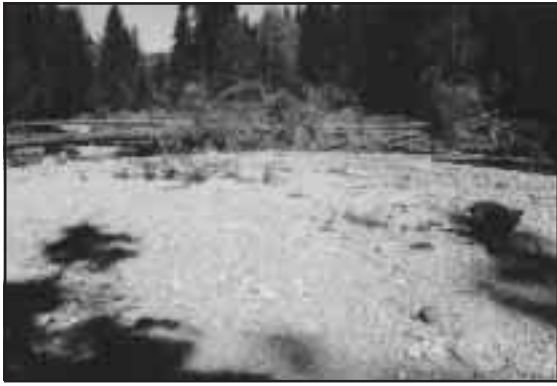
Figure 3-31. View in a northerly direction of Granite Creek at the log jam at 8.3 km Arrastra Cr. Road. Note: partial clearing (west) and fortification (east). (24 September, 1998).

- Five large rootwads were placed into a void in the log jam (8.3 km Arrastra Creek Road) adjacent to the east bank to fortify the east portion of the log jam so that flows would be encouraged to pass under the log jam at the west portion of the log jam (Fig. 3-31). Three large logs in the west portion of the log jam were cut and placed along the east bank immediately upstream for bank protection. Branches were removed from the logs which spanned the flow in the western portion of the log jam to allow flows to pass through and to minimize entrapment of woody debris.

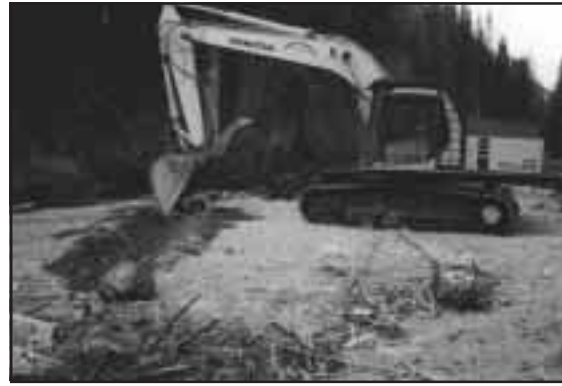
Figure 3-34. View in a northerly direction of the excavator digging a trench into which the black cottonwood nursery trees were planted (24 February, 1998).

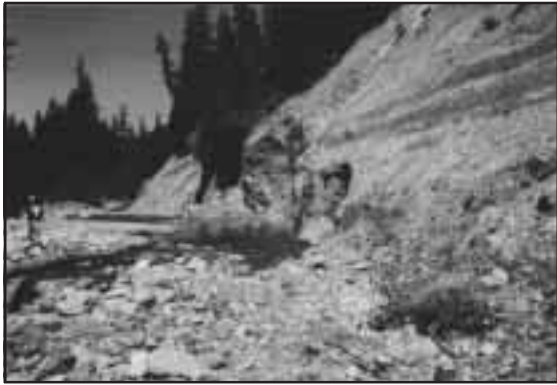
Figure 3-32. View in a northerly direction of Granite Creek facing downstream before installation of the Bendway Rock Weirs (21 July, 1998).

- A total of 130 boulders (approx. 1 m dia.) were used to construct four Bendway Rock Weirs and to protect the toe of the eroding bank between, and upstream of, the base of the four weirs (Figs. 3-32, 3-33). The Bendway Weirs were designed to divert high flows away from the toe of the slope and into the middle of the channel. Four trenches, approx. 0.8 - 1.2 m deep and 6 - 7 m long, were excavated in the creek at an upstream angle of 10 - 15° from perpendicular to the eroding bank. Six to eight boulders were placed within the trench contiguously and the trench was back filled with previously excavated substrate. The next two parallel rows of six boulders each were placed on the creek bed contiguous to, and on either side of, the first row. The last row of boulders was placed on top of the two parallel rows.

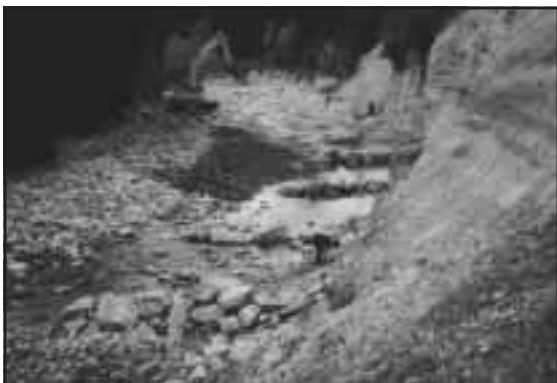
Figure 3-33. View in a northerly direction of Granite Creek facing downstream after installation of the Bendway Rock Weirs (24 September, 1998).

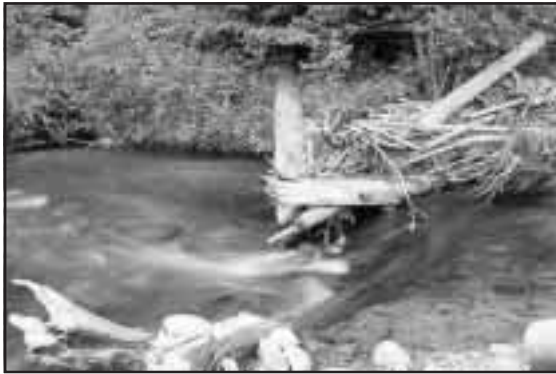
Figure 3-35. Properly functioning lateral debris jam, installed in 1997.

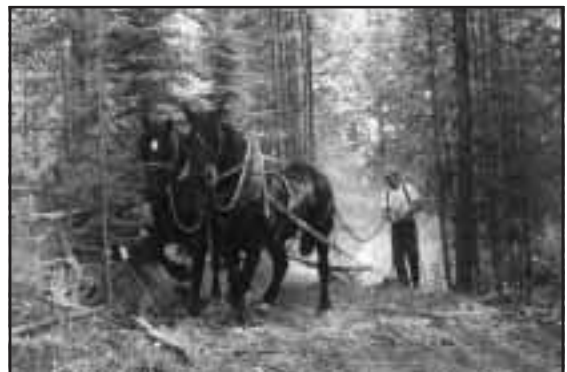
Figure 3-39. Horse logging team moving LWD from road through 25 year old regenerating forest for use in stream restoration.

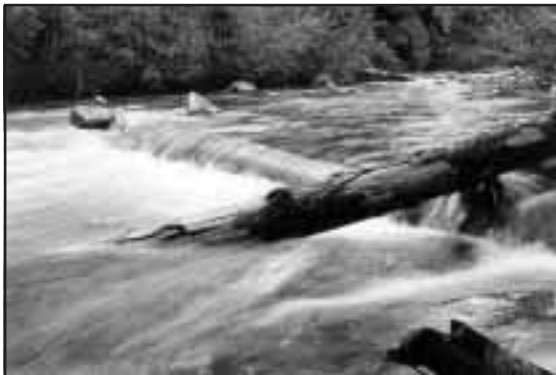
Figure 3-37. Properly functioning diagonal LWD weir, installed in 1997.

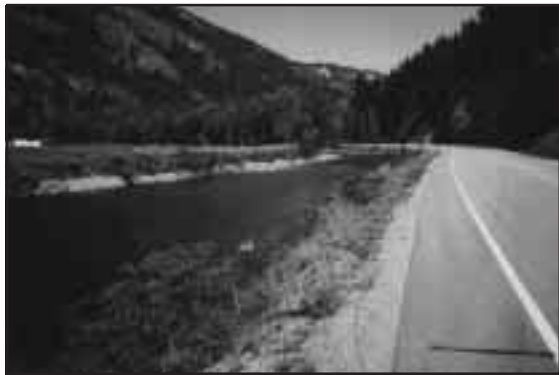
The West Kettle River (mean monthly discharge May-August, 57.9, 36.9, 12.0 and 3.91 m³·s⁻¹ respectively; max. daily discharge, in May 135 m³·s⁻¹; drainage area, 1870 km²; bankfull channel width, approximately 30-40 m) has been affected or impacted by past logging activities, agriculture, road construction (Highway 33), and by the now defunct, Kettle Valley Railroad (Fig. 3-41).

Figure 3-41. West Kettle River, revealing impacts from past logging, agriculture and highway development.

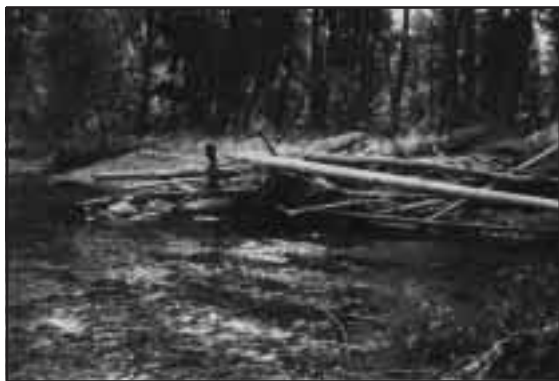
Physical stability monitoring of the lateral jams installed in summer 1997 was carried out to test for condition and durability. The structures were surveyed both prior to and post-flood in 1998. The results indicate that all structures to date are functional, although four had experienced minor lateral movement (D'Aoust and Millar 1999). One triangular structure did cause bank erosion illustrating the need to pre-fill or armour the bank at the upstream log at erodable sites (see D'Aoust and Millar 1999).

Figure 3- 42. A lateral log jam structure installed in the West Kettle River in 1997. The triangular structure accumulated debris during the spring flood.

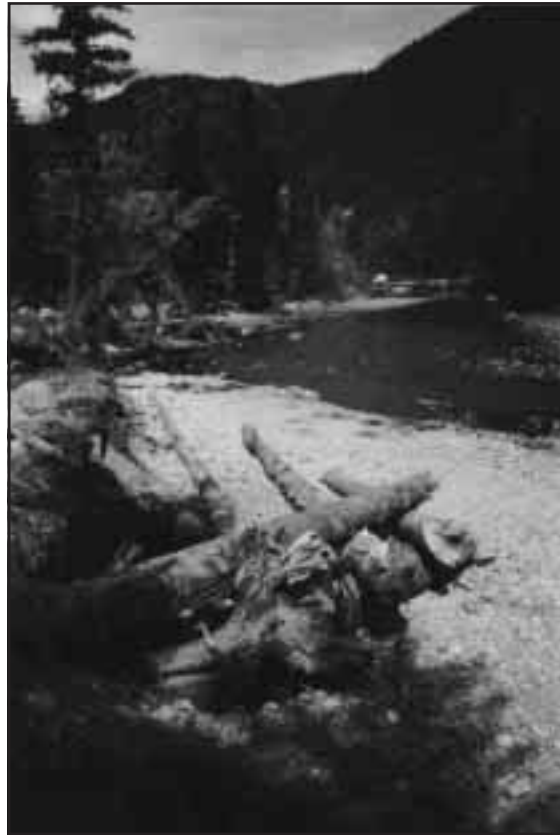
Figure 3- 43. Bank stabilization structures (before ballasting) installed in the West Kettle River as an alternative to the use of rock rip-rap for erosion control.

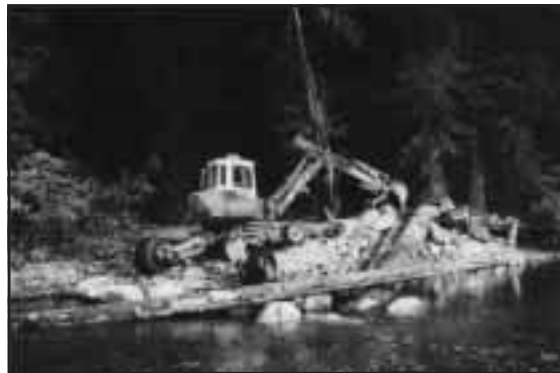
Figure 3- 44. A box groin structure, one of four installed in the West Kettle River in 1998 to provide fish habitat cover and promote pool formation. (During construction, one log to be placed.)

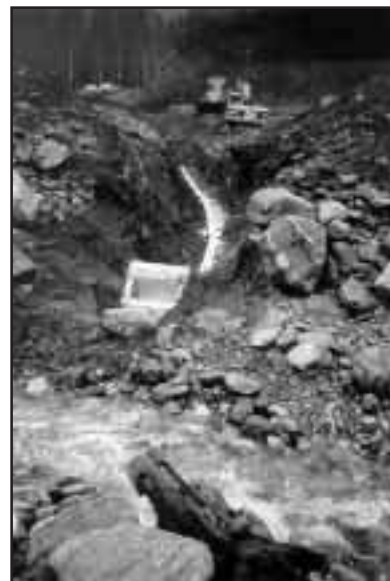
Figure 4-1. Intake box and pipeline installation.

purchased polyethylene box tank (3.75' wide x 2.5' deep x 7' high). The front face of the box was removed and replaced with 2 x 6 boards and a sub-surface intake slot (Fig. 4-1). The slot could be moved up or down to accommodate various flow conditions. The lowest slot position was placed approximately 0.6 m above the bottom of the box in order to form a sediment trap within the box. The outlet hole was set to the same elevation as the lowest intake slot.

- A ditch 2 m deep x 240 m long was excavated from the headpond of the groundwater channel (which feeds the main pond) to the upstream end of the Standfast Creek culvert. Groundwater flows increased as the ditch approached Standfast Creek. As a result, "socked" perforated pipe was ordered to collect this groundwater (Fig. 4-1).

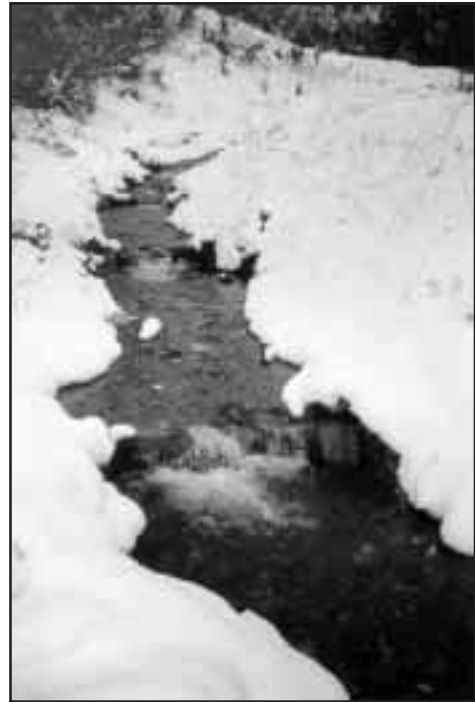
Figure 4-4. Main pond outlet channel after supplemental water and new vortex weirs.

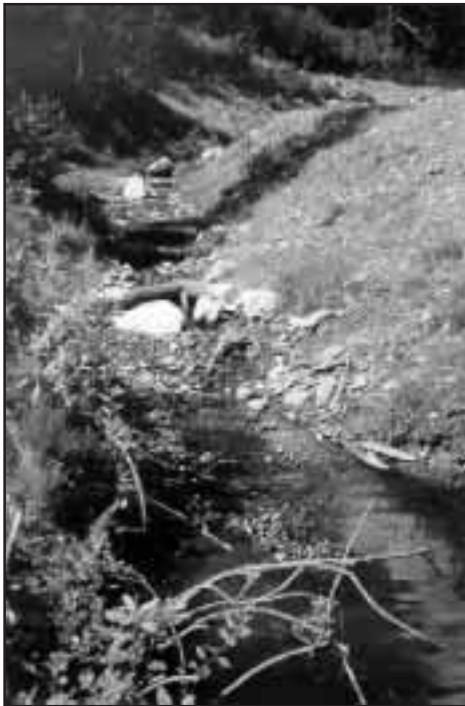
Visual monitoring during 1998 suggested that the log vortex weirs within the main pond outlet channel were a barrier to juvenile fish. Fish observed in the main pond were all greater than 10 cm while the lower pond (which still had mainstem connection) contained numerous fish that were less than 10 cm. Based on the above, it was decided that a reduction in the outlet channel gradient and reconstruction of the log vortex weirs using rock would allow juvenile fish to access the main pond.

Figure 4-3. Main pond outlet channel prior to supplemental water and new vortex weirs.
