Watershed Restoration Program
Ministry of Environment, Lands and Parks
and Ministry of Forests

**Annual Compendium Of Aquatic Rehabilitation Projects
For The Watershed Restoration Program
1998 - 1999**

Watershed Restoration Project Report No. 13

1999

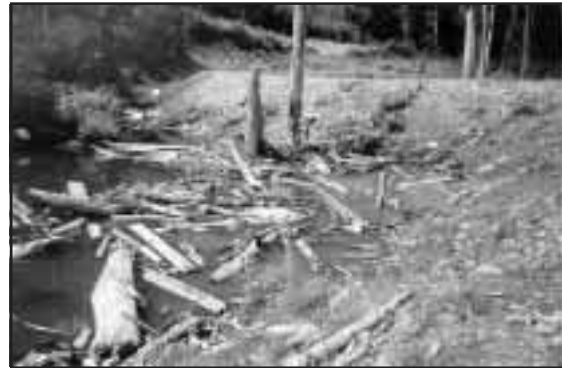
A small bay within the lower pond was found to be collecting iron leachate from the base of the main pond containment berm. This iron leachate was adversely affecting water quality within the lower pond. Removal of the small peninsula which created the bay would allow for the main pond outlet channel water to flush this area out and maintain acceptable water quality.

Figure 4-5. Lower pond prior to works. Note iron leachate (foreground) and main pond outlet channel (upper left).

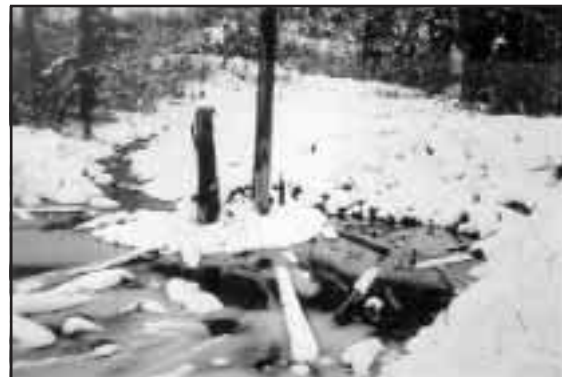
Figure 4-6. Lower pond after removal of peninsula. Note clean water and longer outlet channel with increased flow from main pond.

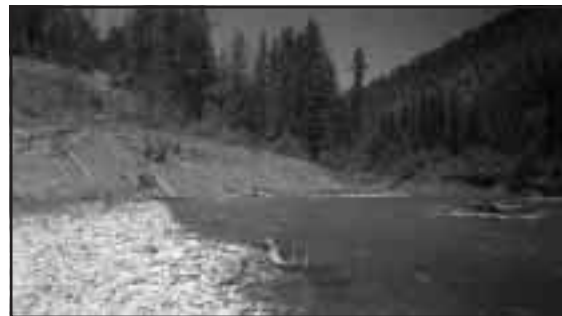
The glaciolacustrine rotational slump was determined to have been caused by sub-surface piping of water and saturation of glaciolacustrine silts and clays. In combination with the lateral instability of the Bighorn Creek channel in the vicinity of the rotational slump (Babakaiff et al. 1998 c), columns of exposed glaciolacustrine deposits subject to physical weathering have continued to topple and accumulate at the toe of the slide. Erosion and undermining of the toe by fluvial processes, particularly during spring freshets, have elevated fine sediment delivery to the channel over the past eight years (Oliver 1998 b). Figures 4-7 and 4-8 illustrate the condition of the site prior to rehabilitation commencing.

Figure 4-7. A downstream view of the rotational slump.

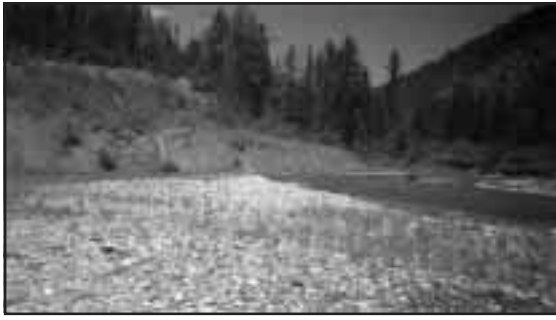
Figure 4-8. Downstream view of the rotational slump. Note that the slump is composed of two distinctive levels/layers. The prescription only focused on the lower level as there is a terrace between the two levels, thus preventing material from the upper level reaching the creek.

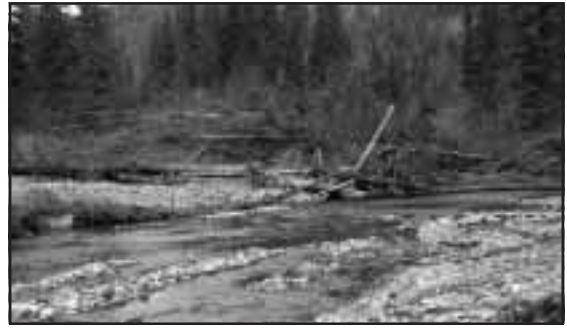
Figure 4-11. The lower log jam situated at the downstream end of the slump.

- Log jams were constructed at the downstream end of the slump (Fig. 4-11) and at the upstream end of the slump (Fig. 4-12). The jams were secured through the use of railway rails, 3/4" cable and clamps. As well, several logs in the jams were partially buried in the substrate for additional security.

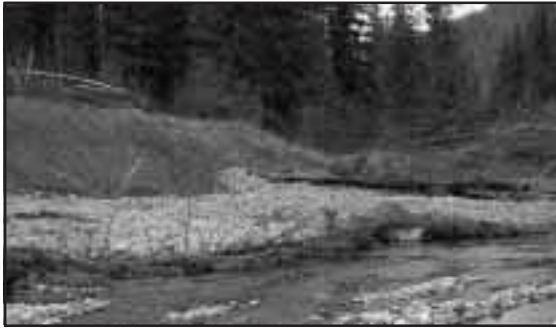
Figure 4-9. The lower groyne with a whole tree deflector incorporated into its streamward edge.

- Finally the groyne was back-filled to the design elevation with cobble-sized material.
- As seen in Figures 4-9 and 4-10, each groyne had whole tree deflectors incorporated into their streamward edge to provide additional cover habitat.

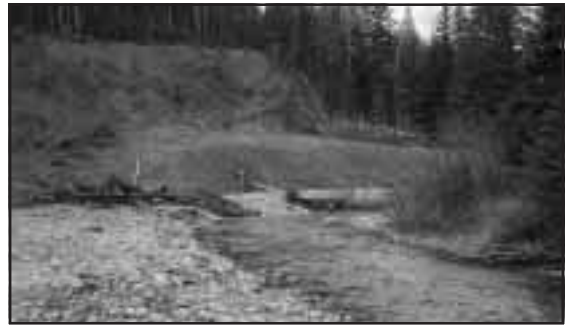
Figure 4-12. The upper log jam situated at the upstream end of the slump, seen on the left hand side of the photo. Also, seen in the background is the re-contoured revegetated hillslope.

- A log deflector was constructed at the start of the gravel bar seen in Figure 4-12 (just upstream of the picture).
- The slump hillslope was recontoured with an excavator to an angle of approximately 26°. The hillslope was then grass seeded and fertilized immediately following recontouring. Following the first frost in the fall the hillslope was live stalked with willow cuttings.

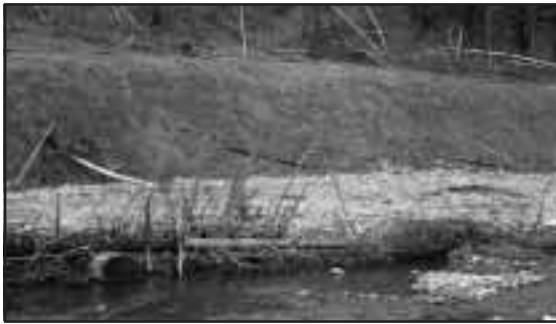
Figure 4-10. The upper groyne. Note the re-contoured hillslope in the background with grass seed starting to become established.

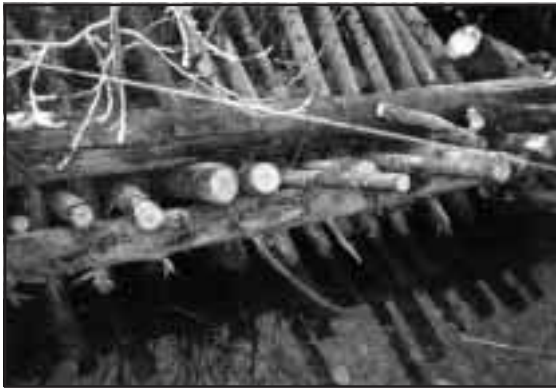
Figure 4-13. Structure #8 on Buckworth Creek, a revetment designed to minimize further undercutting of the stream bank and provide instream cover.

A total of 15 structures were placed in Reach 3 (Figs. 4-13 to 4-16). The structures were comprised of single and multiple log/rootwad placements comprised of triangular log structures and LWD bank revetments. These structures are designed to dissipate energy, promote scour in certain locations, increase habitat complexity and maintain bank stability. In all 49 logs, 38 rootwads, 32 boulders, 4 whole trees and 47m of cable were incorporated into the 15 structures.

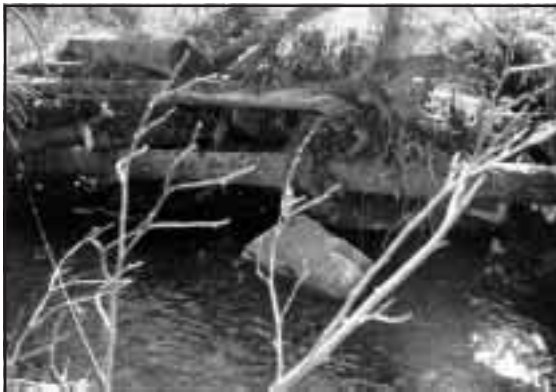
Figure 4-14. A log/rootwad structure on Buckworth Creek.

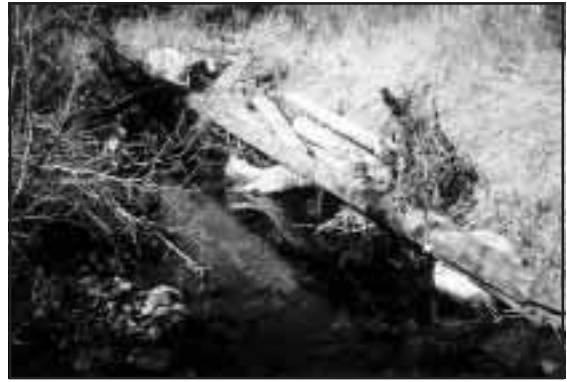
Figure 4-15. A log/rootwad structure on Buckworth Creek provides instream cover and protection to the stream bank.

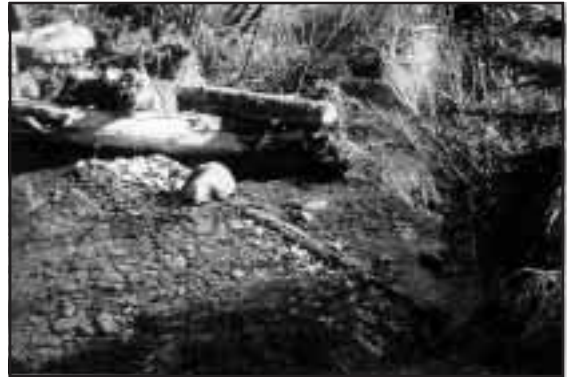
Figure 4-16. A stoplog/rootwad structure on Buckworth Creek.

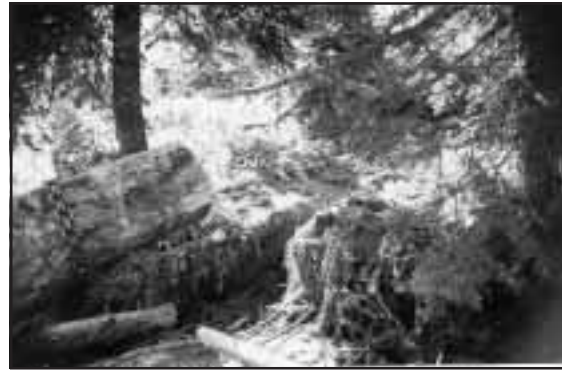
Figure 4-22. Chainsaw winch set up. Note: use of pulley, cable attachment to log and direction of pull for fail safe operation.

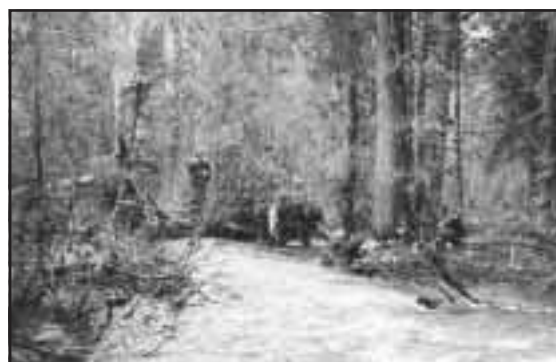
Figure 4-23. Pre-work downstream view of rootwad and bole of toppled spruce and right bank avulsion channel on Pass Creek.

- A 10 m section of bole was cut from the remaining trunk of the toppled spruce and winched into position as a tilt log/flow deflector across the head of the right bank avulsion channel (Figs. 4-23 and 4-24). The bank end of the tilt log was attached to a sound spruce tree of 0.7 m diameter with 5/8" galvanized steel cable and cable clamps. The wetted end of the tilt log was weighted with 4 x 0.5 m diameter ballast boulders. These were attached to one another with 5/8" galvanized steel cable fed through augered holes in the tilt log and fastened with Hilti HY-150 epoxy as detailed in Chapter 9 of Watershed Restoration Technical Circular No. 9 (Slaney et al. 1997).

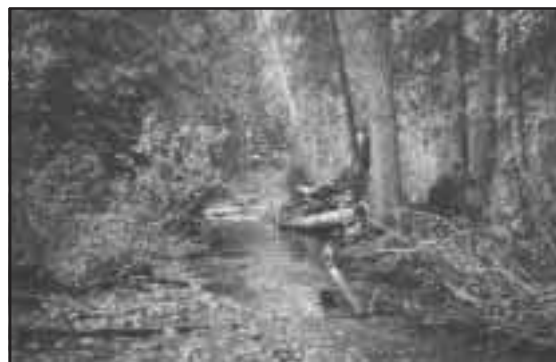
Figure 4-24. Post-work downstream view of spruce tilt log, re-oriented rootwad and re-established stream course on Pass Creek.

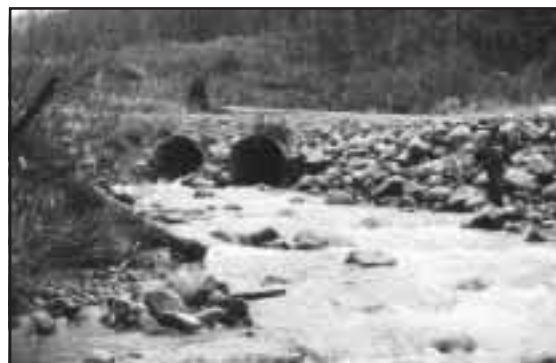
Figure 4-25. Pre-work view of partially embedded culverts posing a velocity barrier to the upstream movement of bull trout in Pass Creek.

Culvert replacement works were initiated on August 29 and completed on August 30, 1998. During this time the twin culverts of the FSR stream crossing were replaced with a clear span bridge deck of 40' in length resting on pre-cast concrete lock-block abutments (Figs. 4-25 and 4-26). Heavy equipment requirements included a CAT 235B backhoe to position lock blocks, a gravel truck to provide backfill and a Komatsu 100 excavator to remove the embedded culverts and position the bridge deck.

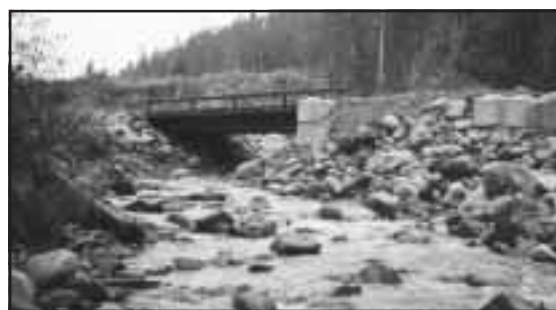
Figure 4-26. Post-work view of clear span bridge stream crossing of Pass Creek.

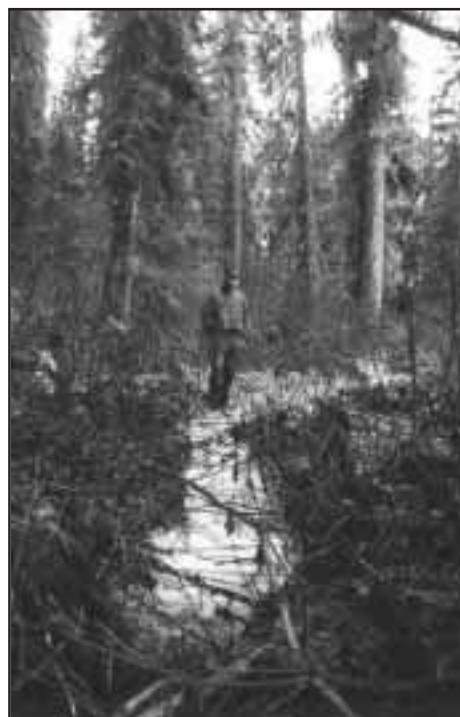
Figure 4-27. Pre-work of 0.8 m falls at 75 m upstream "Shake Block Creek".

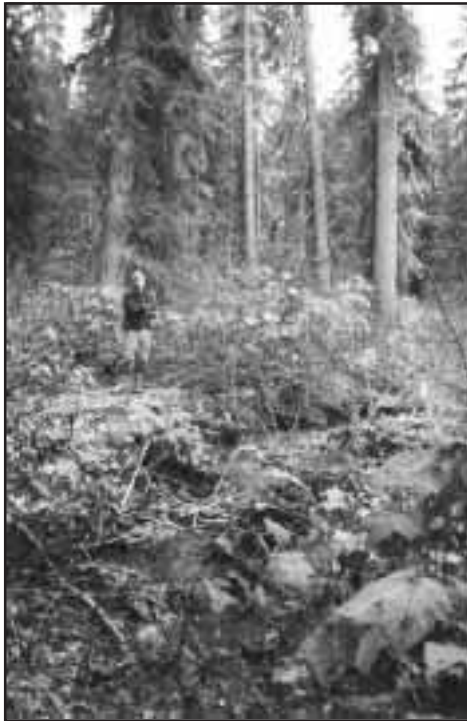
Figure 4-28. Post-work view of excavated channel at 75 m upstream on “Shake Block Creek”.

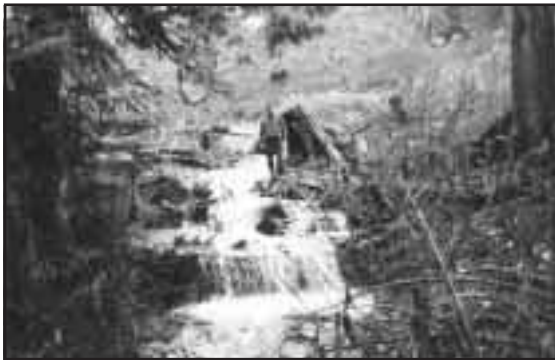
Figure 4-29. Pre-work view of development-related debris jam at 220 m upstream of “Shake Block Creek”.

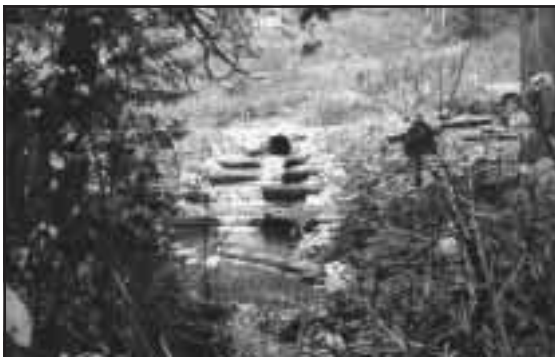
Figure 4-30. Post-work view of upstream v-wiers at 220 m upstream on “Shake Block Creek”.

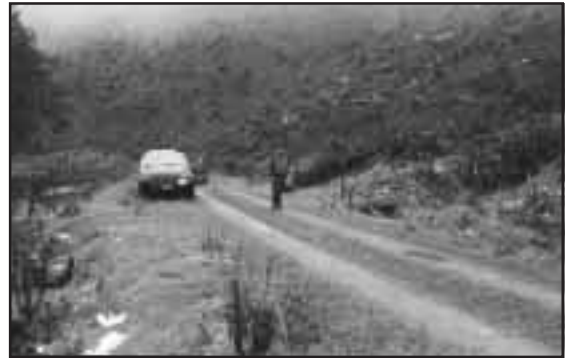
Figure 4-31. Pre-work view of the North Downie FSR crossing of “Shake Block Creek”.

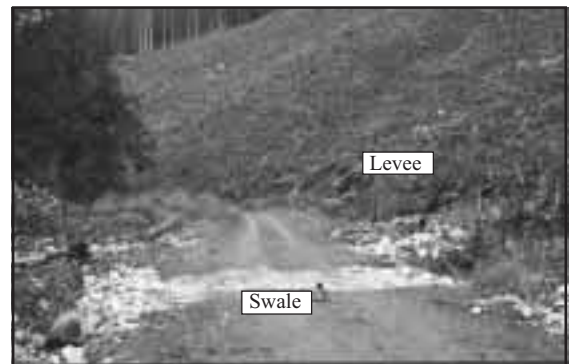
Figure 4-32. Post-work view of cobble swale and ditch block levee at the North Downie FSR crossing of “Shake Block Creek”.

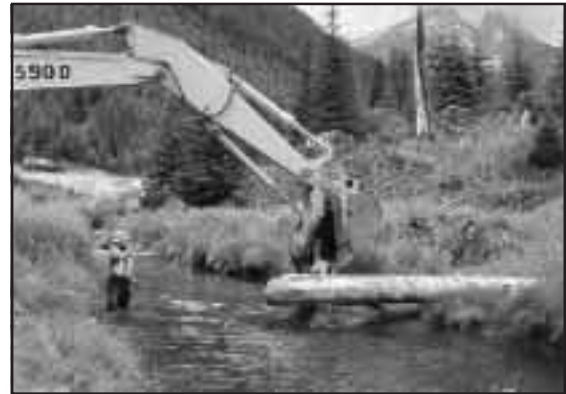
Figure 4-33. Lateral debris jam to provide additional cover in side channel.

Structures built included: lateral debris jams (Fig. 4-33); debris catchers to promote bar stabilization and channel narrowing (Fig. 4-34); boulder vortex weirs (Fig. 4-35); lateral debris jams incorporated into bank revetments (Fig. 4-36); and structures intended to improve bank-side cover for fish (Figs. 4-37). Anchors included ballast boulders, as well as logs pushed vertically or horizontally into areas with softer substrate.

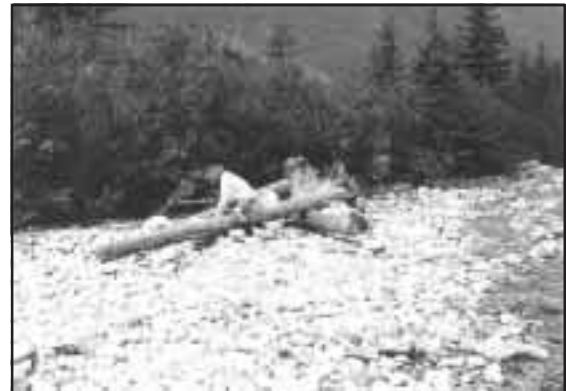
Figure 4-34. Debris catcher at the top end of a meander bend intended to promote bar stabilization and channel narrowing.

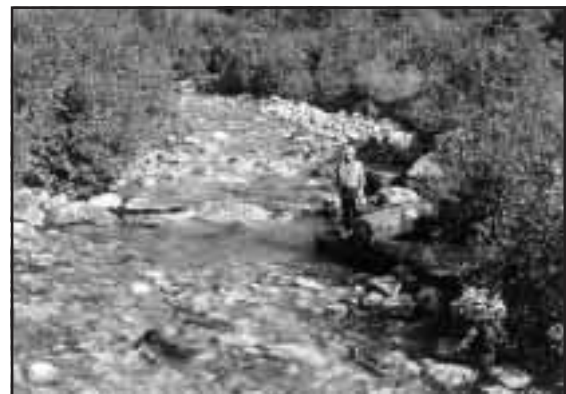
Figure 4-35. Boulder vortex weir and lateral debris jam to enhance existing deep pool habitat with additional depth and cover.

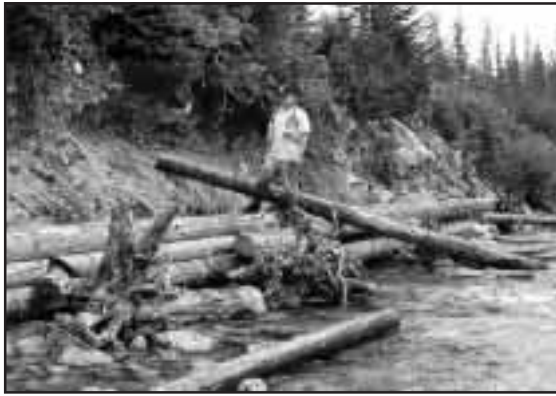
Figure 4-36. Bank revetment with rootwads and lateral debris jam to stabilize toe of slope and increase cover.

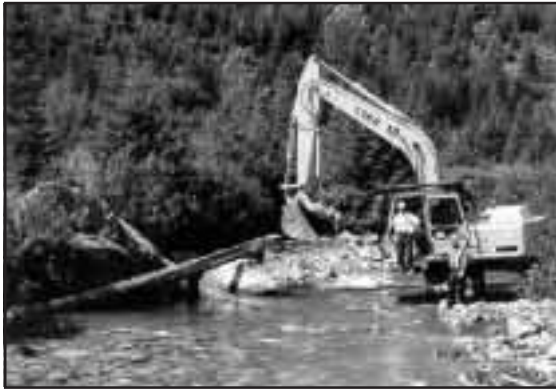
Figure 4-37. Cover log to increase cover, anchored to large boulders in existing pool.

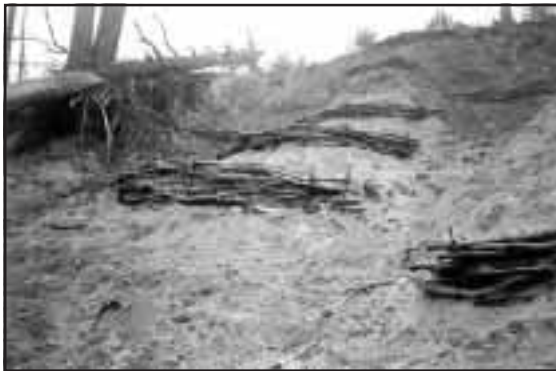
Figure 4-38. Landslide stabilization using wattle fences, live smiles and buried live pole drains (in gullies).

Bioengineering was also completed on a single landslide. The range of techniques used included wattle fences, modified brush layers, smiles, and buried live pole in gullies (Fig. 4-38).

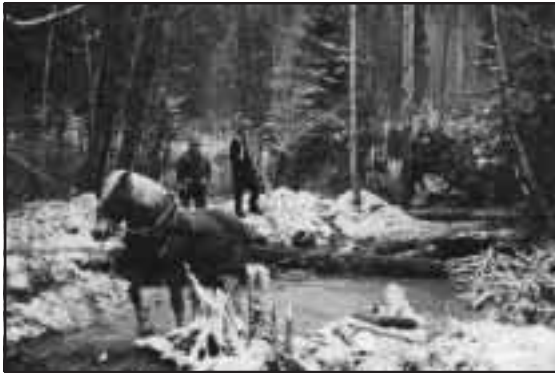
Figure 4-39. Manual labor and horse logging techniques were effective in minimizing impacts to Inlet Creek and adjacent habitat.

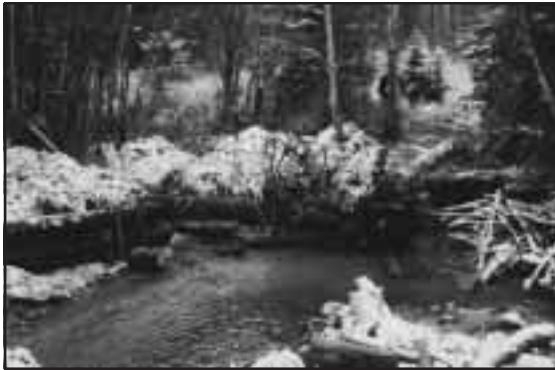
Figure 4-40. Works in progress: streambank stabilization on Inlet Creek incorporating rootwad revetment and log wall armoring.

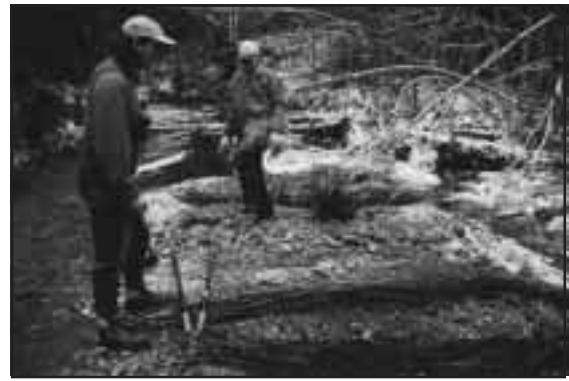
Figure 4-41. Bar stabilization using brush traverses.

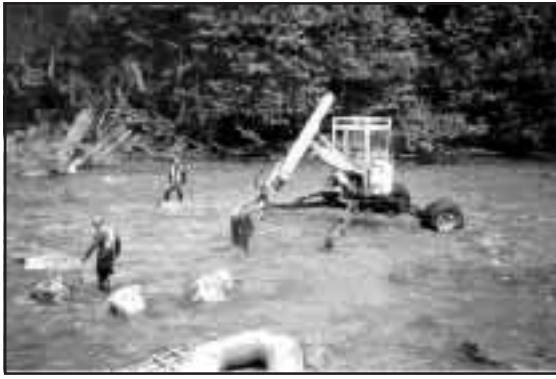
Figure 4-43. “Spider” hoe placing boulder clusters.

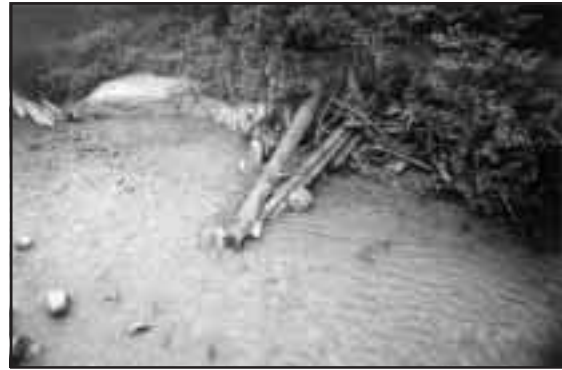
Figure 4-45. Triangular lateral log jam.

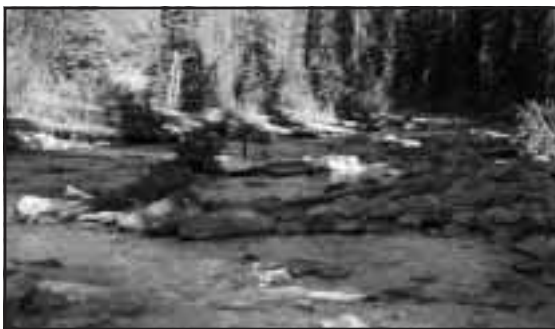
Figure 4-47. Spur log/rock weirs in the foreground with opposing natural material bank revetment in the background.

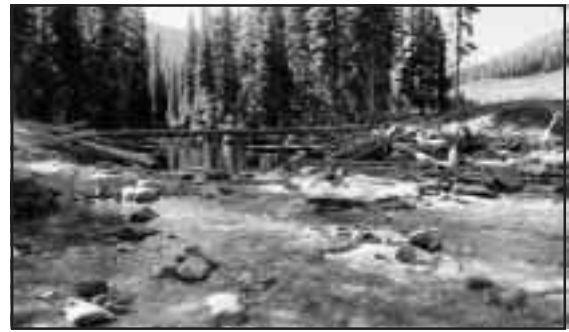
Figure 4-48. Newbury type riffle and natural material bank revetment at a deactivated bridge crossing.

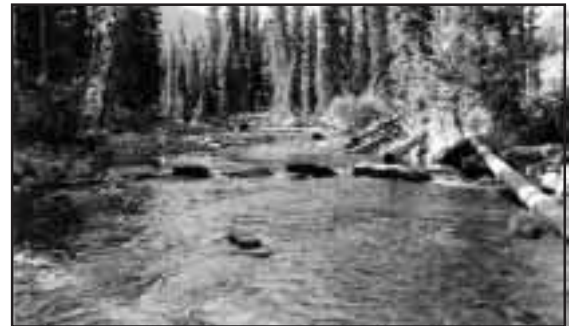
Figure 4-49. Upstream view of vortex type weir.

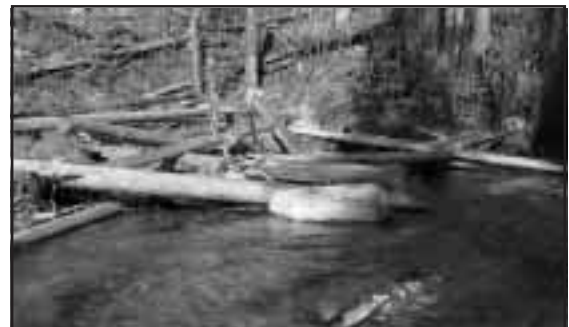
Figure 4-50. A triangular lateral log jam built in a residual pool within a minor bend of Redding Creek.

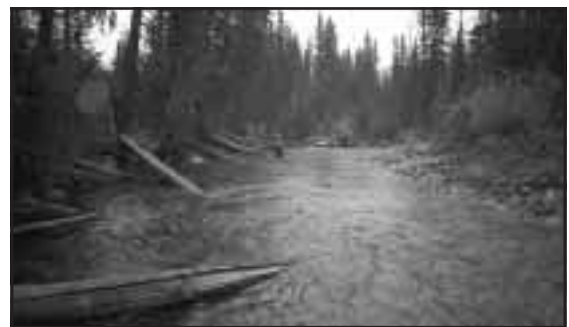
Figure 4-51. A series of three large turning logs placed at 20° upstream angle to transfer the thalweg towards the center of the channel. Note the mid-channel bar stabilization structures in the background.

- In total, 33 structures were constructed within the treatment area. Two structures were considered interim and will require future modifications.
- Structures constructed included: boulder clusters, LWD windfalls, vortex rock weirs, opposing wing deflectors, log bank spurs, native material bank revetments, triangular lateral log jams, lateral log jams, “turning” logs, and “Newbury” rock riffles (Figs. 4-47, to 4-50). The “W” weir proposed in the Cope and Oliver 1998 report was considered too manufactured and thus was replaced with three large “turning” logs (Fig. 4-51).

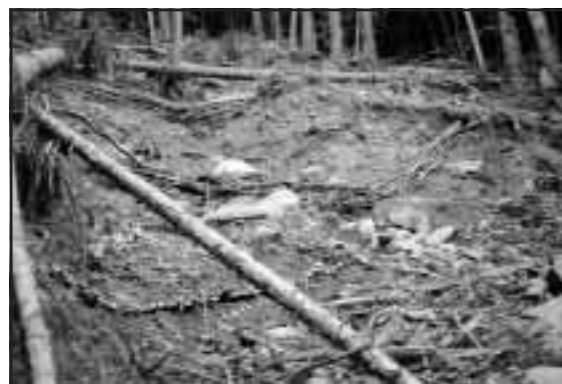
Figure 4-52. Live gully breaks and brush layers on Rover Creek.

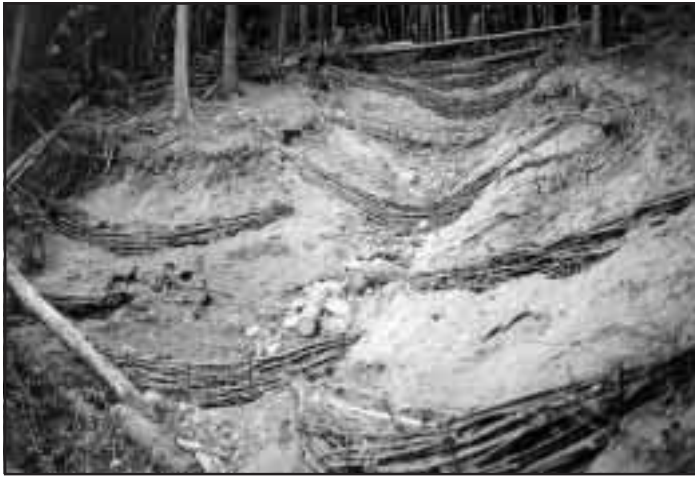
Figure 4-53. Live gully breaks and live smiles on Rover Creek.

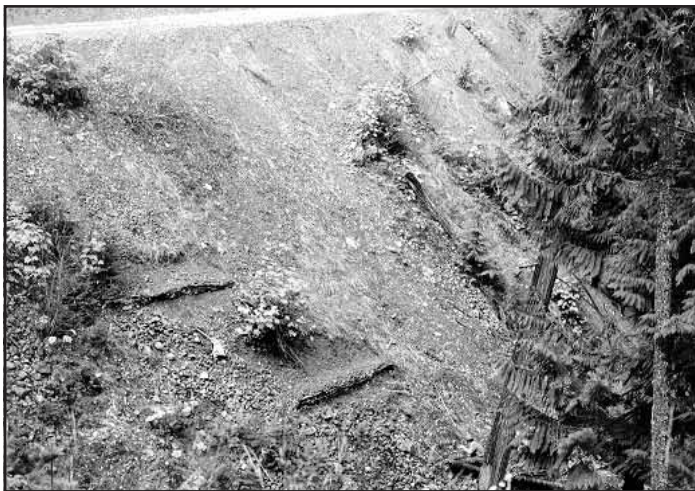
Figure 4-54. Two wattle fences completed on a large raveling slope above Rover Creek. For scale note the worker sitting at the base of the tree.

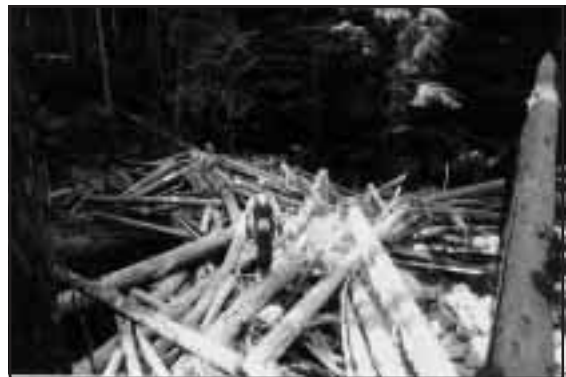
Figure 4-56. The beginning of removal of the debris jam on Sanca Creek.

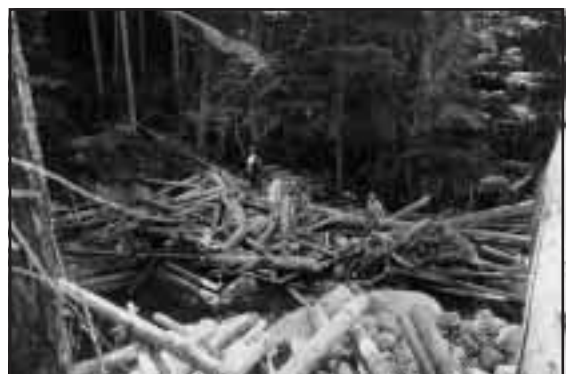
Figure 4-57. The Sanca Creek channel opened at the site of the debris jam.

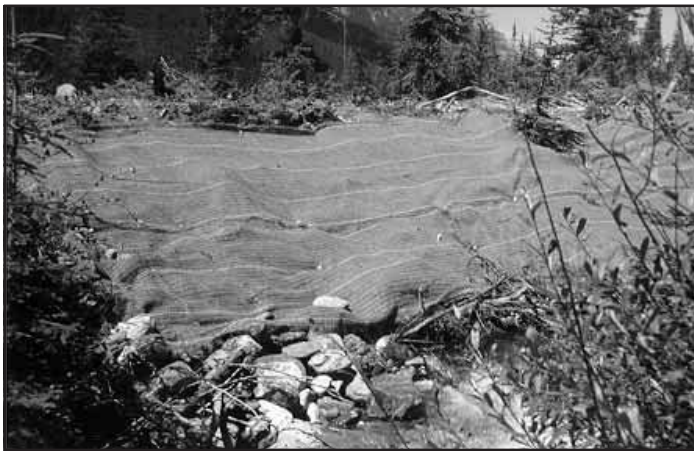
Figure 4-61. Eroding bank re-sloped, toe partially armored and covered with coconut fibre matting.

- A large eroding bank with a distinct overhang was re-sloped to an approximate 1:1 angle. Any boulders encountered during the re-sloping were used to help armour the toe of the slope. The slope was then raked and seeded. A coconut fibre Terra-Mat was then installed over the slope and pinned down with wood stakes (Fig. 4-61). The area was then staked with willow stakes. Areas above and below the site were used as templates; they had significant willow cover and a reduced bank angle.

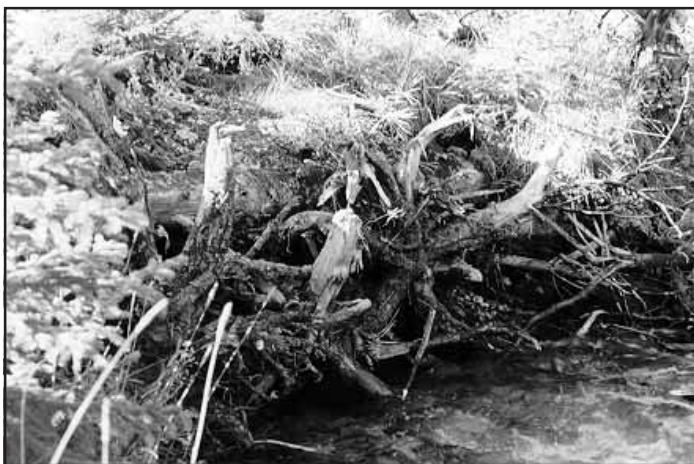
Figure 4-62. Rootwad structure to protect bank and induce pool scour.

- Both sites 2 and 4 were identified during the prescription development as being historic and/or potential pool sites located on bends. At both locations the bank was being undermined from the breakdown of rootwads from harvested trees. In both cases a trench was dug approximately 5 m long to an estimated 0.5 m below the existing streambed profile. Large rootwads with at least 4 m stem were placed in the trench. These pieces of LWD were then covered with LWD perpendicular which were then backfilled with earth and rock to the edge of the rootwad and stream (Fig. 4-62). A small portion of the stream bed was excavated to induce pool scour.

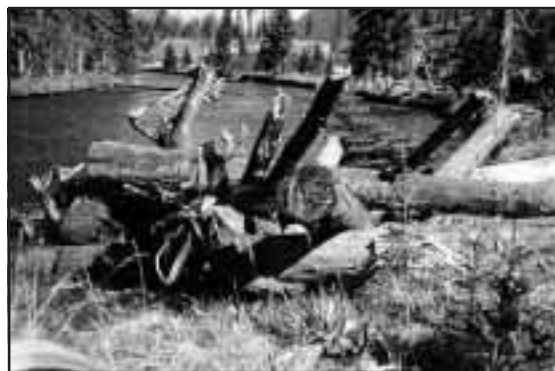
Figure 4-63. One of the large LWD structures constructed and also illustrates the impacts from harvesting on the riparian zone.

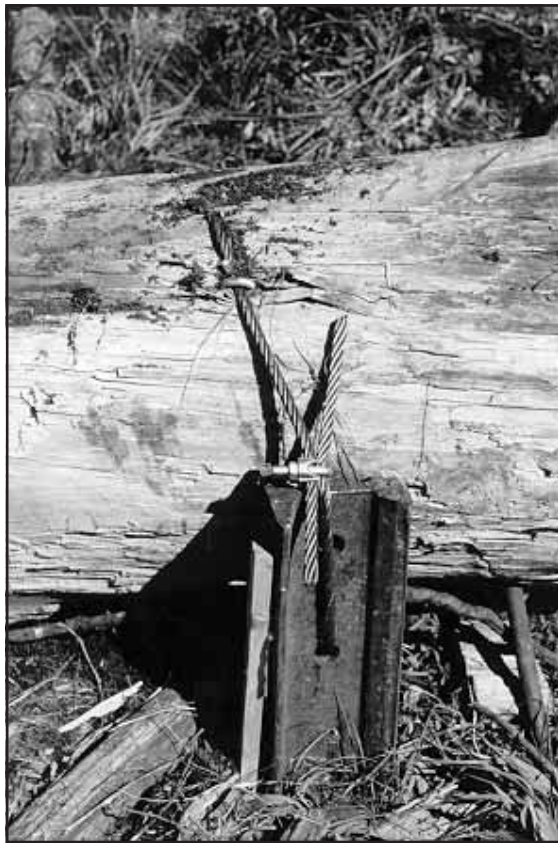
Figure 4-64. Typical placement of anchor “piers” used to supplement boulder ballasting.

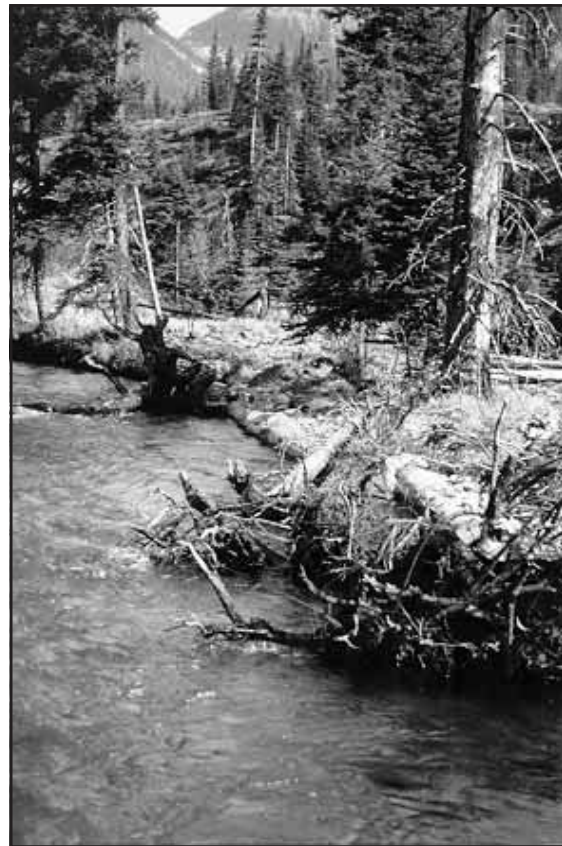
Figure 4-66. Whole tree revetment to protect eroding bank. Note energy dissipation along bank margin.

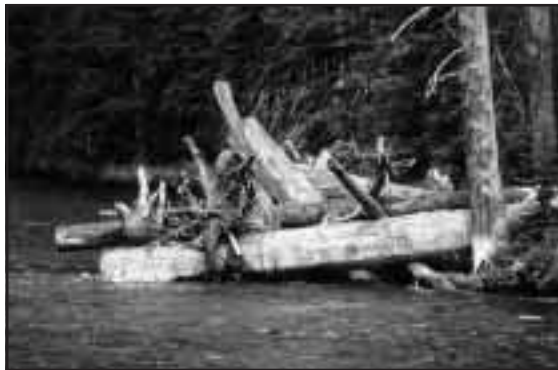
Figure 4-65. Large LWD structure. Note the use of a variety of sized LWD and rootwads for added complexity and strength.

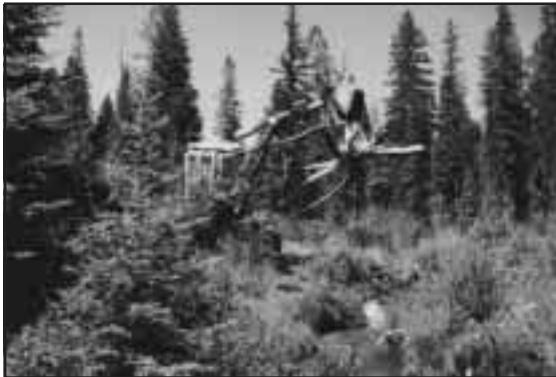
Figure 4-67. Effective use of a “spider” hoe provided low site impact during restoration activities.

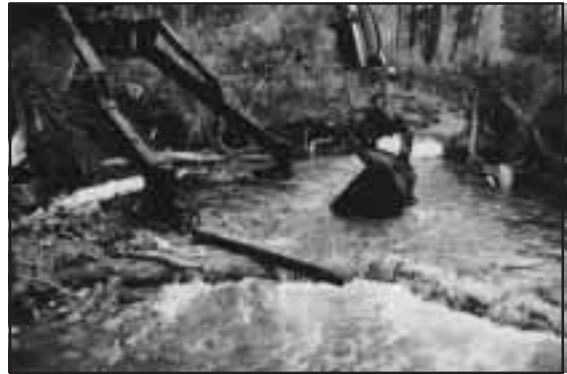
Figure 4-68. Placement of a log V-weir will provide gradient control following debris removal.

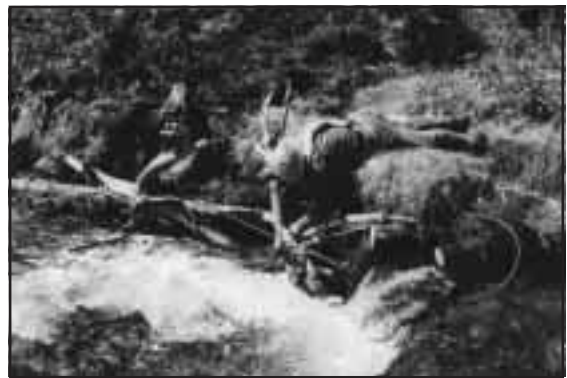
Figure 4-69. Rootwad LWD placement will provide bank stability and create habitat.

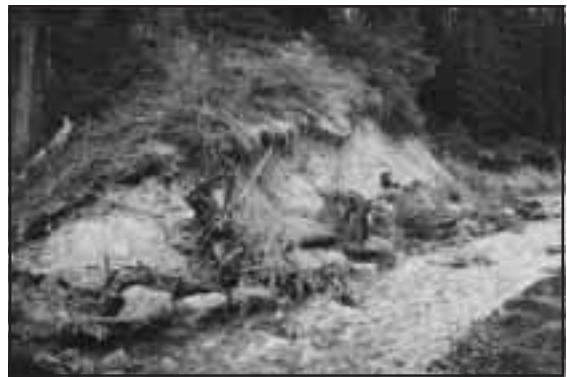
Figure 4-70. Eroding bank stabilization using displaced forest workers.

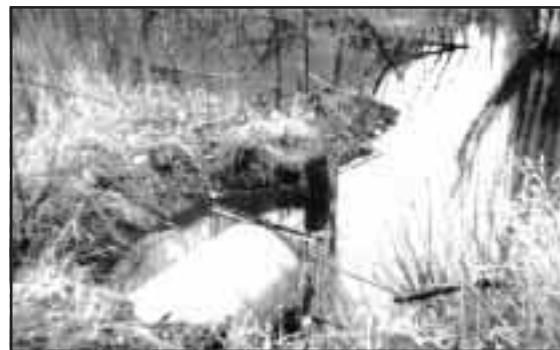
Dump Creek has historically been used as a spawning and rearing area for coho and cutthroat. However, ongoing problems with beaver and scour at a culvert placement on Highway 20 through which the creek flows limited access into and out of the upper pond and channel portions of this creek (Fig. 5-1). A beaver box was constructed and installed on the upstream end of the culvert to prevent beavers from damming the entrance, and a series of riffles were constructed below the culvert to improve access to the culvert and the habitat above (Fig. 5-2). In the fall of 1998 adult coho were observed in the pond above the culvert having successfully negotiated the riffles and beaver box.

Figure 5-1. Culvert before beaver box installation on Dump Creek.

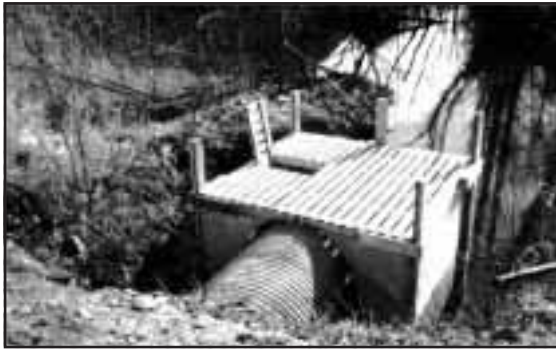
Figure 5-2. Culvert after beaver box installation on Dump Creek.

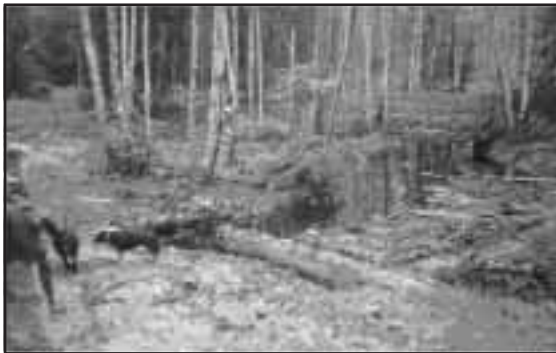
Epp Creek is a small channel primarily used for coho rearing. However, late summer low flows often stranded fish in a few small pockets of water. A refuge pond of approximately 0.025 ha was excavated to a depth of 2 m (Fig. 5-3), and complexed with rootwads, artificial cutbanks, and other LWD placements. As well, a 0.005 ha pond was excavated adjacent to a year-round cool water spring that augments water flows in the creek during low flow periods. These two ponds will provide stable rearing and refugia area for juvenile fish of many species that seek stability from the waters of the Bella Coola mainstem some 300 m downstream.

Figure 5-3. Overwinter pond excavation on Epp Creek prior to wood complexing.

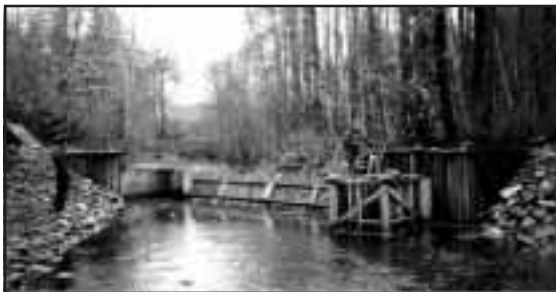
Figure 5-4. Fish counting fence constructed on lower Hagensborg Slough.

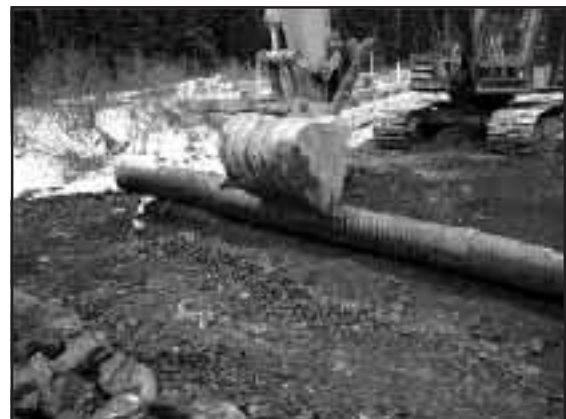
Figure 5-6. Channel bypass.

Water was diverted into the smaller of the two existing culverts while the larger one was removed and the channel reconstructed (Fig. 5-6). Silt fences were placed downstream during all phases of construction to maintain water quality during installation.

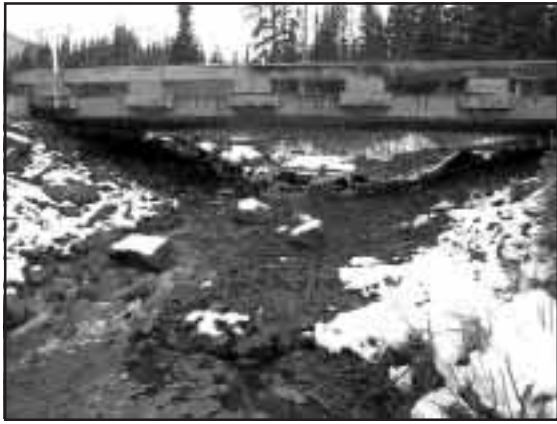
Figure 5-7. Completed installation.

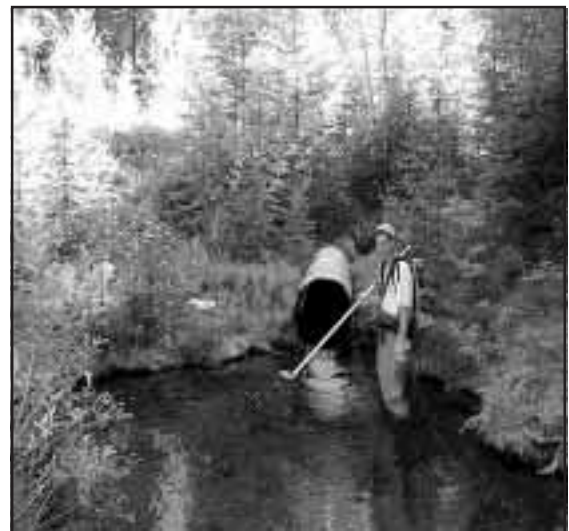
This barrier to fish was identified during a field inspection by Weldwood. The culvert was undersized for Q100 flows, was quite long (25 m), at a gradient that prohibited fish passage and had a small outfall drop (Fig. 5-8). A clear span structure was determined to be the best option for restoring fish passage.

Figure 5-8. Outfall of culvert.

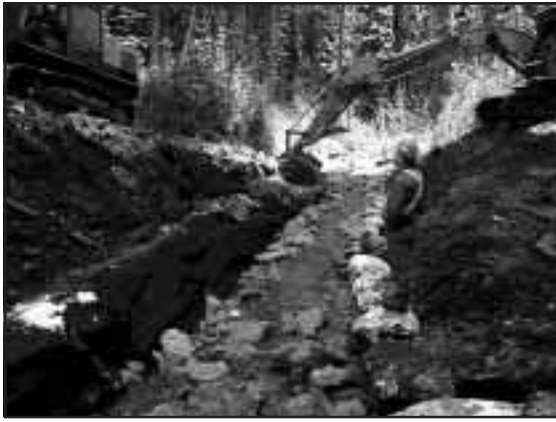
Figure 5-9. Construction of the bypass channel.

- A bypass channel was constructed adjacent to the culvert that was armored with clean rock prior to stream diversion (Fig. 5-9).
- Rip-rap was placed at the upstream bend in the creek to eliminate erosion and potential sediment inputs to the stream.

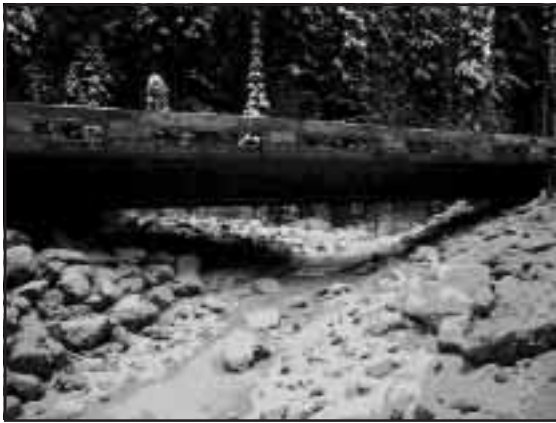
Figure 5-10. Completed installation.

- Fifteen meter concrete slab deck (Fig. 5-10).
- 30% skewed approaches.
- Eight inch steel posts on pre-cast concrete footings.
- Reconstructed channel width 4 to 5 m.

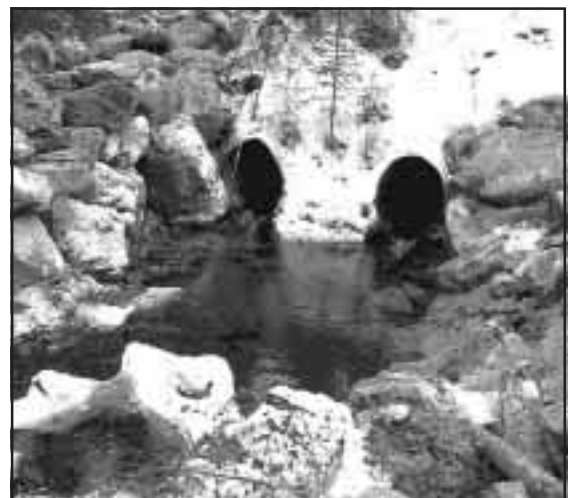
This barrier to fish was identified during a field inspection by Weldwood staff. It was determined during the site plan preparation that the existing culverts were sufficiently large to accommodate the Q100 flows. The primary barrier to fish was caused by the 20 cm outfall at the downstream end of the culverts and increased water velocity during high flow periods (Fig. 5-11). Constructing weirs to eliminate the outfall drop barrier was determined to be the most cost effective solution.

Figure 5-11. Culverts prior to weir construction.

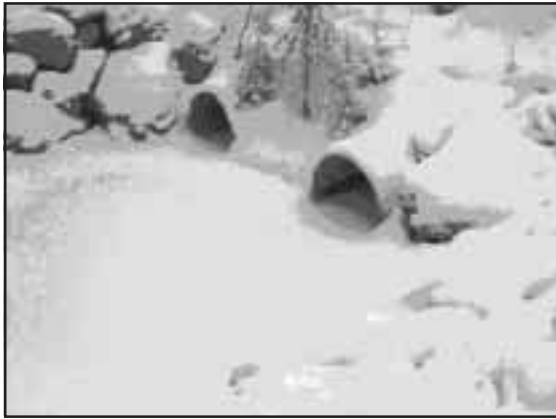
Figure 5-12. Culverts backflooded after weir installation.

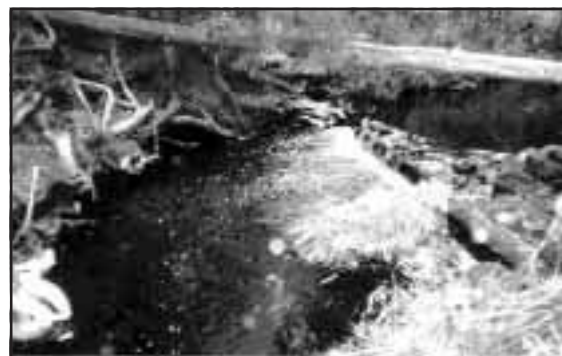
Figure 5-13. Site 8 on Marjorie Creek at extreme low flows during August 1998 installation (above) and approaching bankfull conditions on November 12, 1998 (below).

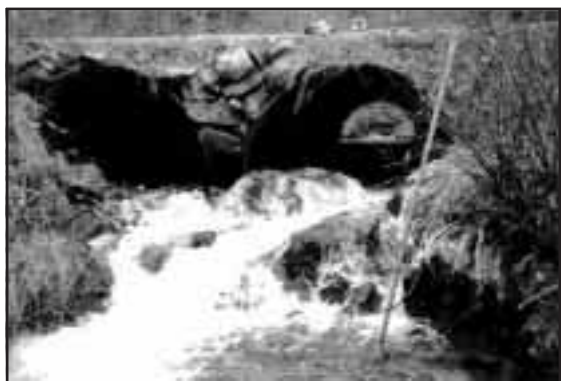
Figure 5-14. Culvert site at 19 km - 1300 Road, Cottonwood River watershed limiting fish access to 1.75 km of habitat. The outfall drop of 30 cm was followed by a cascade of 80 cm height.

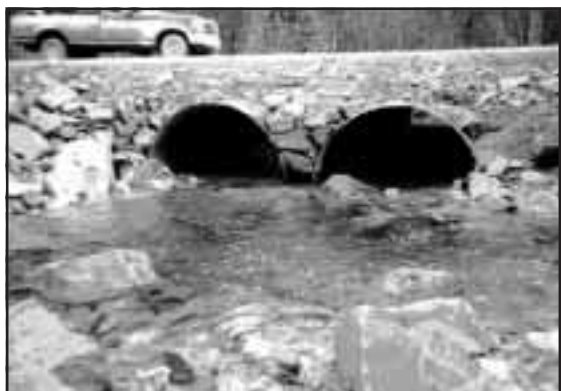
Figure 5-15. Culvert site at 19 km - 1300 Road, Cottonwood River watershed after construction of a downstream riffle.

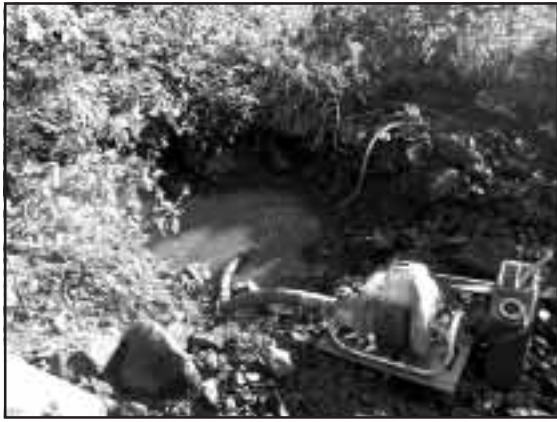
Figure 5-17. Stream diversion during instream works.

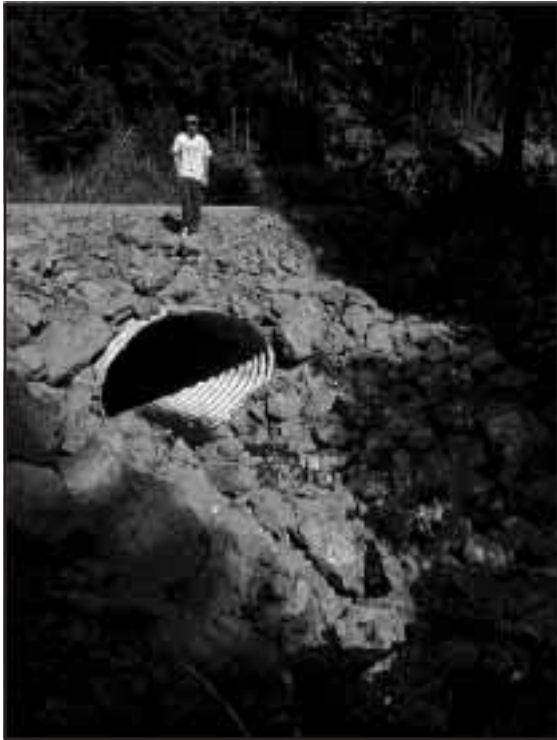
Figure 5-18. Final installation.

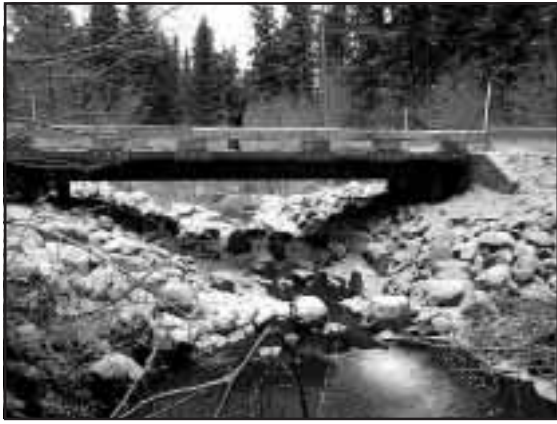
Figure 5-20. Final installation.

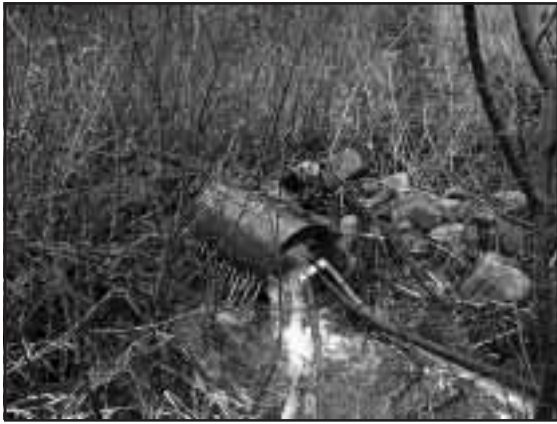
Figure 5-22. Barrel to dissipate pumped water velocity.

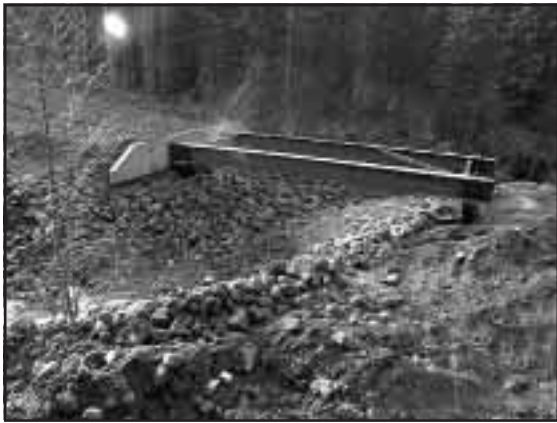
Figure 5-23. Bridge superstructure across reconstructed channel.

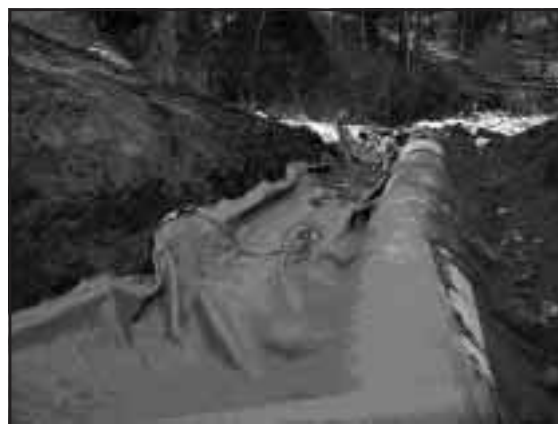
Figure 5-25. Preparing bypass channel.

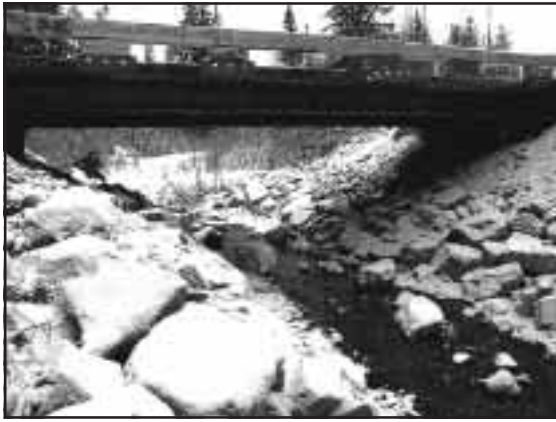
Figure 5-26. Final installation.

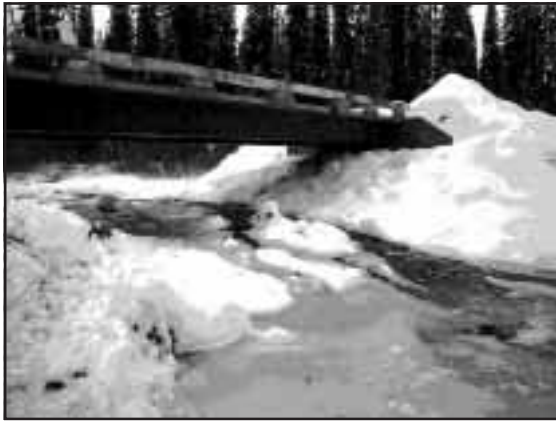
Figure 5-32. Final installation.

- Eighteen meter concrete deck composite design (Fig. 5-32).
- Pre-cast concrete footings with 12 inch steel towers.
- Three percent slope to deck.
- Reconstructed stream channel approximately 10 m wide.

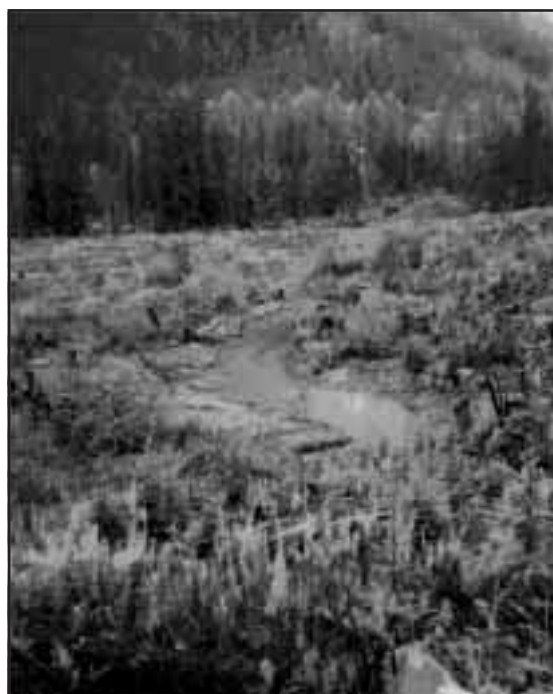
Figure 5-33. Portion of excavated groundwater channel at 77 km, Talchako River prior to LWD complexing.

- Groundwater channel excavation was carried out at one location during 1998. Roughly 200 m of channel was excavated to redefine stream banks and establish deep pond areas in an area that had seen past impacts from skidding and other logging activities (Fig. 5-33). This channel was typically excavated 2 m wide and 1 m deep, with meanders, pools and pond areas. LWD was re-established to the channel and ponds and keyed into the banks. As flows are stable through this groundwater area, no cable anchoring was employed.
