Watershed Restoration Program
Ministry of Environment, Lands and Parks
and Ministry of Forests

**Annual Compendium Of Aquatic Rehabilitation Projects
For The Watershed Restoration Program
1998 - 1999**

Watershed Restoration Project Report No. 13

1999

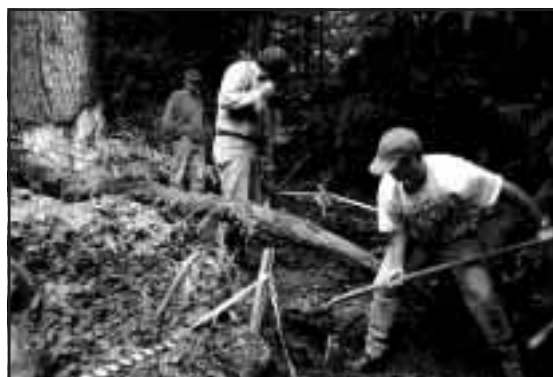
Figure 5-34. Initial hand excavation of beaver dam bypass channel, Talchako River, 77 km.

- A hand dug channel was established around a deserted beaver dam to gain access to nearly 1 km of groundwater channel and rearing pond area (Fig. 5-34). The 20 m long channel consisted of a series of step pools that dropped in total 0.8 m (Fig. 5-35). Each step was no more than 15 cm to ensure access of juvenile target species to the habitat upstream. The channel was lined with filter fabric and covered with an assortment of angular substrate. Rock/log structures created the plunge pools and were keyed to the banks for stability. Minimal riparian impact was created through the use of hand construction and a variety of local sedges, conifers and other vegetation transplanted to the edge of the channel. As the beaver dam itself created high value pond habitat heavily complexed by mature LWD, it was a feature that should be maintained for a long period. Therefore, plastic was placed along the dam on the

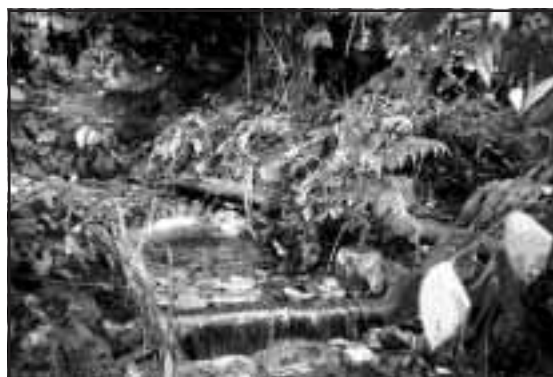
Figure 5-35. Same section of bypass channel with flow and vegetated banks, Talchako River, 77 km.

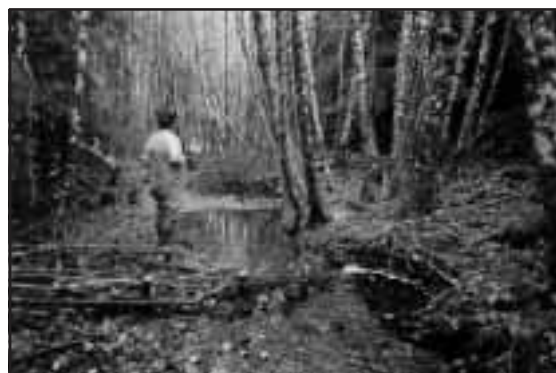
Figure 6-1. Reach 2B2 view from downstream looking up at the three steps created by the installation of two sills.

- Creation of two steps to allow fish passage over a 1m falls. The falls developed due to head cutting upstream from the confluence with the Deena to a log sill installed in 1997. Two sills were installed approximately 3 m apart downstream of the original sill to create three 0.3 m high steps (Fig. 6-1).
- Hand excavation of the outlet from an off-channel pond to increase useable rearing space and allow entry and exit at lower flows.
- Excavation of a natural depression to create a 4 m x 1.5 m alcove pond. The pond was excavated by hand and then covered over with limbs and other small woody debris to provide cover.

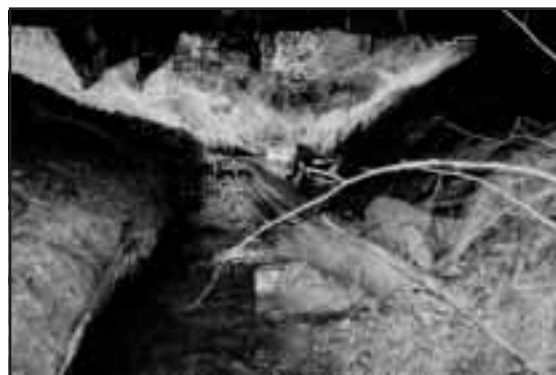
Figure 6-2. Reach 2C3 debris catcher placed on the leading edge of a gravel bar. The structure was pre-loaded with small woody debris.

- Debris catchers installed on the leading edge of gravel bars. These structures were built by driving sharpened upright stakes into the ground, then pre-loading with debris by weaving small wood between the uprights to form a semi-permeable wall. These structures were constructed in pairs and the area between the two walls was loaded with more small woody debris to prevent scour during high flow events (Fig. 6-2).

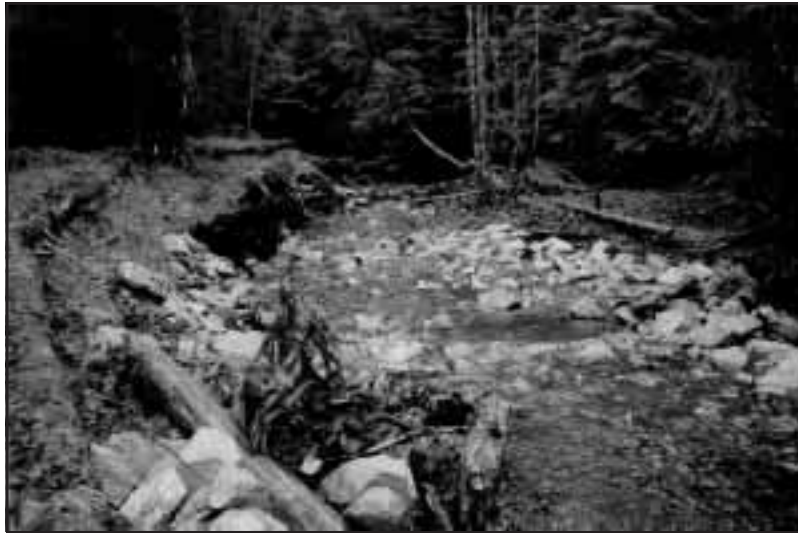
Figure 6-3. Reach 2C3 V-shaped deflector installed under a bridge to protect an eroding bank and promote channel scouring

- V-deflectors were installed to constrict the flow and cause scour under a recently rebuilt bridge. During the bridge reconstruction the left bank sill was removed while right bank sill was left in place. The original bridge had sills placed approximately 0.8 m apart. When the left sill was removed the channel was left in the constricted state with nothing to protect the highly erodable left bank. V-deflectors were installed to simulate the constriction and scour caused by the original bridge, while providing protection to the newly exposed left bank. The deflectors were constructed using short sections of LWD and small rootwads keyed into the left bank to form the V-shape and back filled with large rock (Fig. 6-3). The left bank between the structures was lined with large rock to prevent erosion. The logs and rootwads used to make the V-structures

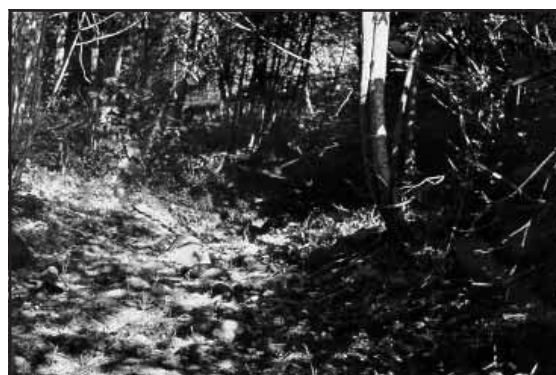
Figure 6-11. Abandoned side channel on Deep Creek prior to off-channel habitat rehabilitation.

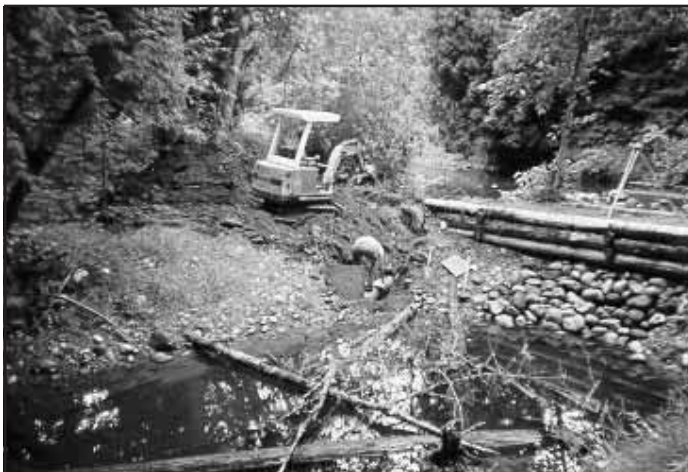
Figure 6-15. Additional culvert intake installed to increase low flow levels in the side channel.

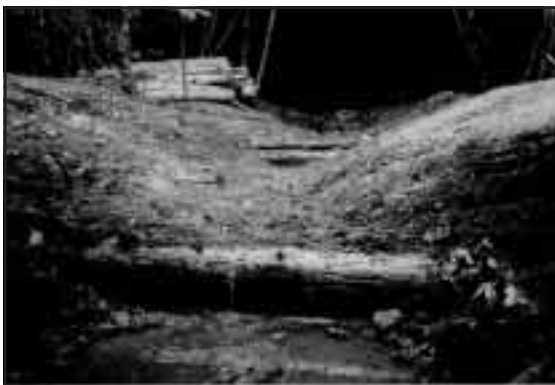
Figure 6-23. View from downstream looking upstream at the completed project.

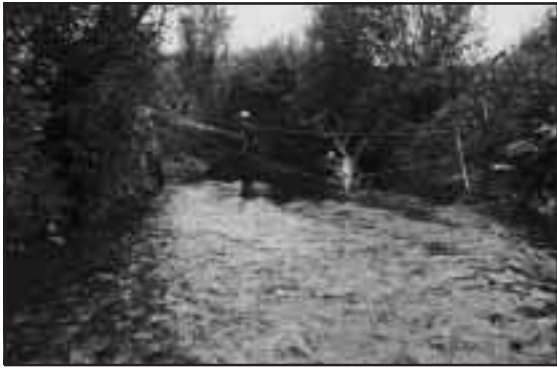
Figure 7-2. Site 7. Pre-restoration. Exposed banks, extended riffles, and lack of pool cover were predominant throughout the lower reaches.

Figures 7-2 and 7-3 portray the pre- and post-effects at site 7. Here, restorative actions were done to create a boulder garden and bank deflector as well as a pool complex. Figures 7-4 and 7-5 show the pre- and post-treatment effects

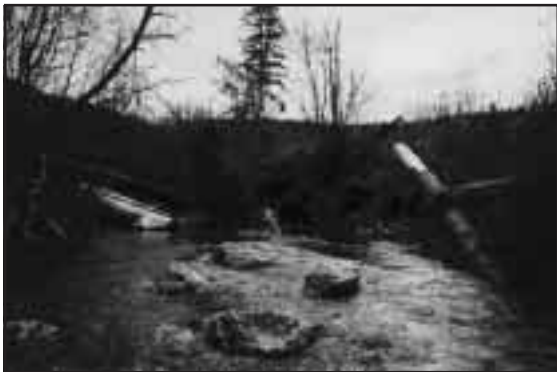
Figure 7-3. Site 7. Post-restoration showing the addition of bank deflectors, LWD in pools, and a boulder garden.

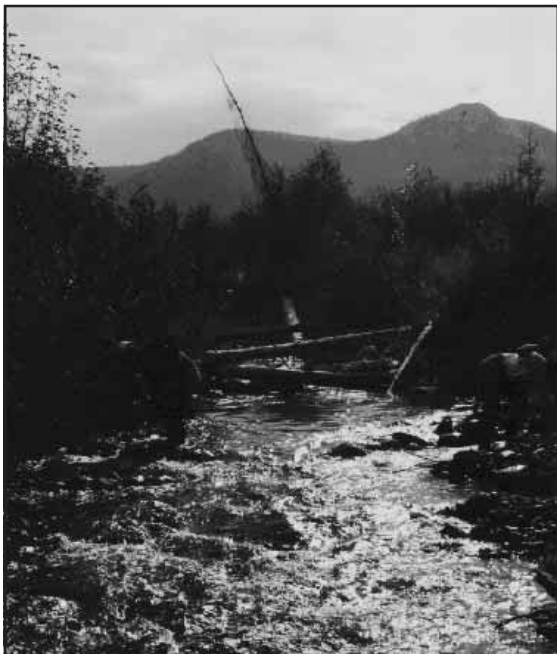
Figure 7-4. Site 9/10. Pre-restoration indicating channelized sections and current LWD breaking down in a small jam upstream.

of opposing wing deflectors at site 9, as well as jam enhancing upstream at site 10. Figure 7-6 is an example of a Hewitt ramp at site 13.

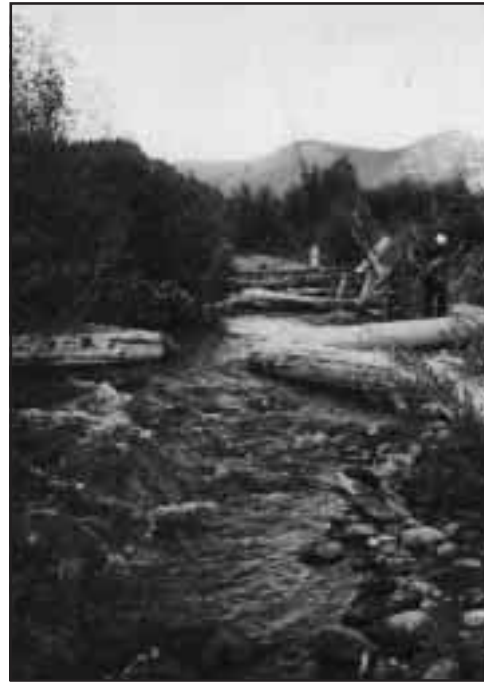
Figure 7-5. Site 9/10. Post-restoration photo of stabilized opposing V-wing deflectors, creating pool habitat, focusing scour, and reducing flow velocities throughout the habitat units.

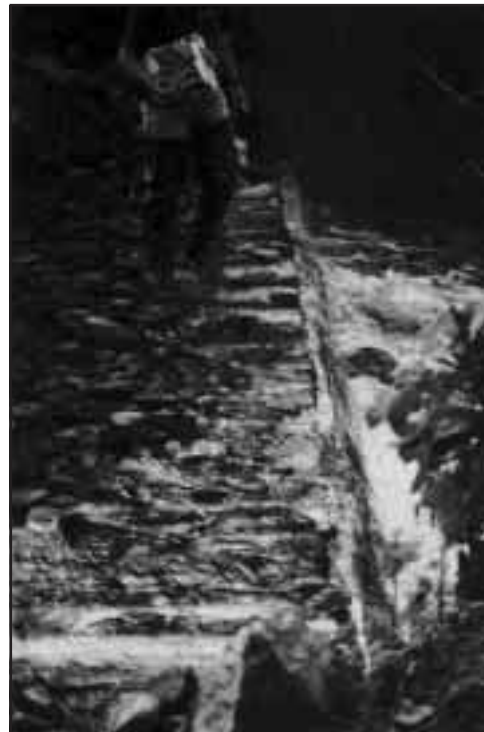
Figure 7-6. Site 13. A Hewitt ramp structure was constructed in a long riffle section. Cedar logs were manually sawn to create 8 foot cedar planks on the ramp. The restored site now provides deep backwater pools and an overall increase in wetted habitat and cover under the structure.

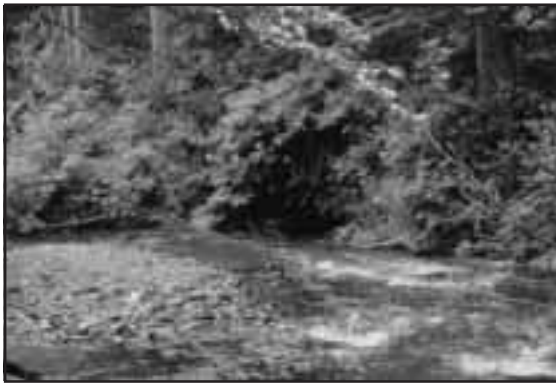
Figure 7-7. Pre-restoration photograph of McPhee Creek, Reach 2 site 5. Note absence of woody debris cover in pool.

size compared to Reach 3, focused on enhancing pre-disturbance LWD jams that were beginning to deteriorate and become nonfunctional. Additional treatments included placement of LWD debris catchers in existing pools (Figs. 7-7, 7-8) as per Slaney et al. (1997), armoring eroding banks with rootwads and LWD (Figs. 7-9, 7-10) and the addition of boulder complexes along glides to increase habitat complexity for juvenile salmonids (Fig. 7-11). Prescriptions in Reach 3, characterized by a complete loss of LWD on both banks, were similar to those described in Reach 2.

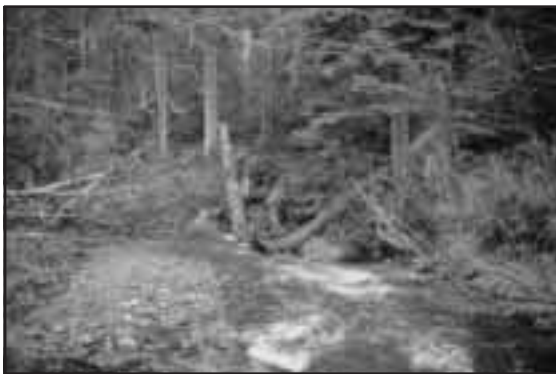
Figure 7-8. Post-restoration photograph of McPhee Creek, Reach 2 site 5. Lateral triangular large woody debris structure constructed in pool to provide overhead cover and induce additional scour.

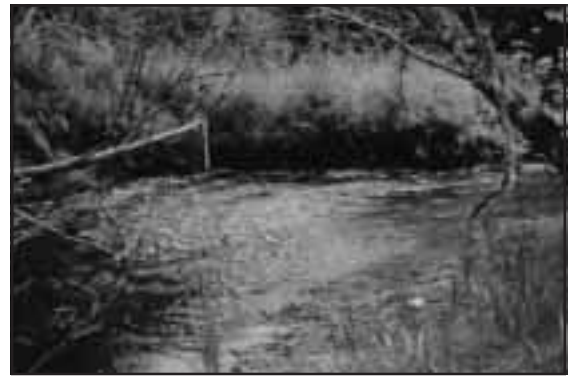
Figure 7-9. Pre-restoration photograph of McPhee Creek, Reach 3 site 6. Note localized area of bank erosion on outside of bend.

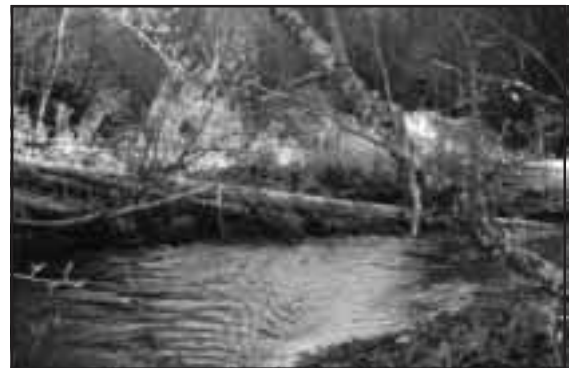
Figure 7-10. Post-restoration photograph of McPhee Creek, Reach 3 site 6. Large woody debris and boulders armoring area of bank erosion and providing overhead cover.

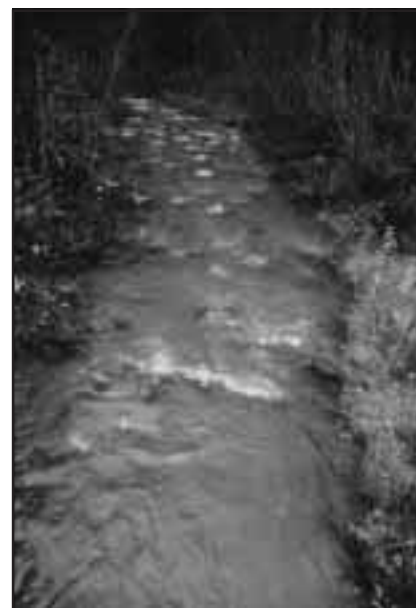
Figure 7-11. Post-restoration photograph of McPhee Creek Reach 2 site 4. Note boulder clusters in groups of four placed in mid-stream channel to provide juvenile rainbow trout rearing habitat.

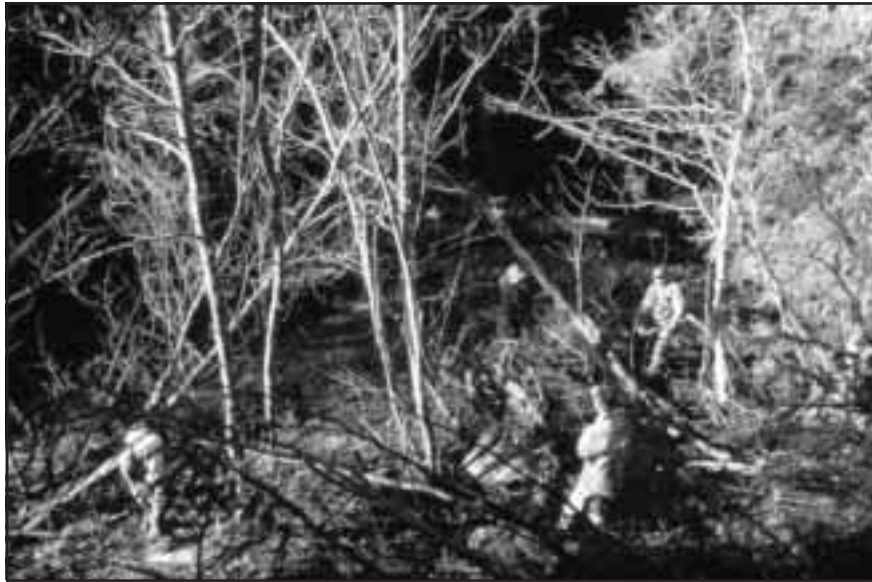
Figure 7-12. Manual labourers from Lheidli T'Enneh First Nation maneuvering large woody debris into McPhee Creek with winches and block and tackle.

The collapsed bridge removal and access deactivation was completed with an EX 220 John Deere excavator. Along treatment Reach 2, LWD was moved by the use of labourers from the Lheidli T'Enneh First Nation. This was accomplished with block and tackle pulley systems, and an 8000 lb truck winch (Fig. 7-12).

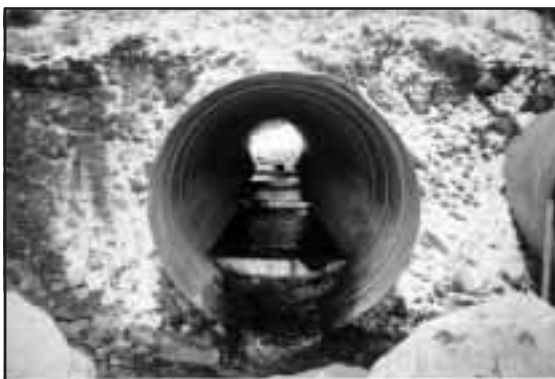
Figure 7-15. Upstream view of crossing #1 with the baffles installed in the culvert but prior to construction of the downstream riffle.

velocity (1.9 vs 1.3 m·s⁻¹). Each baffle was spaced 4 m apart with the first one set 3.5 m from the inlet. Each baffle was 200 mm high with a 100 mm vertical V-notch removed. The notches were offset 245 mm from the culvert centreline and the baffles installed so that the notches alternated from left to right (Fig. 7-15). Once the baffles were installed, the existing riffle and adjacent banks downstream of the culvert were built-up 350 mm so the elevation of the riffle crest caused the stream to backwater the culvert to the top of the first baffle. The riffle was constructed using the techniques of Newbury et al. (1997). The substrate size used to construct the key components of the riffle exceeded the tractive force of water at bankfull stage.

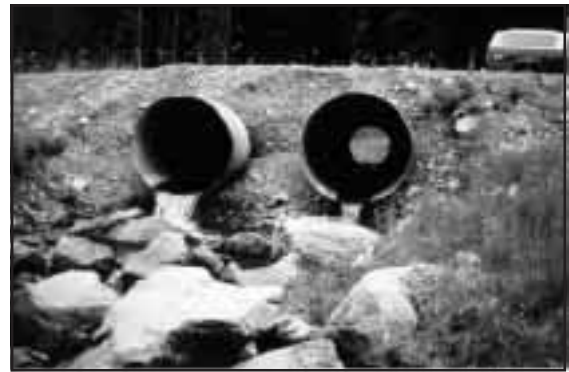
Figure 7-16. Upstream view of crossing # 2 before restoration.

- Crossing 2 was selected as the high cost restoration site. Because the culverts were perched 32 and 34 mm (Fig. 7-16), they were removed and a bottomless arch culvert 5180 mm wide, 2180 mm high and 18.3 m long was installed. This provided a natural stream bottom consisting of gravels, cobbles and a few boulders in the culvert (Fig. 7-17).

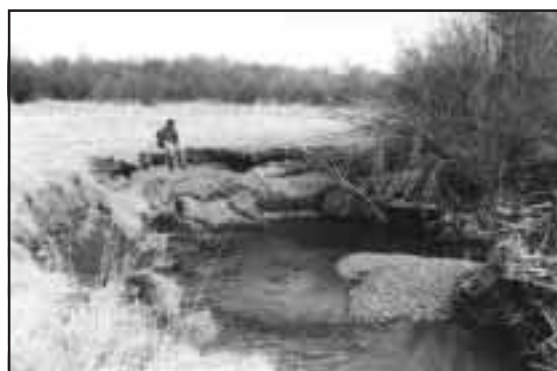
Figure 7-21a. Before restoration of an eroding bank.

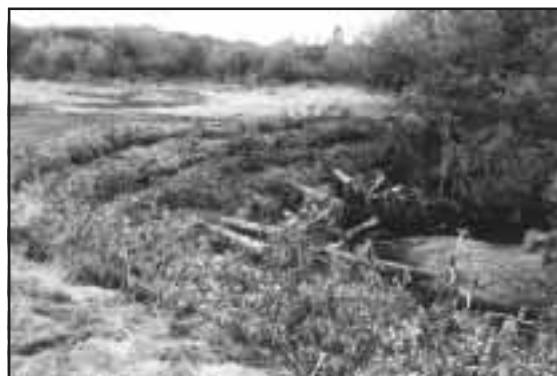
Figure 7-21b. After restoration of an eroding bank.

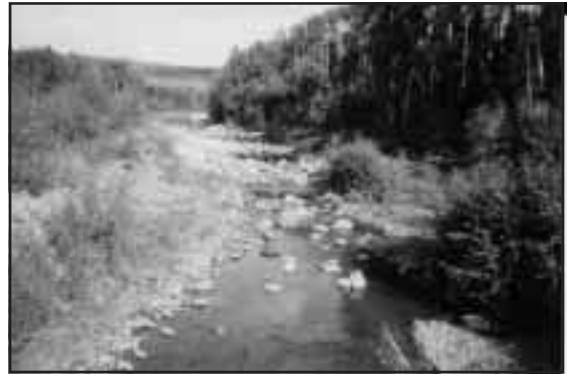
Figure 7-27. Upstream view of channel (from FSR bridge) after riffle-pool construction and LWD placement.

- Construction of 8 riffle-pool sequences in a 500 m section of the main channel using the Newbury/Gaboury technique of tying the crest elevation of the most downstream riffle into the toe elevation of the upstream riffle (Figs. 7-26 and 7-27). Pools were excavated to a depth equal to riffle crest heights and rootwads or other cover structures were placed in most pools (Fig. 7-28). The substrate size used to construct the key components of the riffles exceeds the tractive force of water

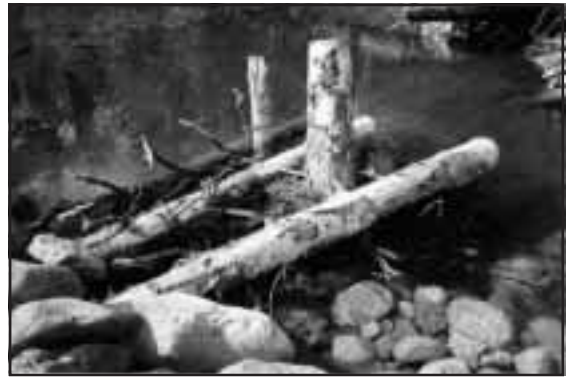
Figure 7-28. LWD structure constructed over a pool excavated below riffle #8.

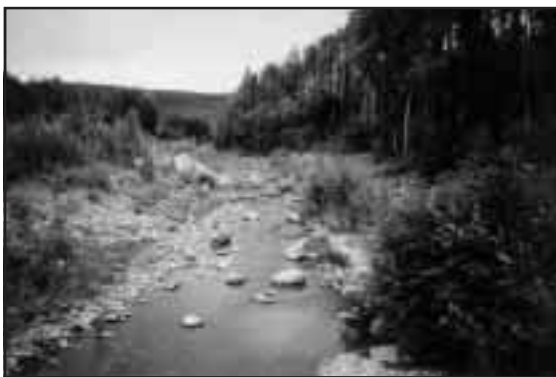
Figure 7-26. Upstream view of channel (from FSR bridge) before riffle-pool construction and LWD placement.

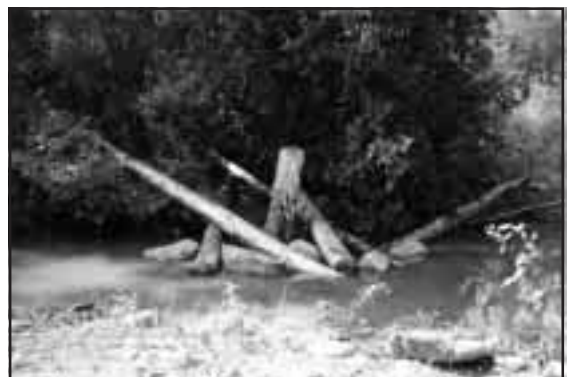
Figure 7-29. Low profile LWD structure designed to maintain pool habitat through bed scour.

- Construction of 14 low profile LWD structures in the mainstem (Fig. 7-29). They were generally multiple log structures arranged in a triangular geometry and ballasted with rock.

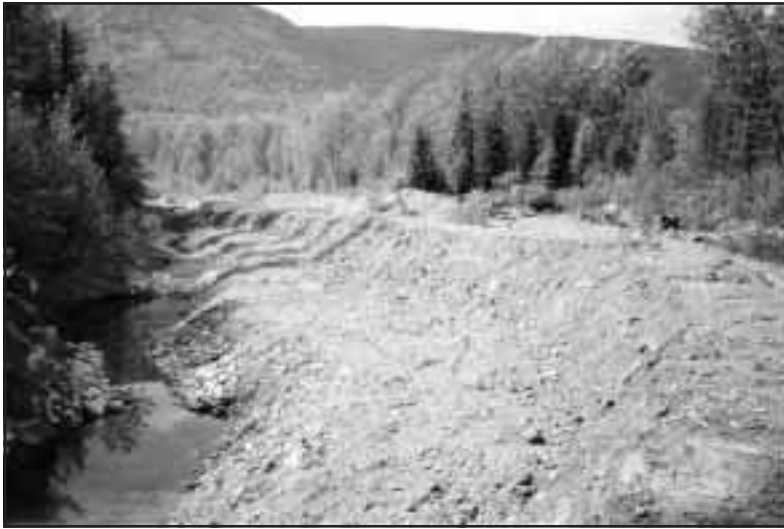
Figure 7-30. Side channel following its excavation to groundwater level and the berm protecting it from high mainstem flows.

- Excavation of an existing but elevated side channel down to groundwater level to ensure the channel will no longer de-water to a level that will strand and kill juvenile fish. The side channel is connected to the mainstem at the outlet end. The channel was reconstructed as a series of 7 shallow pools separated by short (5 m) riffle sections (Fig. 7-30). The newly excavated clay bed was lined with round rock (10 - 20 cm diameter) to provide more suitable substrate for fish and aquatic insect production.

- Construction of a berm between the mainstem and the side channel to protect the side channel during peak flows (Fig. 7-30).

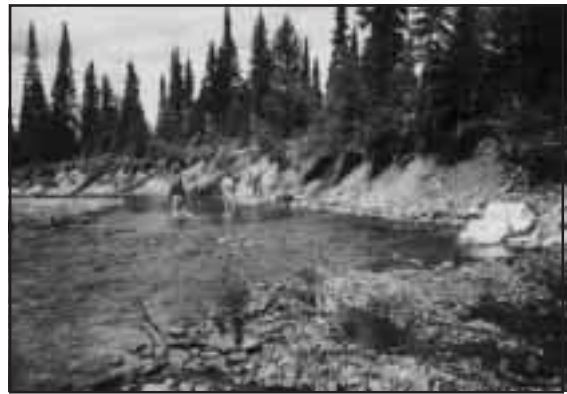
Figure 7-31. Pre-restoration downstream view of large eroding bank along Narrowlake Creek mainstem.

- 2 rock groynes (Figs. 7-31 to 7-33);
- 2 LWD revetments (Figs. 7-31 to 7-33);
- 19 single logs;
- 21 lateral (triangle) log jams (Fig. 7-34);
- 6 LWD flow deflectors (Fig. 7-35), and
- 16 gravel bar stabilization structures (Fig. 7-36).

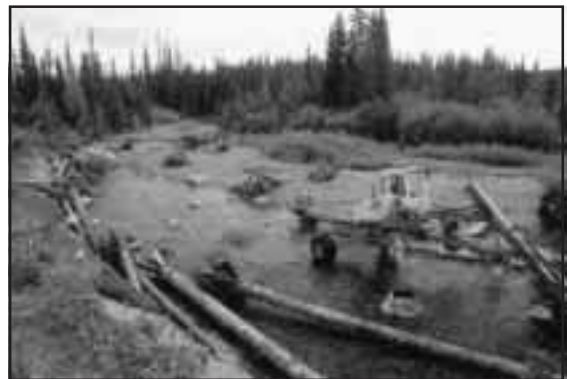
Figure 7-32. Mid-restoration upstream view of large eroding bank along Narrowlake Creek mainstem. Note LWD revetment and rock groynes under construction.

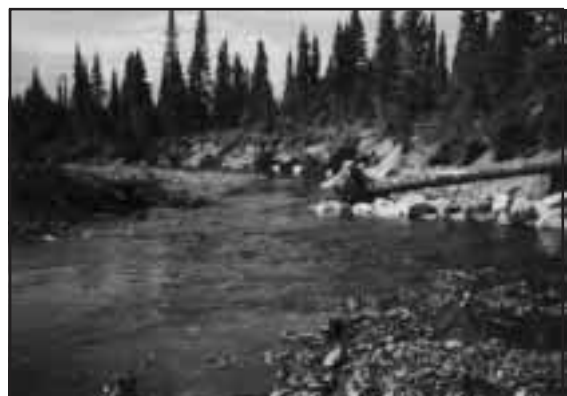
Figure 7-33. Post-restoration downstream view of large eroding bank along Narrowlake Creek mainstem. Rock groynes were colonized by juvenile rainbow trout within days of structure completion.

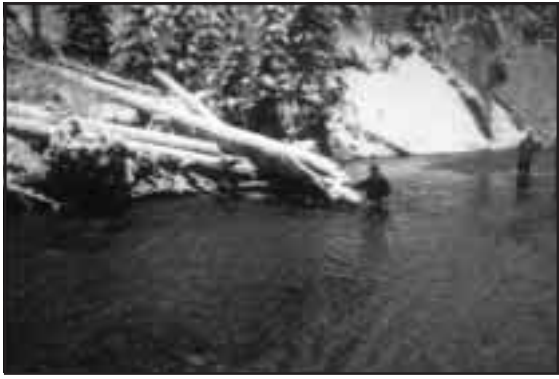
The LWD structures placed in the wetted channel were colonized by rainbow trout, bull trout, and whitefish almost immediately following installation. These structures, when constructed in existing pools or placed in pool-forming areas provide an immediate benefit to fish habitat as the percentage of woody debris cover in pools increases by approximately 20% following restoration (Fig. 7-34). From production

Figure 7-34. Post-restoration view of lateral LWD jam. Note depth of pool scoured out after October rainstorms. Large woody debris cover in pools is increased on average 20% following restoration.

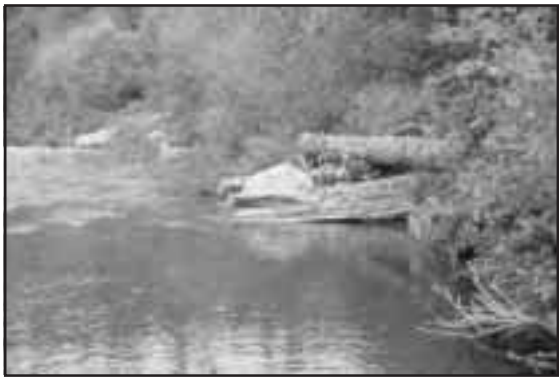
Figure 7-35 Post-restoration view of LWD / boulder deflector.

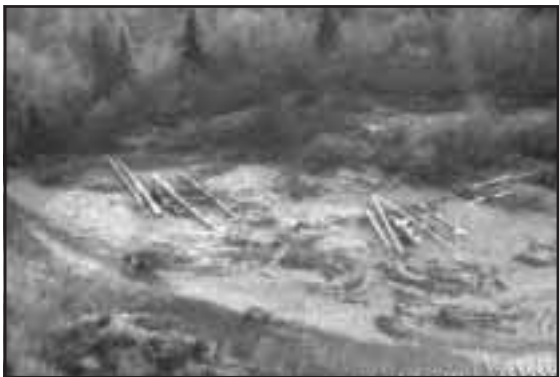
Figure 7-36. Post-restoration view of multiple lateral gravel bar stabilization structures in the lower reaches of Narrowlake Creek.
