## **Exchamsiks Fish Ladder Repairs Construction Summary Report**

## Exchamsiks Fishway Repair Prescription

EXCHAMSIKS FISHWAY  
REPAIR  
PLAN, PROFILE, AND NOTES

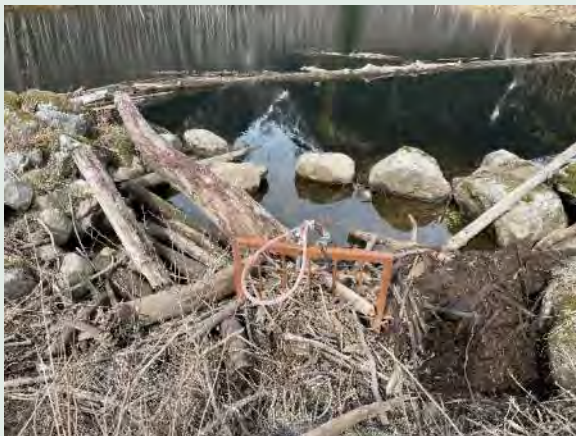
The inlet of the culvert upstream of the ladder is clogged and filled with debris (see photo 5); this debris will require removal to ensure that water can freely flow through the pipe. The protective grate appears to be lifted (see photo 6) and may not be protecting the inlet of the culvert from debris. Although this was difficult to tell during the inspection but once it is cleaned it should be inspected to confirm that the grate is covering the inlet of the culvert. If debris has managed to enter the pipe, additional care should be taken to ensure that all debris is removed from inside the pipe. An additional debris protector is recommended that is located upstream of the existing boulder deflector to assist with catchment of the larger debris. This protector should be connected to the existing riprap outcropping and constructed to match the road elevation in order to maximize the protection.

*Photo 5 - Upstream Debris*

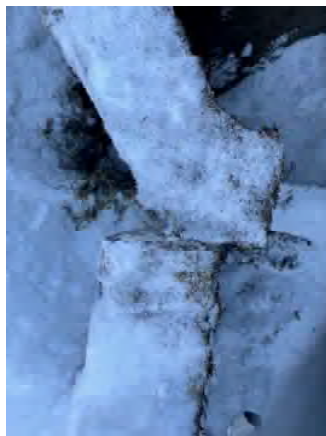
After review of the fish ladder, it appears that the individual boxes have shifted positions, causing gaps to form between the boxes (see photo 3, 8 & 11). The overall location of the ladder does not appear to have changed. Large amounts of material around the boxes have been eroding away causing large gaps between the concrete boxes and the adjacent ground (see photo 3 & 4). The material under the culvert into the ladder has been completely eroded away causing the pipe to be suspended between the road fill material and the concrete boxes. It is recommended to disconnect the boxes from each other (see photo 12 for bolt connection) and lift the individual boxes out of the way in order to re-establish the base materials. Since the overall elevation of the boxes doesn't appear to have changed much it is assumed the support rails under the boxes are still in good condition and have not moved. Therefore, only the base material will only require repair, but a review of the rails and base should be inspected to confirm this upon removal of the boxes. Upon re-installing the boxes, Con Seal CS-102 Butyl Rubber (product information is attached) sealant (or approved fish friendly equivalent) should be placed on all joints prior re-bolting the boxes securely together. After the boxes have been put back into place, they should be backfilled with an approved granular material to match the existing ground with a minimum 2% grade away from the boxes to reduce the potential for additional erosion. Care should be taken when backfilling around the culvert to ensure that compacted material is established underneath the pipe. Within the locations that the backfill is within the water, Class 50 kg riprap should be used to prevent erosion specifically in the location of the left side of section B on the drawings between the boxes and the railway grade, as depicted in photo 10 where water continues to flow during low flow periods.

*Photo 11 - Amount of Box Displacement*

- DISCONNECT AND LIFT OUT EXISTING FISHWAY CONCRETE BOXES
- REPAIR BASE AND FILL DIRECTLY ADJACENT HOLES WITH 25mm MINUS MATERIAL. COMPACT TO 98% STANDARD PROCTOR DENSITY, SLOPE AND ELEVATION OF BASE TO MATCH EXISTING
- RE-INSTALL FISHWAY CONCRETE BOXES, APPLYING PASTE TO SEAL WALL JOINTS AND THEN RE-BOLTING THE BOXES SECURELY TOGETHER
- BACK FILL AROUND BOXES

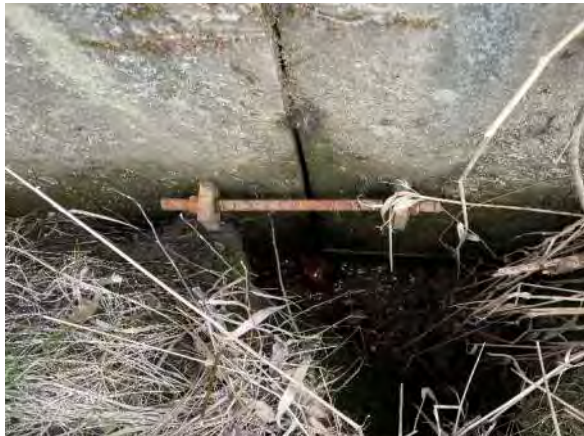
*Photo 12 - Connection Bolts*

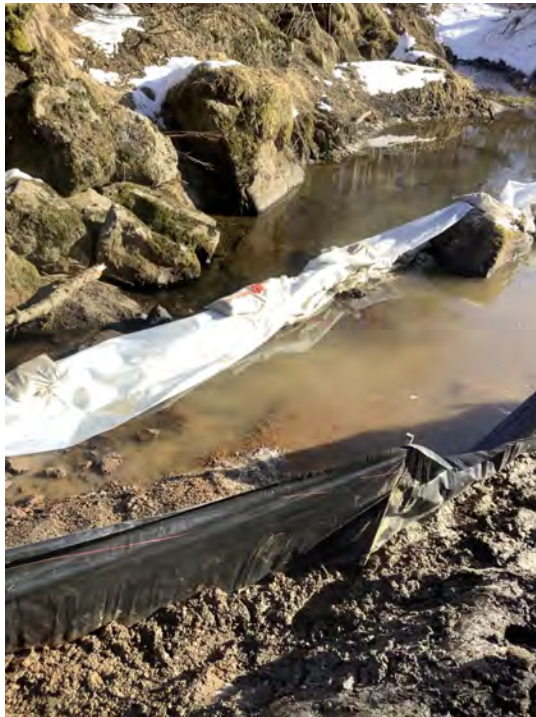
5 Reinforced sandbag berm

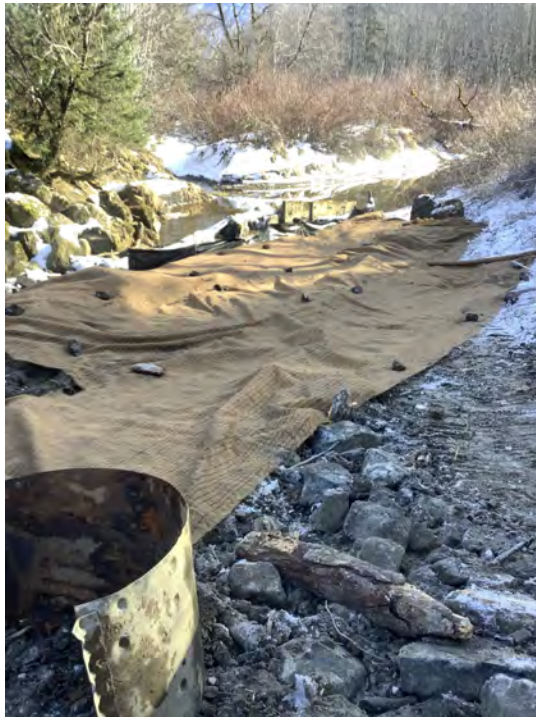
7 Coco matting installed

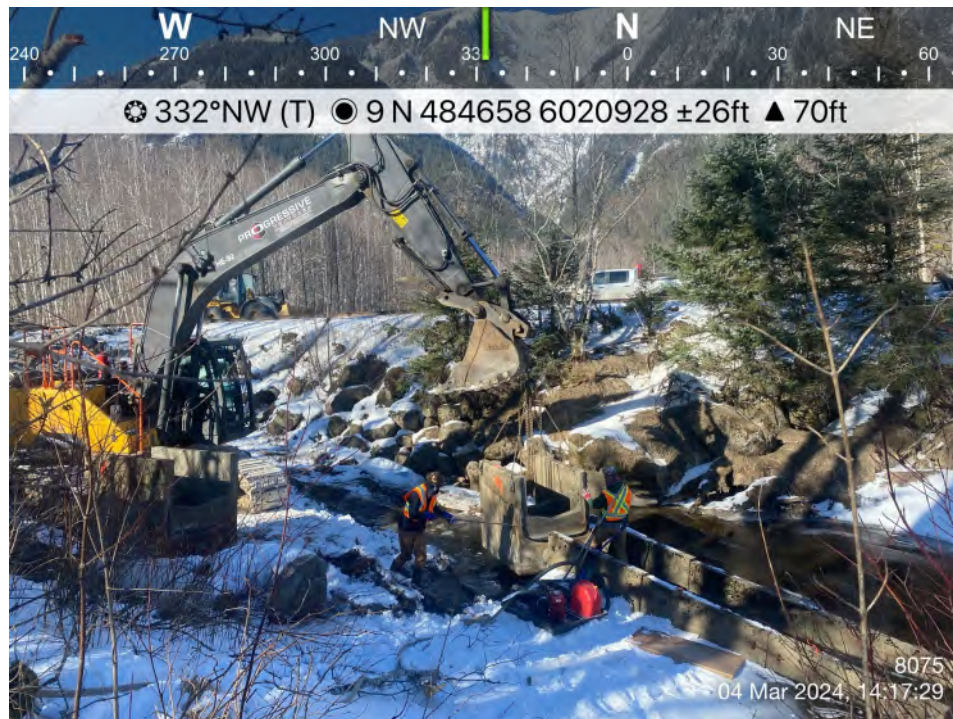
9 Attempting block placement

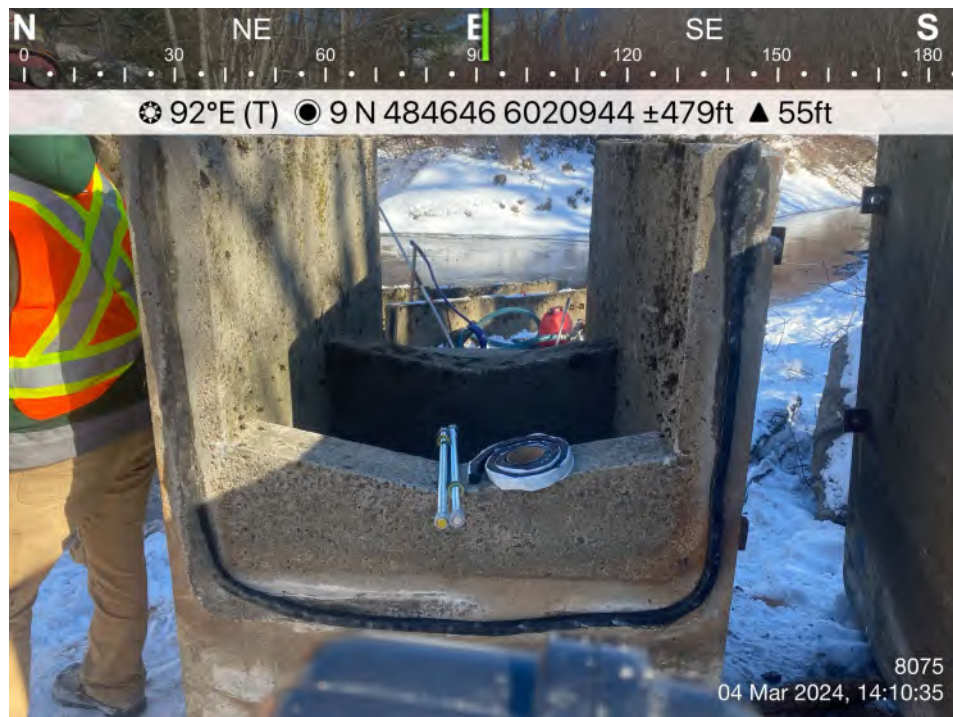
10 Sealant application

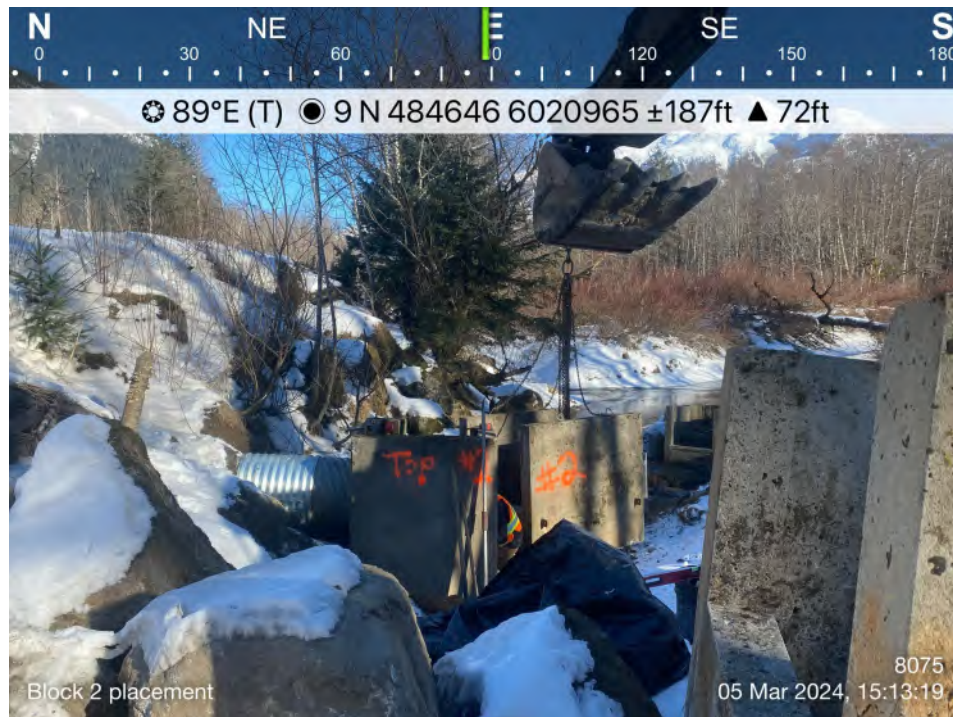
1 Block 2 placement

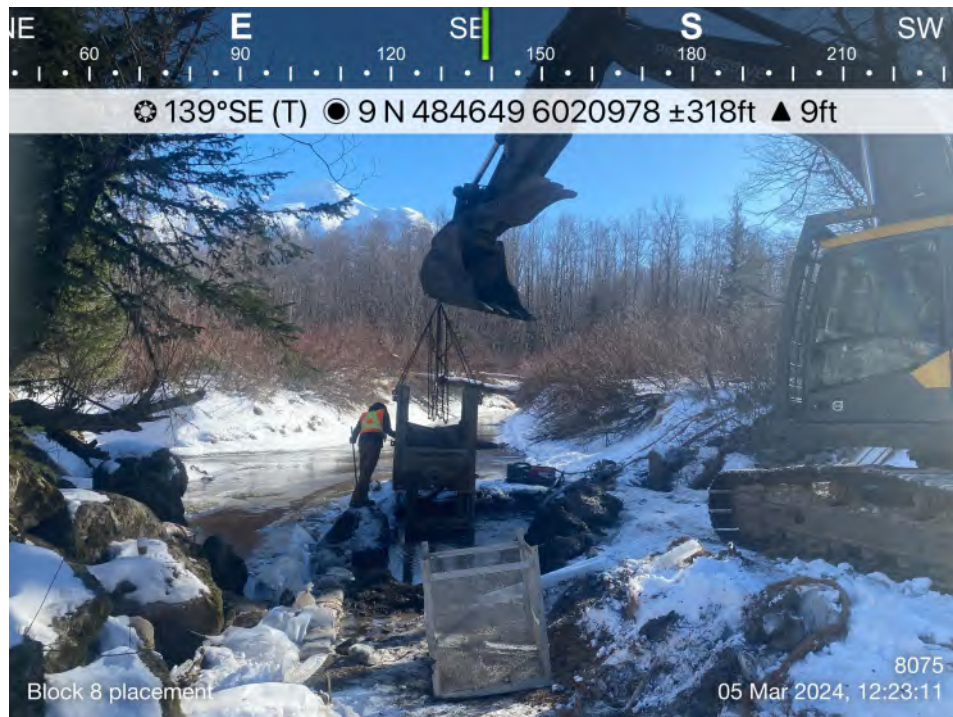
5 Block 8 placement

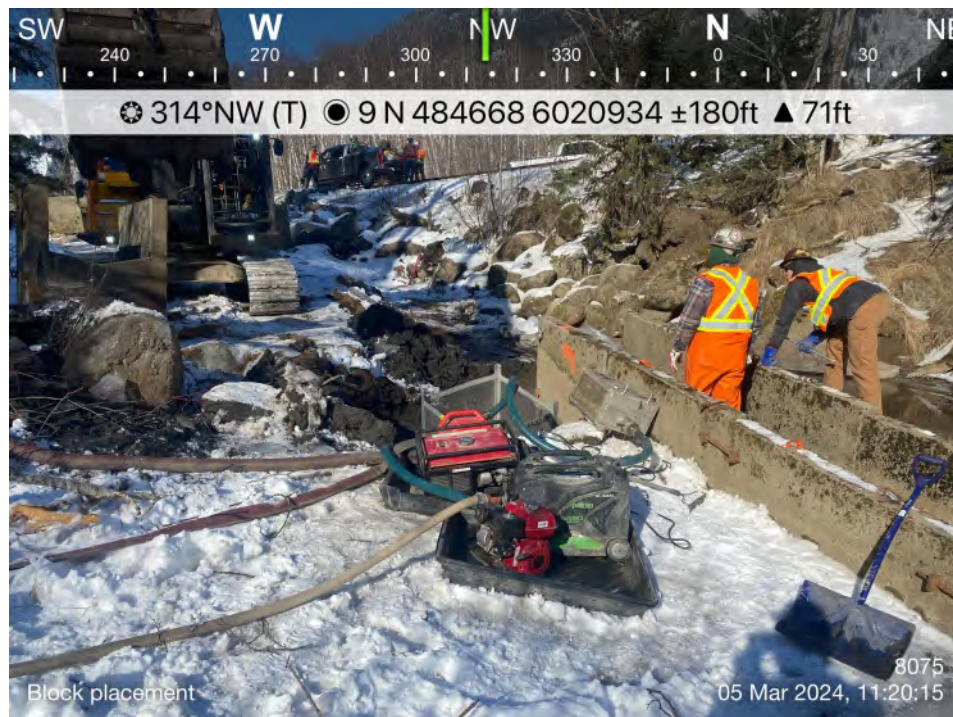
6 Block 9 installment

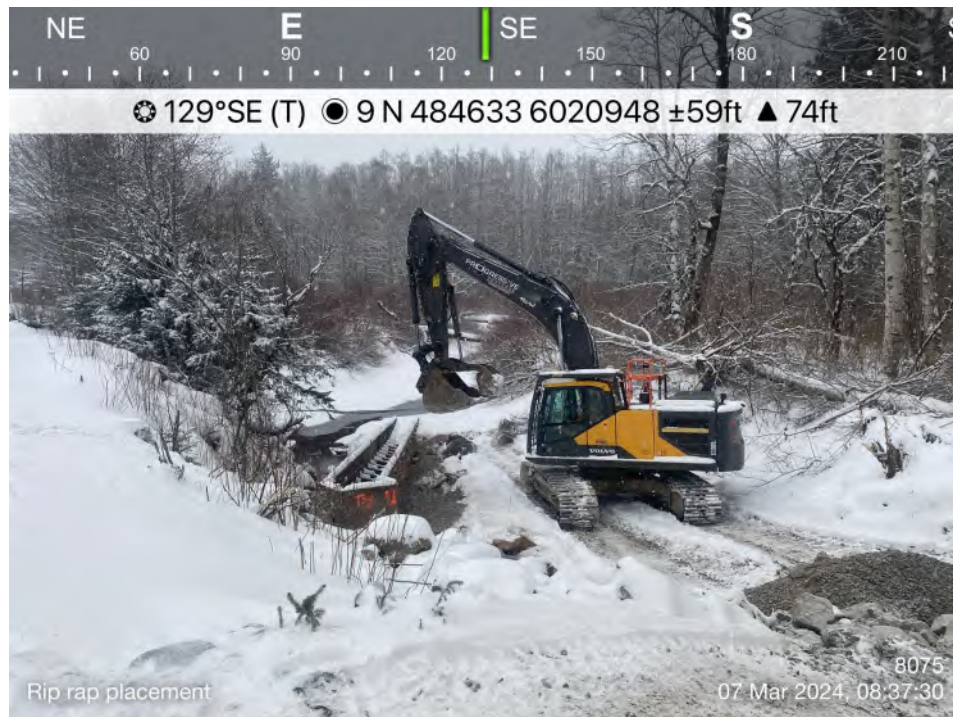
- 9 Excavator placing drain rock and rip rap.

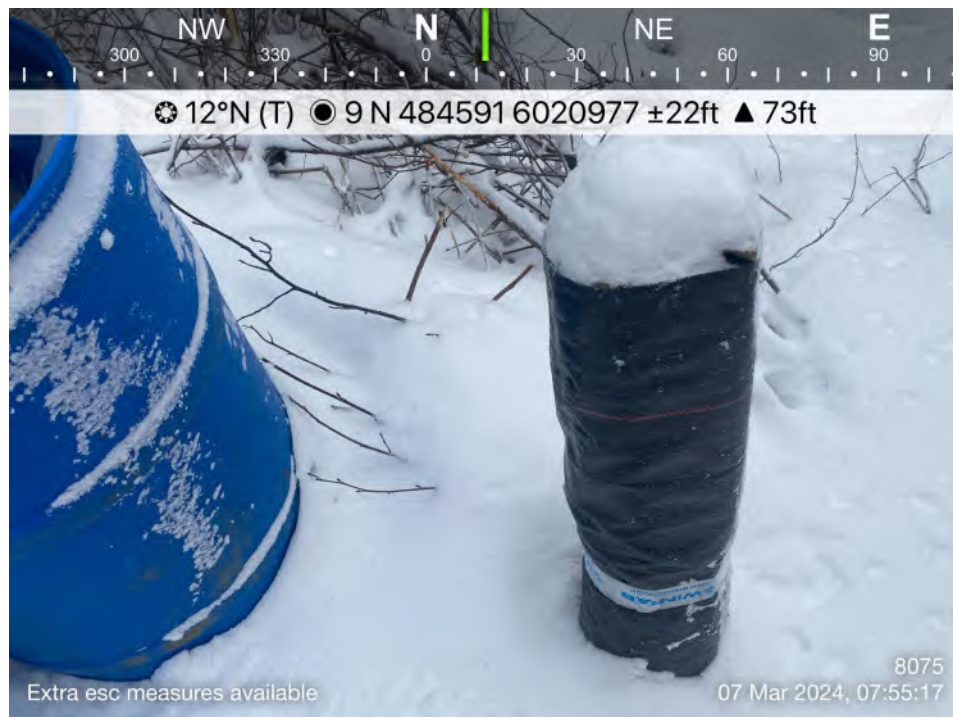
- 10 Extra ESC measures available on site.

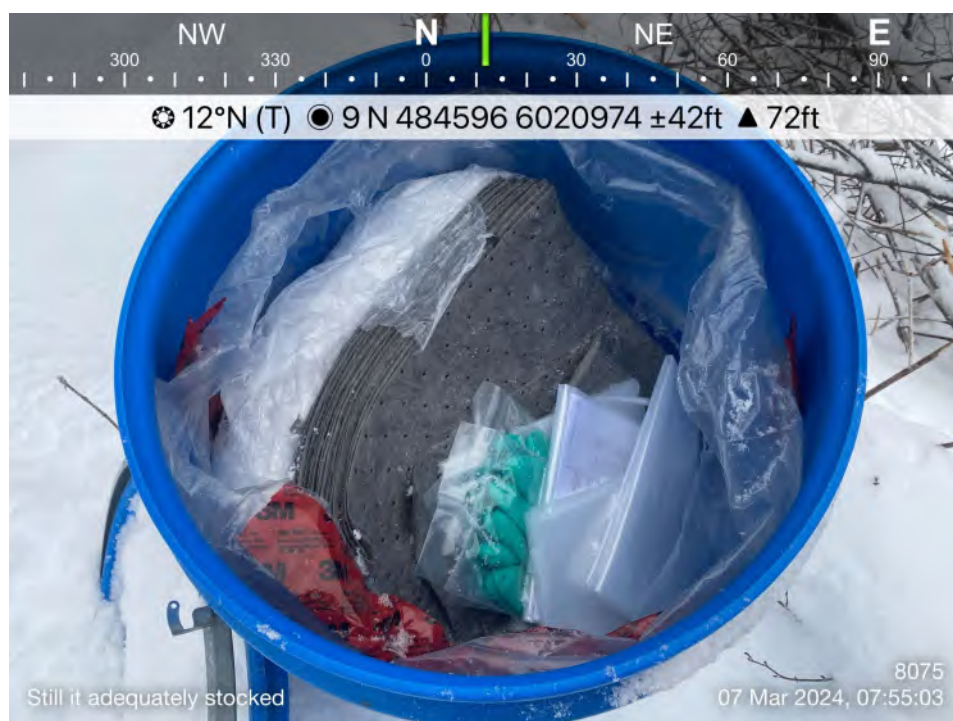
- 11 Spill kit drum well stocked.

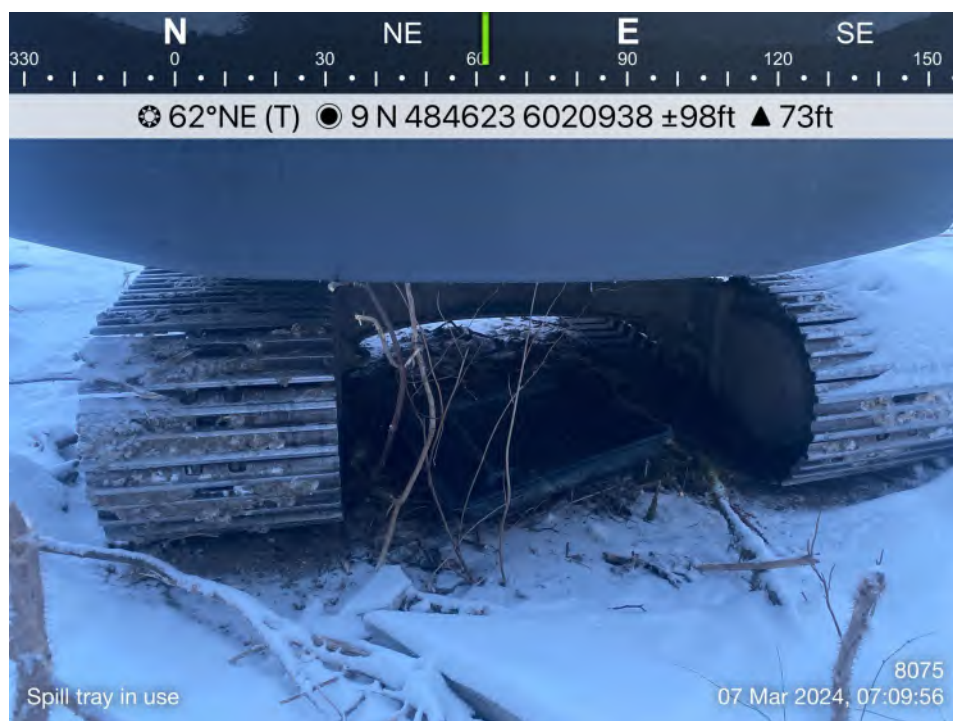
- 12 Spill tray in place upon arrival

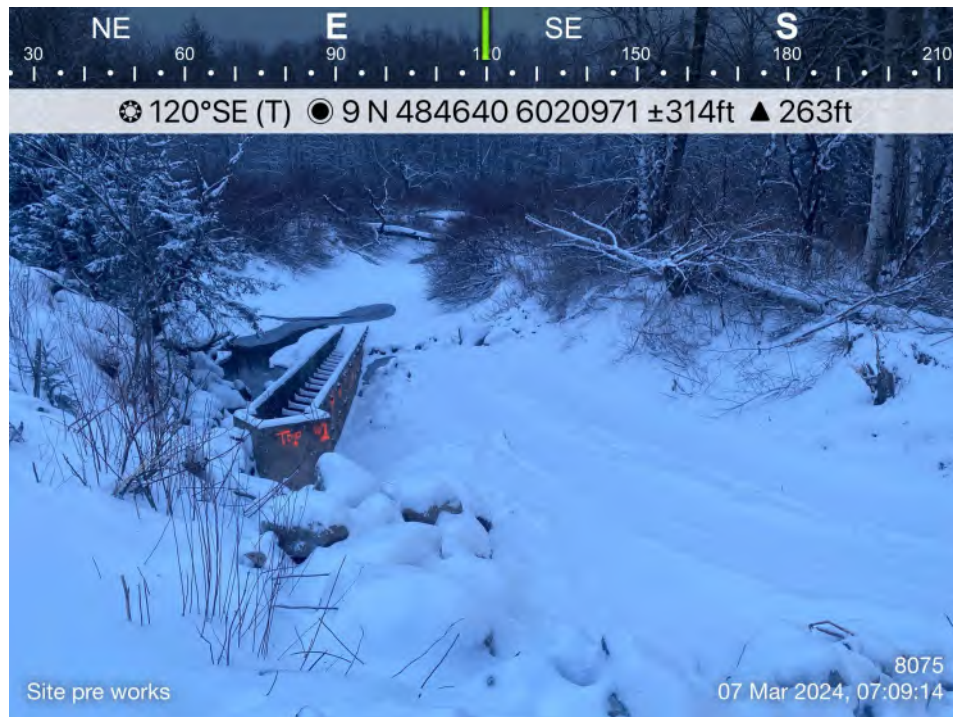
13 Site pre works.

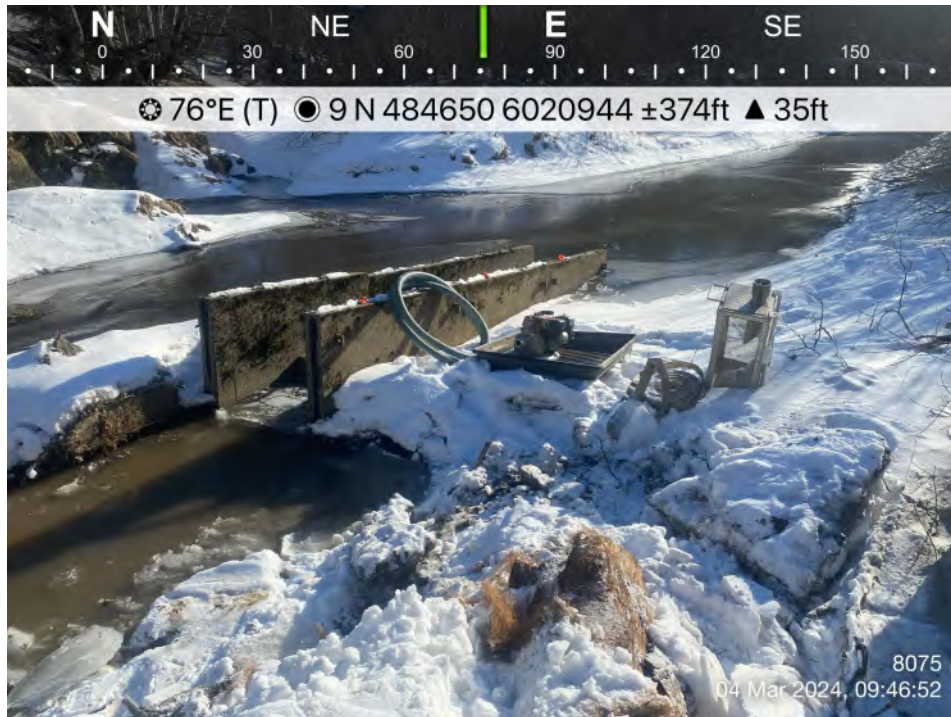
11 Fish screen for dewatering
