**Detailed Fish Habitat, Riparian and
Channel Assessment
for
Select Central Bulkley River Tributaries**

Greg Tamblyn
Resource Management Consultant
Smithers, BC.

Matthew Jessop
British Columbia Conservation Foundation
Smithers, BC.

February 29, 2000

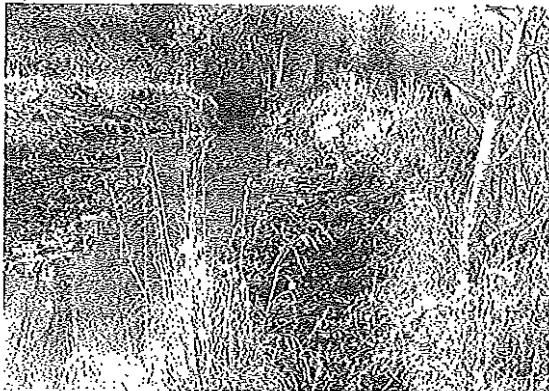
C: Downstream view of ditched channel used as a watering area by cattle.

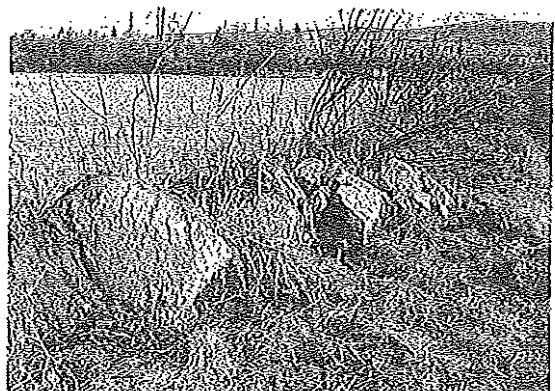
D: View of stream bank at 0+155 m showing the removal of soil and riparian shrubs.

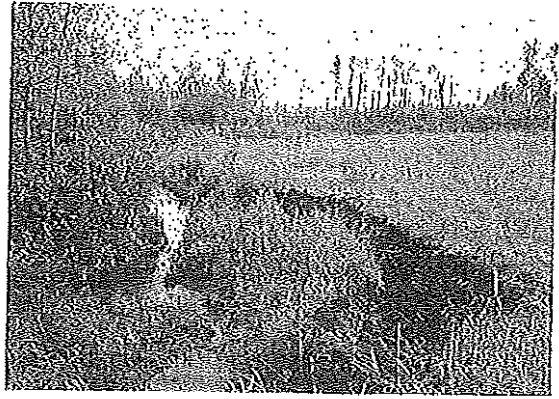
B: View of typical impacted channel and riparian habitat at 1+043 m. Note the bank shear and sediment input.

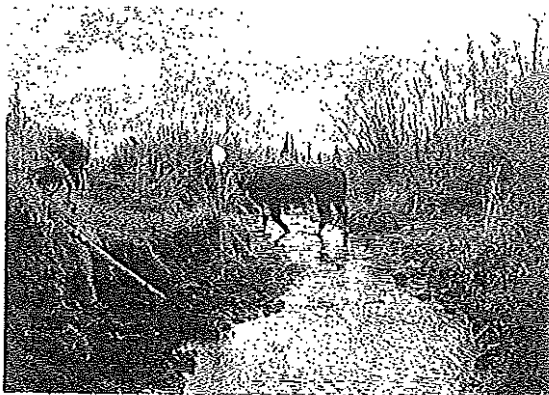
E: Downstream view of cattle crossing at 1+522 m.

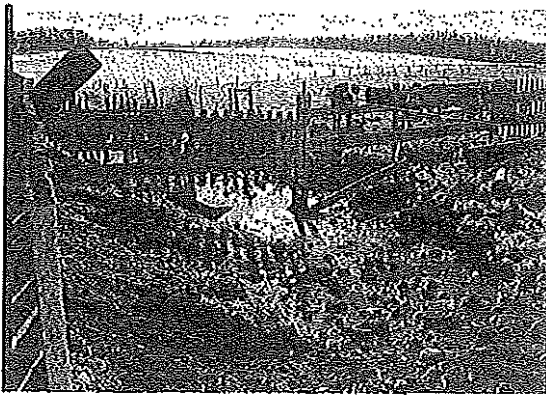
C: View of cattle watering enclosure at 0+687 m.

In addition to a lack of riparian vegetation and channel excavation, dairy cows are impacting the creek channel. Access by cattle to large sections of the creek for watering is contributing to bank erosion and is causing bank shear, particularly in the upper half of the reach. In addition, cow use is widening the creek near the upper end of the reach. Finally, cow feces in the creek may be impacting water quality. Feces was particularly prevalent the fenced cattle pen across from the barn and immediately downstream of the access road to the barn (Fig. 13C).

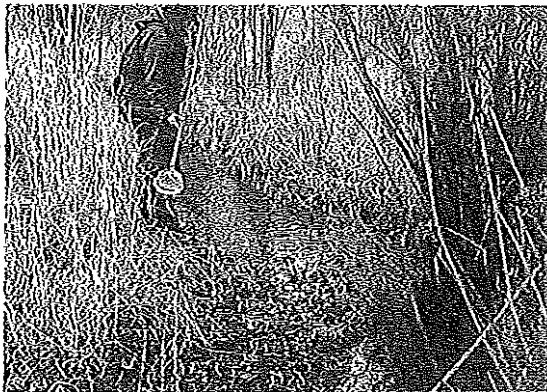
E: Upstream view of channel and riparian vegetation at 1+143 m.

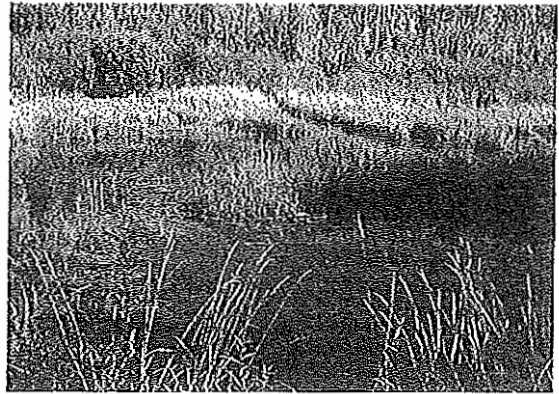
B: View of beaver ponds in section 1B.

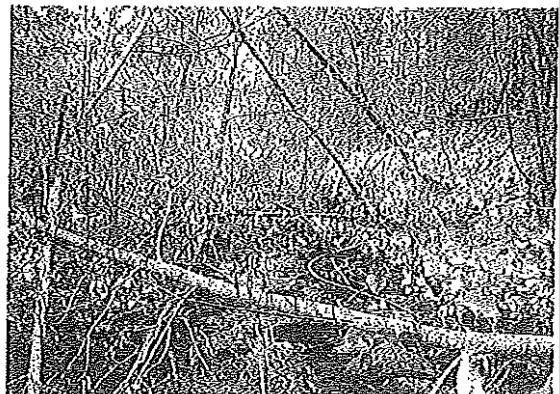
B: Upstream view of typical channel and riparian habitat at 1+250 m.

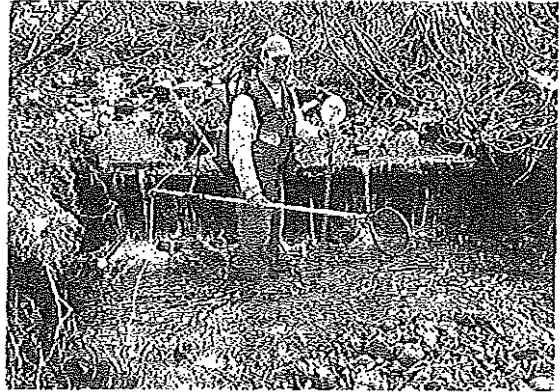
B: View of a potential temporary barrier to fish migration, 60 cm high, at 0+215 m. This feature was typical of the reach.

No permanent barriers to fish migration were observed in this reach. Several small falls formed by LWD or SWD are temporary and may wash away during a flood (Fig. 32B).

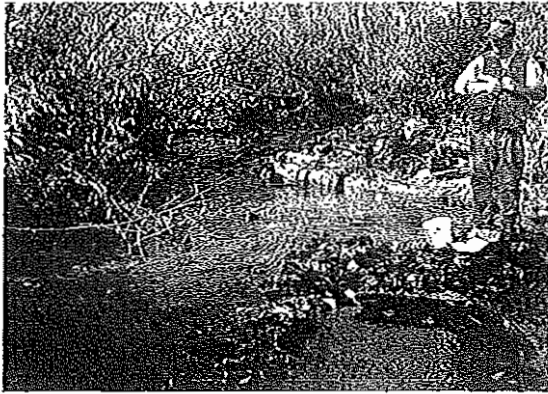
A: Downstream view of channel and riparian vegetation at 0+188 m. Note the functional LWD in the background.

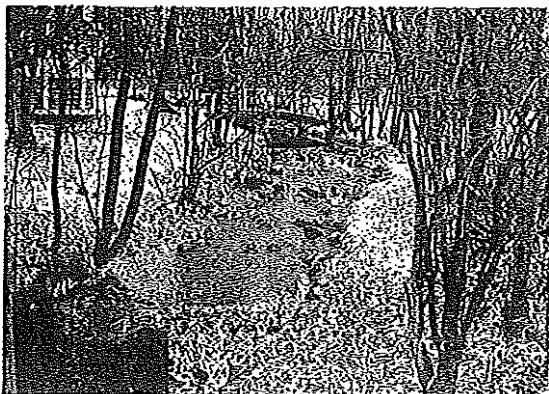
Very few mature, native trees remain in the riparian zone in this section (Fig. 37a,b,d,f). The dominant riparian overstory vegetation is mountain alder and a variety of willow species. Very few black cottonwood, spruce or trembling aspen were observed and most of these were young trees or pole saplings. Common shrubs included red-osier dogwood, black twinberry, red raspberry, prickly rose, hardhack (*Spiraea douglasii* ssp. *menziesii*), highbush cranberry (*Viburnum edule*), saskatoon and the occasional common snowberry (*Symphoricarpos albus*). Herbaceous plant cover included purple peavine (*Lathyrus nevadensis*), horsetails (*Equisetum* sp.), fireweed, cow parsnip (*Heracleum lanatum*), Canada thistle (*Cirsium arvense*), grasses, sedges (*Carex* spp.), wild strawberry (*Fragaria virginiana*), large-leaved avens (*Geum macrophyllum*) and lady fern (*Athyrium filix-femina*). The overstory layer in wetland section 3B consisted of a higher density of mature trees including cottonwood, willows and alder with aspen occurring on the drier sites. Shrub cover included young alder, aspen, spruce and willows, red-osier dogwood, black twinberry, highbush cranberry with prickly rose and snowberry in the drier aspen forest. Commonly observed herbs included scouring rush, common horsetail, wild strawberry, fireweed, great northern aster and lady fern.

A: Upstream view of the stream flowing through private land. The photo was taken from Victoria Dr. at 0+000 m.

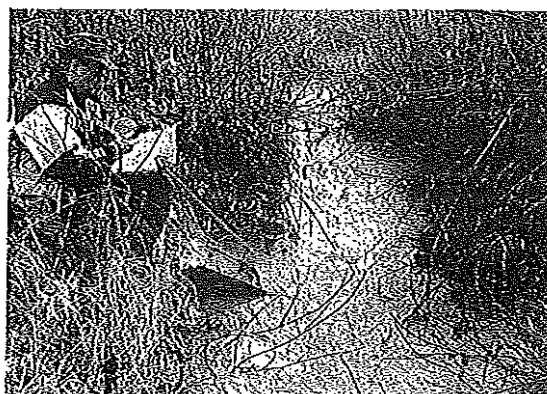
B: View of typical channel and riparian habitat below Highway 16 at 0+476 m.

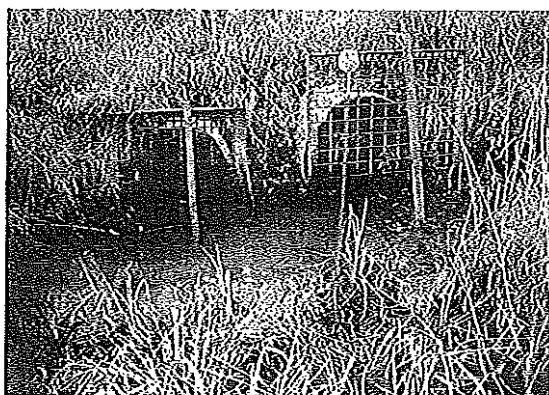
C: Upstream view of culverts under Highway 16. Note the screens that would prevent adult salmon migration.
