Fish Habitat Assessment and Selected Rehabilitation Prescriptions within the Zymoetz Watershed

Terrace Salmonid Enhancement Society
Terrace, B.C.

Ministry of Environment, Lands and Parks Watershed Restoration Program

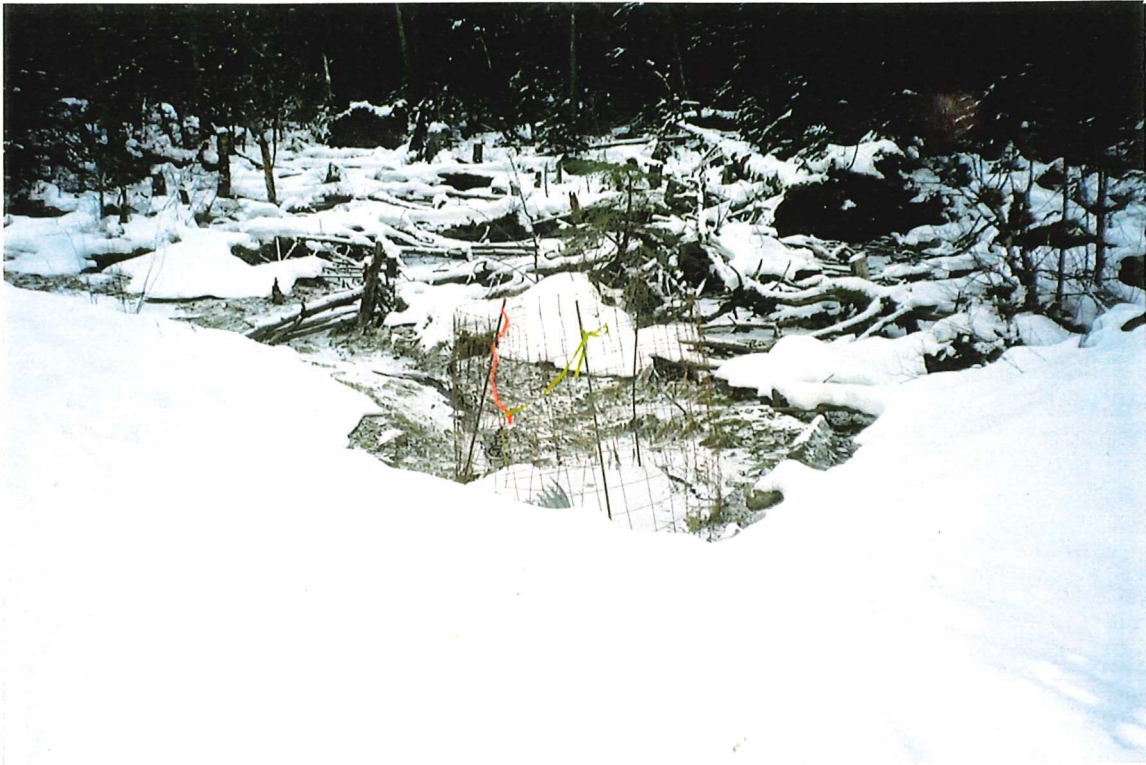
This creek has a steep gradient at its confluence with the river. It provides some woody debris and large boulders for shade and cover. Extensive impact from logging and the construction and maintenance of Copper FSR that was the original Highway 16 (photo 1).

Photo 1: Looking above the Copper FSR at Mocha Creek amongst a logged off area.

could be installed upstream of the dams. No plans are in place to do anything with the habitat above the road other than to clean any debris (cans, bottles, etc.) from the pond area. Signs should be made stating the creek is fish habitat and posted around the pond. The contractor carrying out this work should take note of any additional rehabilitation that is required and make a recommendation to the project manager for additional restoration of the Mocha Creek habitat.

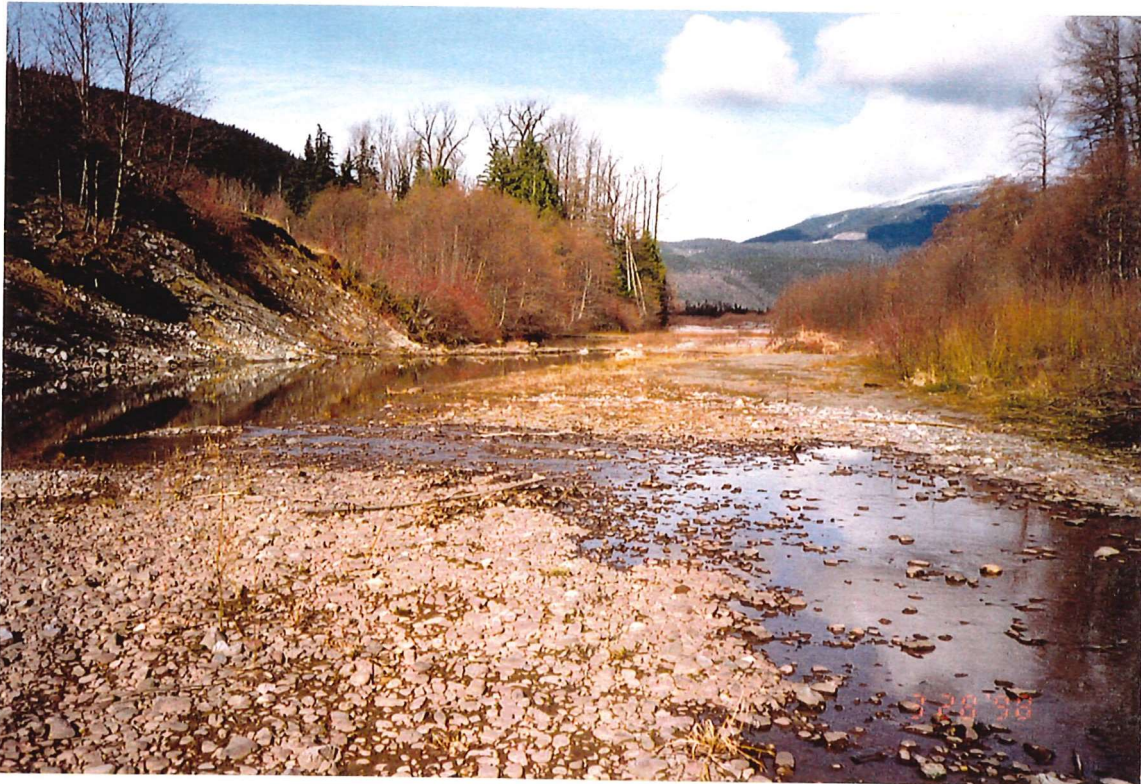
Photo 3: Looking downstream mid-channel below the ground water creek inlet.

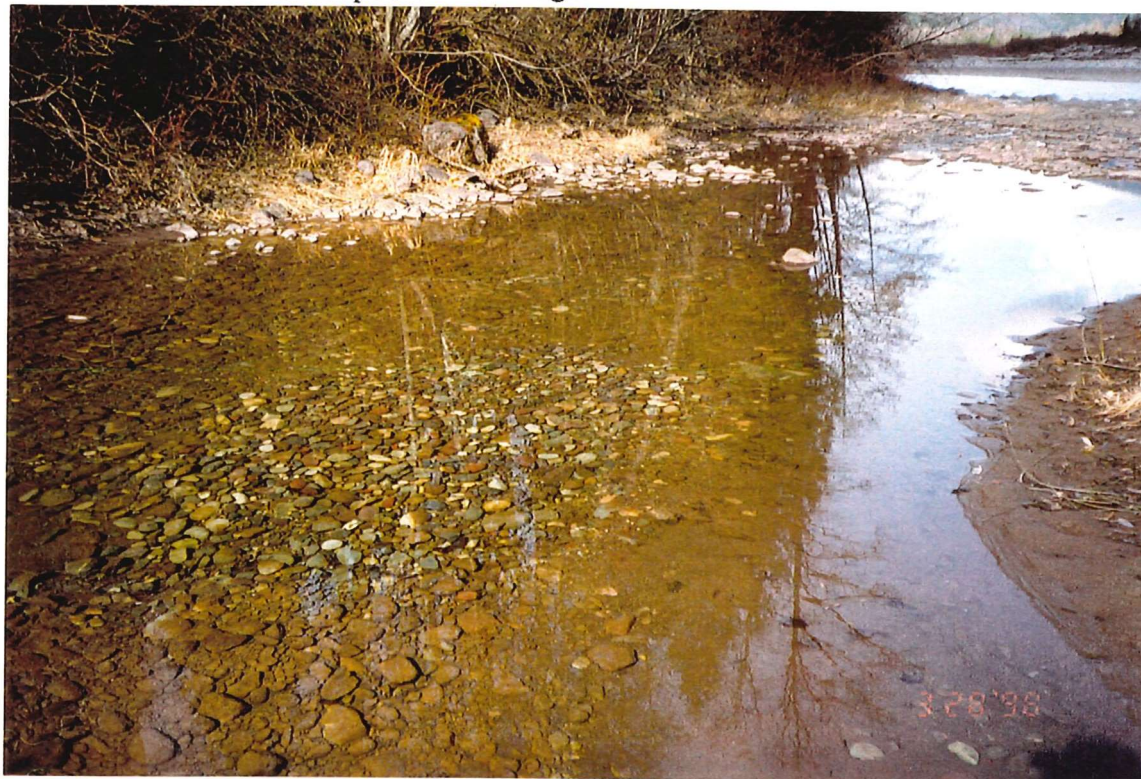
On November 14, 1997, one minnow trap set in an isolated pool yielded 2 juvenile coho with fork lengths of 60 mm and 65 mm. Two days previous, two coho redds were observed in a ground water pond at the west end of the channel (photo 5). On December 2, 1997, a pH reading of 8.6 was taken. The relative abundance of fish at this site is 0.02. Four test holes were dug on March 31, 1998, by a rubber tired back hoe (photo 6 and 7). At the first hole, 100 m from the Zymoetz River, water was reached at 1.5 m and flowed faster than the back hoe could bucket it out. Water was reached at slightly less than 2 m for the second hole, 200 m from the Zymoetz. Water from the third hole, 300 m from the river, was found at a depth of 2.2 m. Water was found at just over 1 m in the fourth hole, 400 m from the river; there was excellent flows at hole one and four. At the time of digging, the Zymoetz River was within a few centimeters of the lowest seasonal flow seen in 20 years.

Photo 5: Coho redd in lower channel.

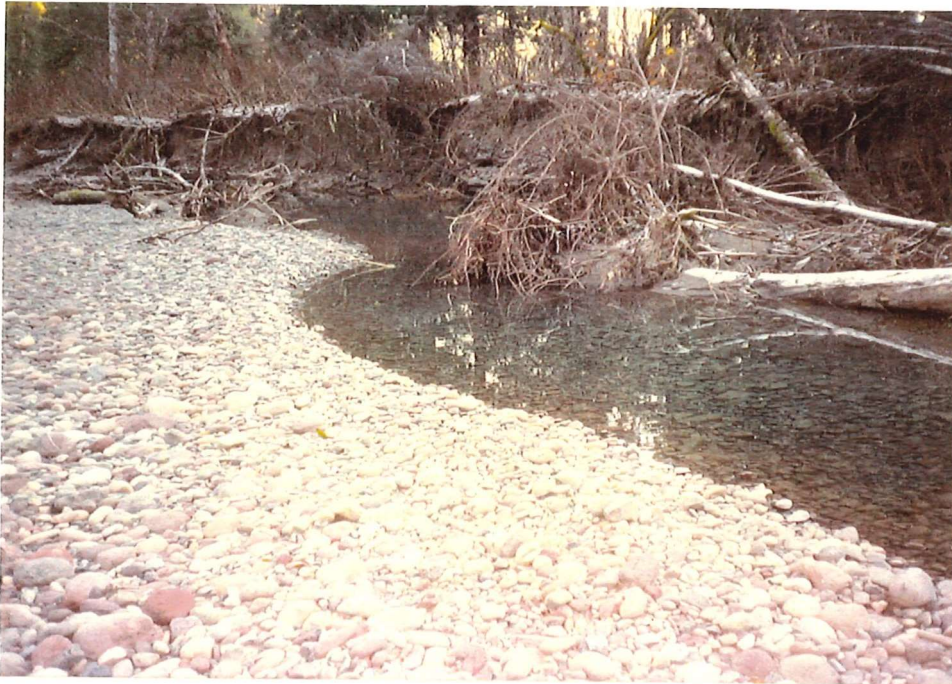
This side channel's length is 810 m with an average gradient of about 2%. The channel is mainly fed by, what appears to be, a perennial flow of ground water resulting in four isolated pools when the water table recedes below the elevation of the channel bed (photo 8 and 9). The water flow changes to sub-surface after leaving the fourth pool. There is sufficient water flow during the late summer and fall months for coho and pink or chum salmon to enter the channel. The channel is surrounded by mainly deciduous

Photo 8: Pool just past mid-channel with sub-surface water flow.

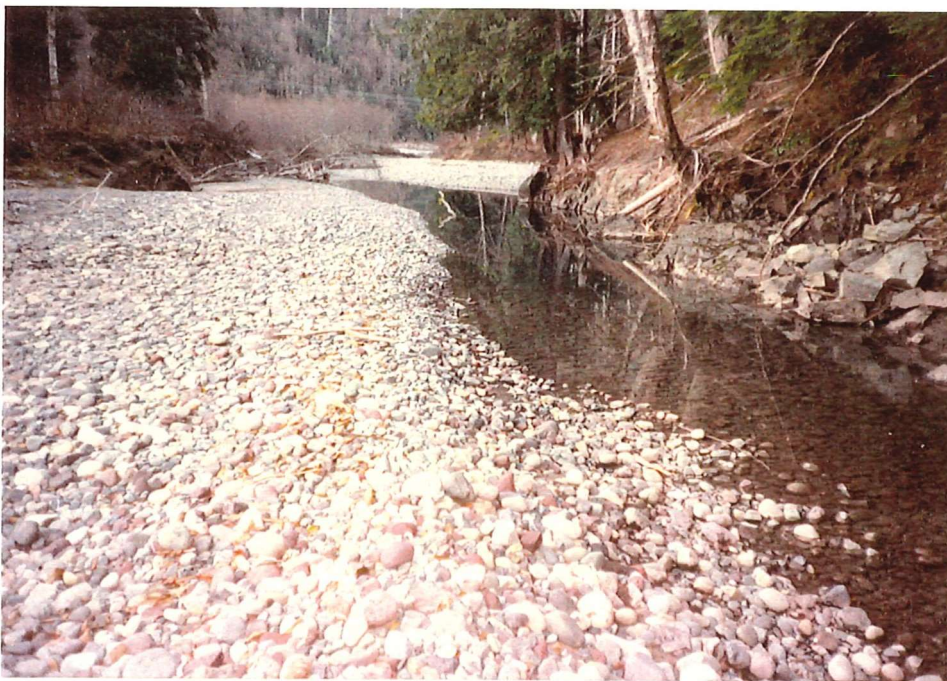
Photo 9: Pool mid-channel, coho spawned at the tail-out.

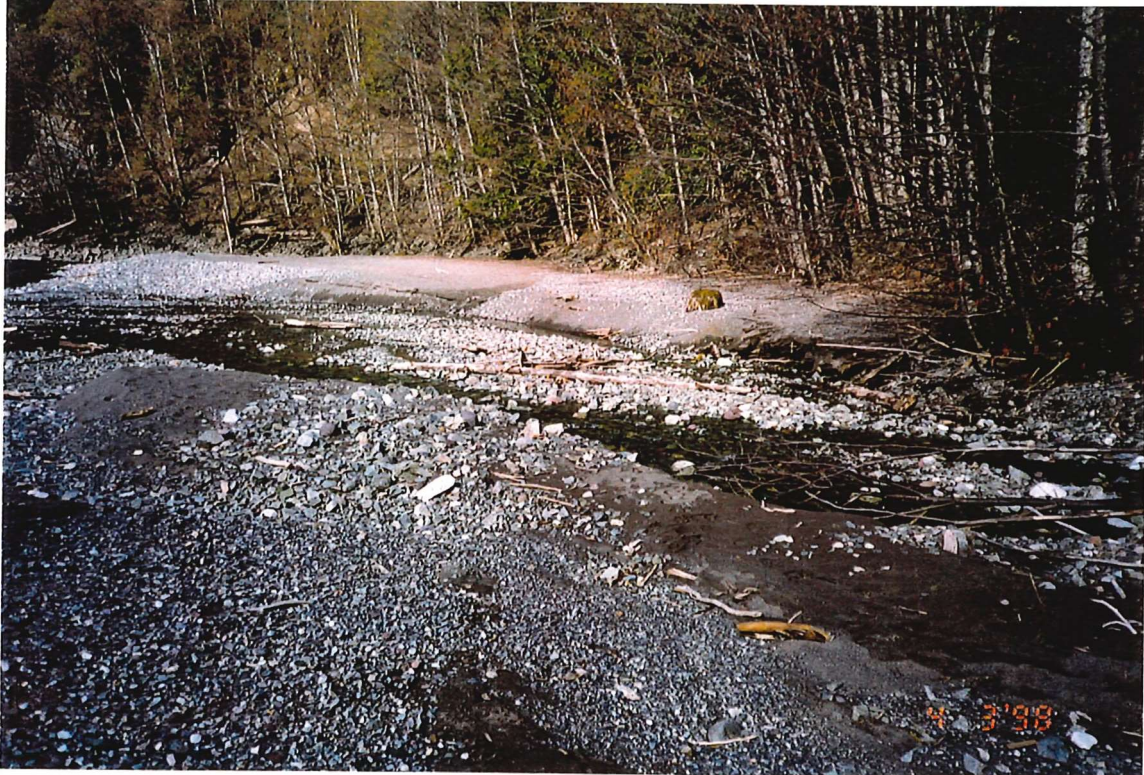
Photo 12: The fan of Something Creek running through site 24B side channel.

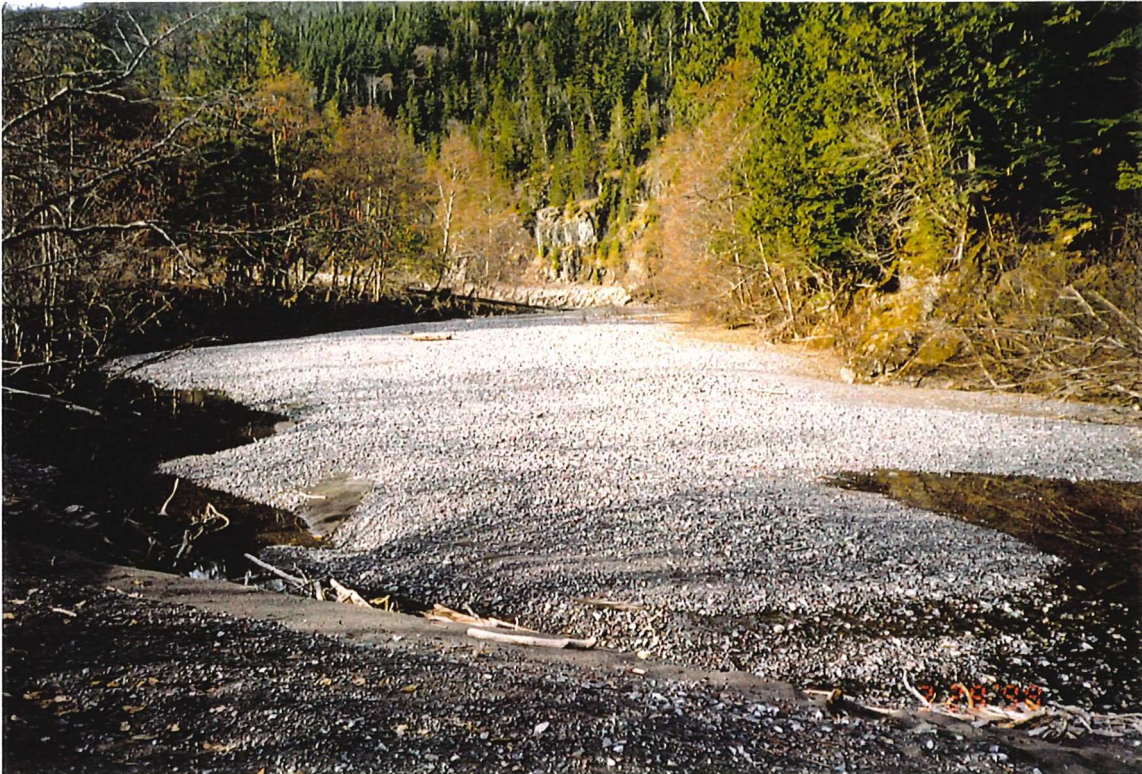
Photo 14: Mid-channel.

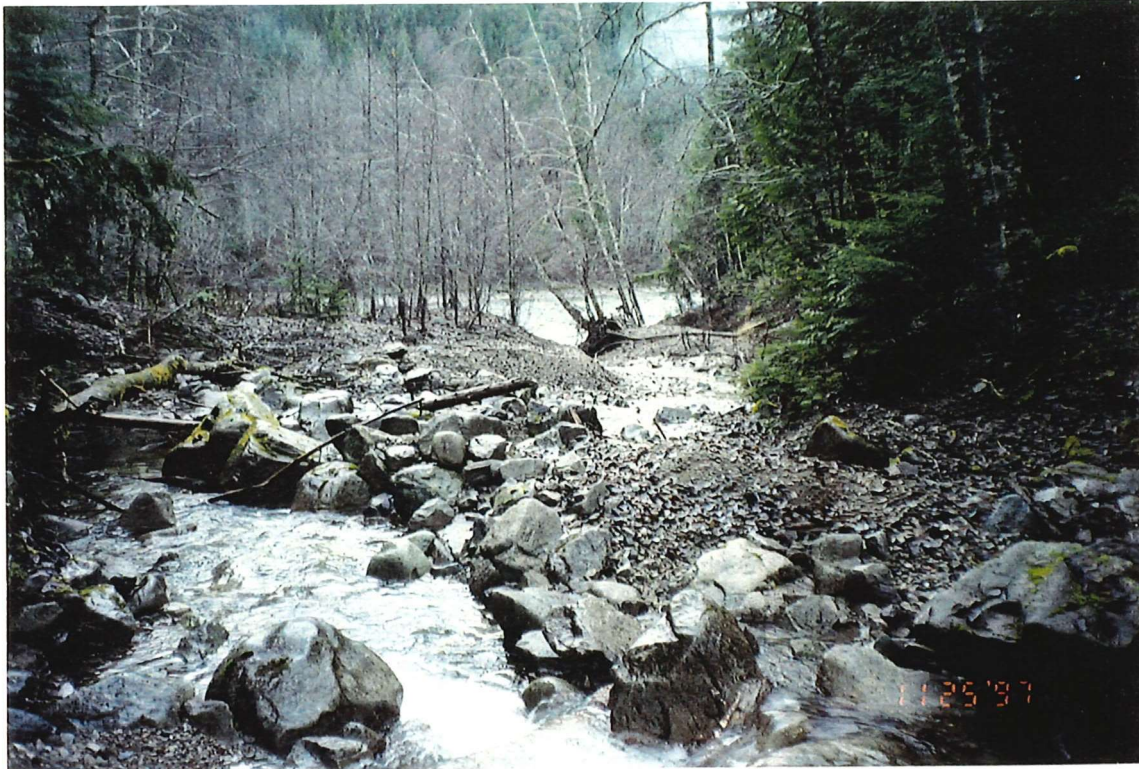
Photo 19: Looking downstream to the Zymoetz River.

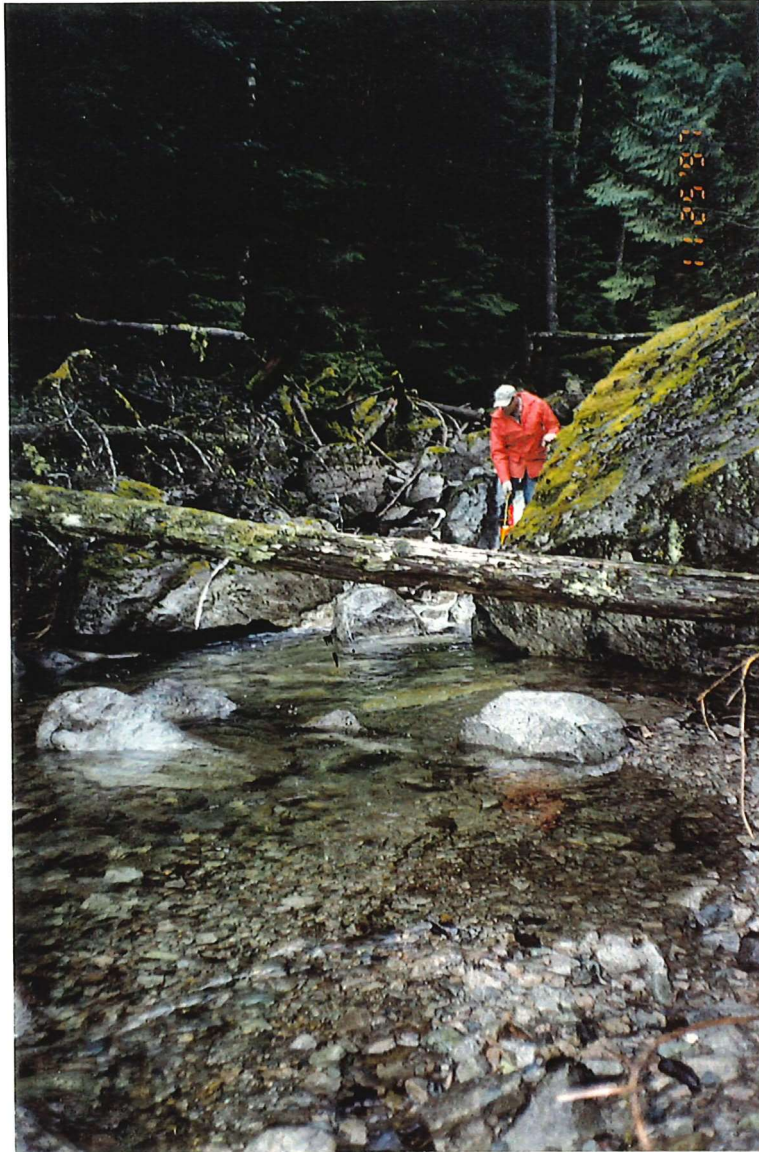
Photo 21: Looking upstream. A coho redd just below the large rock.

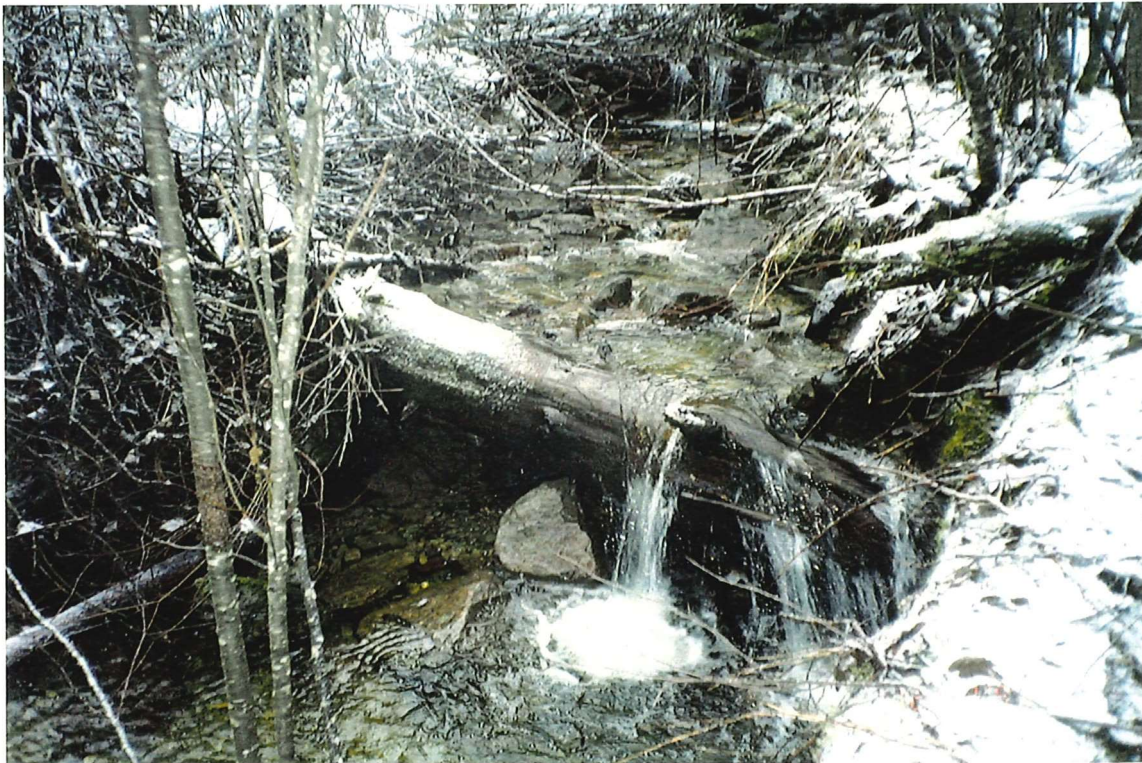
Peace Creek splits into two channels about 150 m above the road resulting in the water disappearing before the road. The gravel has built up against the culverts increasing its depth. The division of flow and build up of gravel has resulted in no water at the lower end during normal and low flows. A pH reading of 8.4 was recorded January 6, 1998.

Photo 22: Peace Creek flow upstream above the gravel fan.

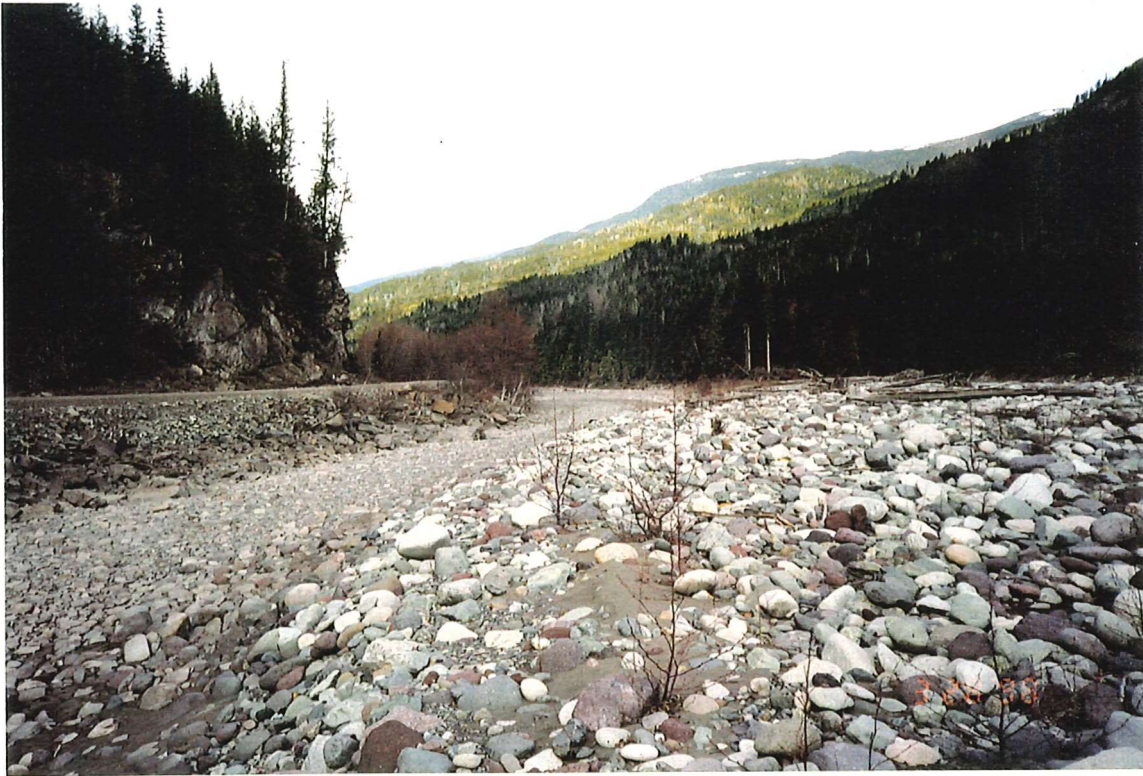
We were unable to separate sites 47 and 50 as individual impact sites as a result they have been consolidated into one site. The road is too close to the river and may have taken over a portion of the side channel when it was constructed. During major floods the road is usually partly washed away and covered with water.

Photo 26: Looking downstream from the top of the channel. Loss of stream side vegetation has resulted from adjacent road construction.

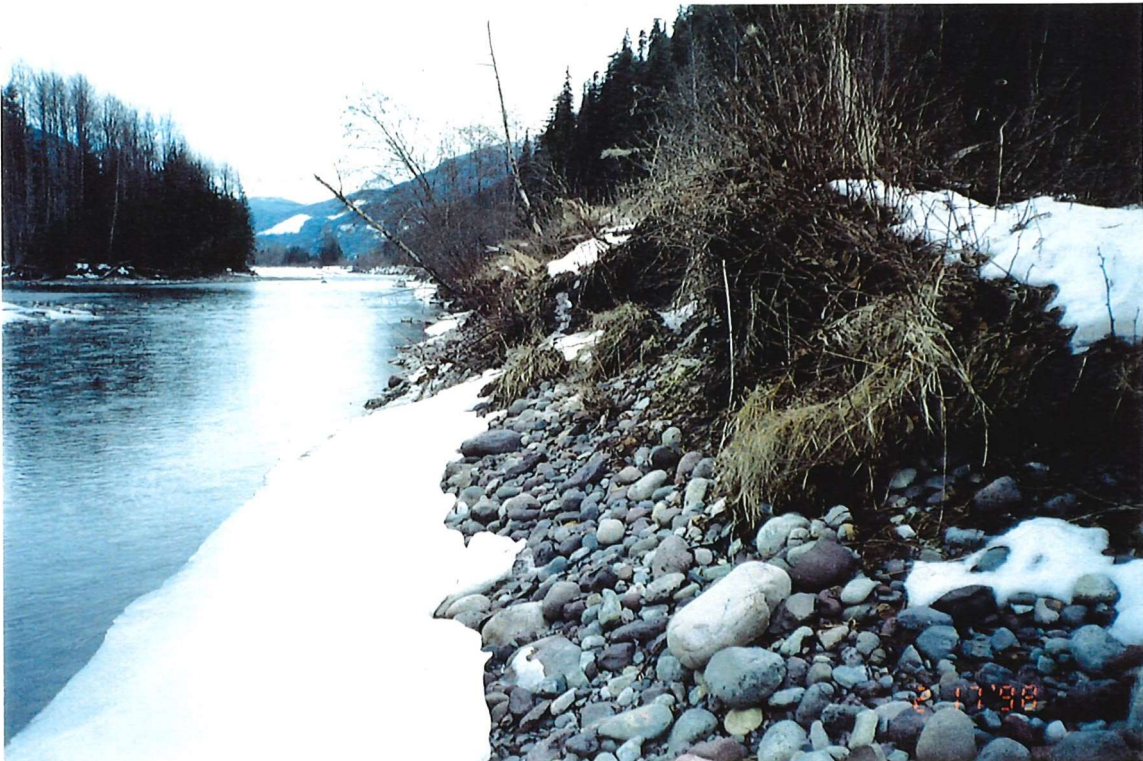
This erosion is natural in a logged off riparian area between the Zymoetz River and the FSR (photo 35 and 36). During high water events the bank is being undercut and the remaining old growth one by one is falling into the river. Grasses have re-vegetated naturally, but Pollard et al. (1996) believes this will not be sufficient in stabilizing the bank.

This side channel that is causing all the problems and is getting larger because it is facing directly into the main flow of the river and will likely become the main flow over time unless it is trained away from the riparian area.

Photo 35: Eroded bank and disappearing riparian zone looking upstream.

Construct two deflecting groynes about 10 m apart with the first just upstream of the start of the side channel. These would be short groynes about 3 m long with about 1.5 m sunk into the bank and buried about 0.5 m into the substrate (see Appendix VI for groyne construction). Because the water velocity in the Zymoetz can be very powerful requiring the construction of any works to be built to withstand major flood conditions.

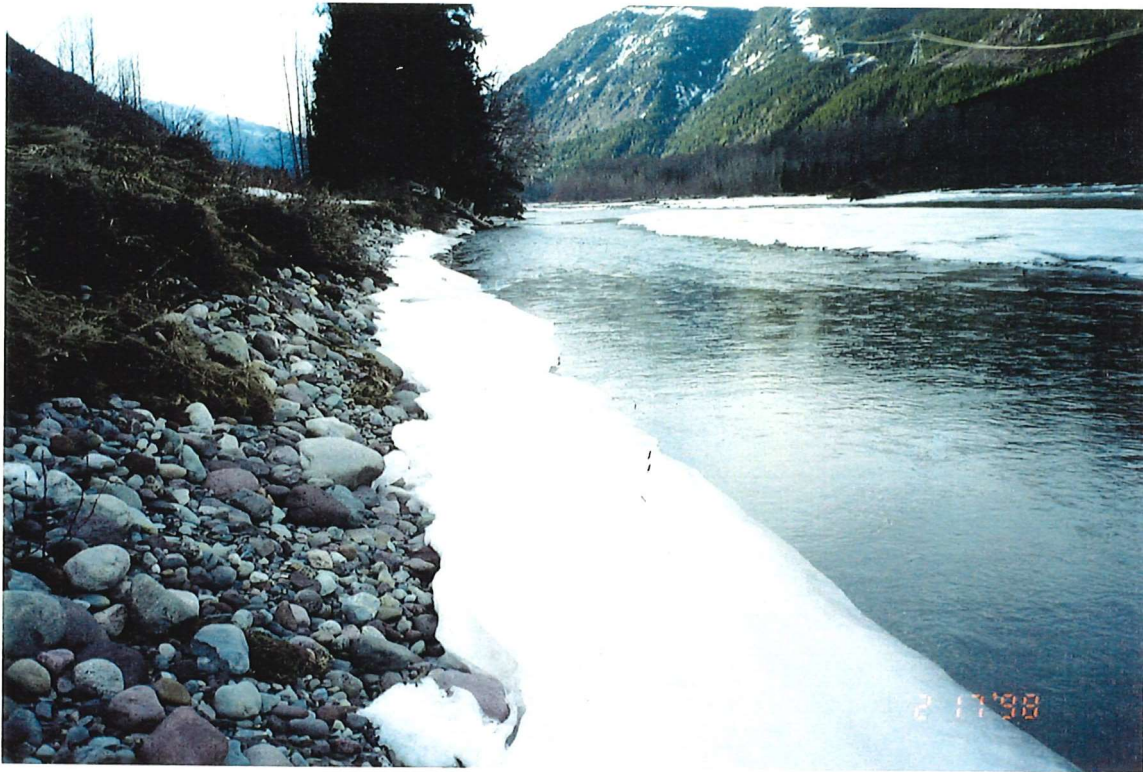
Photo 36: Looking down stream along the same bank.

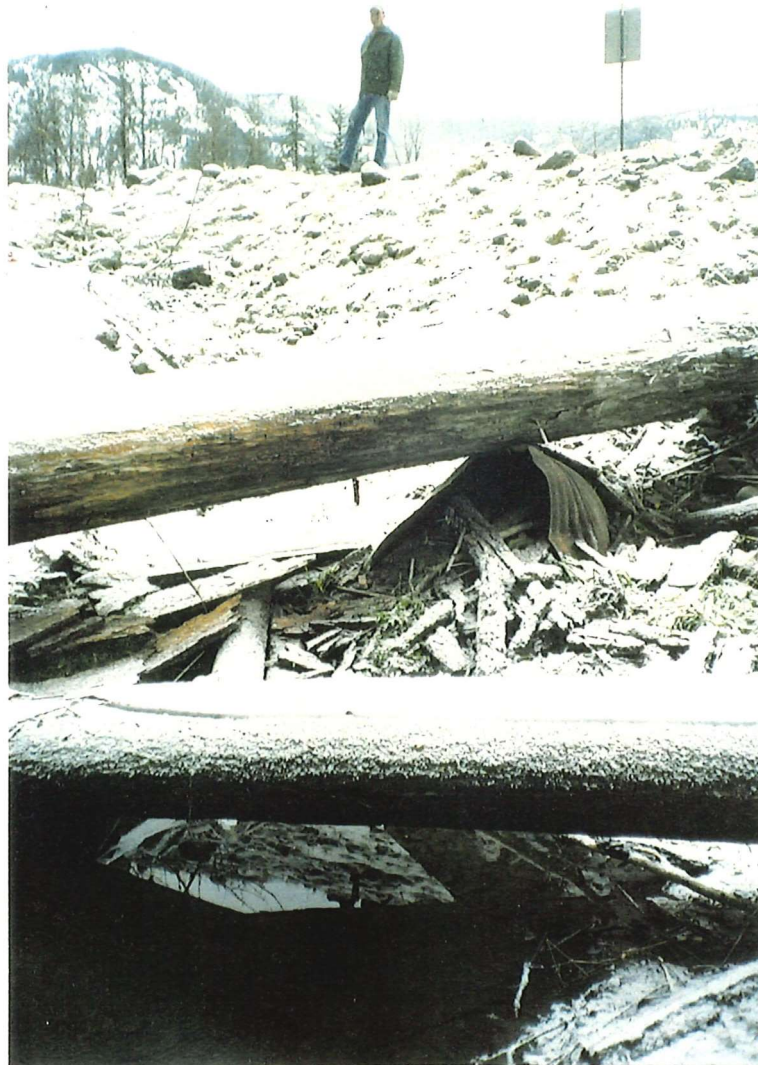
This site was found to have two trickling water sources: a ground water source on its east side and a surface flow on its south end. The culverts on either side of the FSR are plugged preventing water flow from the Zymoetz River (photo 37 and 38). The minnow traps checked on November 14, 1997 revealed a total of 19 coho and 1 char. The water is flowing through the porous shot rock at the end of the channel likely as a result of PNG reconstructing its pipeline. The relative abundance calculated is 0.83. The chart below represents the fork lengths of these fish.

Photo 37: This plugged culvert provides no access to adult salmonids.

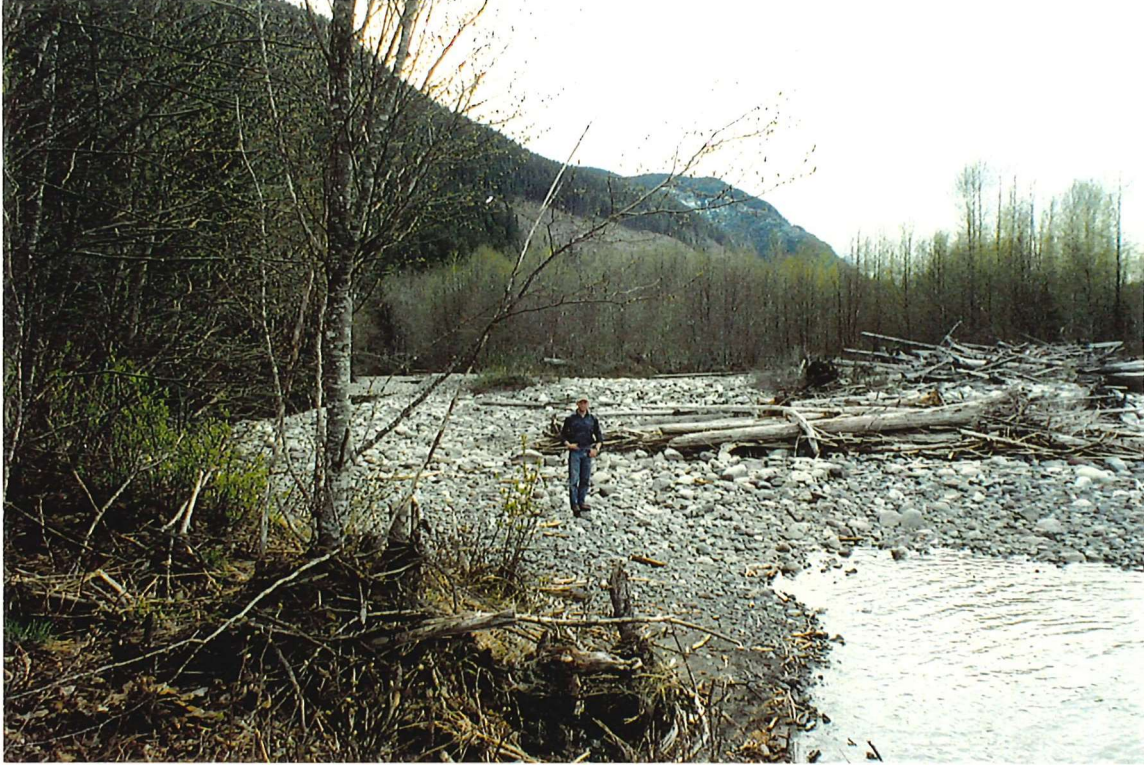
This side channel is 589 m in length (photo 39, 40 and 41). The presence of stumps in the wetted portion of the channel is evidence that this area has been affected by past logging practices. As well, beavers have negatively impacted the flow of water into the channel from a creek (Swan Creek) running across the road under a bridge located mid-channel (photo 42). Currently, the channel is mostly fed by sub-surface water that has a small flow year round. This creates more of a back water area than a functional side channel. The channel bed is composed of a mix of spawning size gravel and boulders and the channel banks provide some deciduous cover.

Photo 39: Entrance of 29.5 Km side channel with Zymoetz River in foreground.

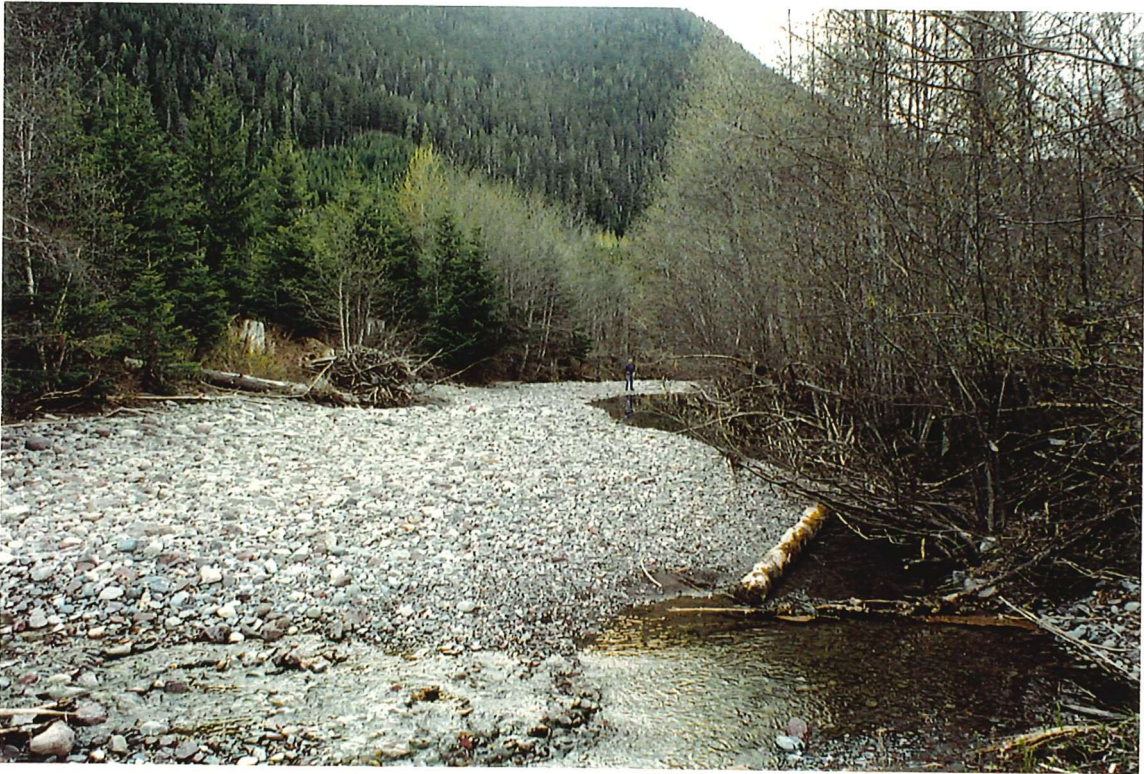
Photo 40: Just downstream from the entrance.

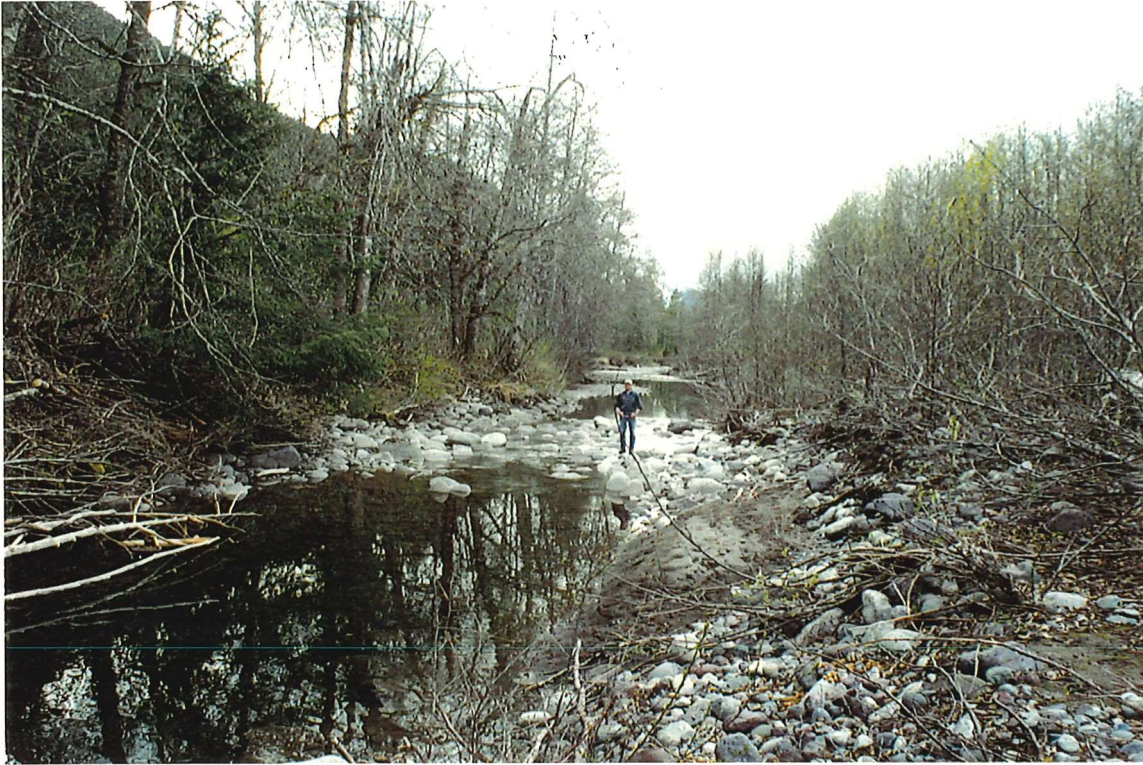
Photo 41: Just past the midway point of the side channel.

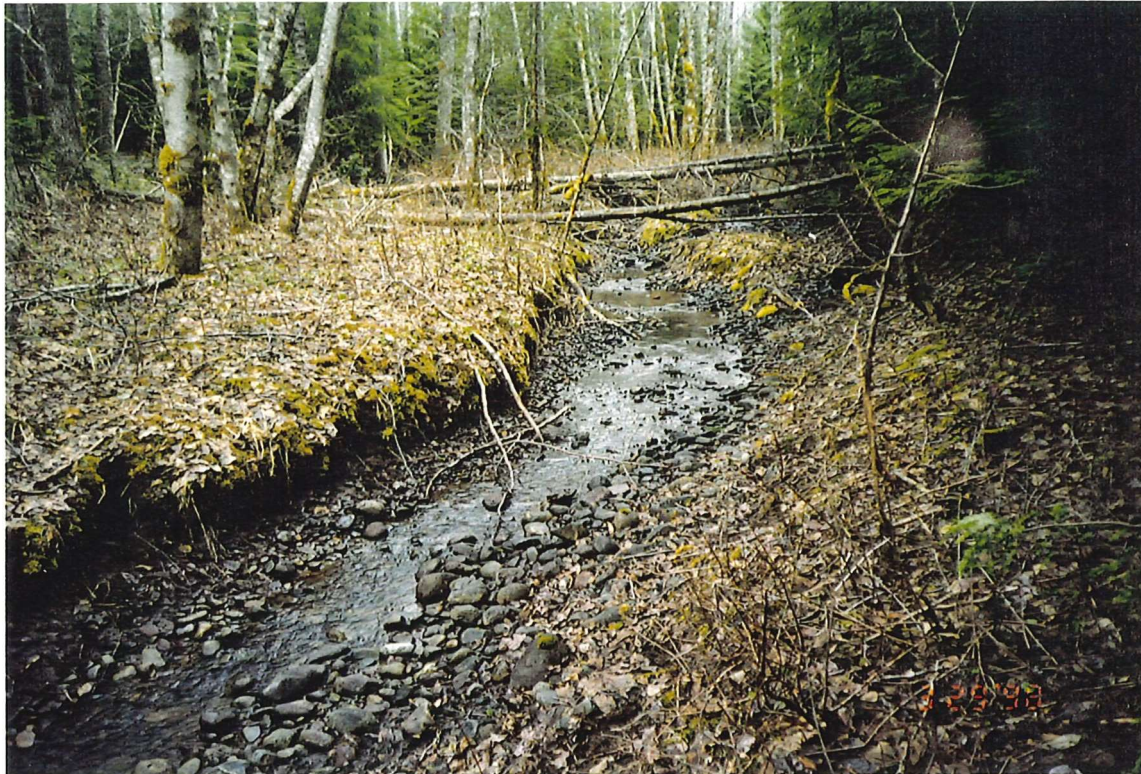
On November 14, 1997, a minnow trap located in the channel: one upstream above the in channel dam at the bottom of the channel (reach 1) revealed 51 juvenile coho. A trap found below the same dam (reach 2) contained 8 juvenile coho and 5 char (photo 43 and 44). This channel provides a substantive amount of vegetative cover for shade and shelter. The relative abundance at this site is the highest overall of all the sites sampled during this study at 2.4. A redd from an previous season was observed above this dam. The dam at the end of the channel is completely impassable to adult fish except, possibly, during very high flows. It is approximately 25 m wide and contains four small streams flowing from it directly into the Zymoetz River. A pH of 9.1 and 8.4 were recorded. The chart below displays the fork lengths of the fish captured at this site.

Photo 43: Beginning of channel, sub-surface water flow.

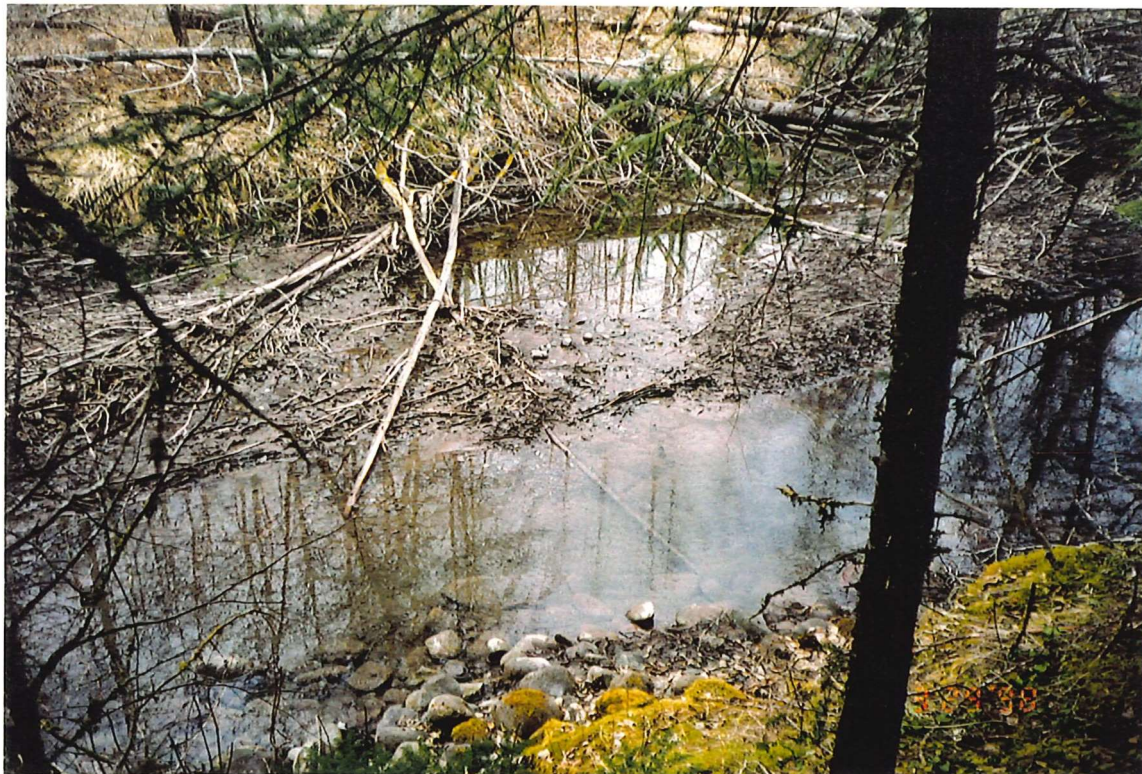
Photo 44: Mid-channel below second in stream beaver dam.

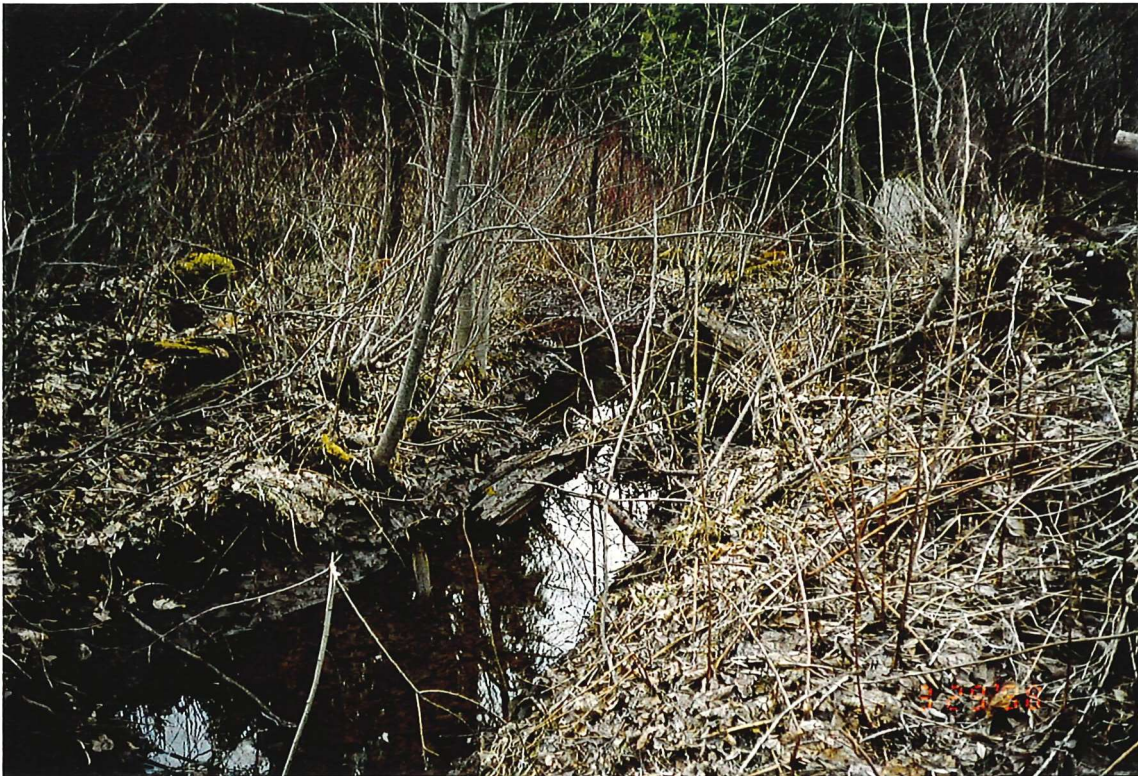
Photo 47: Water flow into ditch stopped by small beaver dam.

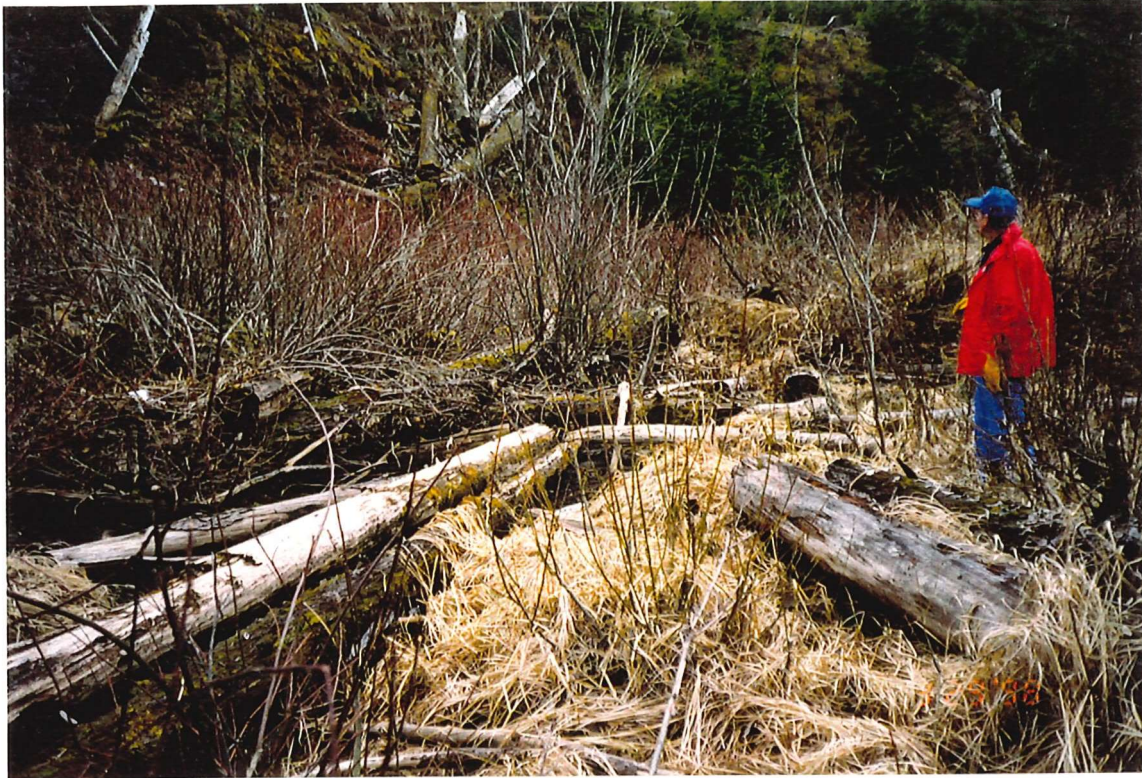
This creek has two main reaches. The first is a number of sections on either side of the FSR consisting of mostly dammed pools. The second is a steep section, upstream, where the original flow has been partially diverted into roadside ditches by the alluvial fan at the bottom of the steep gully (photo 45 and 46). There is a total of 11 beaver dams of various size throughout this creek's 2+ km length which have also contributed to its flow diversion (photo 47 and 48). The vegetation surrounding this stream consists of about 60% sitka spruce, 20% western hemlock and the remaining 20% is a mixture of young subalpine fir, cottonwood, sitka alder, willow and red osier dogwood. There is no flowing water in Swan Creek below the fluvial fan (photo 49).

Photo 49: Swan Creek below alluvial fan, no flowing water in creek.

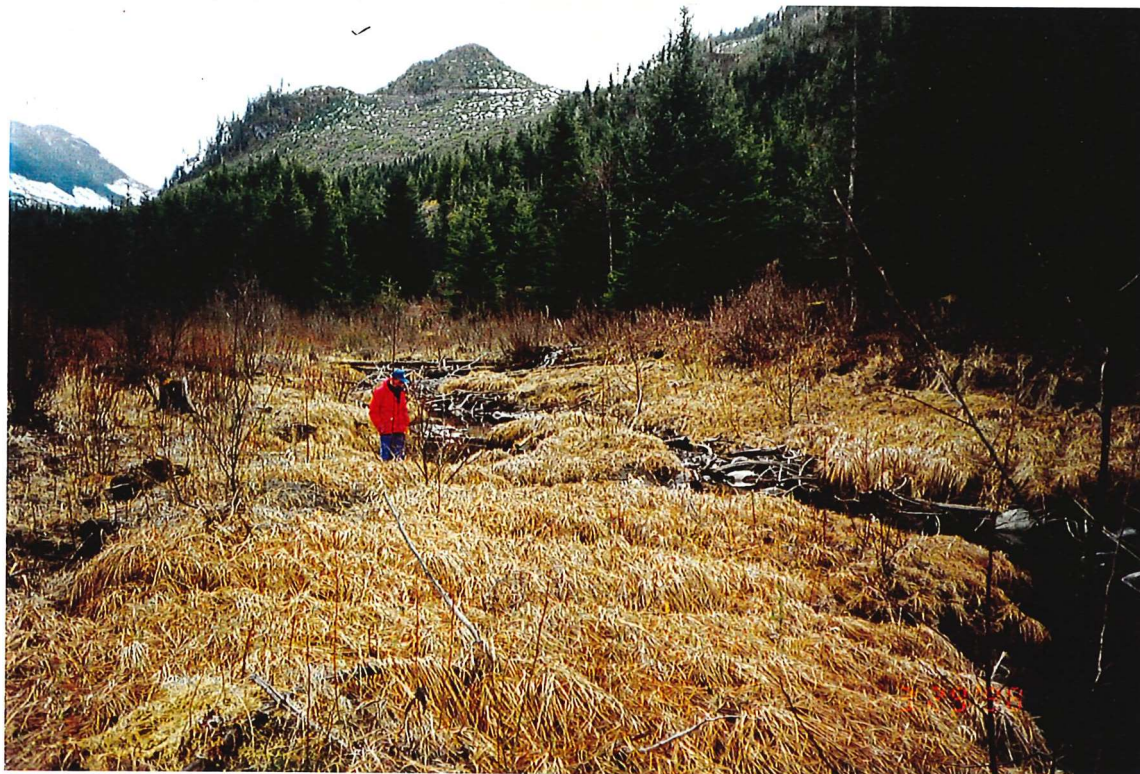
Photo 52: Upstream around the corner from the confluence with Doll Creek.

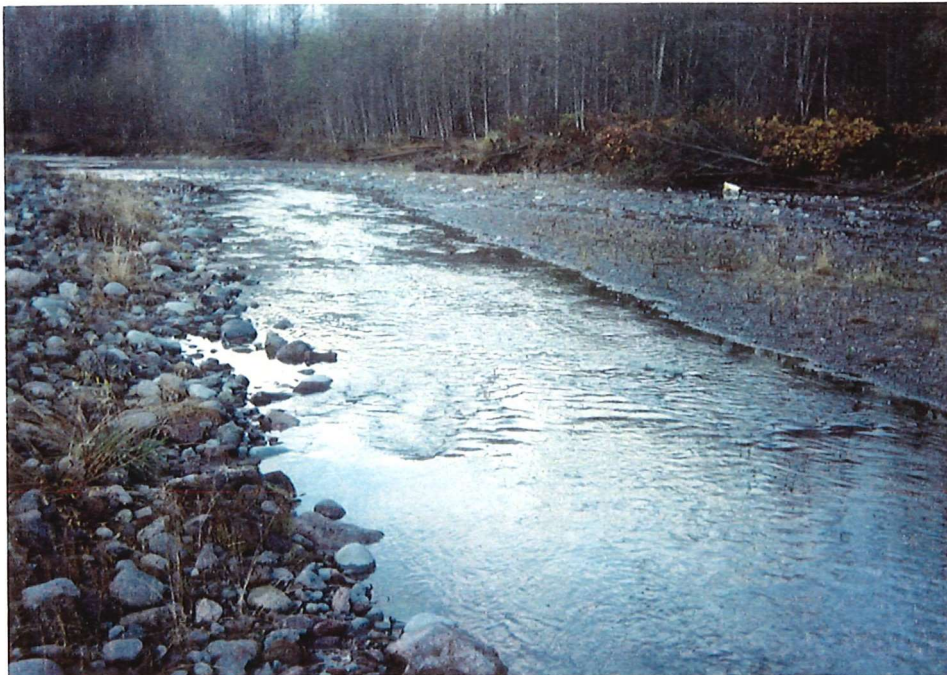
Photo 57: Above the confluence of the channel and creek.

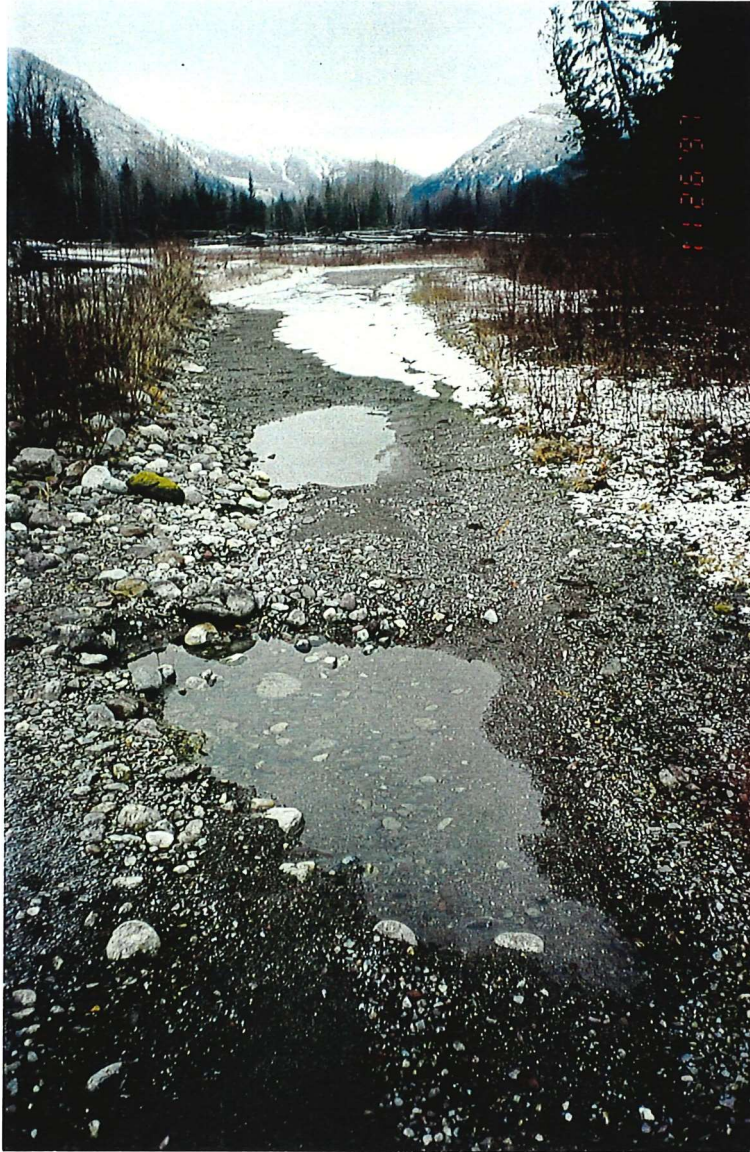
Photo 58: Upper side channel, coho redd in an almost dry channel.

branch feeding it lost its flow. The loss of flow was caused by the drop in the water level in the creek drying up a number of coho redds and trapping juveniles in isolated pools.
