Fish Habitat Assessment and Selected Rehabilitation Prescriptions within the Zymoetz Watershed

Terrace Salmonid Enhancement Society
Terrace, B.C.

Ministry of Environment, Lands and Parks Watershed Restoration Program

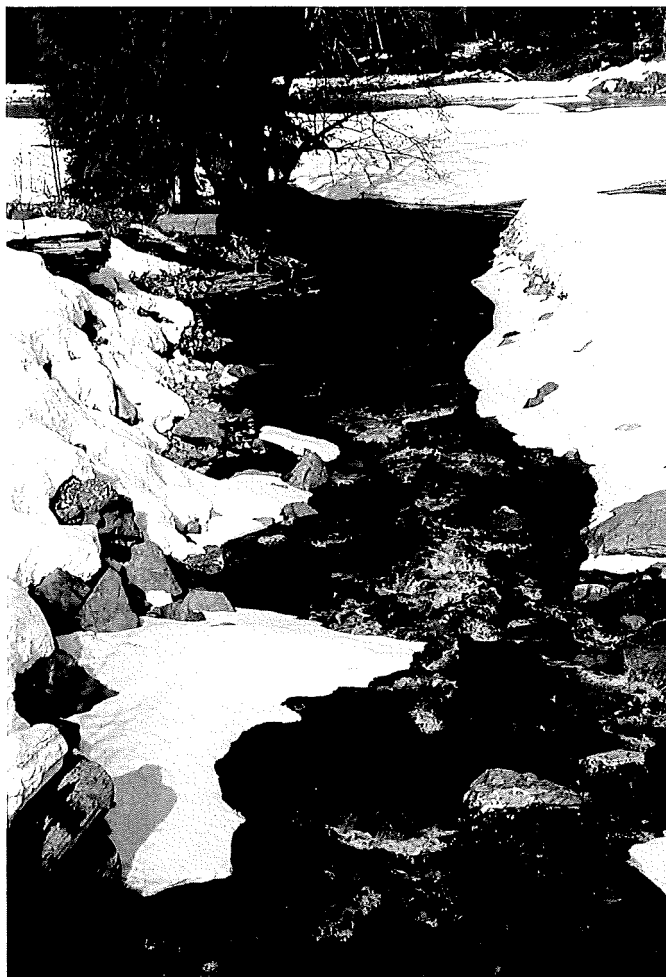
This site is a narrow, medium sized stream with a steep gradient and is made up of medium and large boulders with little spawning size gravel (photo 59). The exception is in front of the two upstream vees that were constructed in the creek and in the tail-out of the last pool in the creek. The fish habitat from the falls pool to the Zymoetz River has been severely degraded by the two major floods in 1991 and 1992. The high velocity of the flow has transported most of the gravel to the unstable fan at the outlet of the creek. Road and bridge construction has had an impact upon the creek. Riparian harvesting occurred adjacent to the creek at this site. Pollard et al.(1996) considered this area a chute therefore claiming no impact on the stream.

Photo 59: April 1995, before any in stream rehabilitation began.

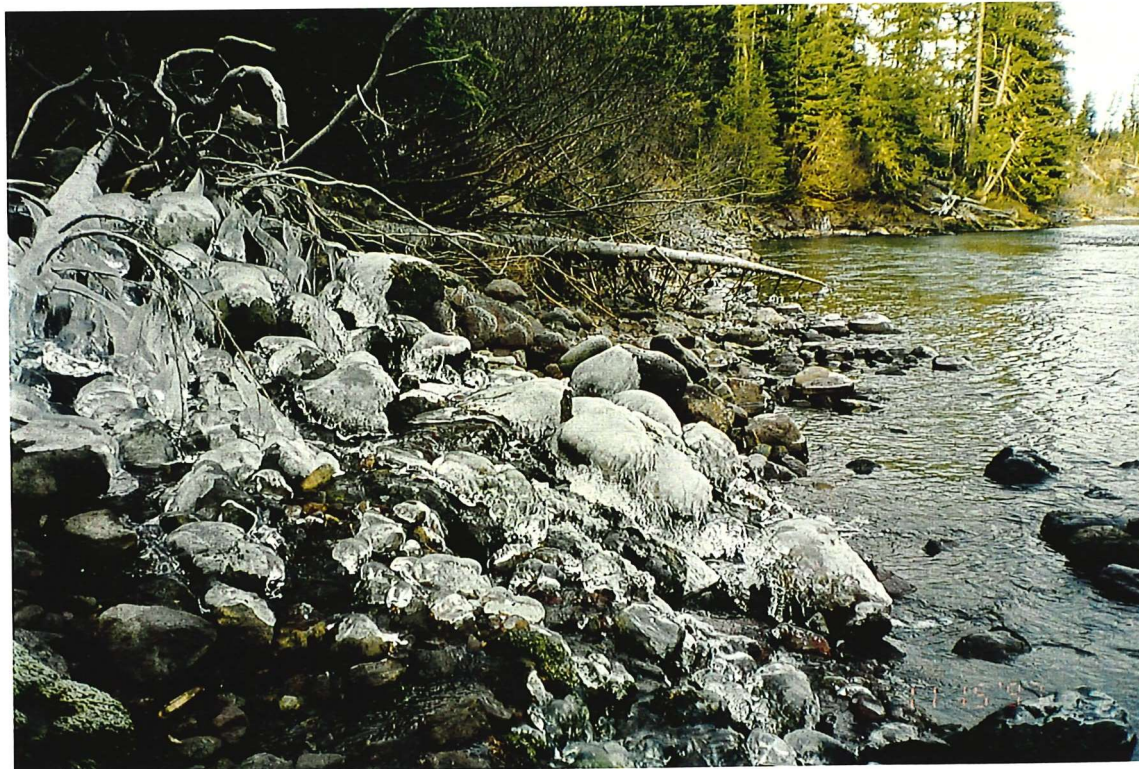
This stream was blown out by the 1978 flood or one of the floods in the 1980s. It has an average gradient of approximately 14% over its 290 m length from Clore mainline bridge to the Clore River (photo 62). There are a number of spots throughout this creek that are likely not passable to adult or juvenile fish due to steep gradients, debris barriers and high velocities (photo 63 and 64). On either side, this creek is surrounded by mostly coniferous vegetation with a few deciduous shrubs. Within the creek lies large amounts of LWD and large rocks.

Photo 63: 17 Km Creek flowing into the Clore River.

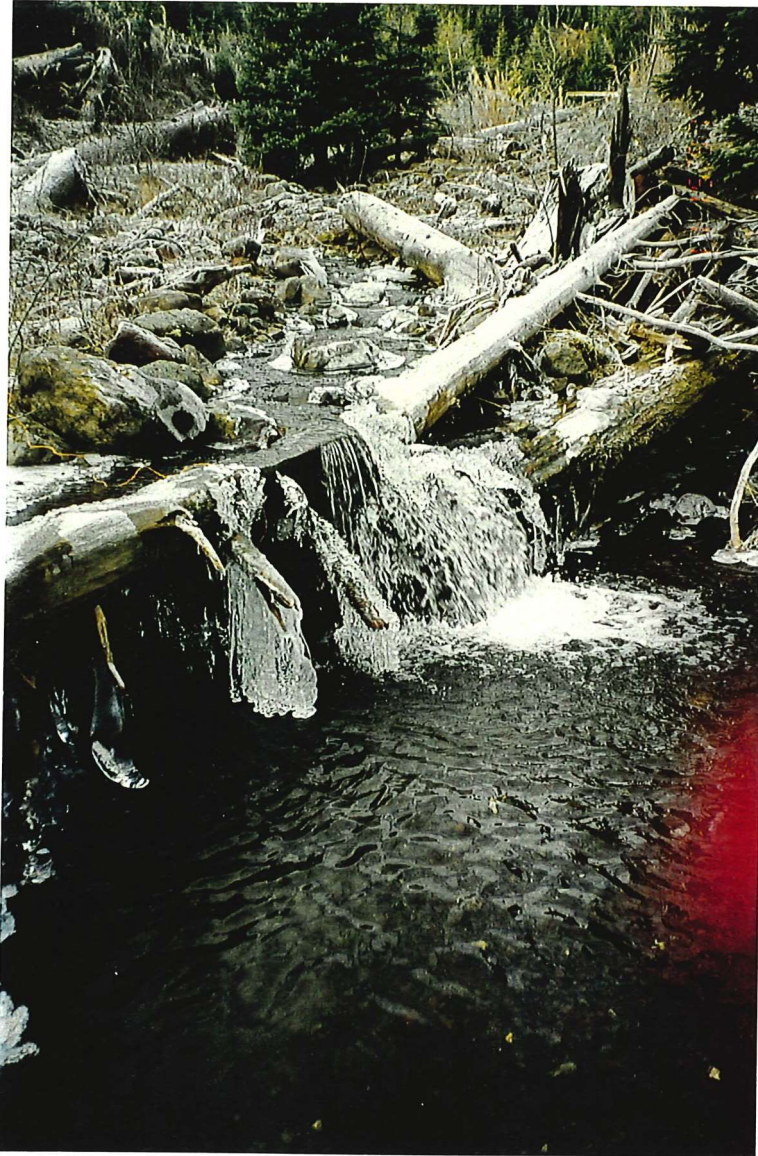
Photo 64: A mid-channel section, likely impassable.

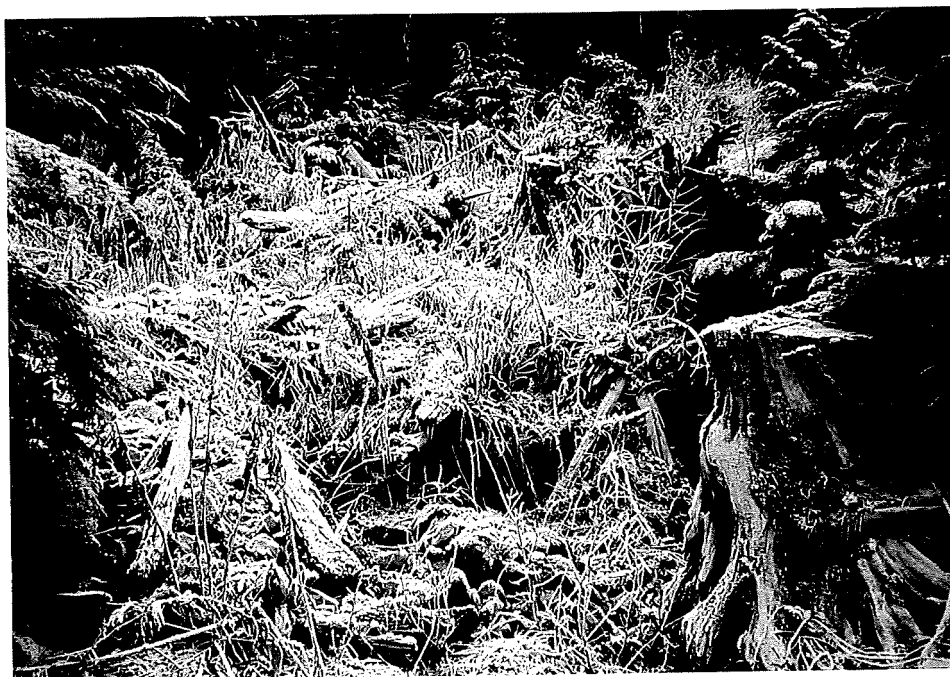
Photo 69: Proposed new channel for 12 Km Creek.

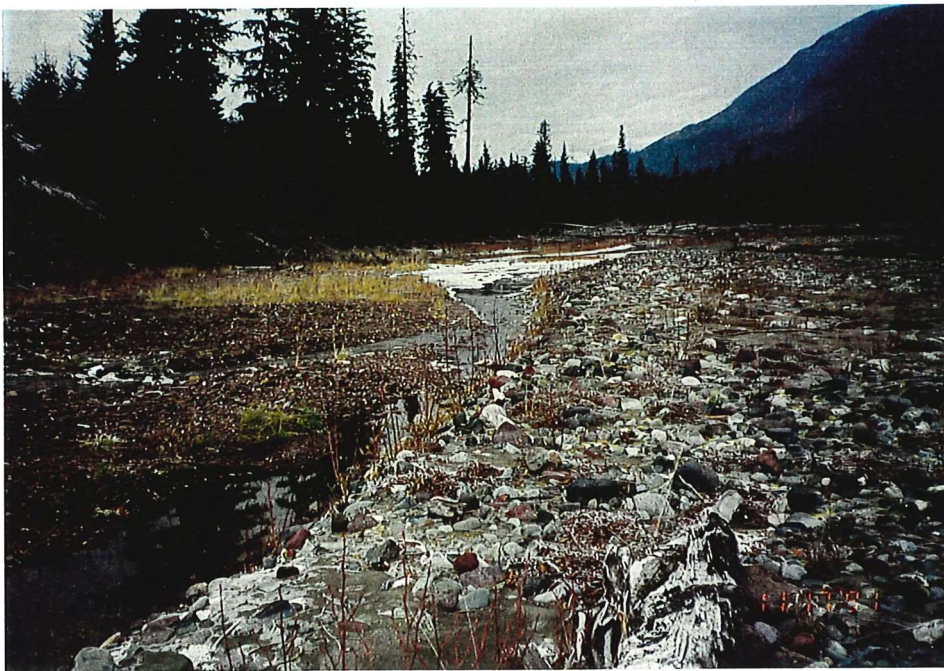
This creek above the Clore mainline bridge (reach 3), flows down a steep gully (photo 70) then reduces its gradient below the bridge to approximately 10% for 145 m where it meets with the old river main channel (reach 2) (photo 71 and 72). It flows along this channel for an additional 592 m before joining with the river. In some places, the old river channel is too wide to accommodate the relatively low volume of water from the creek. The result is an inadequate flow, or fanning effect in some areas making adult fish passage difficult if not impossible at times of low water. An additional problem suggested by Pollard in his Level 1 assessment (1996) is that the banks of the creek are actively eroding and this material is obstructing the old river main channel.

Photo 71: Top of Elf Creek side channel below the fan.

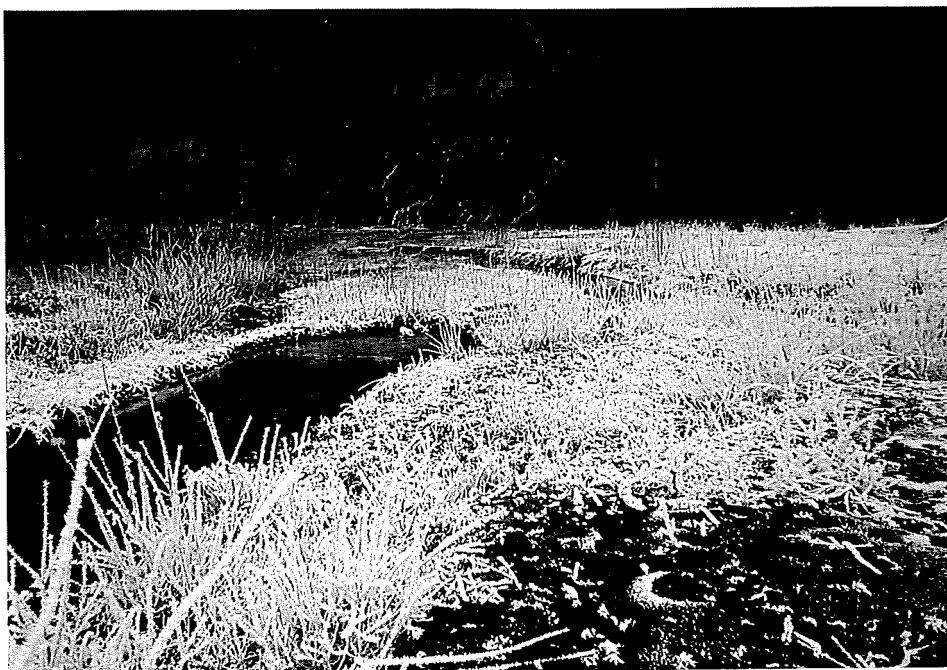
Photo 72: Mid-creek side channel looking towards the Clore River.

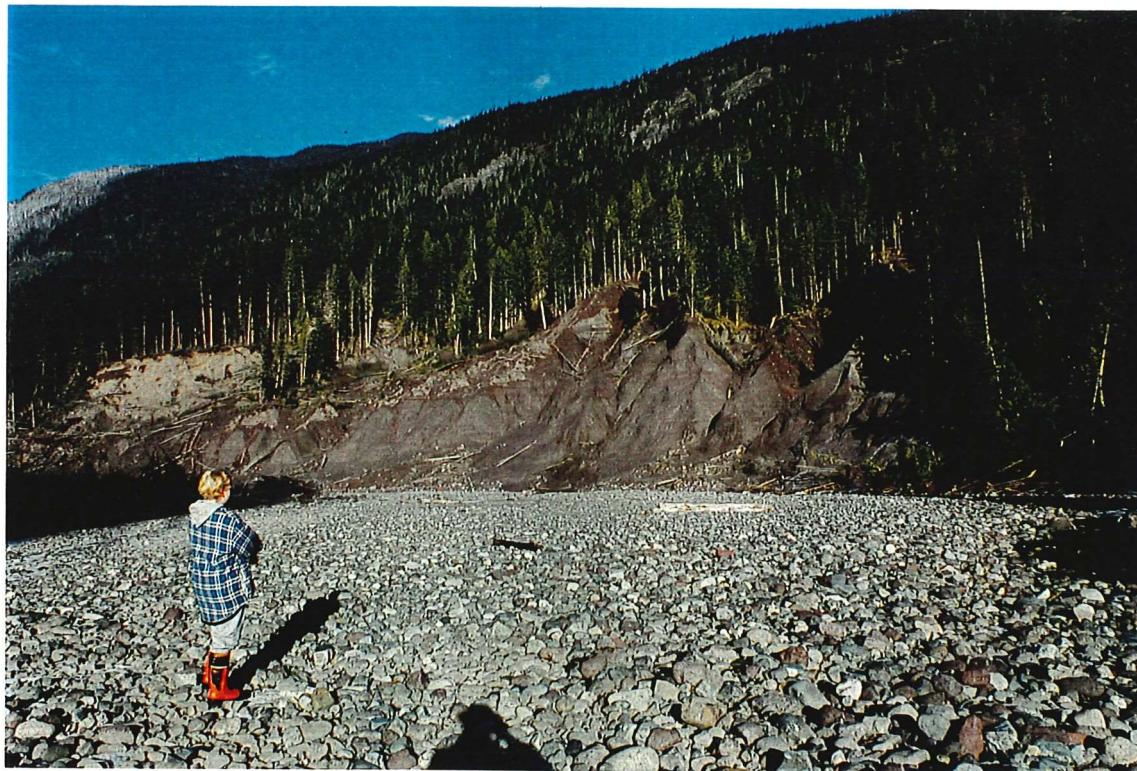
This slide is likely the single largest habitat impact in the Zymoetz watershed (photo 73, 74, and 75), particularly, in the opinion of anglers who fish the river and are intimately familiar with the watershed impacts. Composed of mostly clay and fines that are transported by sloughing and small creeks that run through the slide, it is estimated to span 300 m of the Clore River's edge, to be over 150 m high in most places and to be of a gradient near 90% in some places. From the location of the slide downstream, the Clore and Zymoetz Rivers have much higher deposits of red silty, fine material in the river and on the bottom substrate. The amount of material has been increasing as the slide has evolved. While no logging or logging roads have directly impacted this site, accelerated runoffs caused by logging and the 1978 fall rainstorm triggered the slide with later slides exacerbating the problem.

Photo 73: Looking downstream to the Clore River.

While its tempting to try and do major things with the slide itself, experience elsewhere has shown that usually more harm than good comes out of disturbing a slide such as this. The approach that we are proposing is to try and stabilize the slide by drying out the critical areas where the small streams are eroding the clay banks and causing material to slough off and break a way, with the water flowing over the loose material washing it into the river. The proposal is to test the use of flumes to pick up the water and transport it over the unstable sections or if possible higher up the slope drain it away in another direction. While this work is taking place the planting of appropriate plants, trees and grasses will contribute to the stabilizing of the slide, particularly in the older sections where gravel and sandy soils have begun to cover the clay.

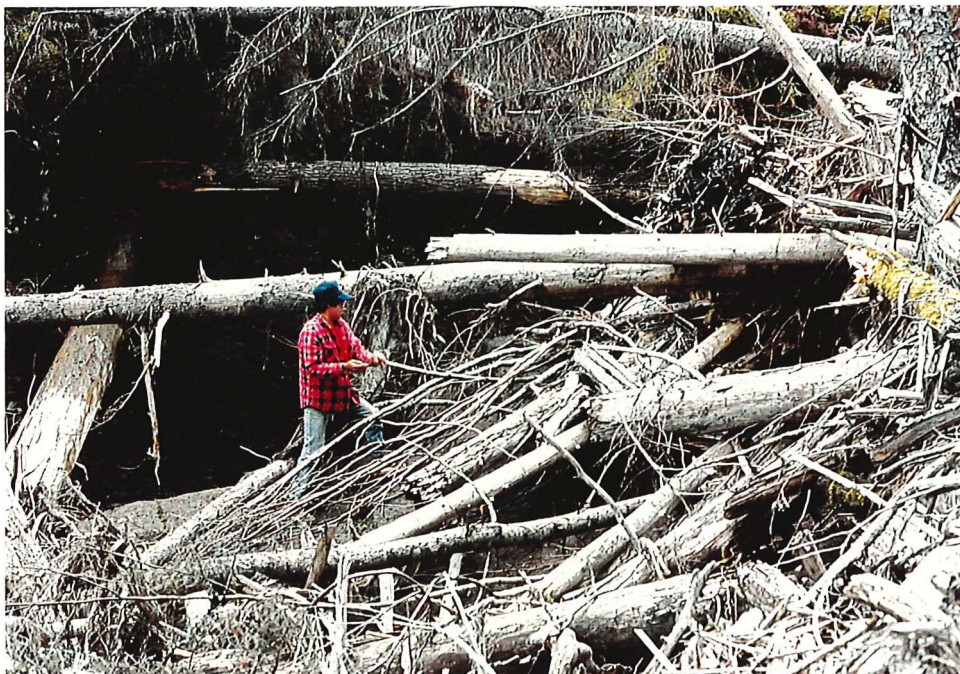
A log jam (photo 77 and 78) has partially blocked off the left channel looking downstream on Thomas Creek immediately above the high falls (photo 79) and it is likely that both barriers have stopped the migration of summer coho salmon and steelhead trout into the habitat above the falls. Historically, coho have been seen upstream of the falls prior to the log jam (pers. comm. Gene Llewellyn) and it is likely that steelhead were present also.

Photo 78: Log jam.

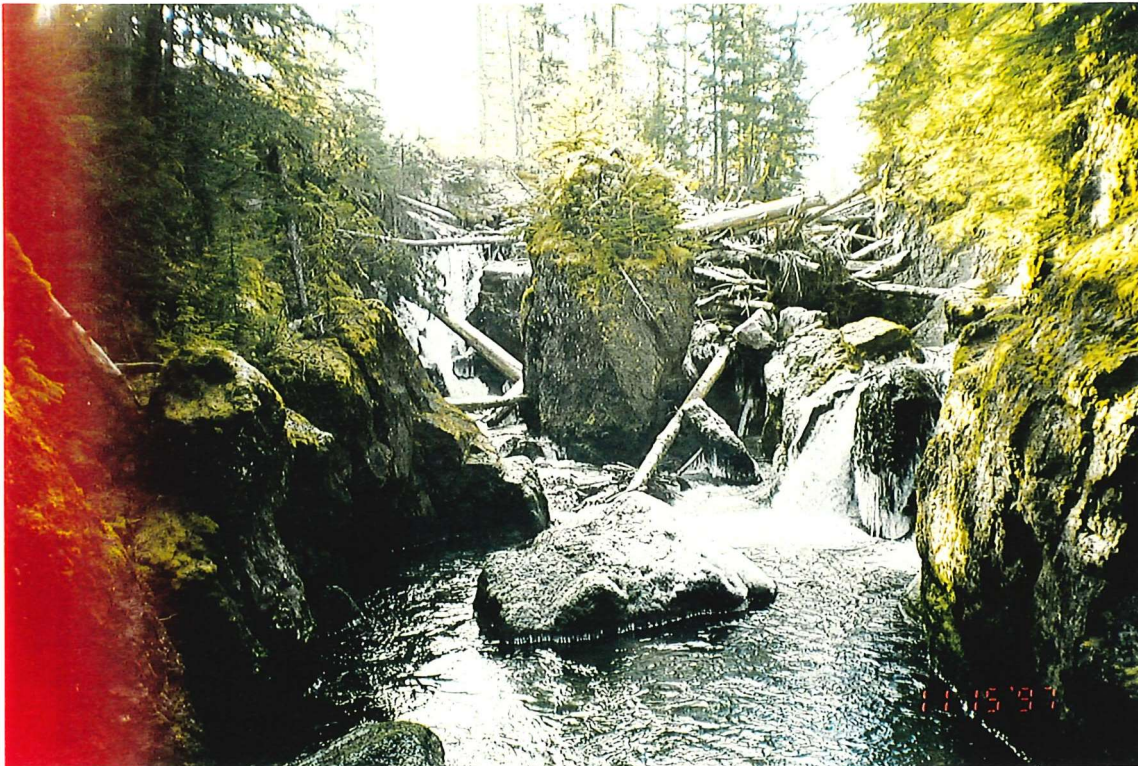
Photo 79: Looking towards the log jam and falls.
