# Reconnaissance Level Fish and Fish Habitat Inventory for the Kispiox Forest District

*Prepared for:*

**Repap Smithers**

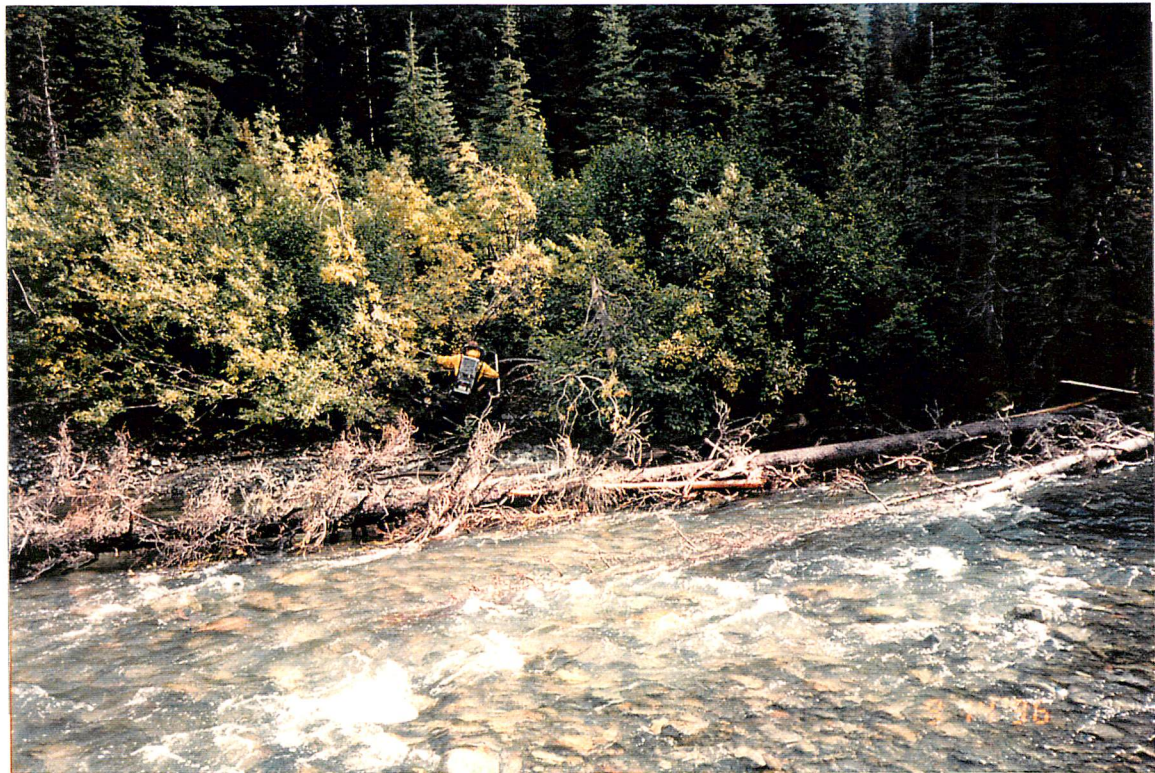
Photo #: A-3-23, 14-Sep-96

Site #: A23, Looking towards mouth of tributary from Tommy Jack Creek.

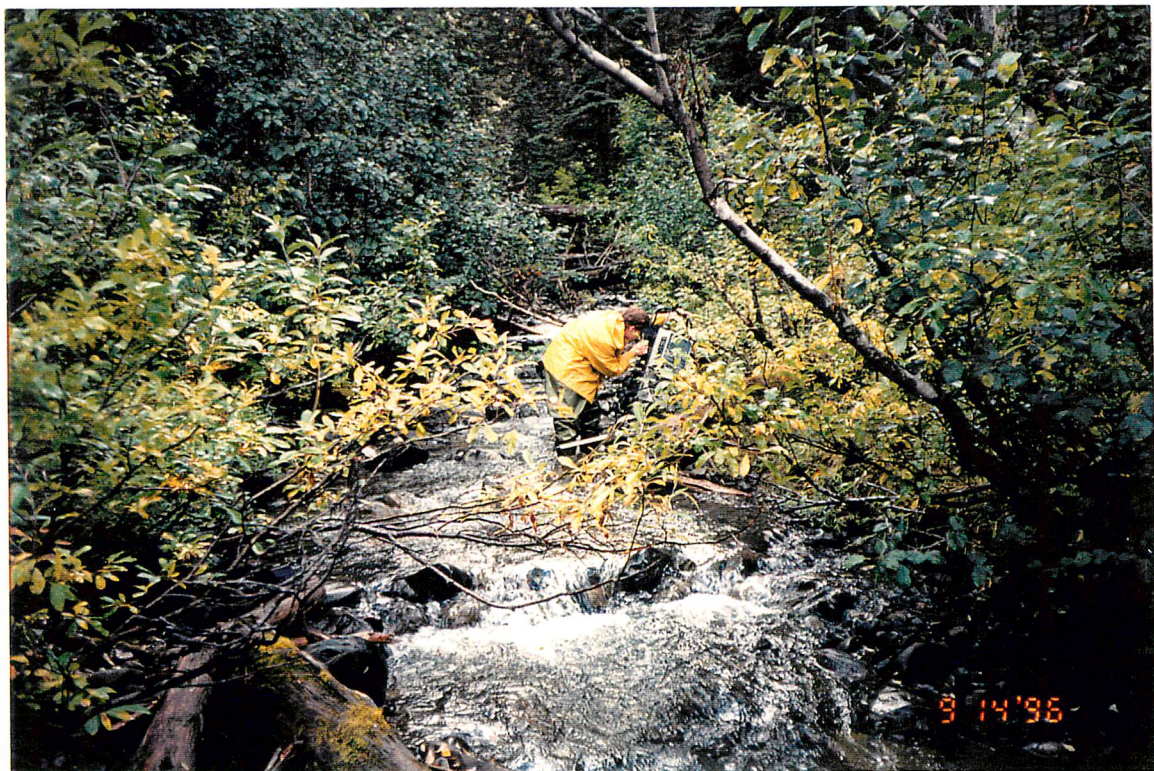
Photo #: A-3-24, 14-Sep-96

Site #: A23, Looking upstream.

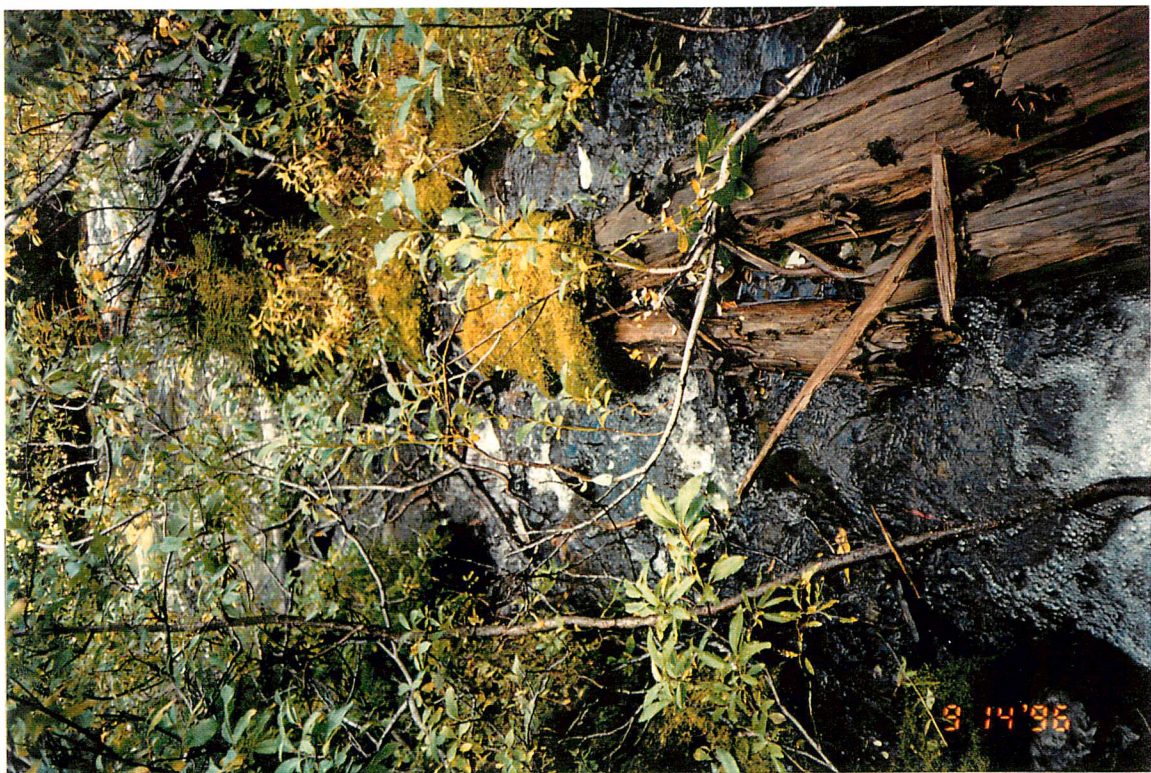
Photo #: A-4-2, 14-Sep-96  
Site #: A24, Large organic debris parallel to flow.

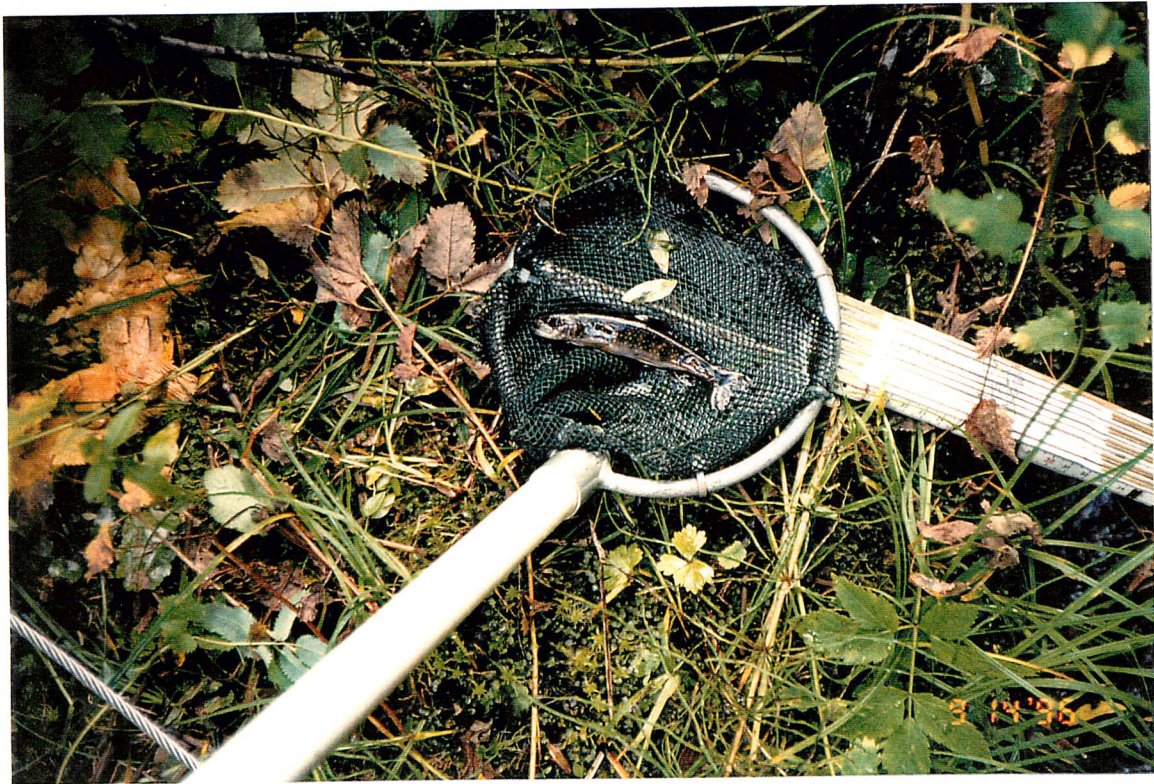
Photo #: A-4-3, 14-Sep-96  
 Site #: A25, Dolly Varden on anode.

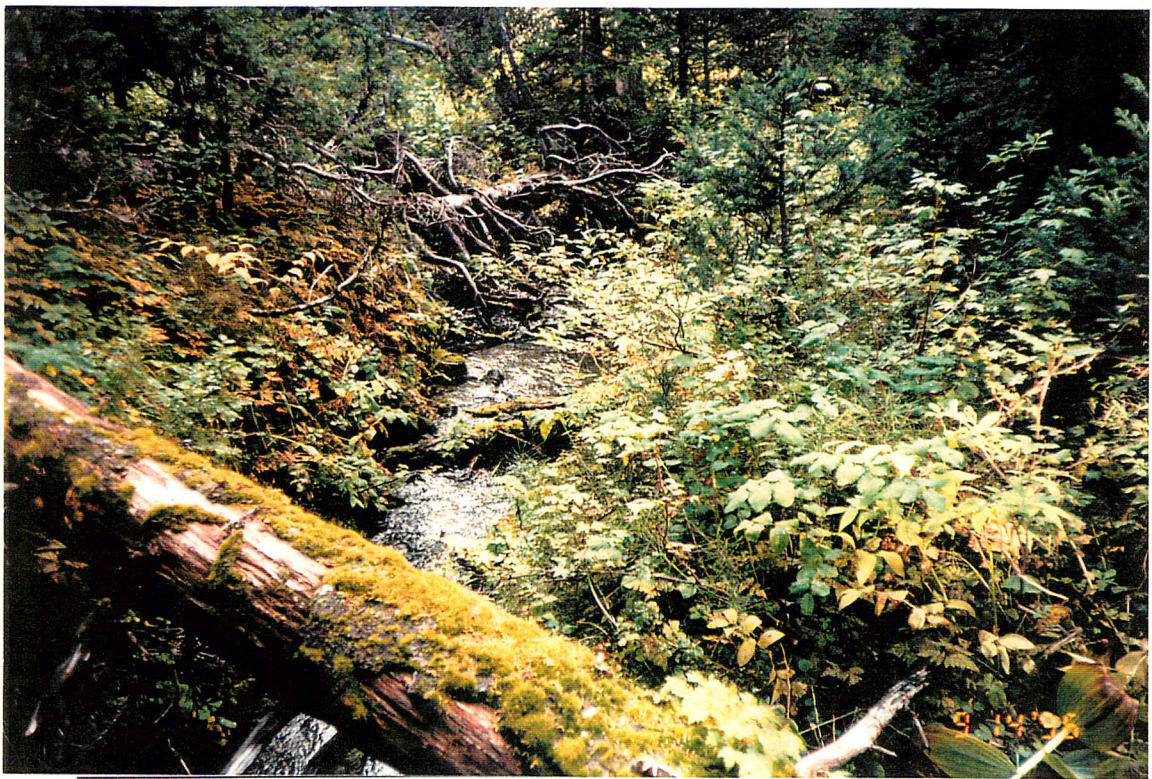
Photo #: A-4-8, 14-Sep-96  
Site #: A26, mossy log across channel.

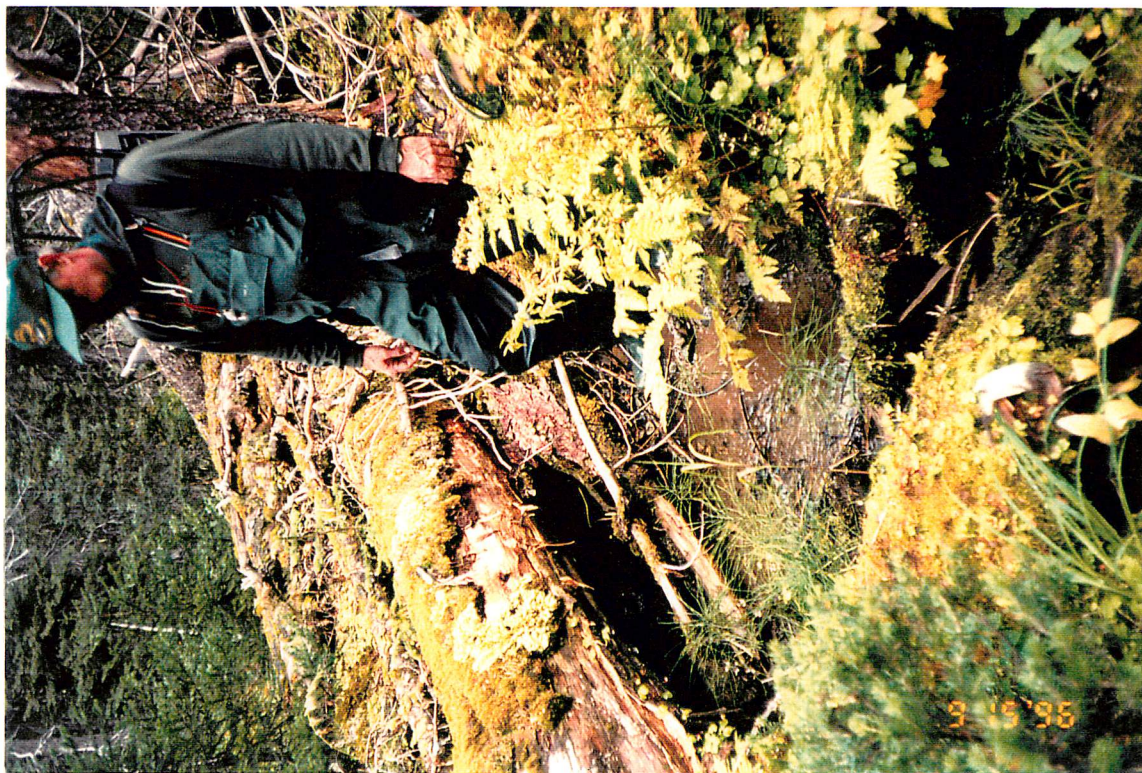
Photo #: A-4-12, 15-Sep-96

Site #: A28, There are falls at the mouth of the tributary.

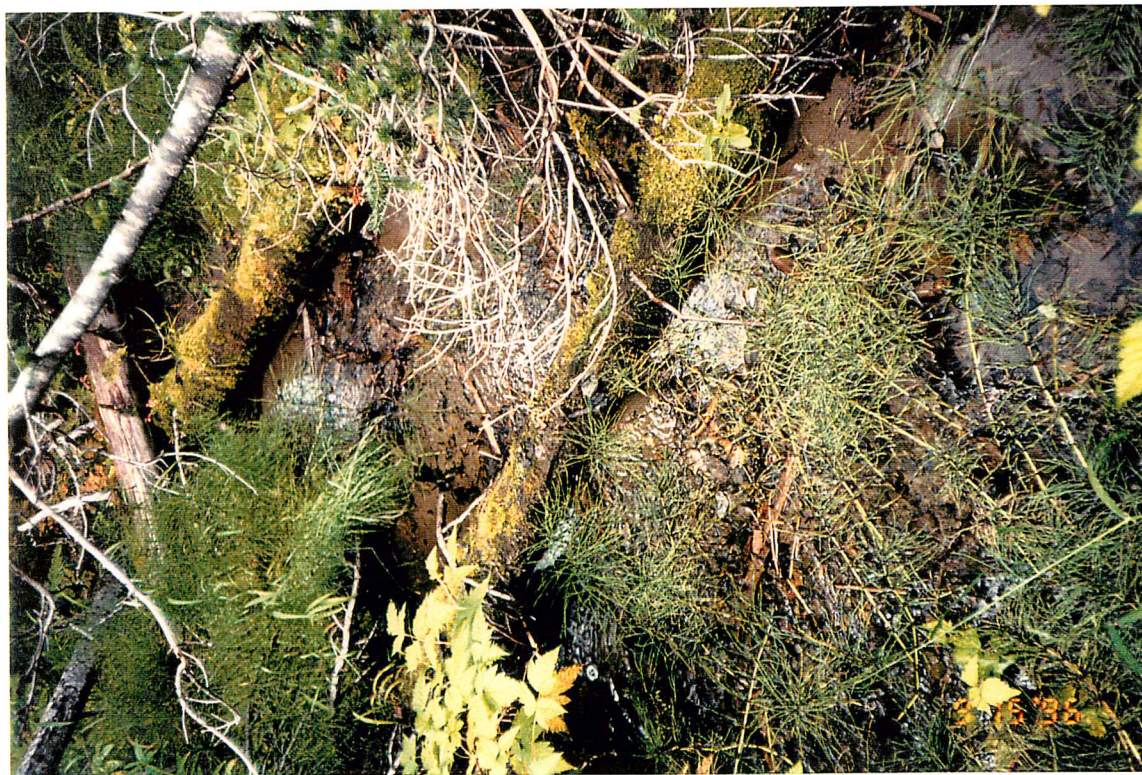
Photo #: A-4-13, 15-Sep-96

Site #: A28, Wood debris over fine substrate..

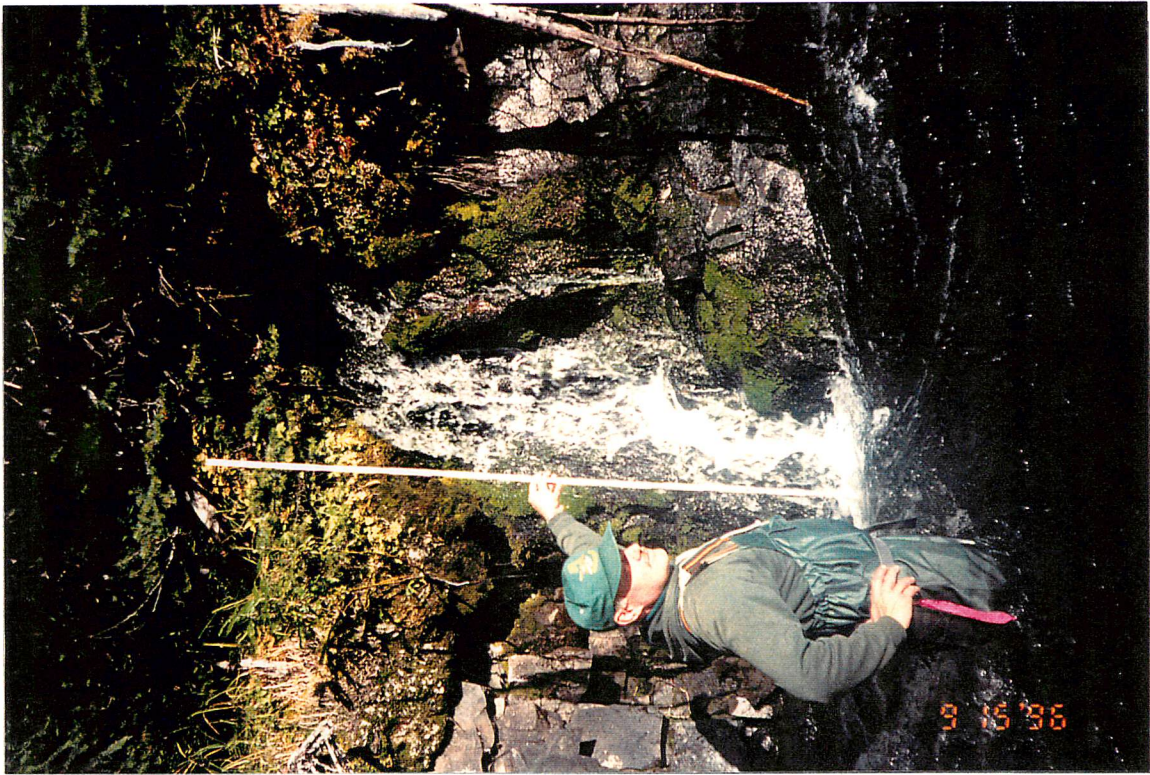
Photo #: A-4-14, 15-Sep-96  
Site #: A28, Falls at mouth of creek.

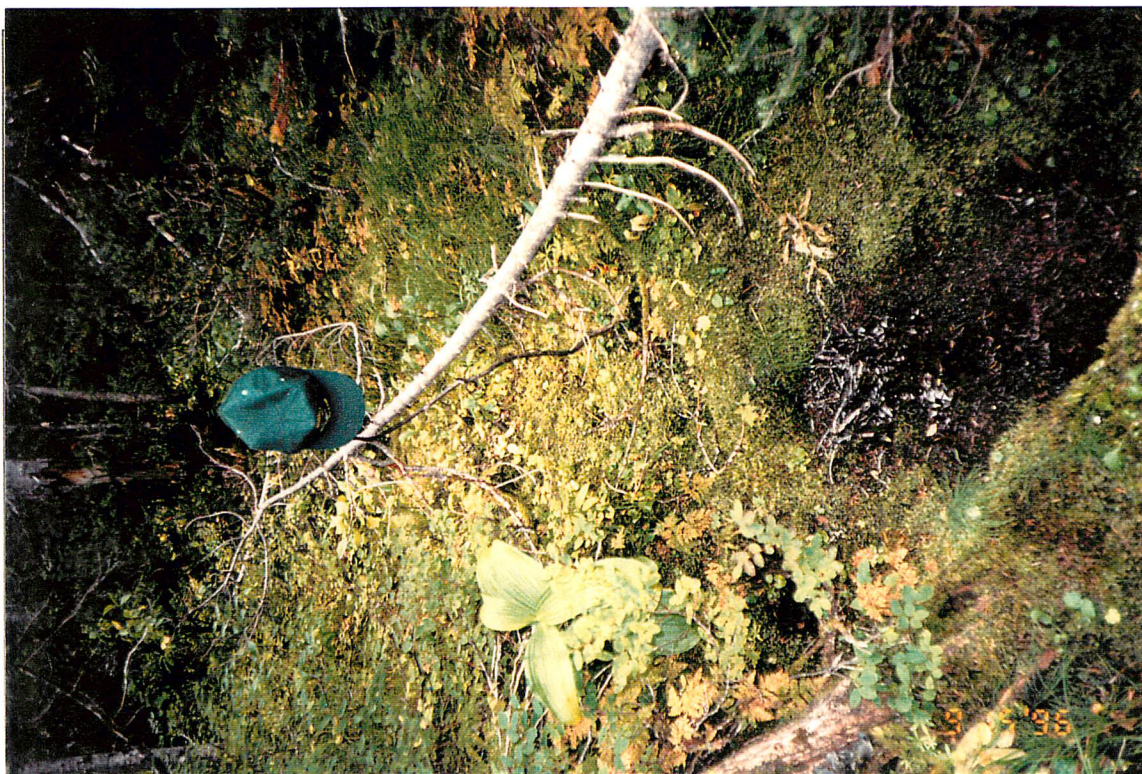
Photo #: A-4-15, 15-Sep-96

- C1 NC. This site MUST be groundtruthed to confirm the absence of a seasonally wet channel channel.  
C2 The side slopes were not measured.  
C4 This site was not electrofished.  
C5 Lat N 56 04' 53.4", Long W 127 42' 35"  
C6 Bank texture not applicable.  
C7 Water quality not applicable.  
C8 A defined channel was not observed.

Site #: A29, Not a creek due to a lack of defined channel..

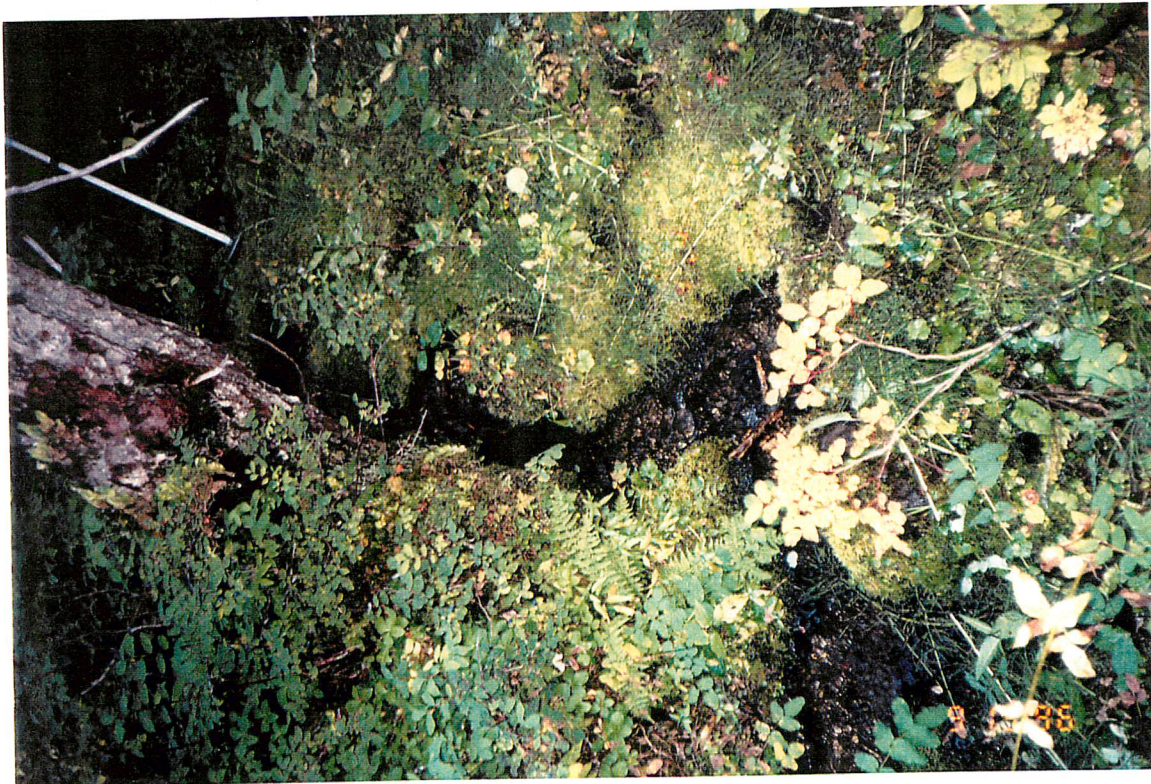
Photo #: A-4-17, 15-Sep-96  
Site #: A30, Small channel at base of tree..

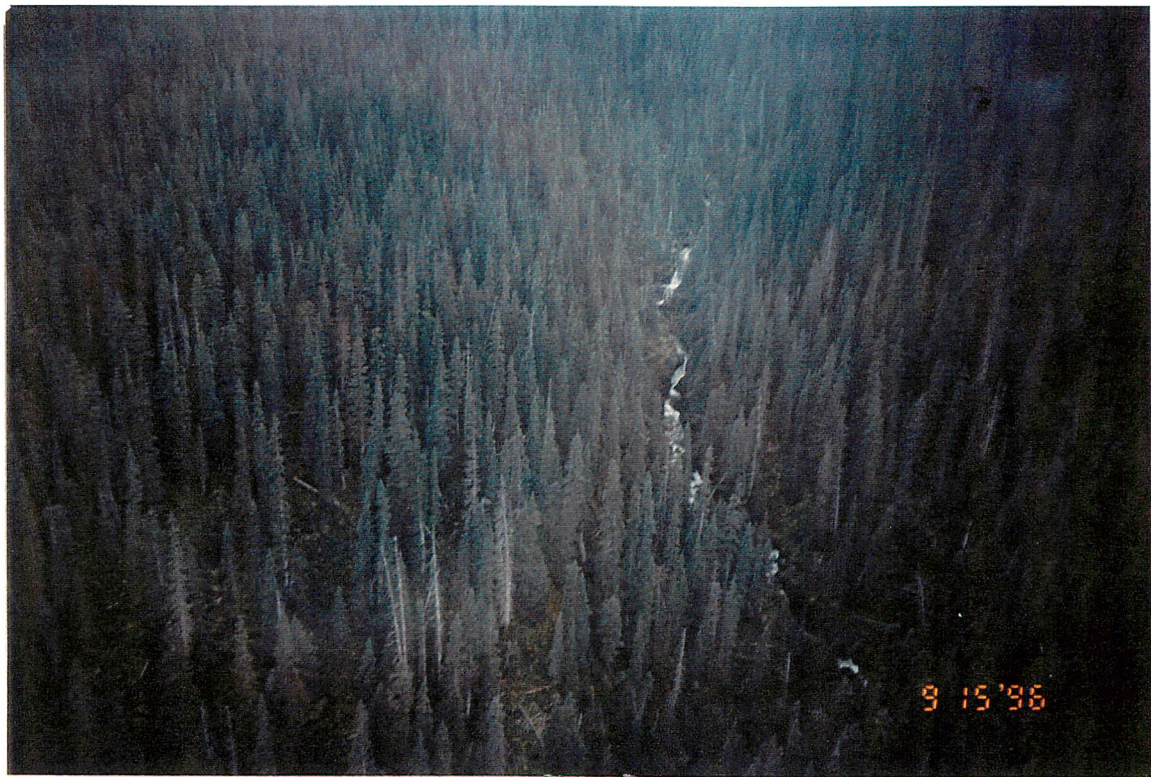
Photo #: B-5-4, 15-Sep-96

Site #: B39, Aerial view of falls located downstream of site.

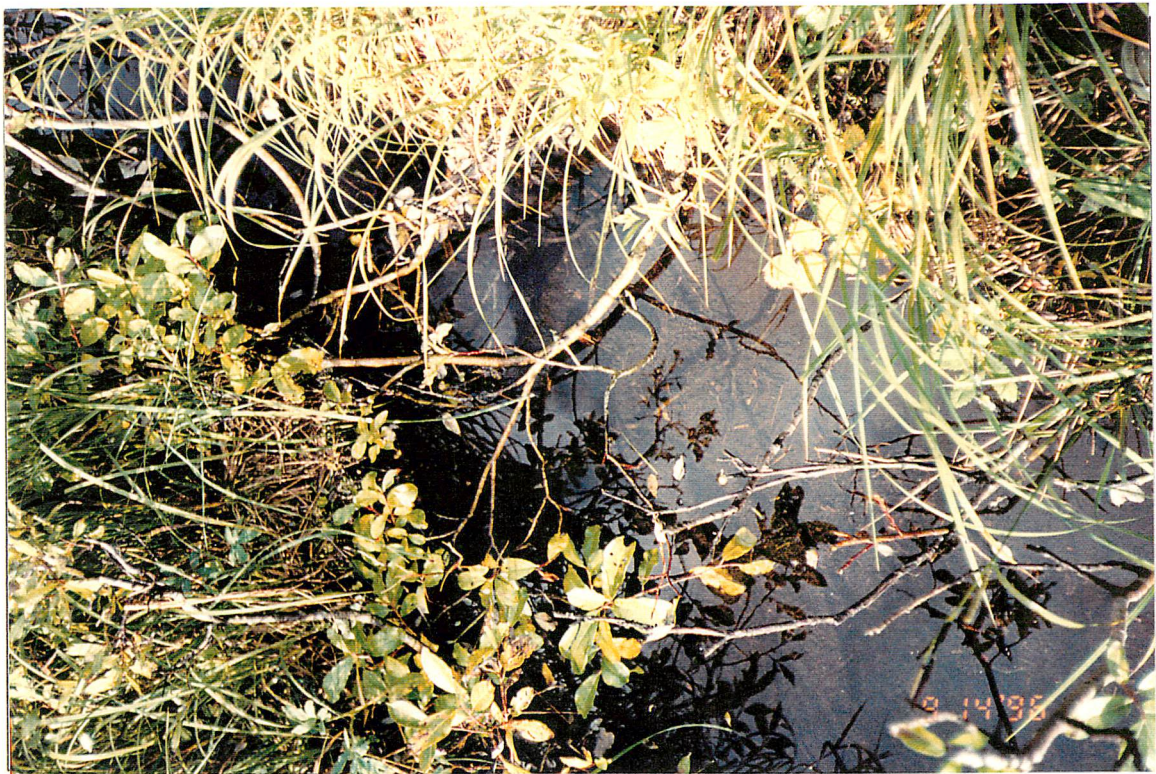
Photo #: A-3-21, 14-Sep-96  
 Site #: B28, Grass and willows, fine substrate.

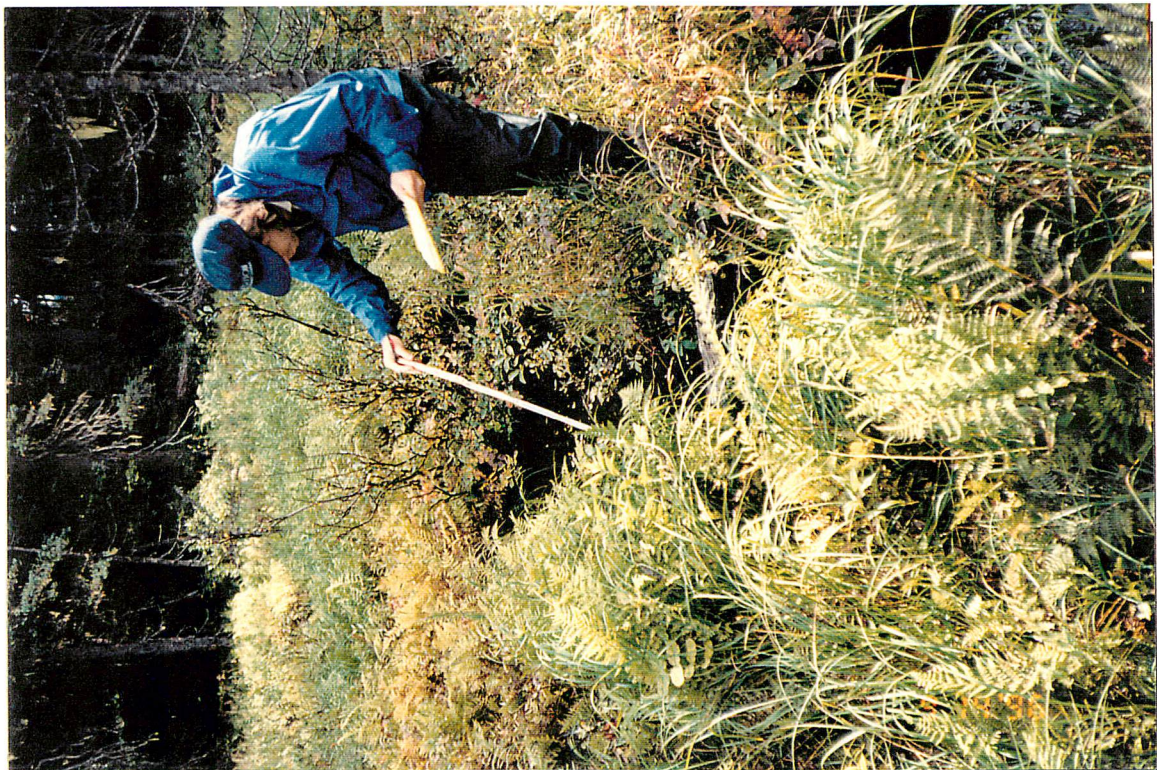
- C1 S4  
C2 LS = 11%, RS = 0%  
C3 No fisheries sensitive zones were noted at this site.  
C4 The electroshocking effort, using a 12 B POW model, was 86 seconds over 50 meters.  
C5 Lat N 55 58' 05.7", Long W 127 43' 53.5"  
C6 No additional bank texture information.  
C7 DO was not measured at this site  
C8 Very marginal rearing habitat was observed in the area. Perhaps it could be used for rearing and as such future sampling is recommended to determine the presence or absence of fish at this site.  
C9 Cascades at the confluence of this tributary and Shedin Cr. may prevent passage of fish upstream.  
C10 The air temperature at this site was 8 degrees celcius.

Photo #: A-3-22, 14-Sep-96  
 Site #: B28, Very marginal rearing habitat..

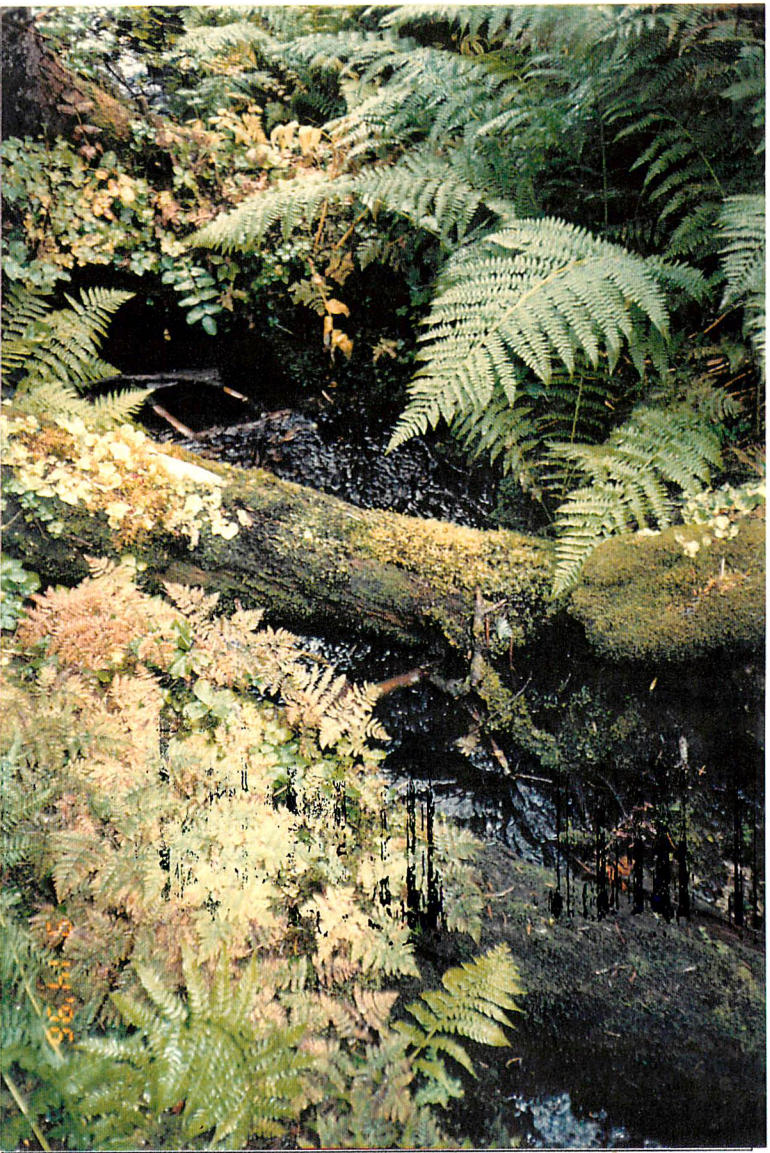
Photo #: A-3-18, 14-Sep-96  
Site #: B27, Looking upstream, 2 logs across creek.

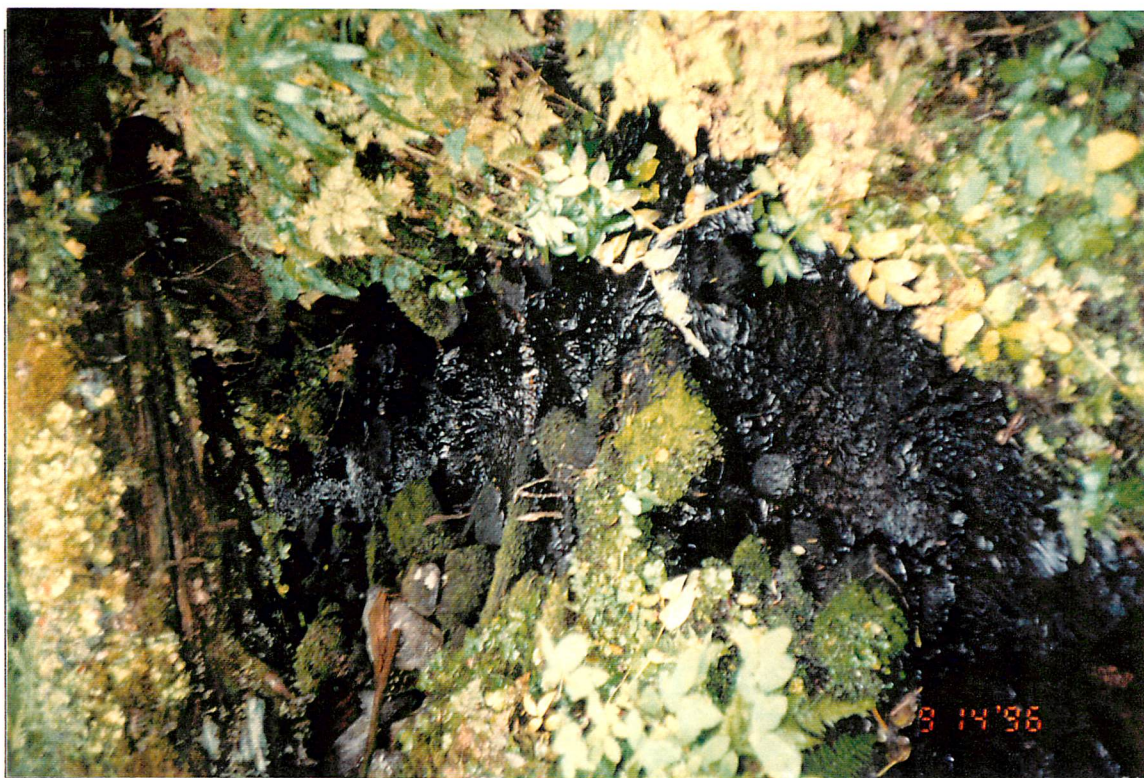
Photo #: A-3-20, 14-Sep-96

Site #: B27, Looking upstream, moss-covered log across channel..

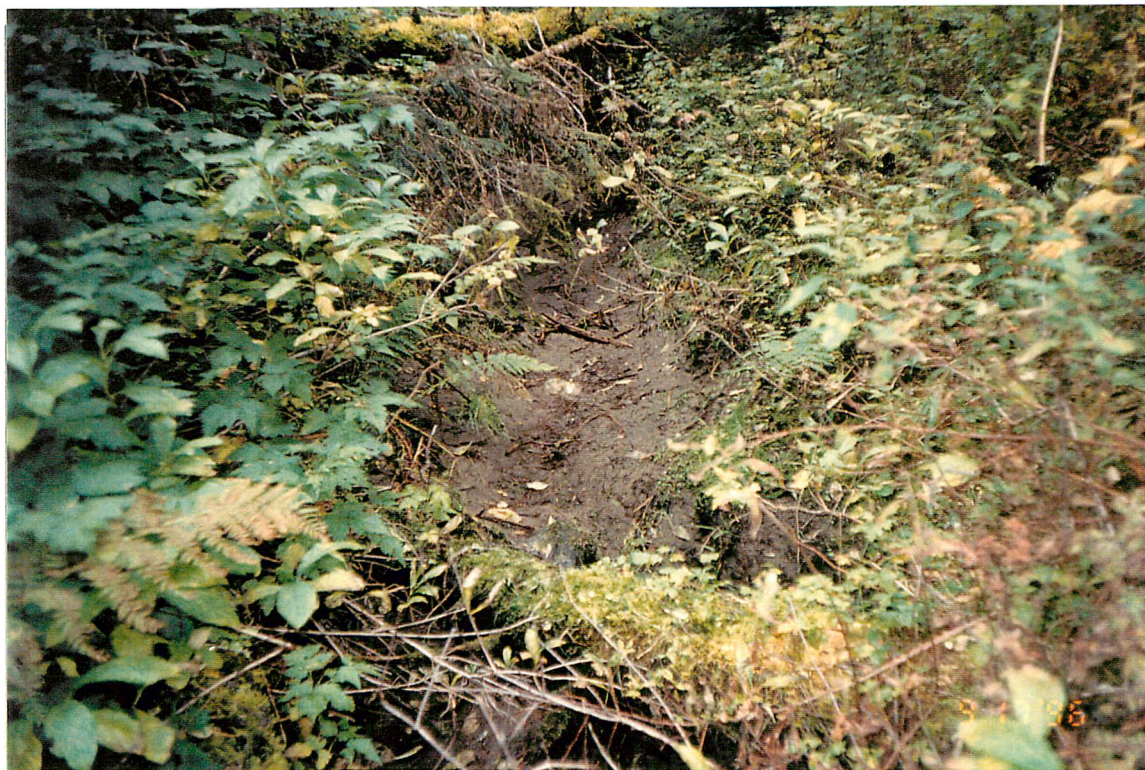
Photo #: B-6-17, 17-Sep-96  
Site #: B50, Dry channel near Shedrin Creek.

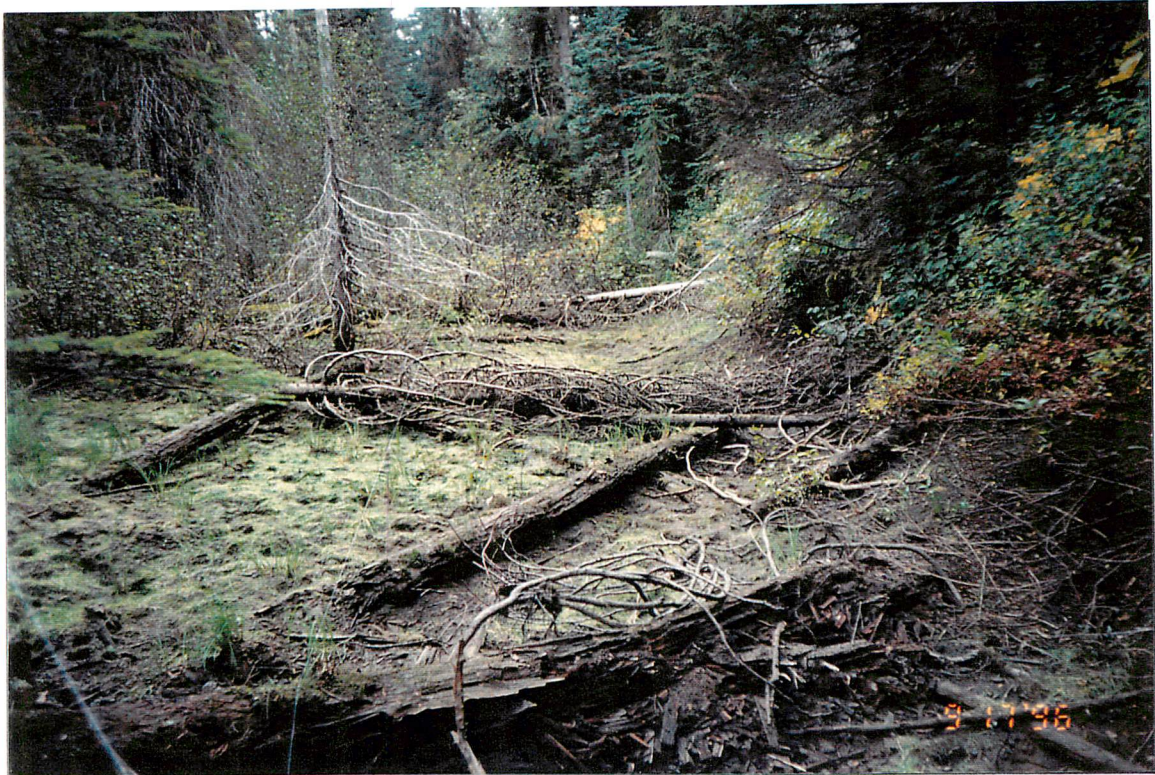
Photo #: B-6-19, 17-Sep-96

Site #: B51, Area appears to have contained standing water in the past.

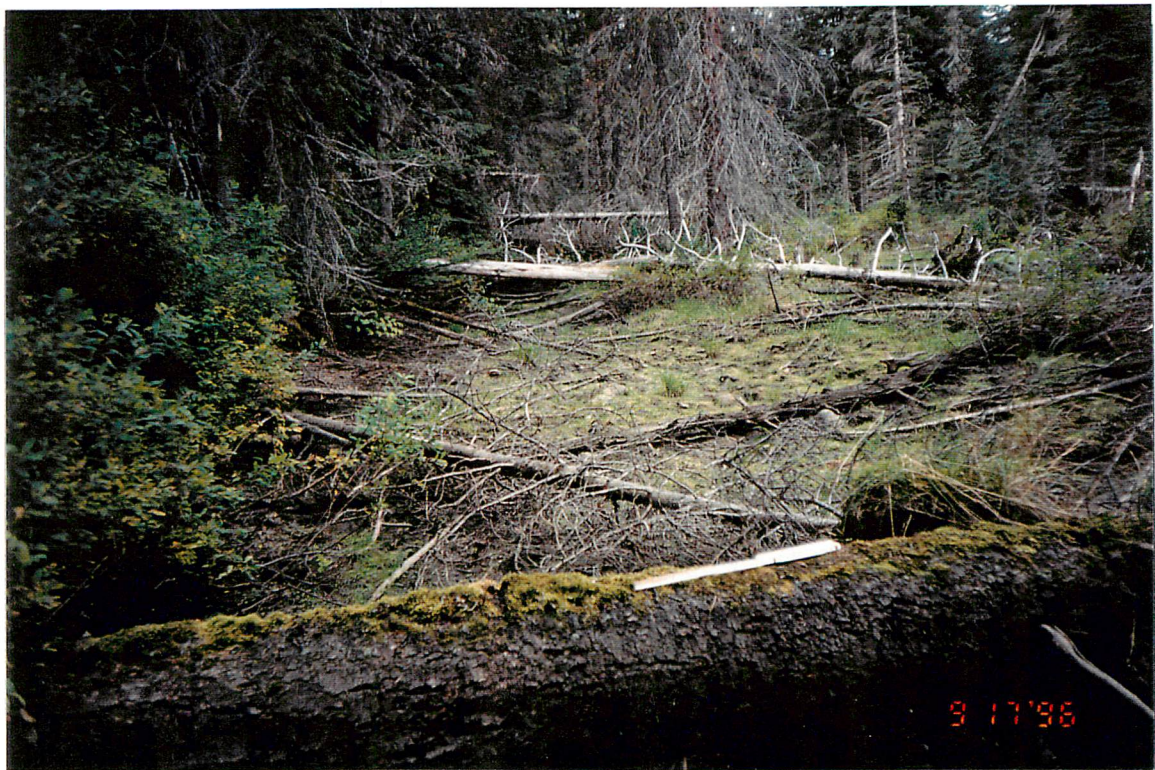
Photo #: B-6-18, 17-Sep-96

Site #: B51, Channel only marginally defined.

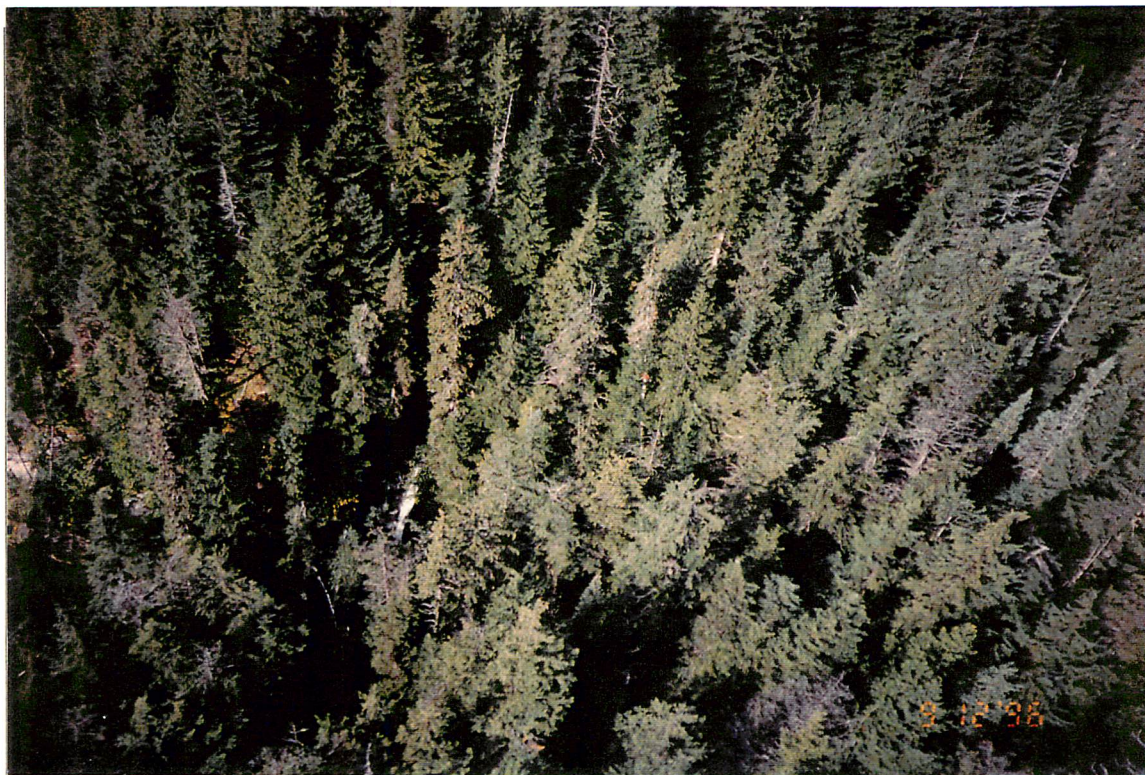
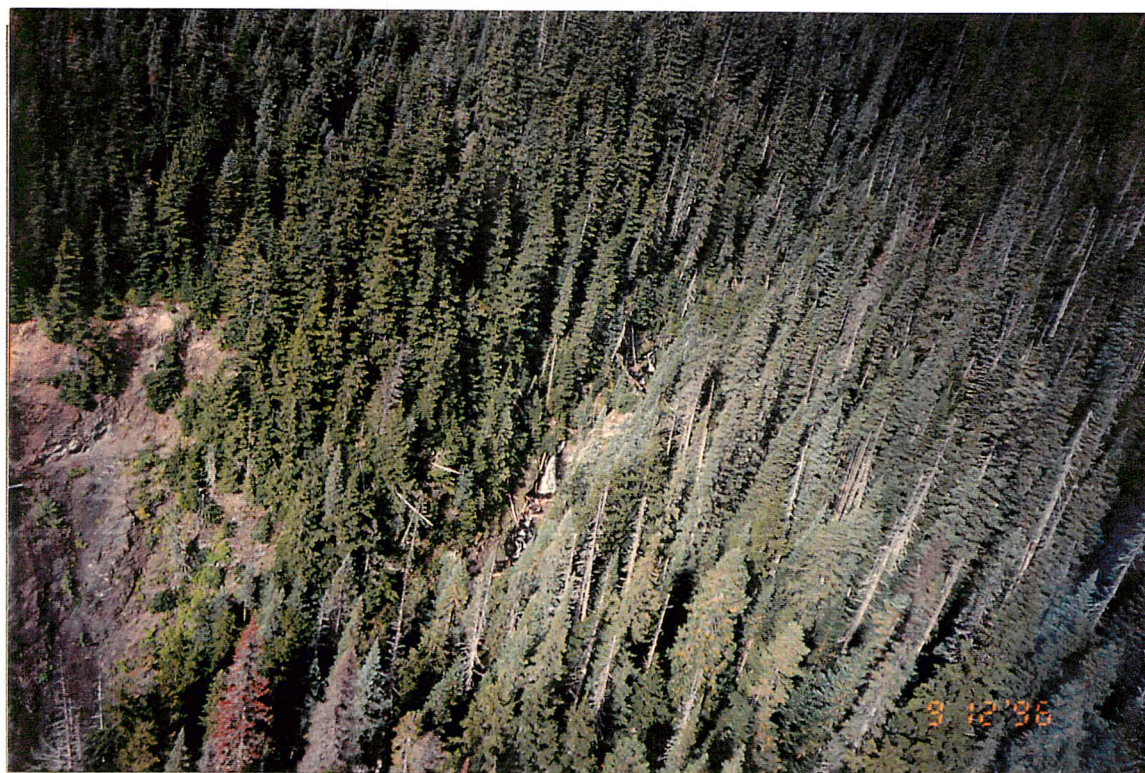
The main tributary sampled at B13 was classified as S5 due to presence of the impassable barrier and lake of overwhelming habitat. The other tributaries noted were all too steep (>30%) to support fish populations.

- C1 S5  
C2 LS = 60%, RS = 60%  
C3 No fisheries sensitive zones were noted at this site.  
C4 The electroshocking effort, using a 12 B POW model, was 764 seconds over 440 square meters. The lake upstream of this site was minnow trapped and no fish were caught.  
C5 Lat N 55 51' 35.3", Long W 127 56' 16"  
C6 No additional bank texture information.  
C7 DO was not taken at this site.  
C8 The steep gradient and 7 meter falls would prevent fish access into this stream from Kuldo Creek. A resident population may be present upstream of the barrier system. However, overwintering habitat may be insufficient at this site, hence the S5 classification. Future sampling above the barrier system is recommended.  
C9 The air temperature at this site was 15.5 degrees celcius.

Photo #: B-2-21, 12-Sep-96  
Site #: B13, Falls from air.

Photo #: B-2-22, 12-Sep-96  
Site #: B13, Falls from air.

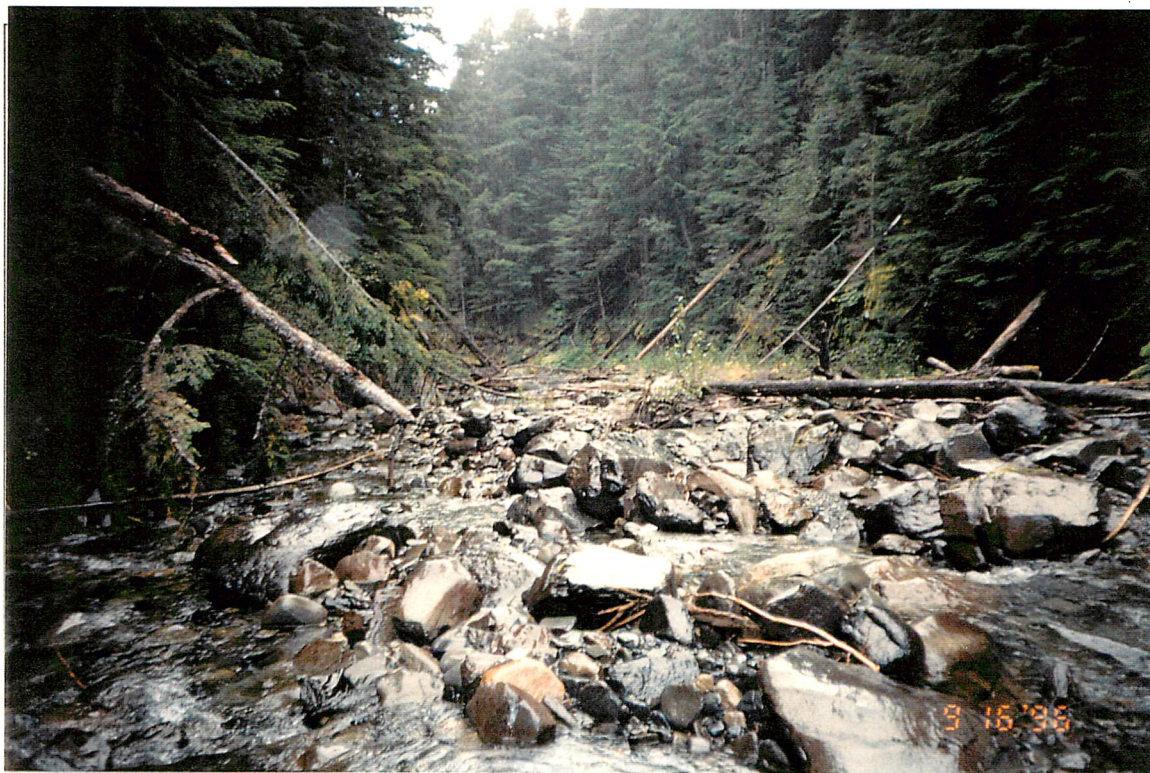
Photo #: B-6-2, 16-Sep-96  
Site #: B45, Downstream view, note high potential for debris transport.

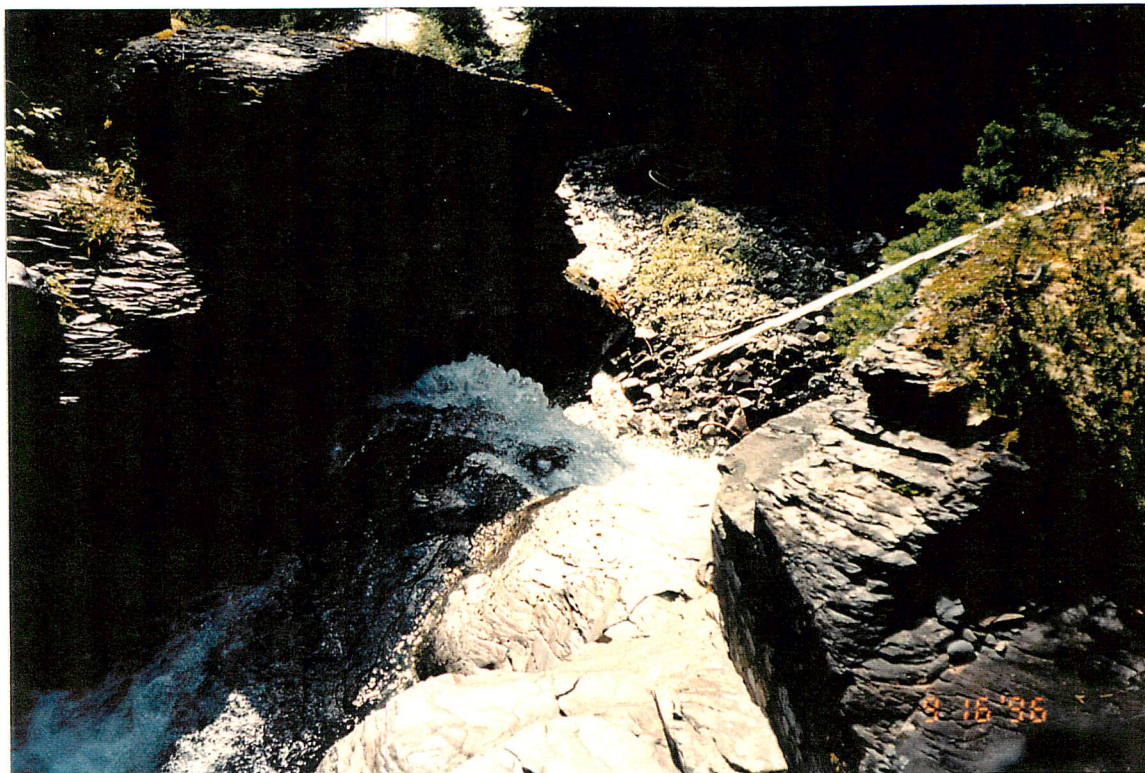
- C1 S5  
C2 LS = 70%, RS = 70%  
C3 No fisheries sensitive zones were noted at this site.  
C4 The electroshocking effort, using a 12 B POW model, was 543 seconds over 480 meters squared. This stream was sampled above a 10 meter falls.  
C5 Lat N 55 47' 05", Long W 127 41' 60"  
C6 No additional bank texture information.  
C7 DO and conductivity were not measured at this site. The water was clear to the bottom.  
C8 There is a very low probability of the presence of a resident population above the 10 meter falls on this stream and as such this reach has been classified as non fish bearing. An additional 8 and 4 meter cascade was also noted.  
C9 There are large sections of exposed bedrock in this reach, over which water sheets. This site was sampled just above the falls. The crew walked down to a 10 m falls and took a photo and a GPS Lat N 55 46' 58", Long W 127 41' 59.6"  
C10 The air temperature at this site was 7 degrees celcius.

Photo #: B-5-18a, 16-Sep-96  
Site #: B43, Looking down on 10 m falls, meterstick on ledge.

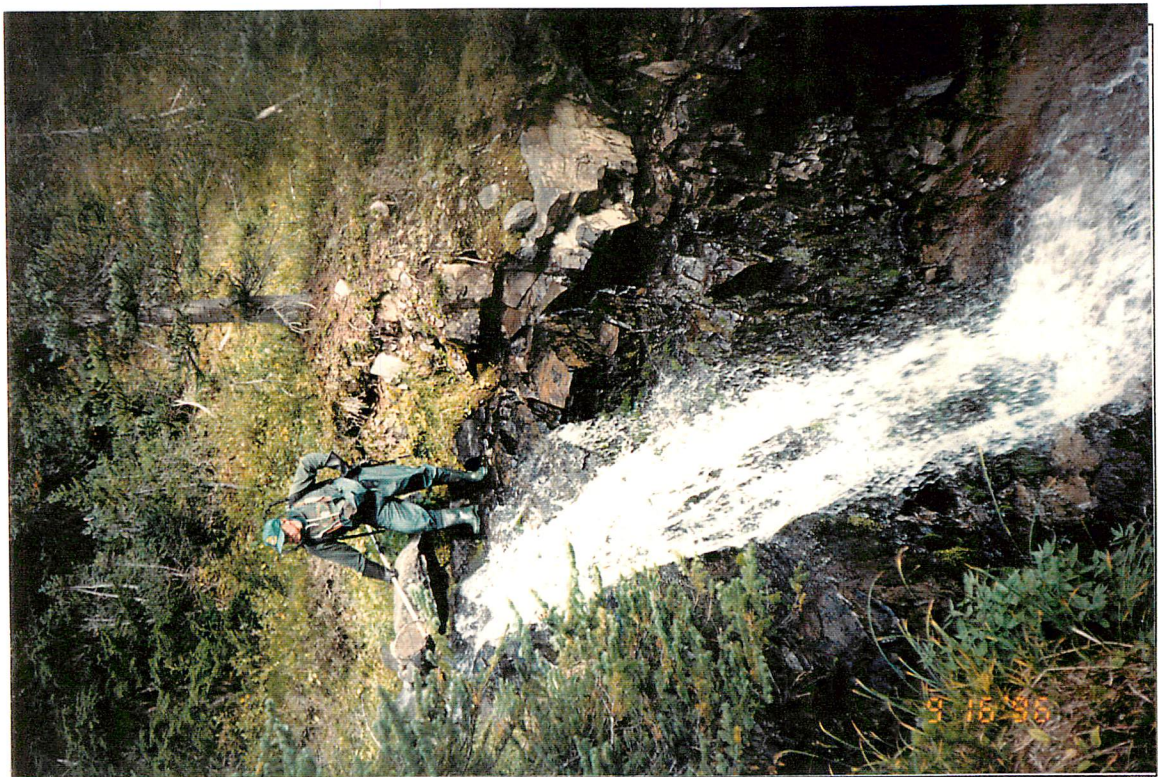
Photo #: B-5-17, 16-Sep-96

- C1 S5  
C2 LS = 50%, RS = 70%  
C3 No fisheries sensitive zones were noted at this site.  
C4 The electroshocking effort, using a 12 B POW model, was 746 seconds over 600 square meters.  
C5 Lat N 55 47' 06.5", Long W 127 41' 58.9"  
C6 No additional bank texture information.  
C7 DO and conductivity were not measured at this site. The water was clear to the bottom.  
C8 No additional fish habitat information.  
C9 The entire reach was sampled from the junction of B41 and the S5 creek. A 4 meter falls was noted 442 meters downstream from the junction of B41 and B42. Many fossils were noted in this area as well as some slightly unstable talus slopes.  
C10 A series of 1 meter cascades are scattered throughout this site. There are sections of exposed bedrock in this stream over which water runs in sheets. The 5m falls is located 115m from the mouth of this stream and the 4m falls is located 58m from the mouth of this stream. These falls, which would prevent fish access upstream, and the lack of overwintering habitat, have resulted in the classification of this reach as non fish bearing.

Site #: B42, 4 m falls that are a barrier to fish passage.

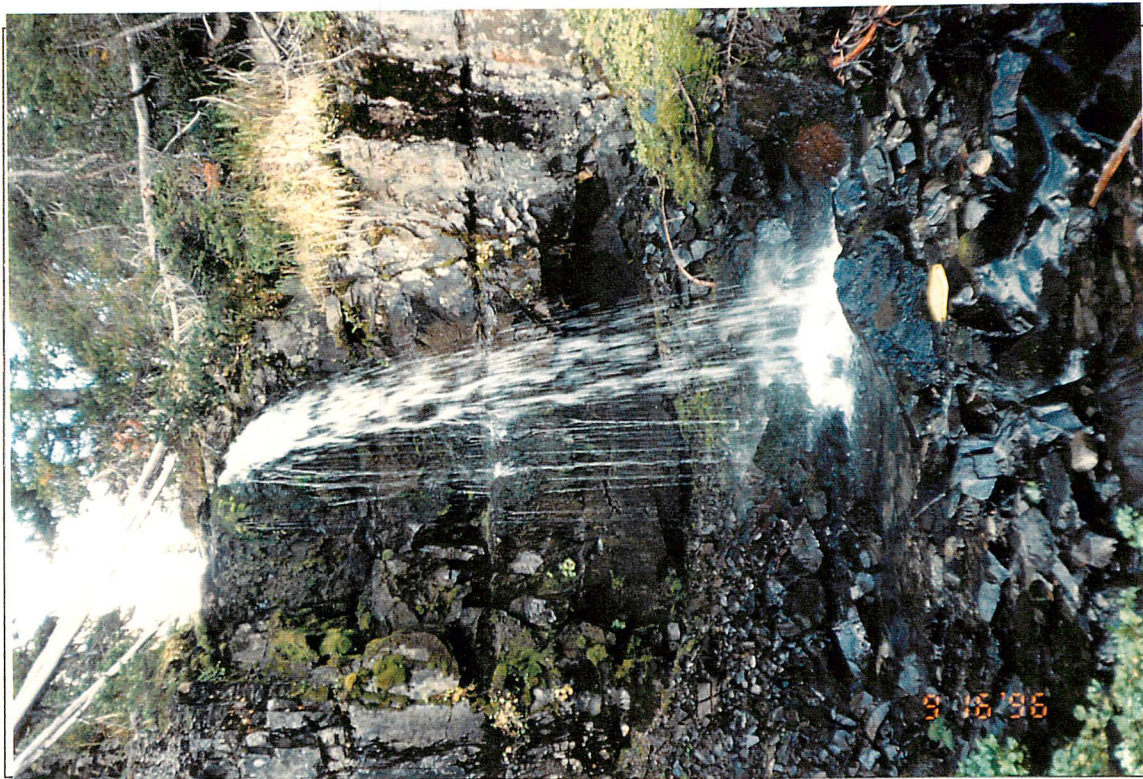
Photo #: B-5-14, 16-Sep-96

Site #: B41, Falls that serve as a barrier to fish passage.
