# Reconnaissance Level Fish and Fish Habitat Inventory for the Kispiox Forest District

*Prepared for:*

**Repap Smithers**

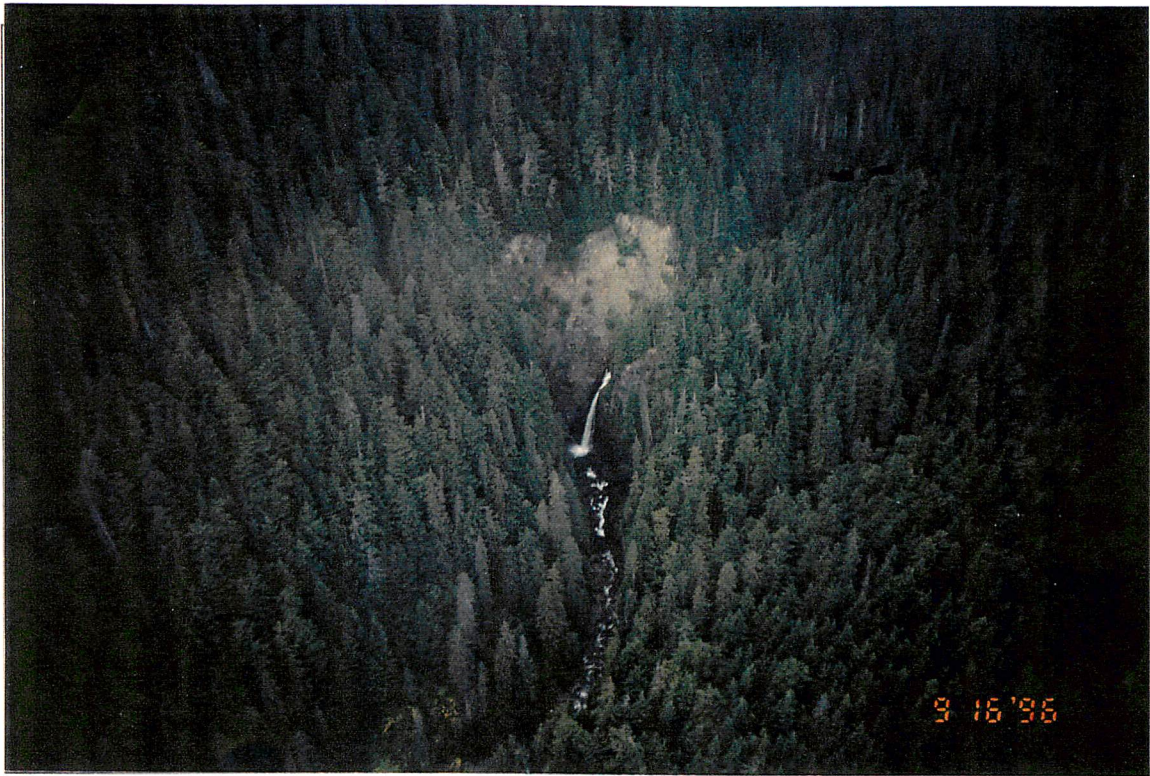
Photo #: B-5-24, 16-Sep-96

Site #: B44, Falls downstream which are a barrier to fish passage.

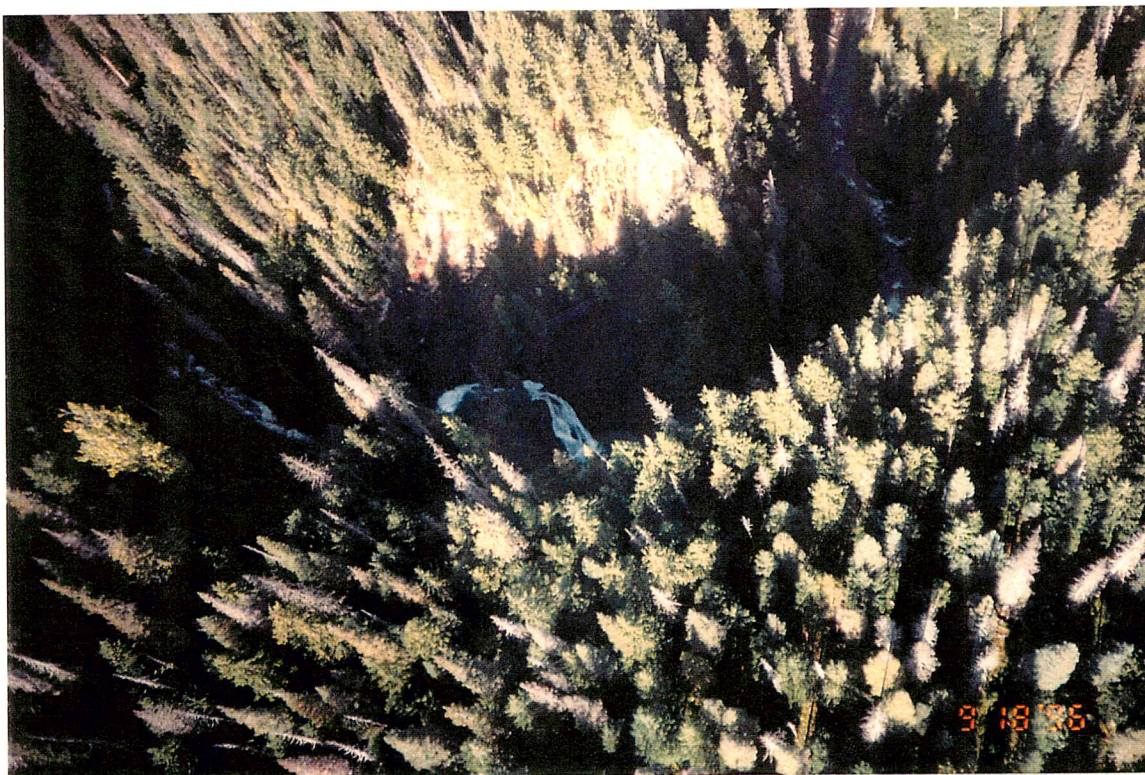
Photo #: A-6-22, 18-Sep-96  
Site #: A49, 10 m falls - downstream from site A49..

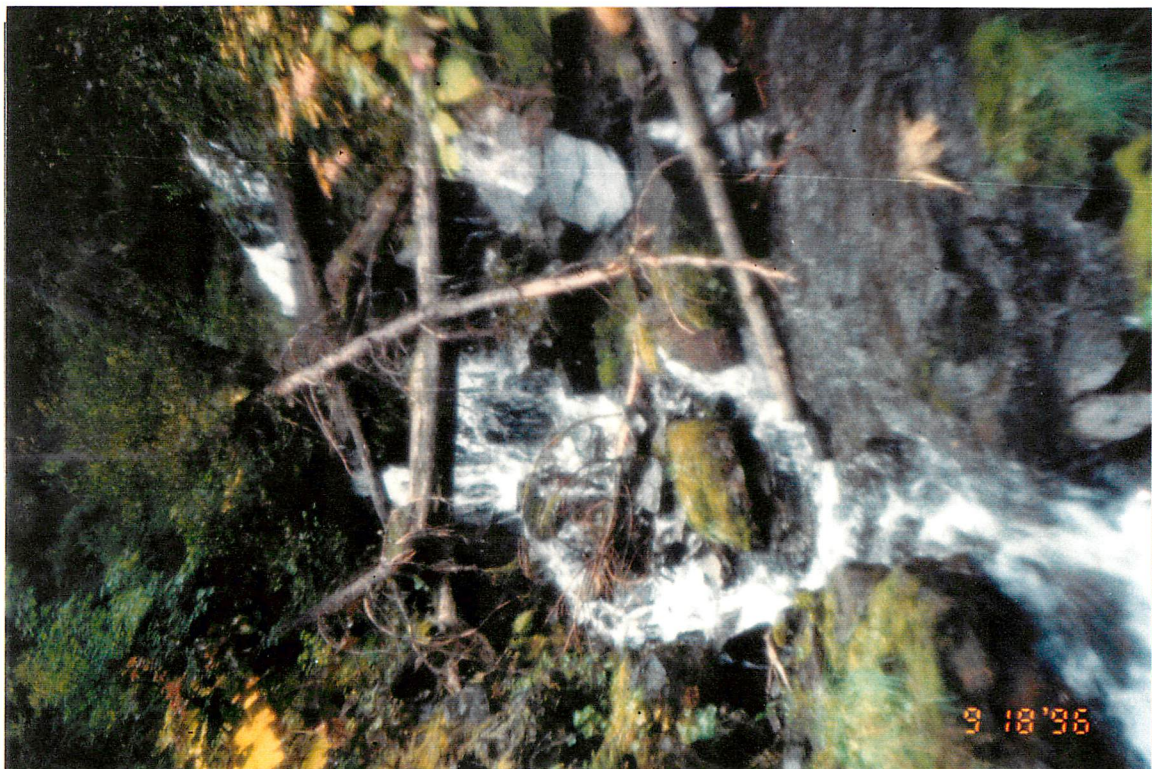
Photo #: A-6-18, 18-Sep-96  
Site #: A48, Cascade.

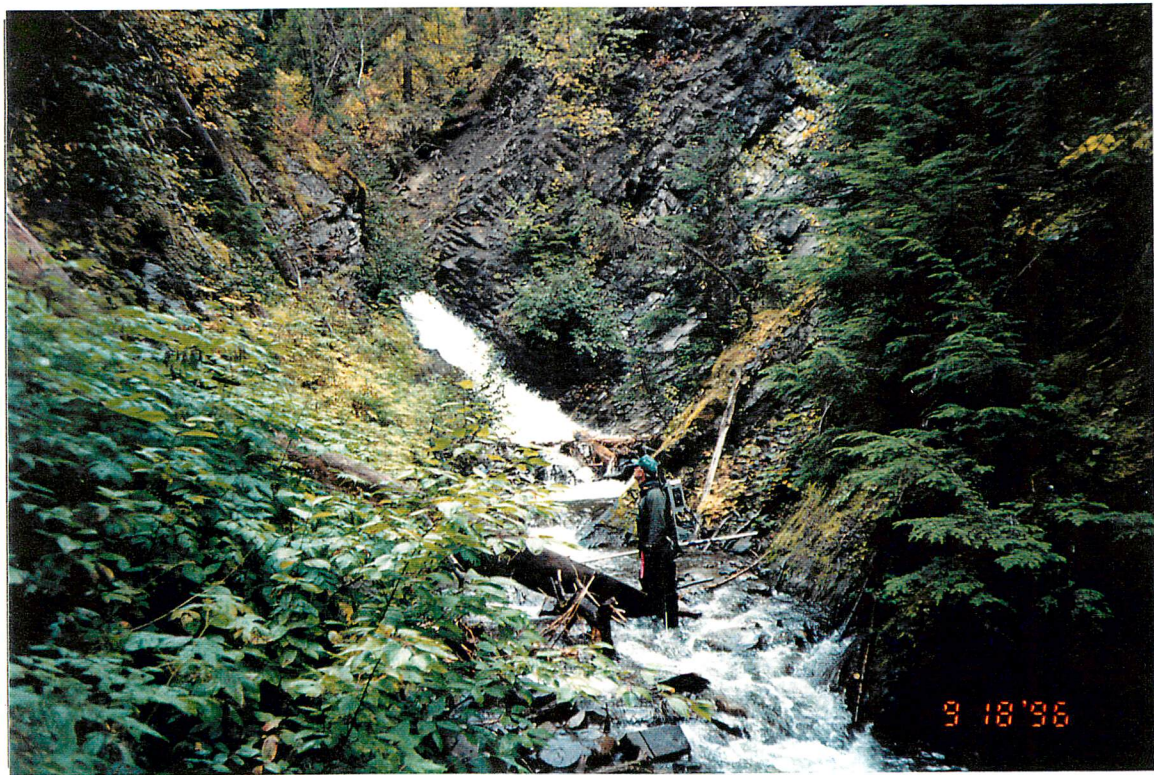
Photo #: B-7-1, 18-Sep-96  
Site #: B60, Cascades.

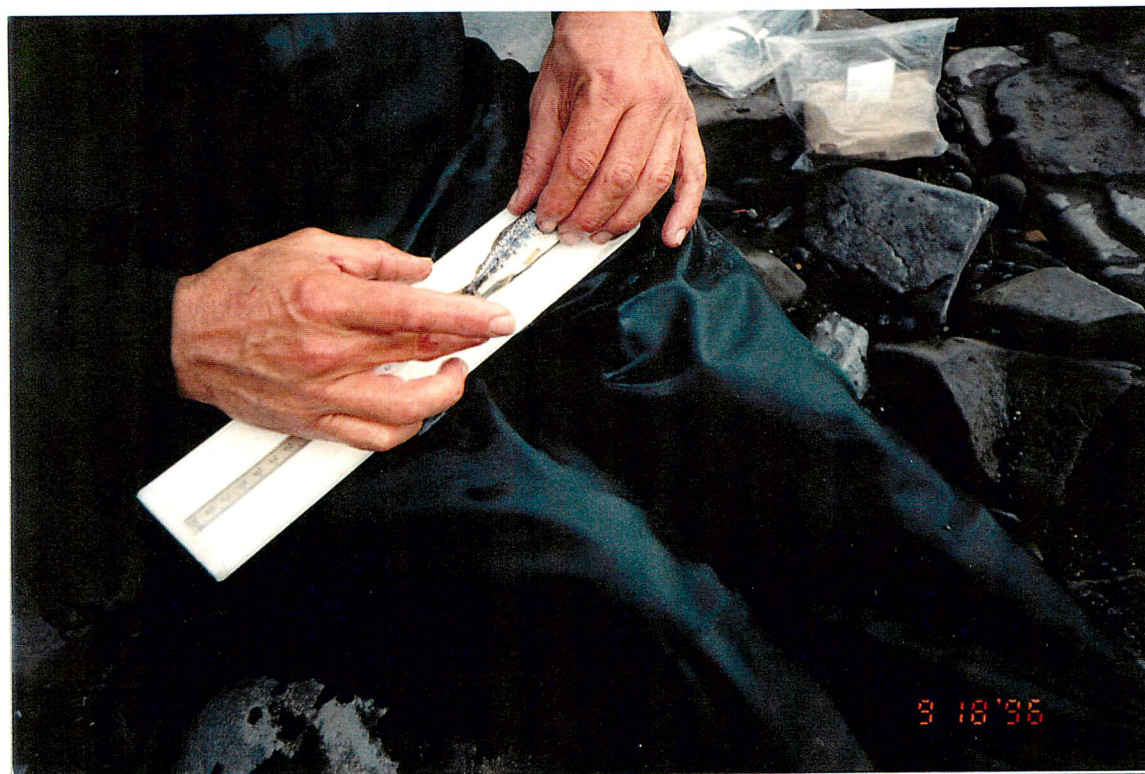
Photo #: B-7-2a, 18-Sep-96  
Site #: B60, Rainbow trout.

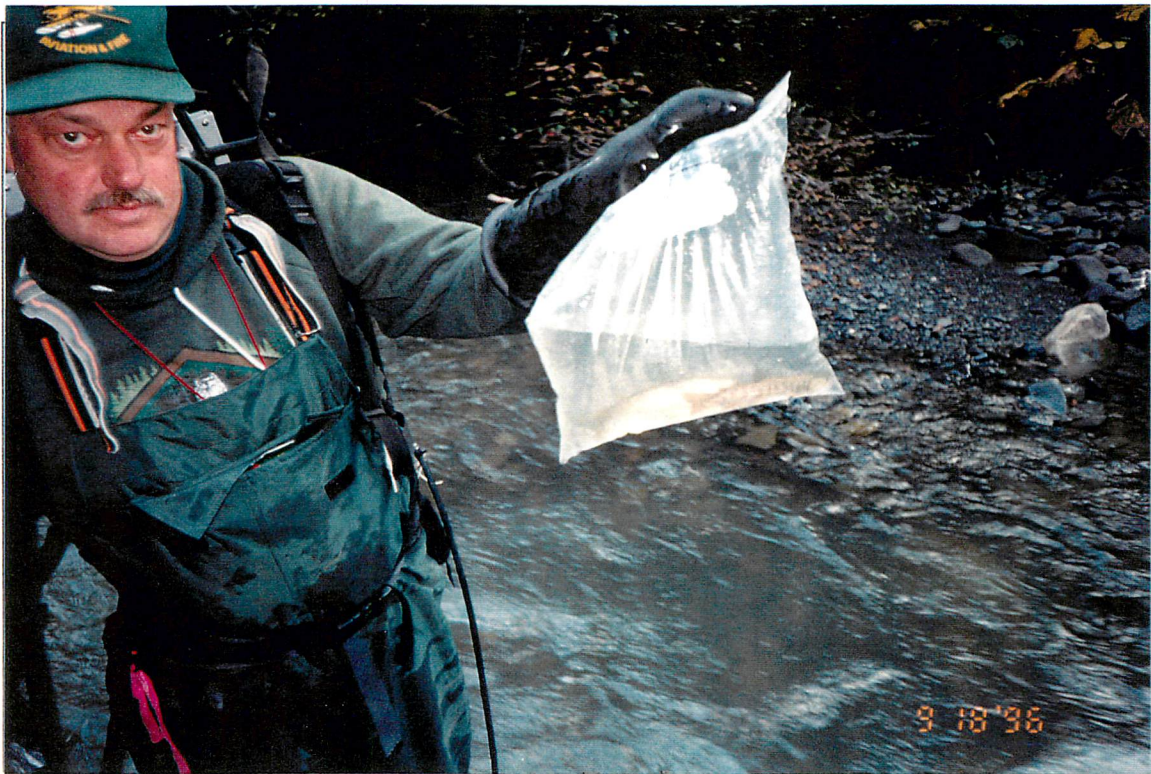
Photo #: B-7-15, 18-Sep-96  
Site #: B65, Rainbow trout captured by electrofishing.

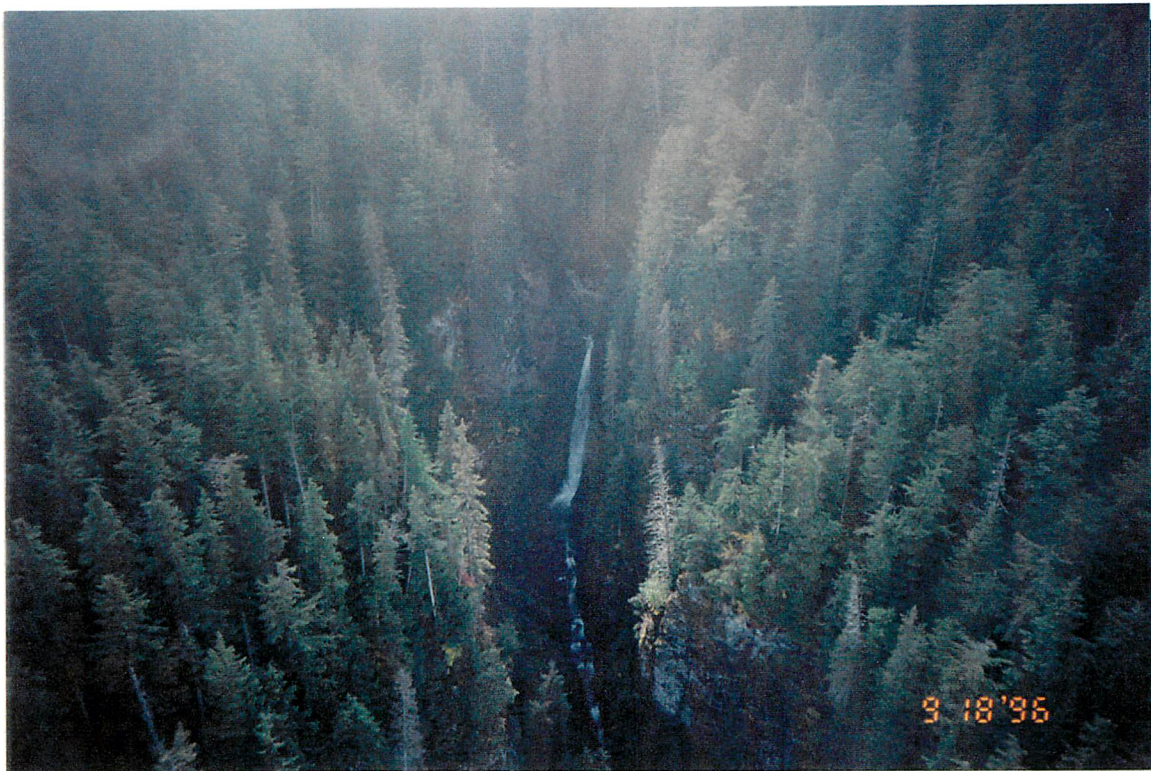
Photo #: B-7-16, 18-Sep-96  
Site #: B65, Barrier to fish passage that is upstream of site.

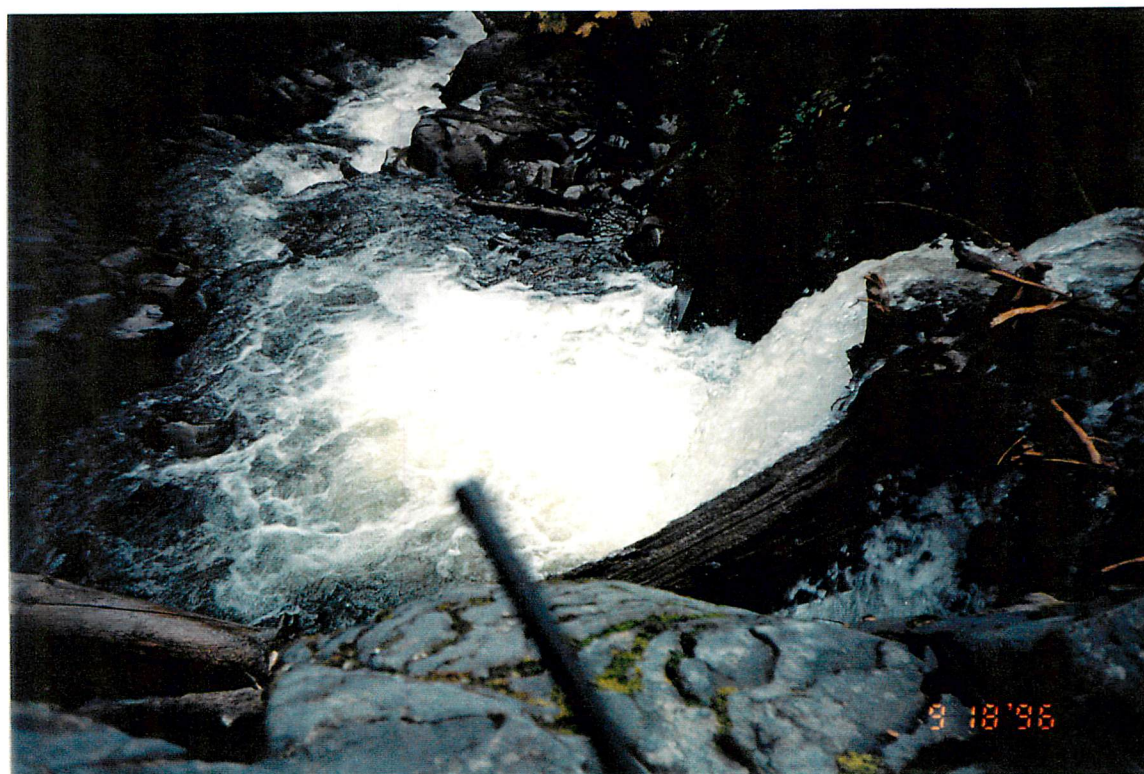
Photo #: B-7-11, 18-Sep-96  
Site #: B64, 3 m cascade.

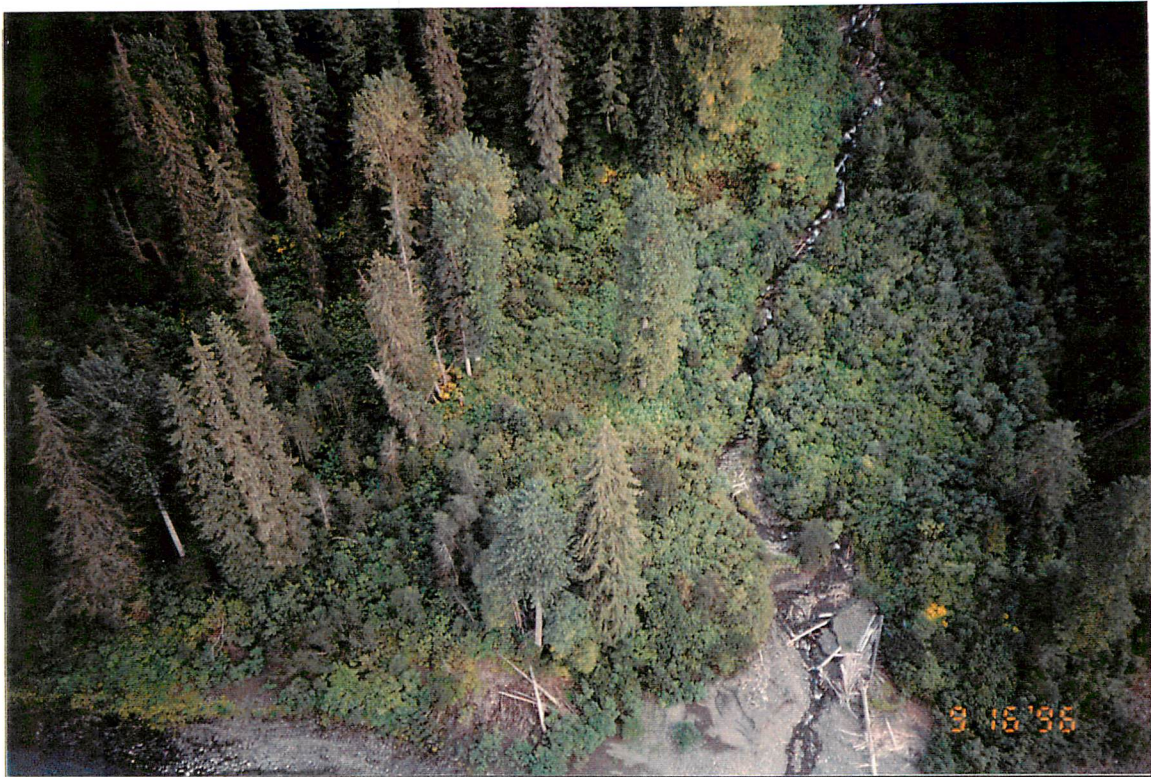
Photo #: B-6-7, 16-Sep-96  
Site #: B47, Aerial view of confluence with Skeena River.

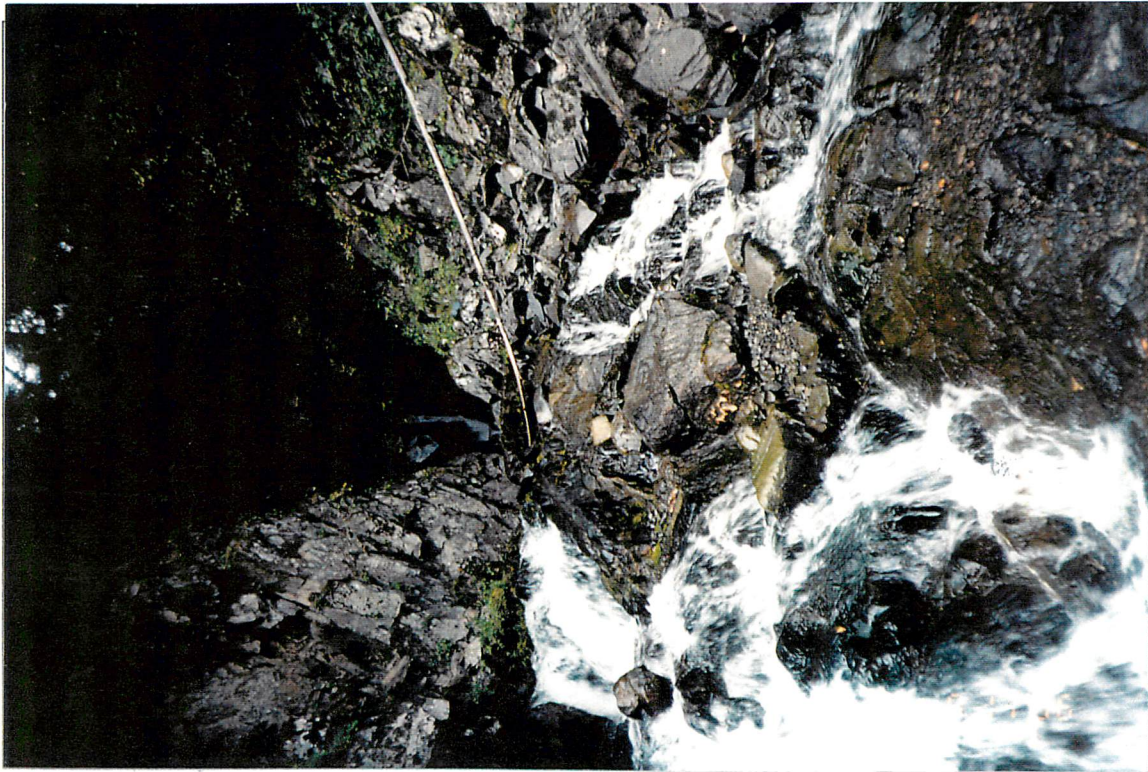
Photo #: B-6-21, 17-Sep-96

Site #: B58, Looking upstream at cascade and falls.

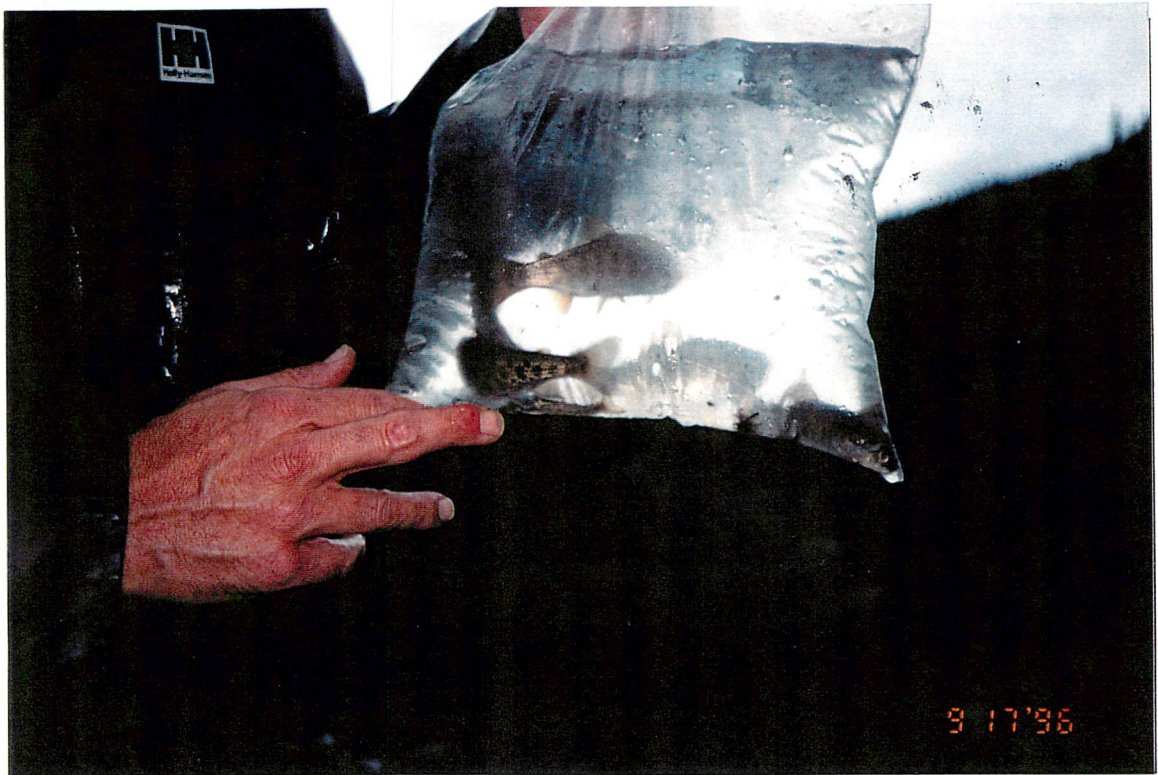
Photo #: B-6-25, 17-Sep-96  
Site #: B59, Rainbow trout in bag.

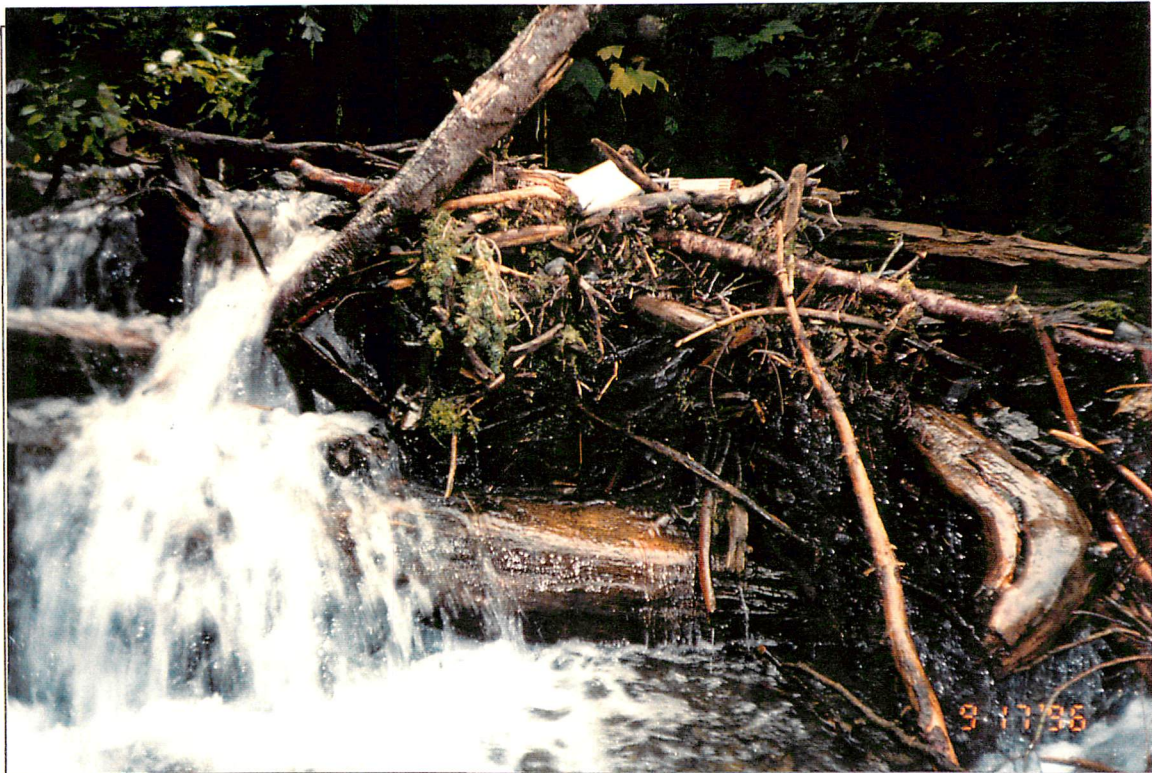
Photo #: A-6-8, 17-Sep-96  
Site #: A45, Log jam above cascade.

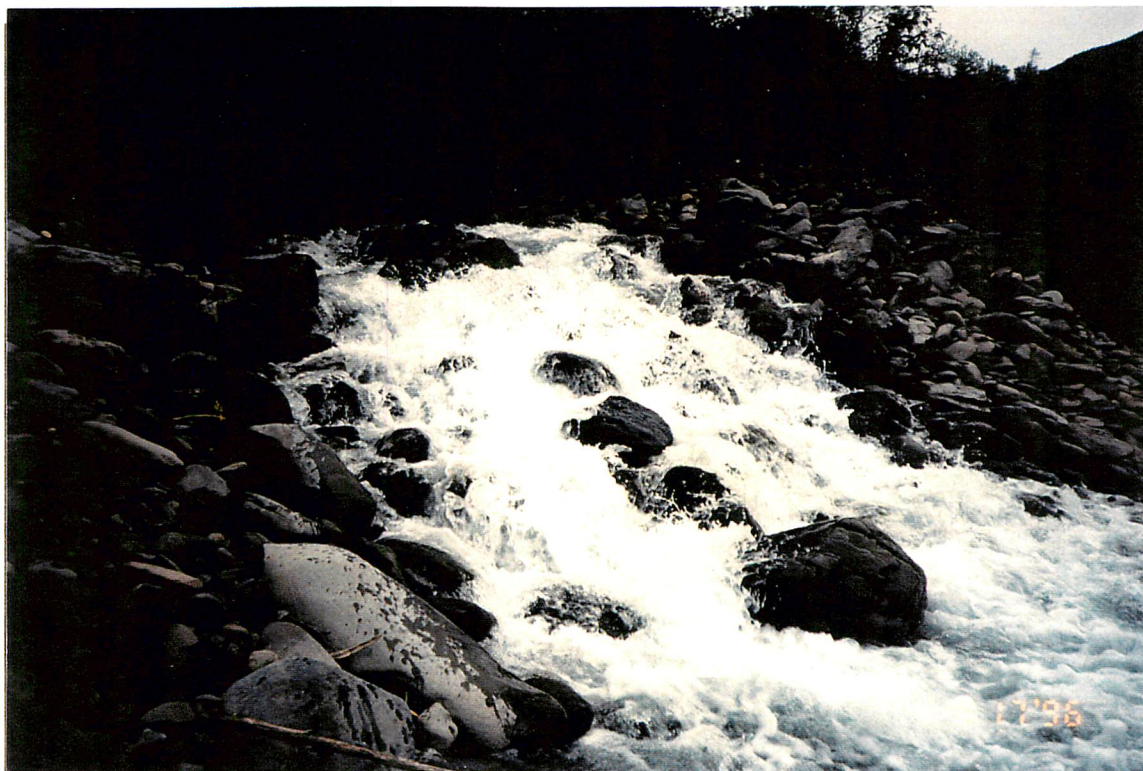
Photo #: A-6-5, 17-Sep-96

Site #: A44, Cascade at confluence which is not a barrier to fish passage.

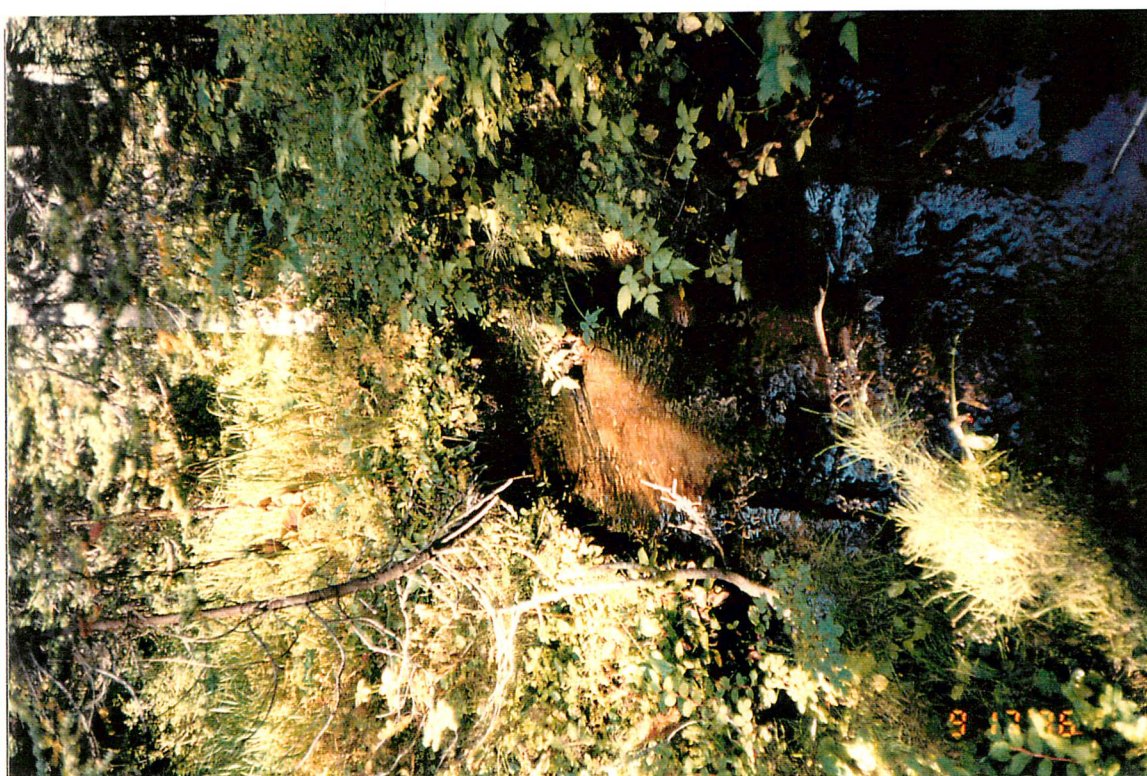
Photo #: A-6-2, 17-Sep-96  
Site #: A42, Potential rearing habitat.

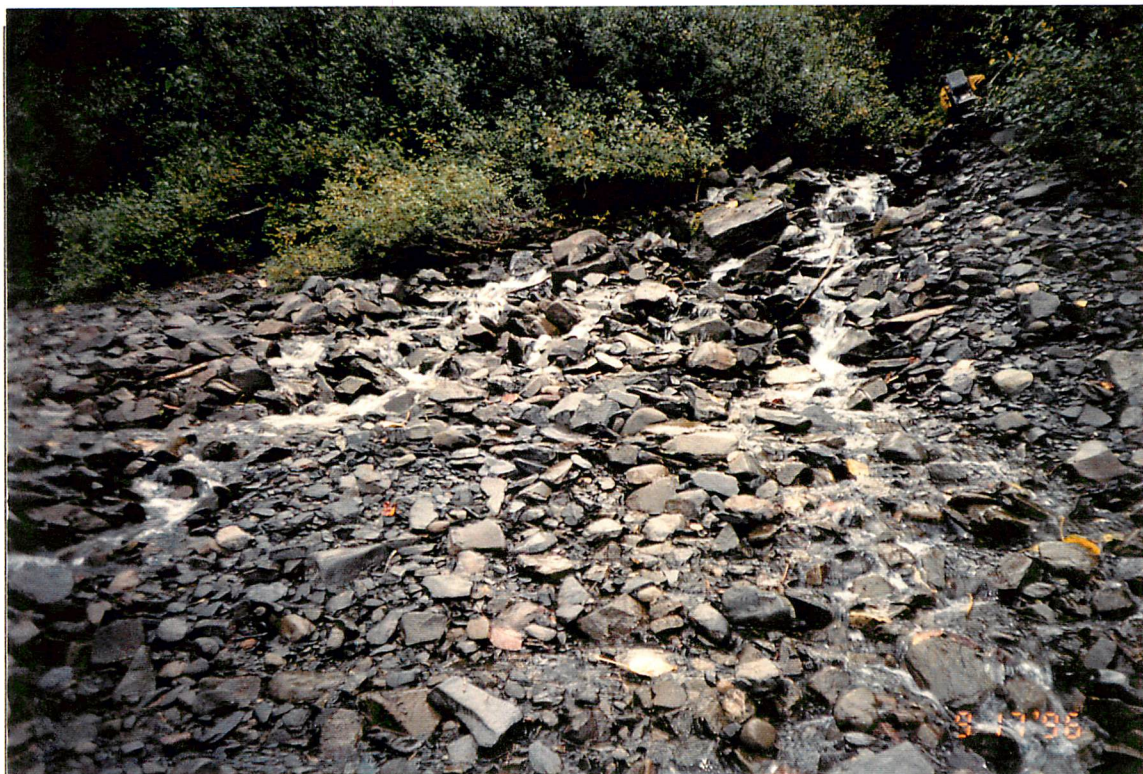
Photo #: A-6-10, 17-Sep-96  
Site #: A46, Sampling by electrofishing at confluence.

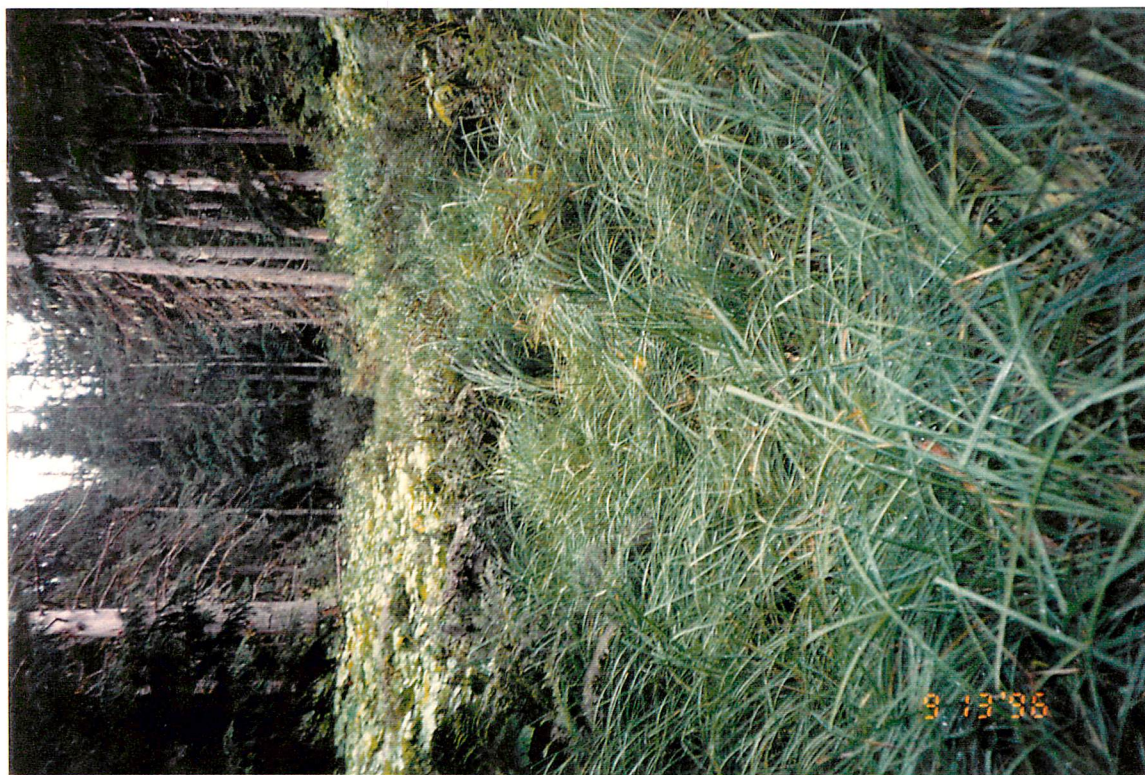
Photo #: B-3-7, 13-Sep-96  
Site #: B17, Channel ingrown with grasses.

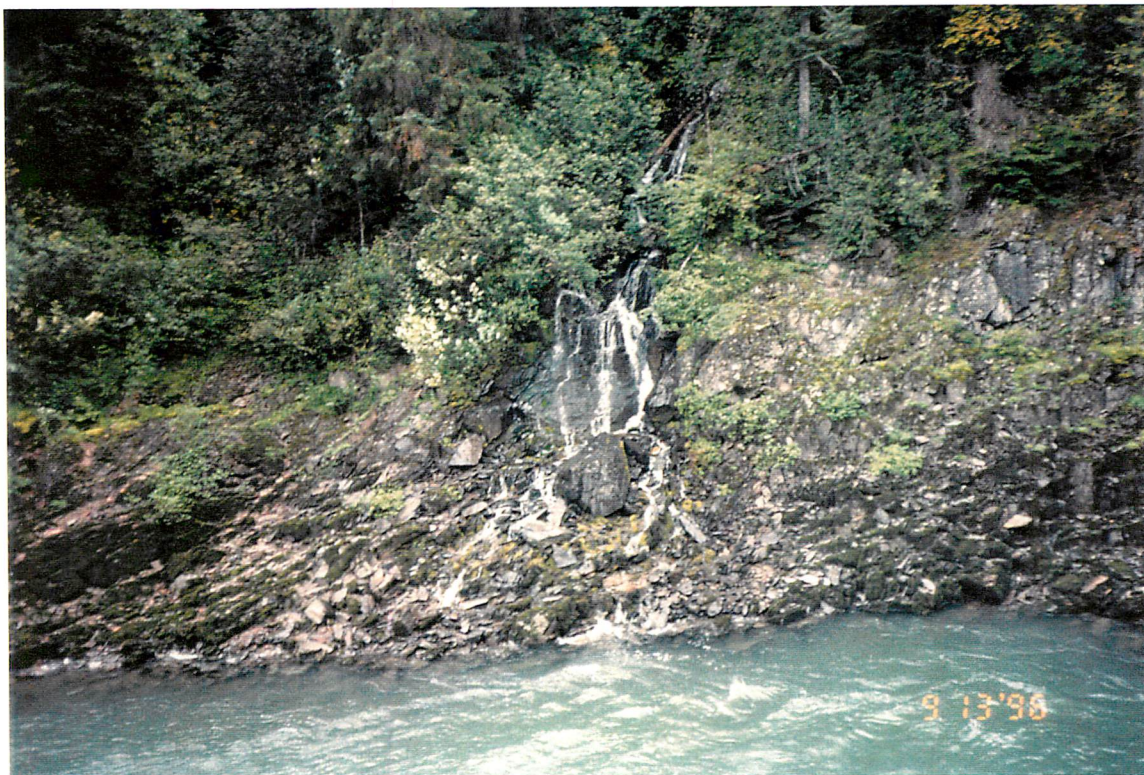
Photo #: A-3-3, 13-Sep-96

Site #: A16, Falls into Skeena, upstream view. Falls are an obstruction to fish passage.

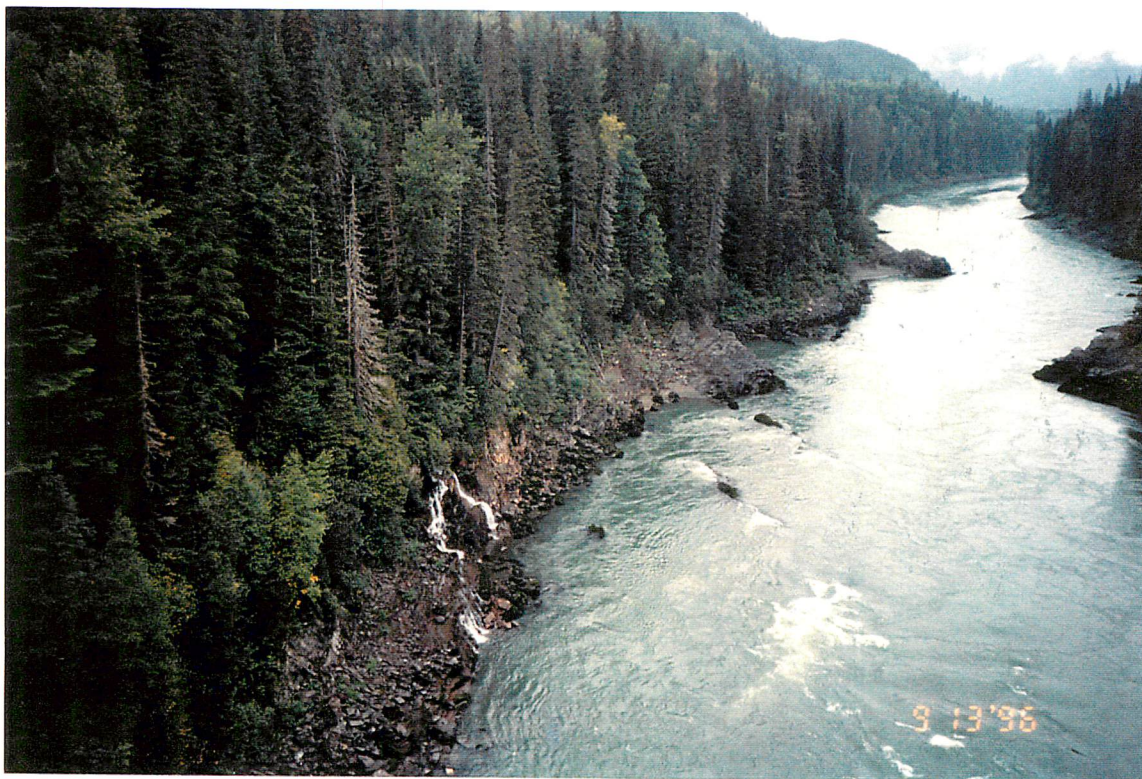
Photo #: A-3-8, 13-Sep-96

Site #: A17, Upstream view of Skeena river, falls on left are a barrier to fish passage.

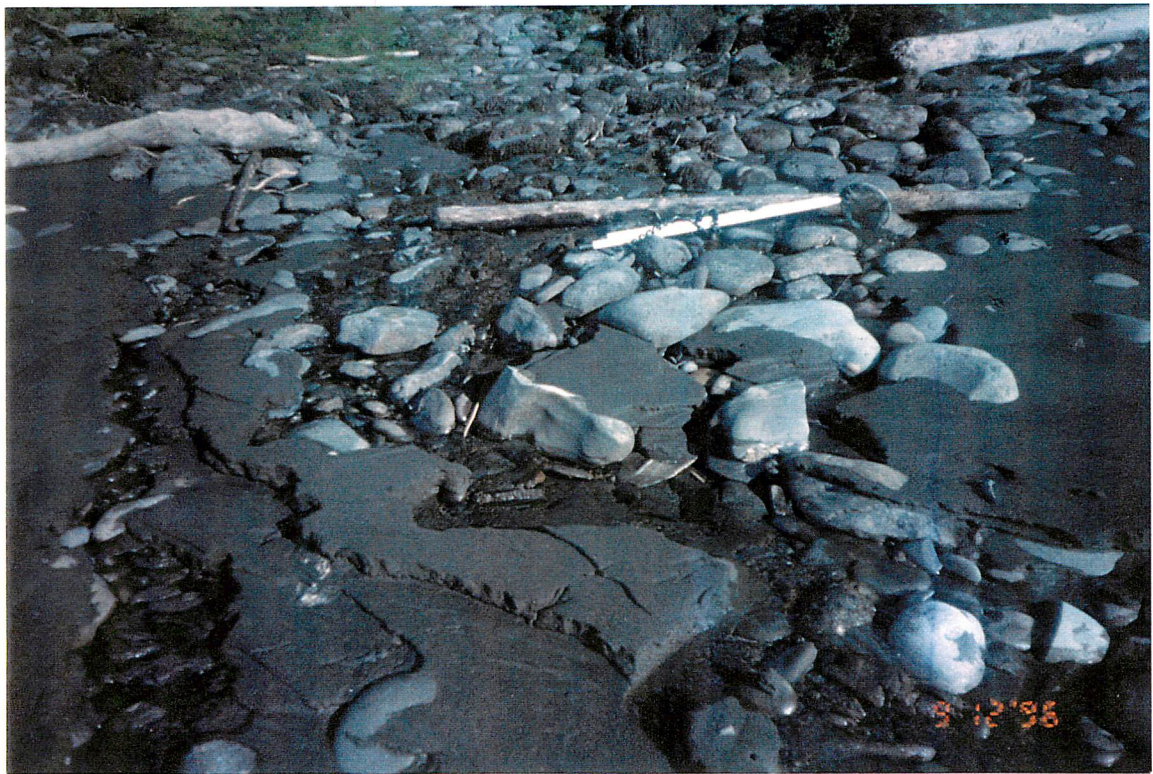
Photo #: A-2-18, 12-Sep-96

Site #: A13, Trickle flow observed in exposed section.

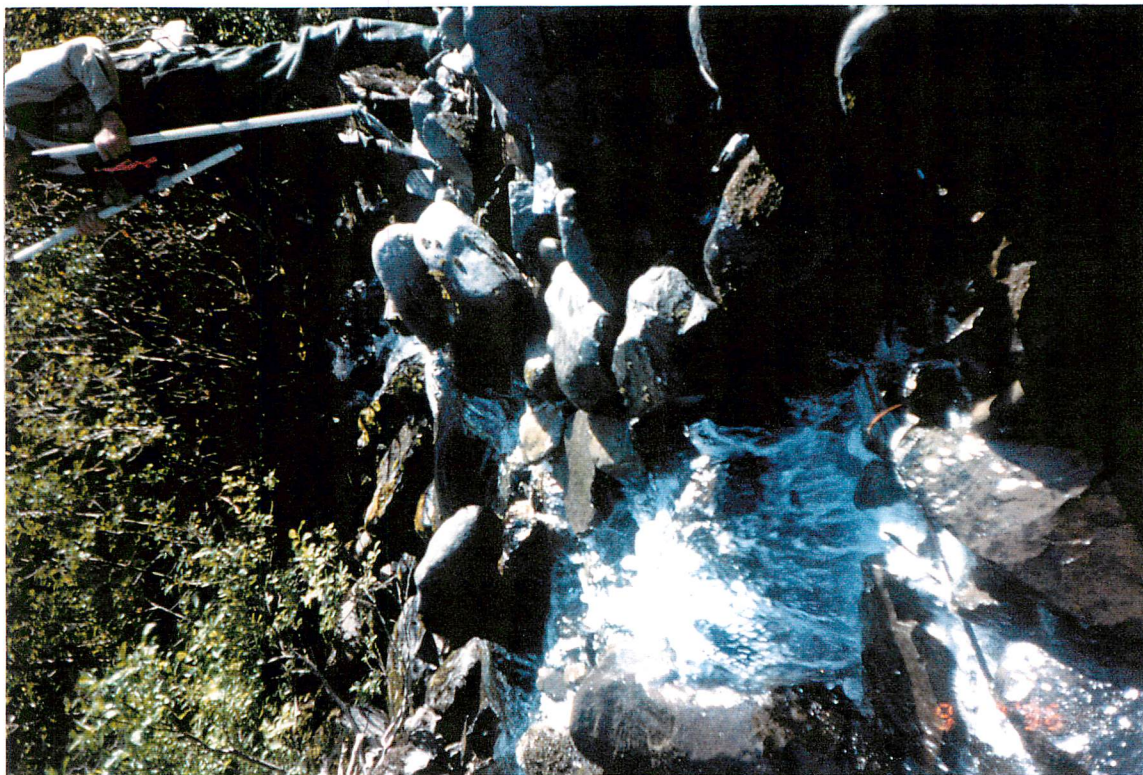
Photo #: A-2-12, 12-Sep-96  
Site #: A12, Cascade that is not a barrier to fish passage.

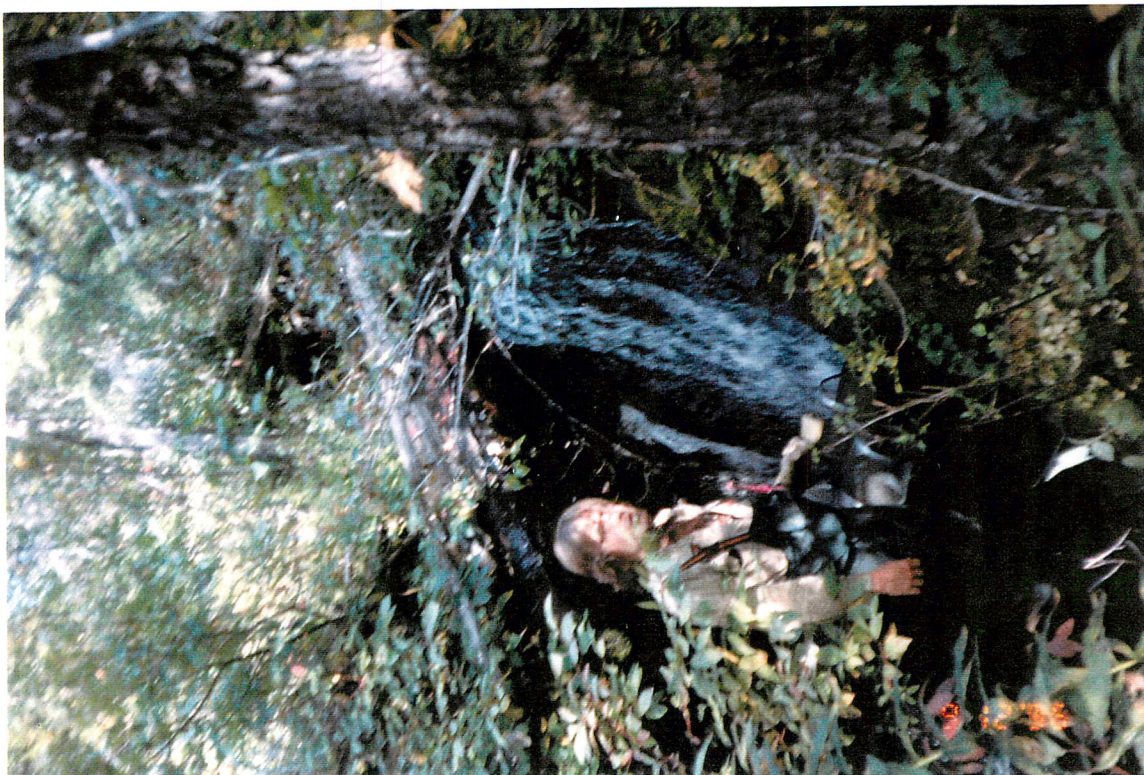
Photo #: A-2-10, 12-Sep-96  
Site #: A11, 2.5 m high falls.

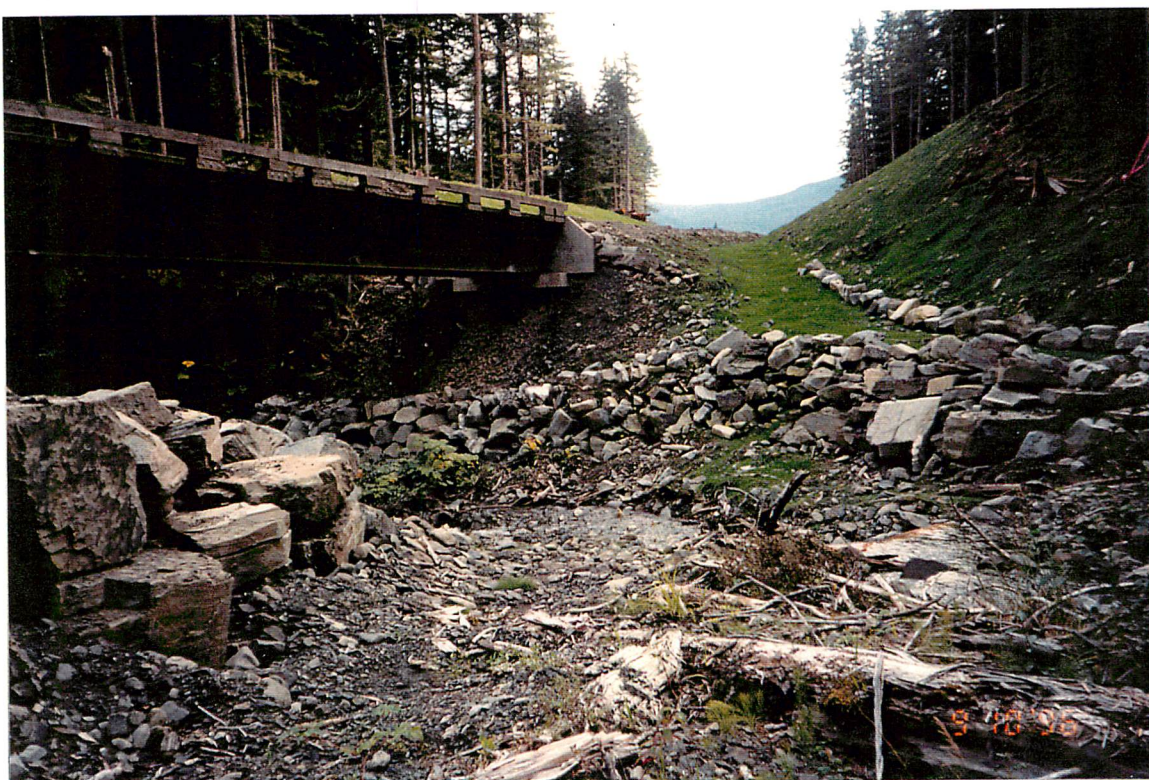
Photo #: B-1-6, 10-Sep-96  
Site #: B2, Looking across at road crossing.

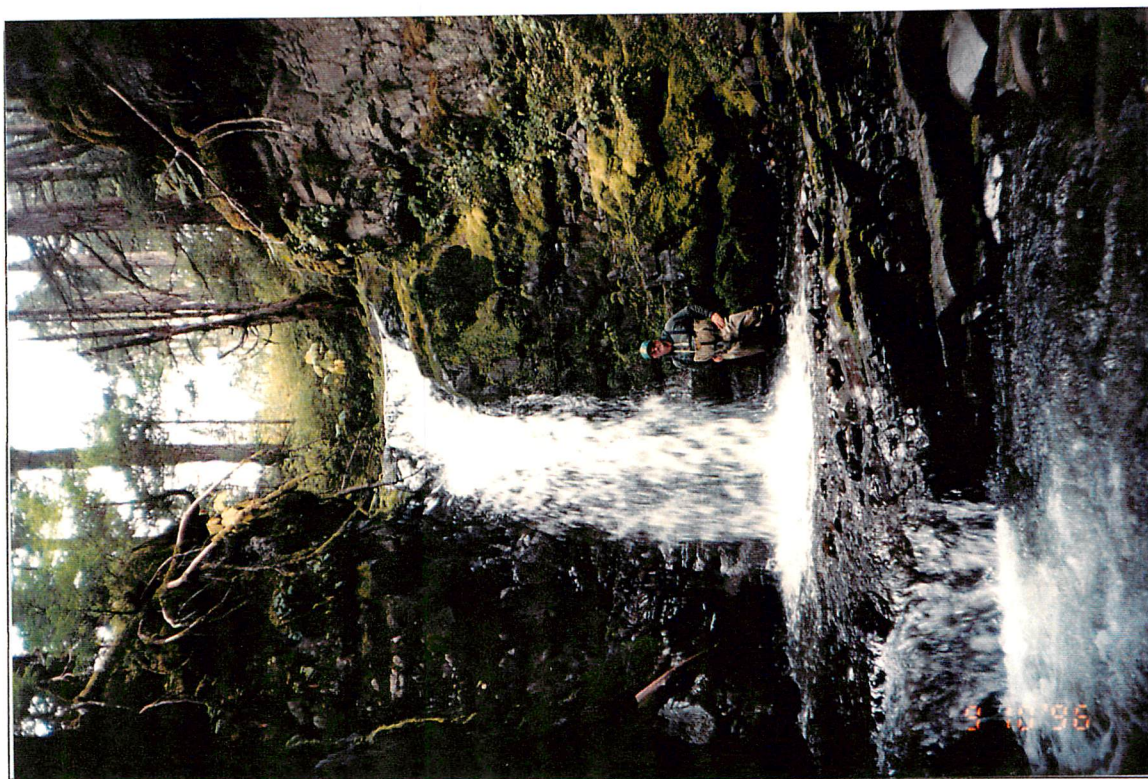
Photo #: B-1-7, 10-Sep-96  
Site #: B2, 5 m falls.

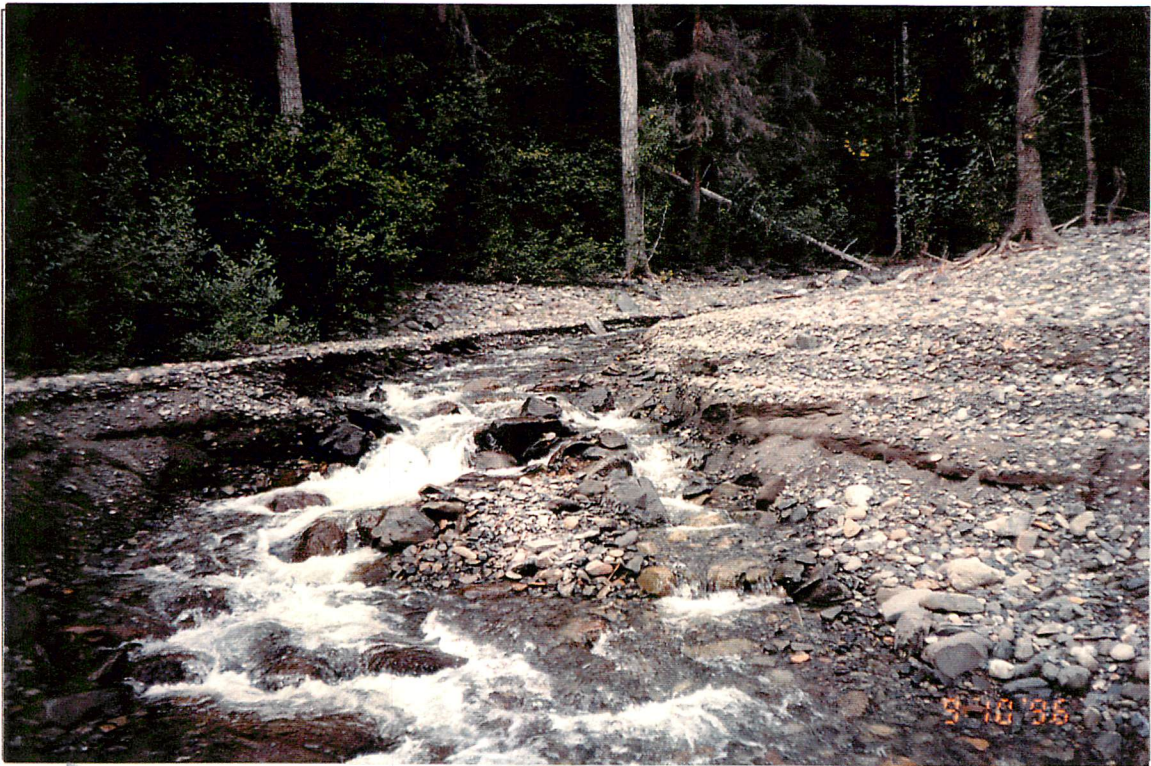
Photo #: B-1-12, 10-Sep-96  
Site #: B4, Looking upstream.

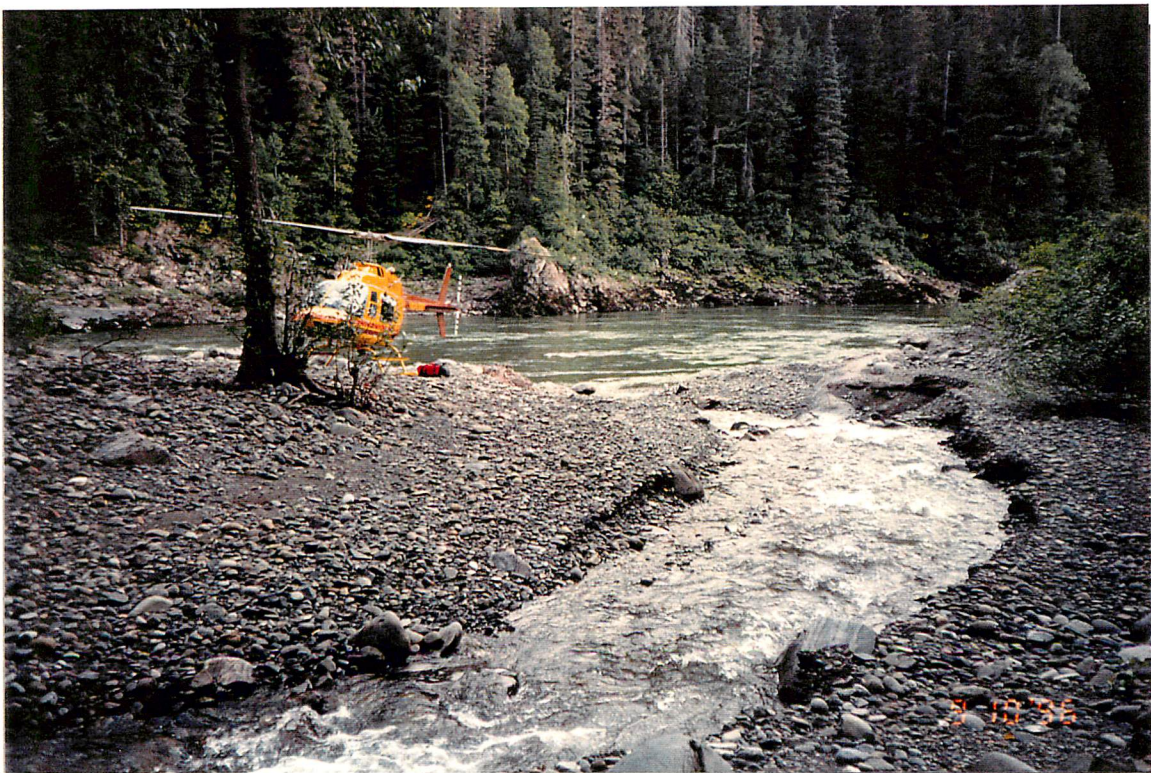
Photo #: B-1-13, 10-Sep-96  
Site #: B4, Looking downstream at confluence with Skeena River.
