# Reconnaissance Level Fish and Fish Habitat Inventory for the Kispiox Forest District

*Prepared for:*

**Repap Smithers**

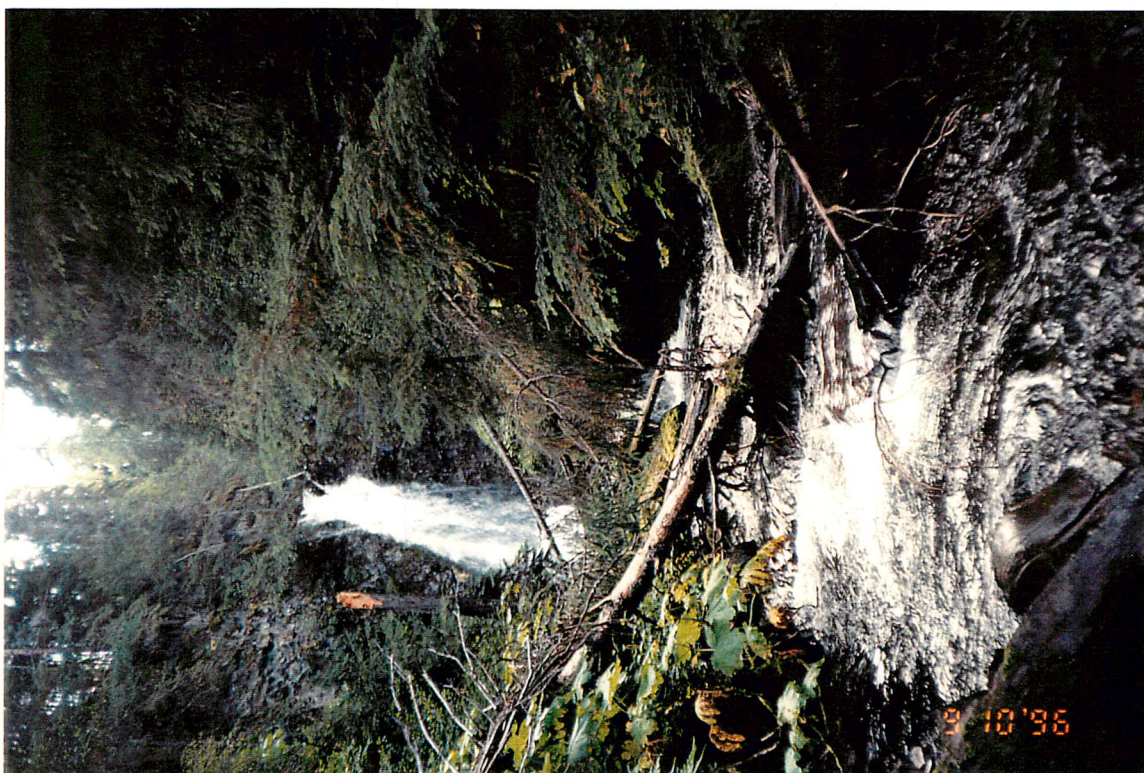
Photo #: B-1-15, 10-Sep-96  
 Site #: B4, 8 m falls.
